Investigation Report (FRACAS)

NTSB Investigation CEN14LA127

Customer:	Eaton Corp.	R/O Number:	Hand Carried
Part Number:	453847	P/O Number:	
VRM P/N:	40459-1B	Serial Number:	0319
Date Received:	4/9/14	Debit:	TBD

National Transportation Safety Board (NTSB) investigation related to an accident involving a Piaggio P180 aircraft that had an un-commanded landing gear collapse during landing roll following an emergency landing gear extension. NTSB Investigation: CEN14LA127.

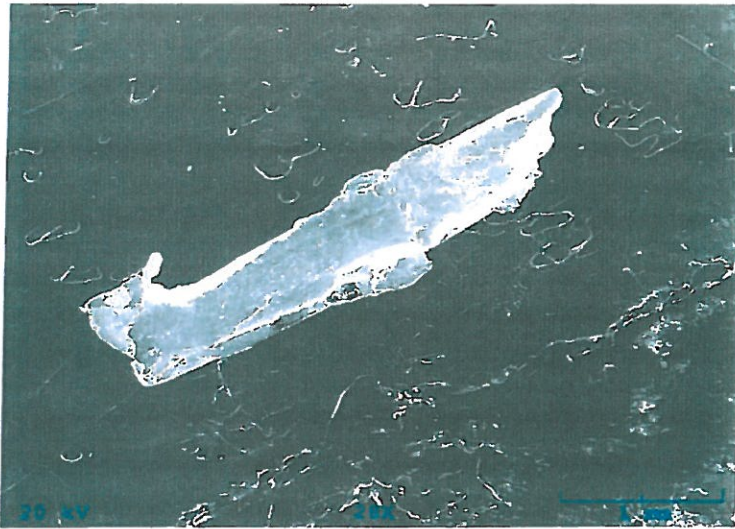
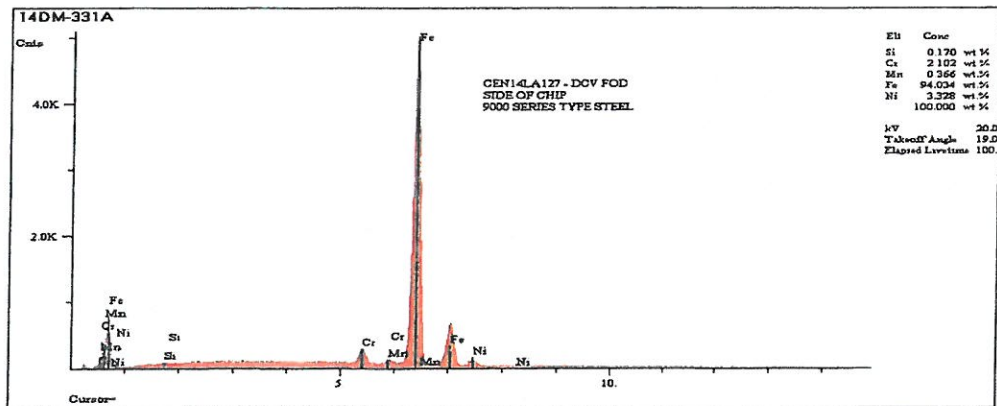
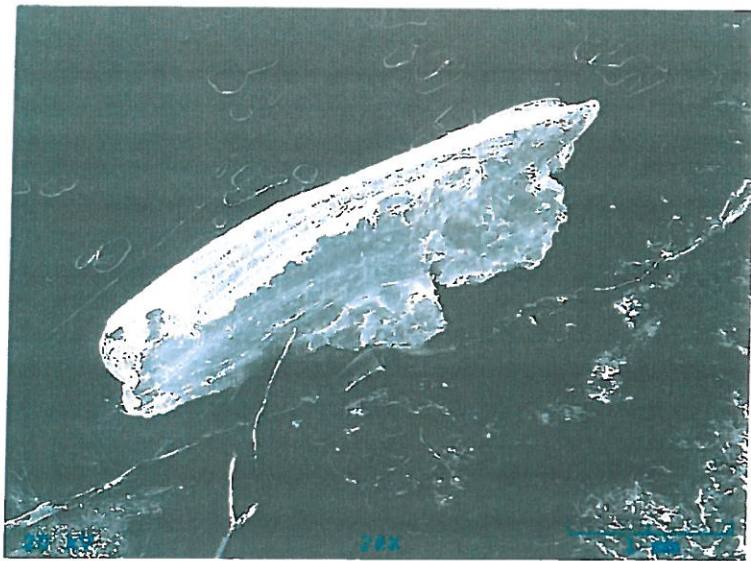
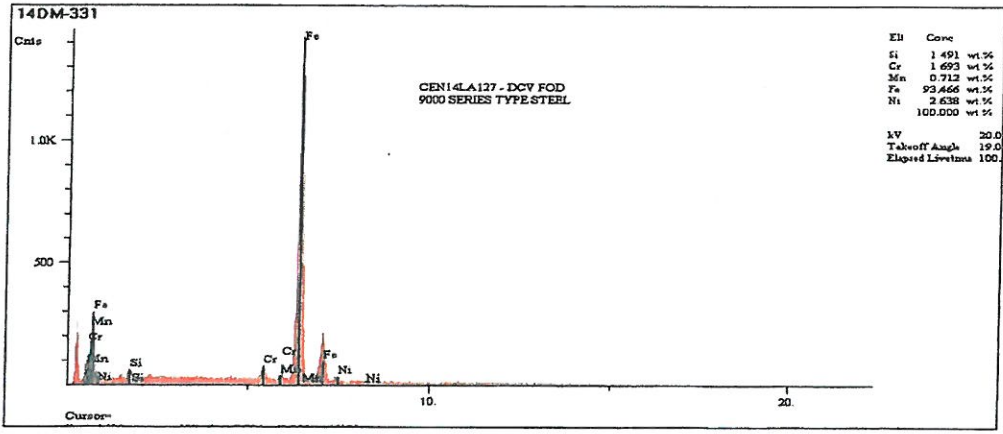
ADDENDUM A

Images taken by QC Metallurgical suggest the particle measured 3.3 mm long, 1 mm wide, and 0.5 mm thick. The particle was not mounted or metallurgic ally prepared so the measurements are approximations. SEM analysis indicated the chip is consistent with a 9000 series steel. Ref. Addendum A

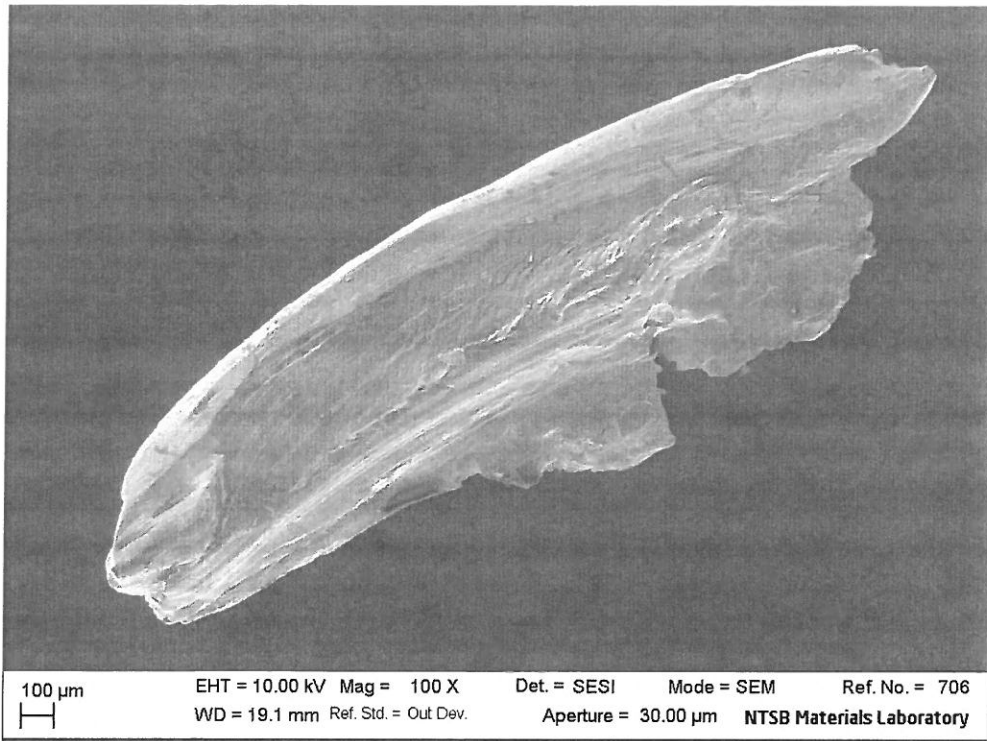
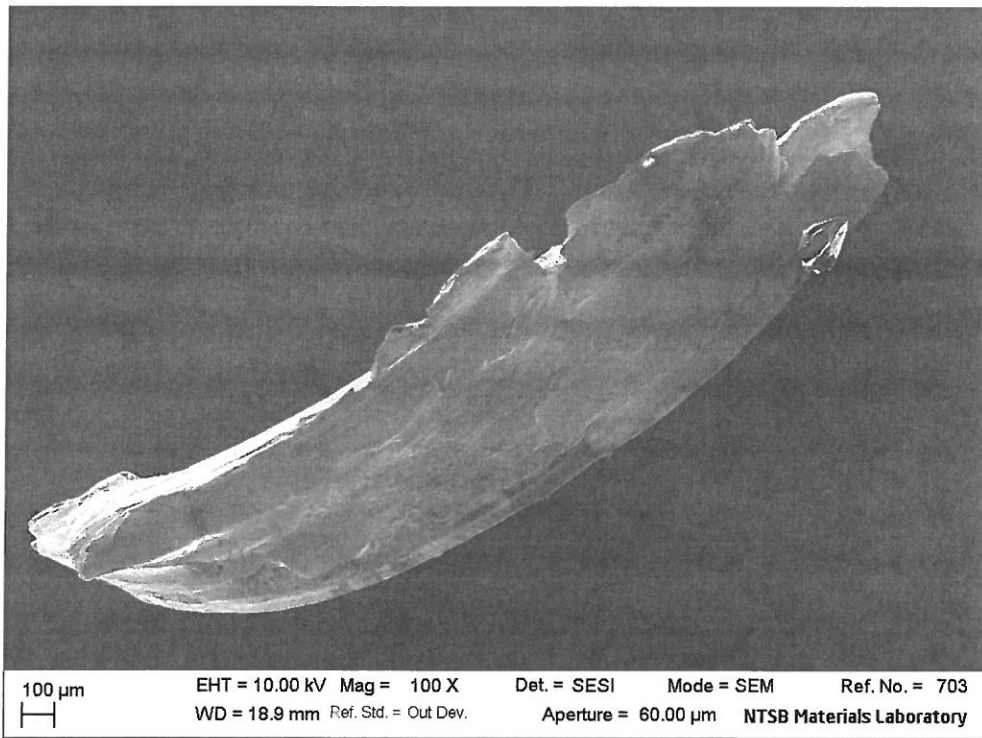
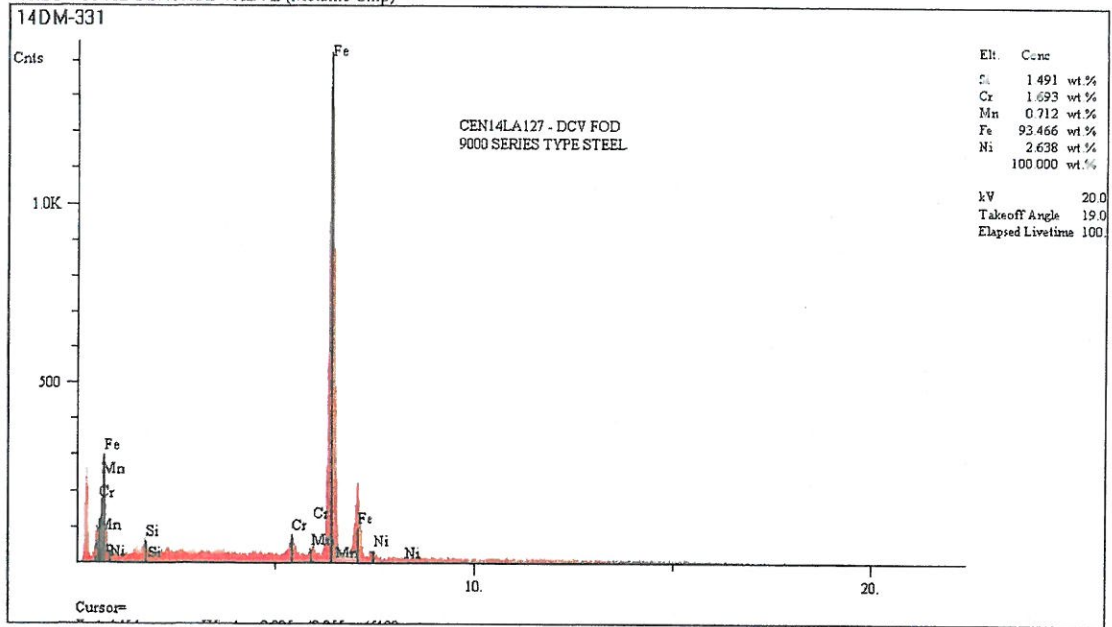
ADDENDUM B

The particle was taken by Todd Fox (NTSB) for additional analysis. Images taken by the NTSB suggest the particle measured approximately 2.9 mm long, 0.98

mm wide and an unknown depth. NTSB analysis of the composition of the particle indicates it is consistent with 93xx or 33xx steel. EDS testing determined that the composition was approximately 94% Fe, 3% Ni, 2% Cr, and d0.5% Mn. Other trace elements identified (Al, Mg, Si) are likely related to the particle being in close contact with aluminum component within the DCV. Ref. Addendum B
