## Caution and Warning Panel Documentation of Light Bulb Filaments

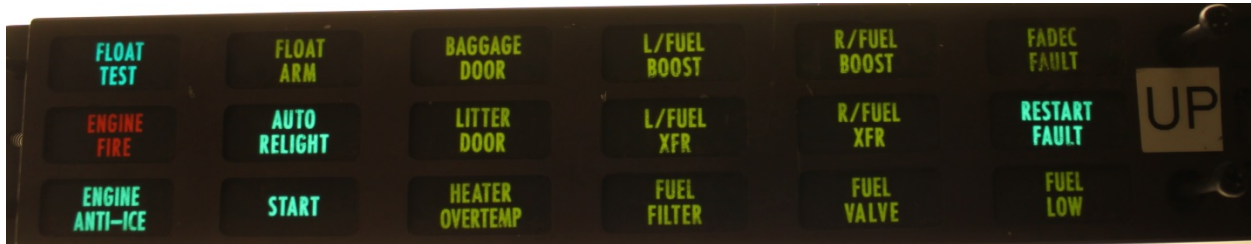
Caution Advisory Panel – Left Side

Photographs depict the accident panel backlit to document all caution/warning annunciations.

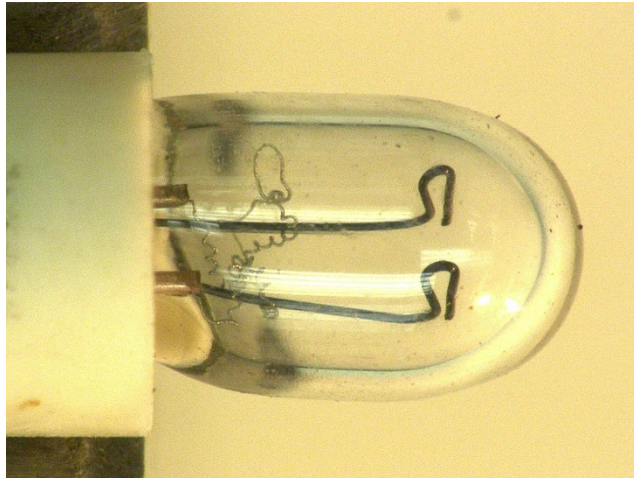
**Bulb 1 – Left position**  
Filament stretched / intact

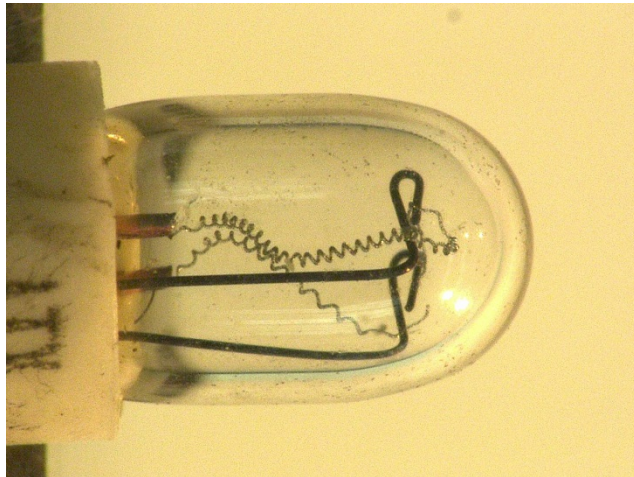
**Bulb 2 – Center position**  
Filament stretched / broken

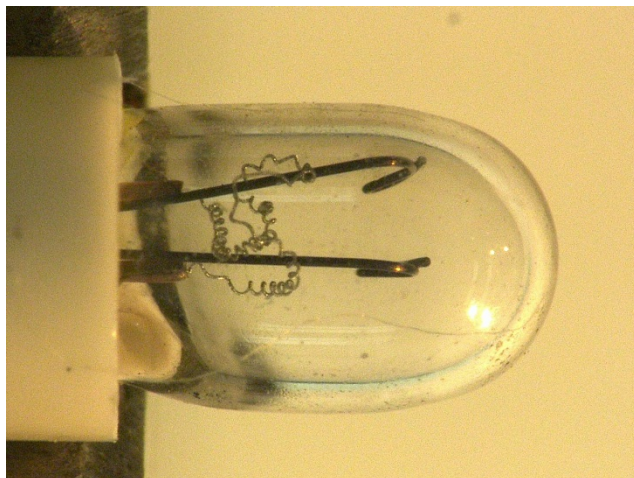
**Bulb 3 – Right position**  
Filament stretched / intact

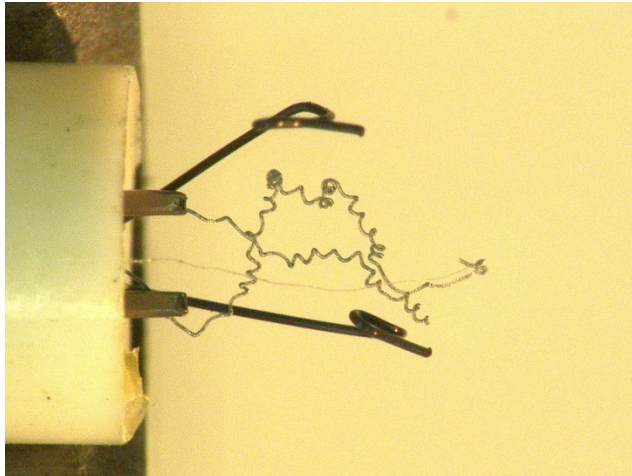
#### **Bulb 1 – Left position**

Glass envelope broken  
Filament stretched / broken  
(Strand from base/insulator fused  
to filament strand.)

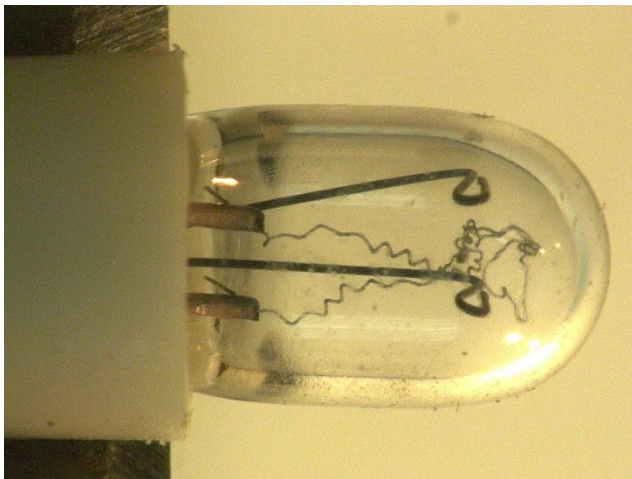
#### **Bulb 2 – Center position**

Filament stretched / intact

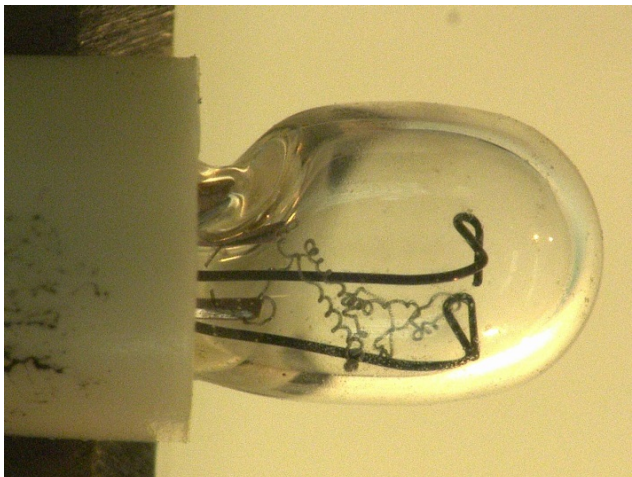
#### **Bulb 3 – Right position**

Filament stretched / broken

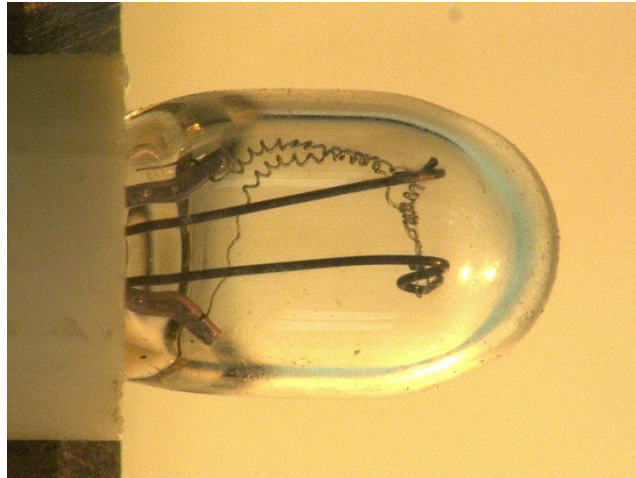
#### Bulb 1 – Left position

Filament stretched / intact

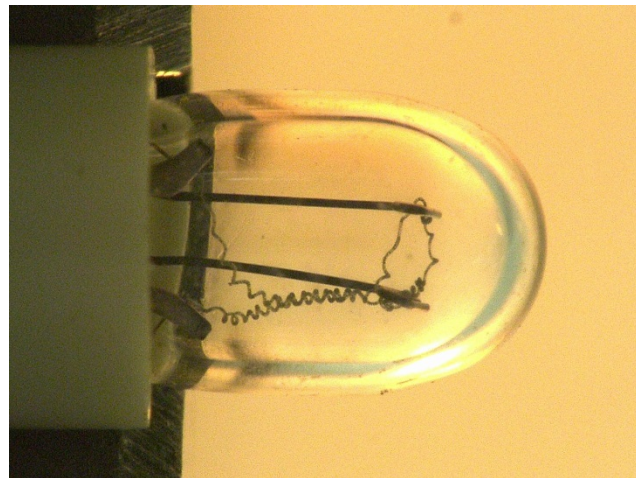
#### Bulb 2 – Center position

Filament stretched / intact

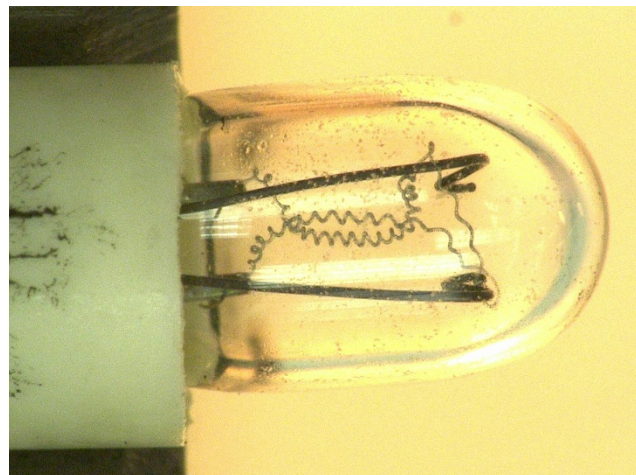
#### Bulb 3 – Right position

Filament stretched / intact

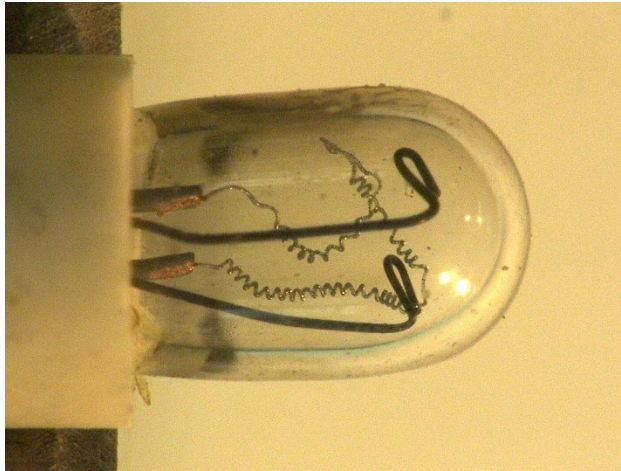
**Bulb 1 – Left position**

Filament stretched / intact

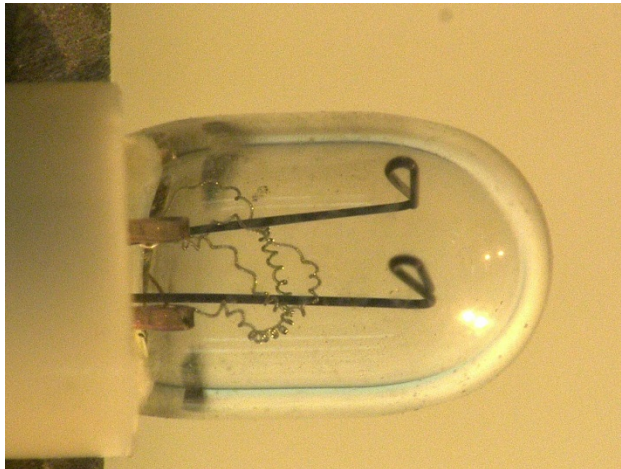
**Bulb 2 – Center position**

Filament stretched / intact

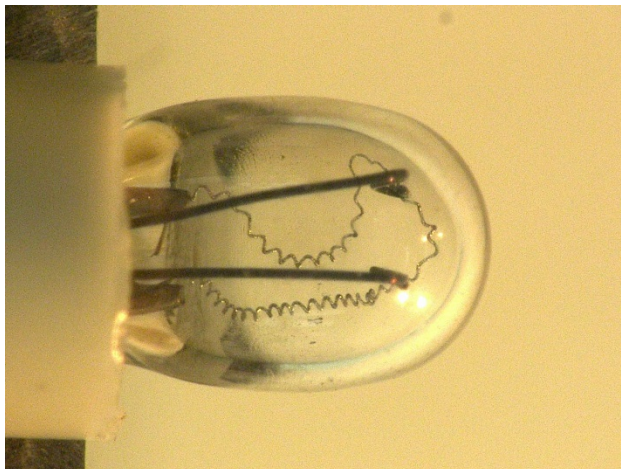
**Bulb 3 – Right position**

Filament stretched / intact

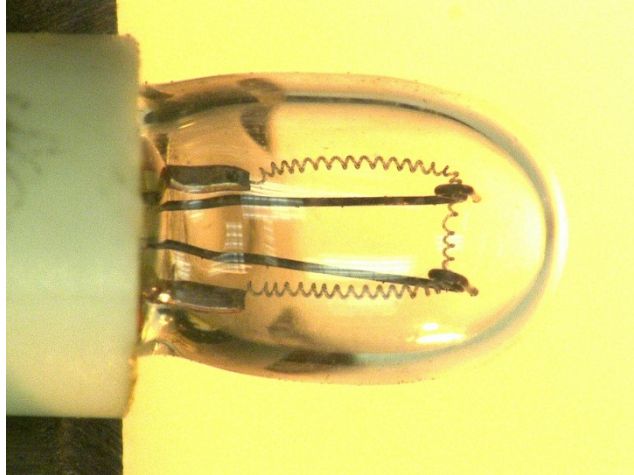
##### Bulb 2 – Center position

Example of a bulb filament that is intact with minimal stretching between the supports.

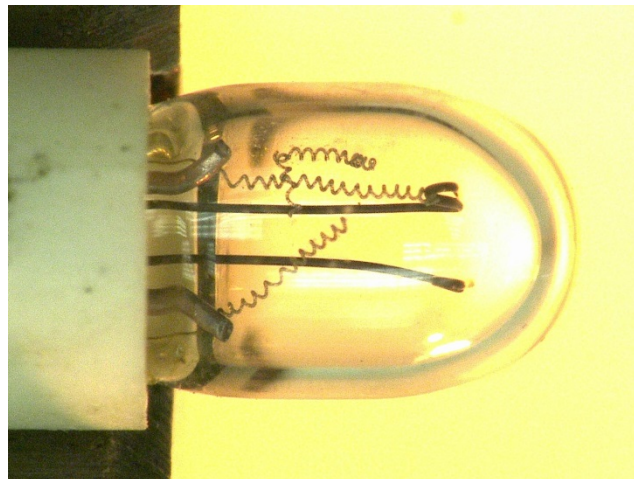
##### Bulb 3 – Right position

Example of a bulb filament that is broken, but otherwise exhibits minimal stretching.
