GLENDALE, CALIFORNIA
Dynamic Science, Inc. No. 013
Volpe, John Hopkins/FRA

Injury Causation Study Field Notes

Crash Date: January 26th, 2005
Crash Time: 0602 Hours (6:02 a.m.)
Crash Type: Metrolink Train No. 100 Southbound impacts Jeep Cherokee
Parked perpendicular on tracks and derails impacting northbound
Metrolink Train No. 901. The lead car of Train No. 100
subsequently impacts stationary Union Pacific locomotive

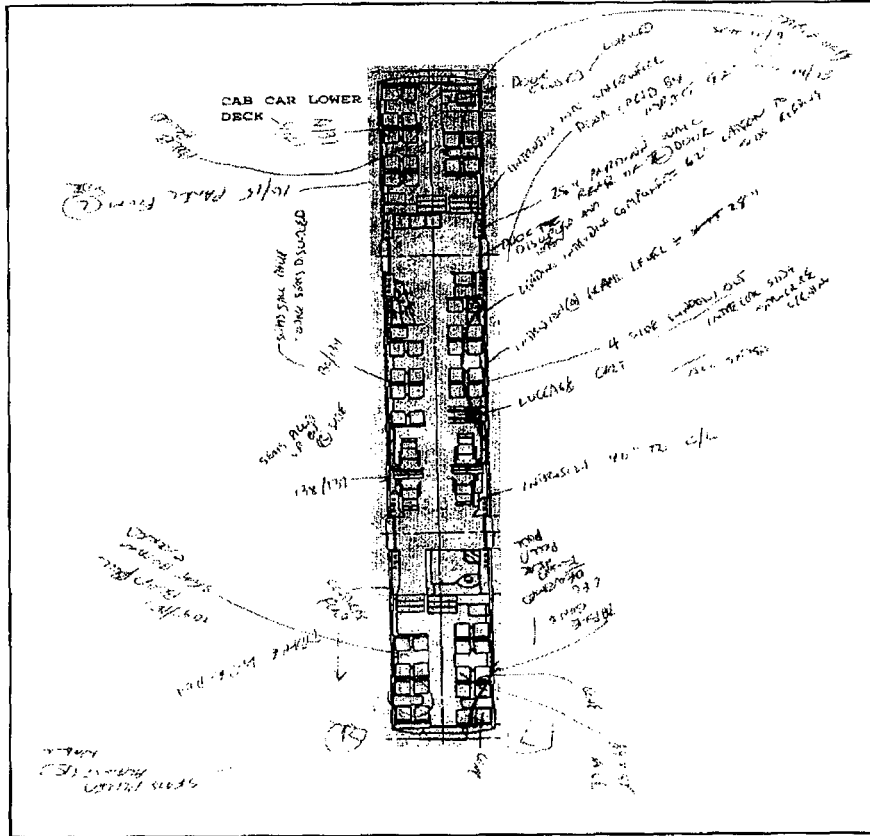
The seats along the left side of the car were heavily damaged, almost beyond recognition. Only

the aluminum seat anchor structure remained and was heavily deformed to the right, but still attached to the left side longitudinal re-enforcement beam structure. The actual fiberglass seat structures and cushions were piled up against the right side wall surface of Car No. 623. All left

side windows in the lower level were completely displaced due to the impact.

The left rear side entrance/exit doors completely separated due the impact and the opening was approximately 92 longitudinally. The trailing edge of the door was “snagged” which increased the longitudinal displacement and resulted in the left door opening. The partition door rearward of the left rear side entrance door intruded laterally 28 in.

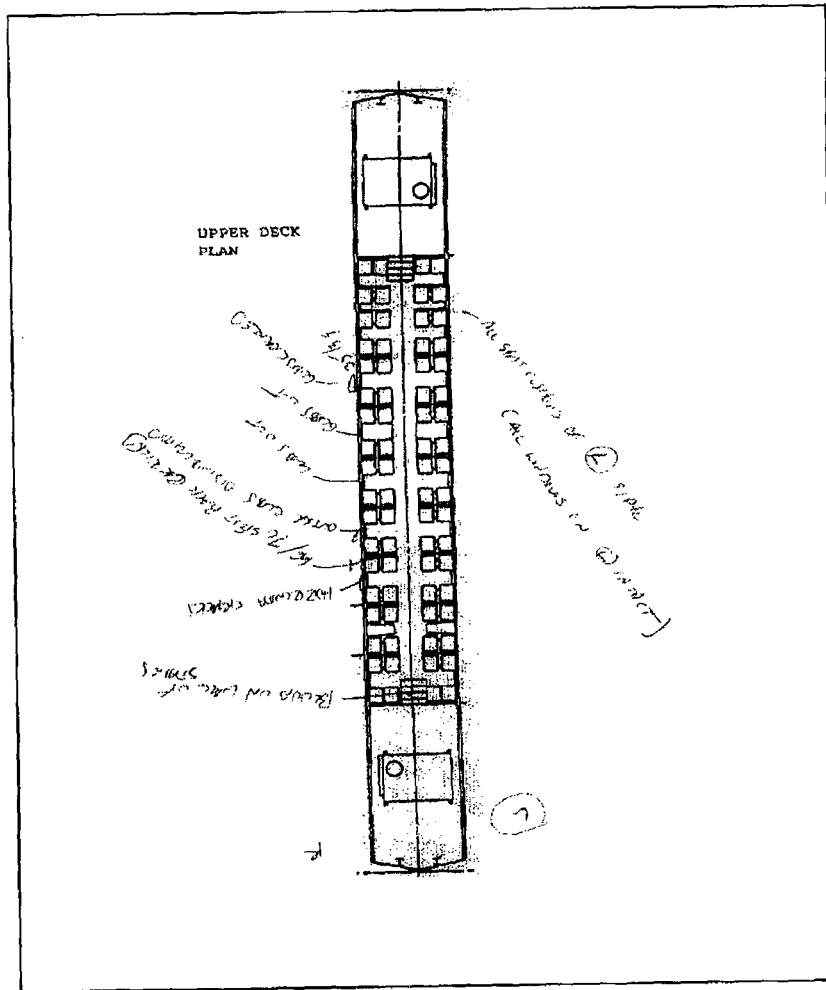
The lower, front mezzanine area was accessed and there was large blood deposit noted to the right side seated positions adjacent to seat 97 on the right hand side. Moving forward of this area, on the left hand side, there was a large gapping hole present to the left side plane/ corner area.. This hole measured 89 in. x 55 in. which resulted in a large area for possible occupant ejection.

A large blood deposit was noted against the right side wall, adjacent to seats 98/97. There was a cigar that was stuck or pasted to the wall due to the drying blood deposit. There was large amount of seating material and debris noted to have been piled up against the right side of the car adjacent to seats 106 & 105. The left roof side rail/lighting air ventilation ridge intruded laterally 36 in. into the forward, lower level mezzanine area (refer to Figure 2).

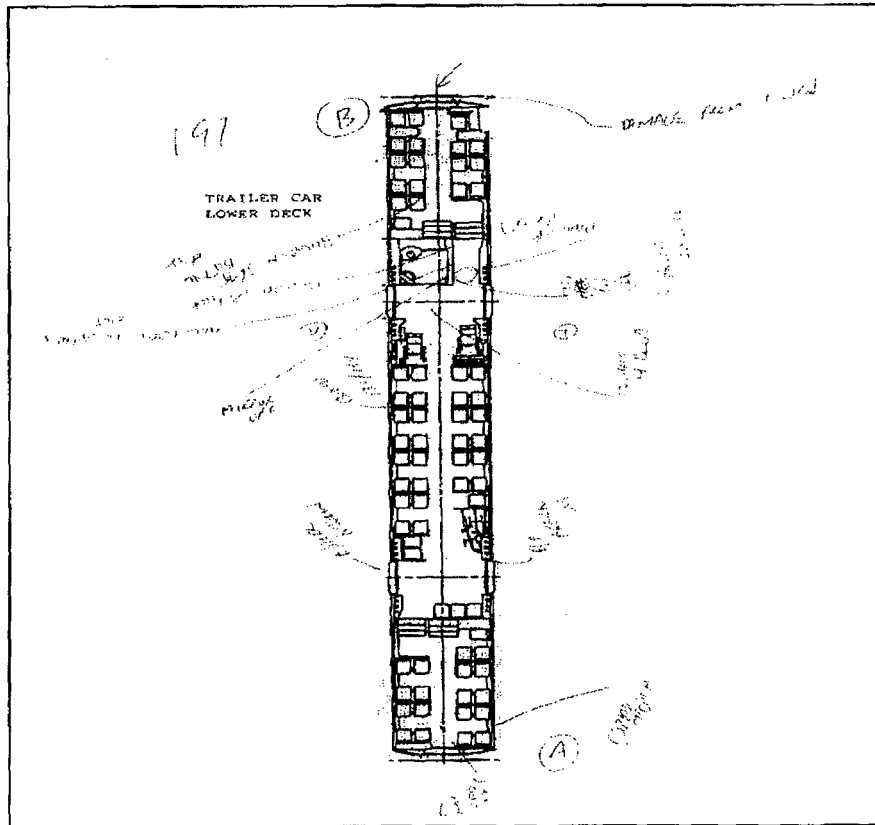
Moving down the stairwell towards the front of the car, it was noted that the panels which cover the sledge hammer/saw and fire extinguisher were opened/broken. Immediately forward of the narrow hallway, a large blood pooling and spatters were documented on the floor surface,

adjacent to the left rear side entrance/exit door. The door to the handicapped bathroom was noted to be operational and the latching mechanism worked. The left wall mounted mirror fell off of its mounts, onto the bathroom floor. There was small blood deposit noted to the leading edge of the handicapped bathroom door frame. This was probably a hand smear that occurred during the vehicle exiting process.

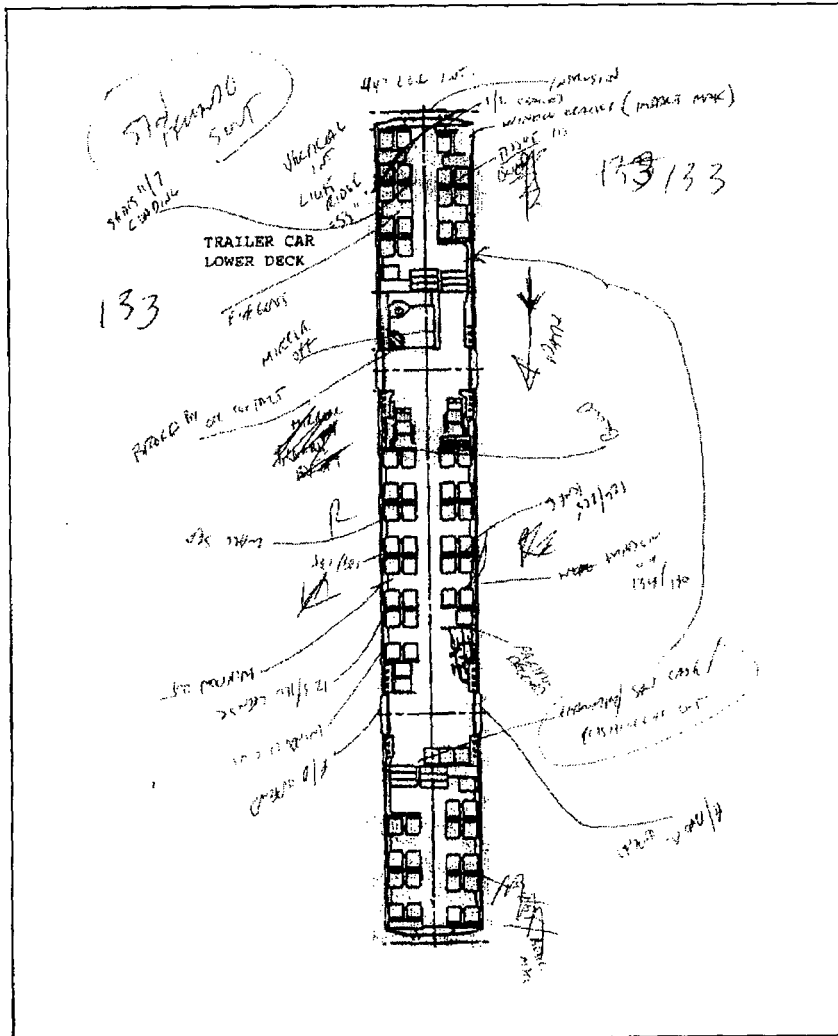
Proceeding up the stairwell, the forward, mezzanine area was inspected. The forward, left area and seated positions sustained significant deformation due to contact with the northbound train (while leading car No. 625 was angulated). The left light/ventilation ridge and roof panel was displaced vertically downward 55 in. and also intruded laterally approximately 31 in. to the right, nearly to the vehicle centerline. There is a blood deposit noted to the head restraint next to isle seat No. 10 on the right side of the car and immediately across the isle, there is loading evidence to the seatback support of isle seat No. 11 and 7. Blood deposits and broken side seat panels are noted adjacent to seat No's 9 & 2 on the right side of the car. In addition, the window on the right side in this vicinity is shattered. The leading end wall where the door is located, intruded longitudinally approximately 44 inches due to the impact.

Moving up the stairwell from the lower/ forward mezzanine area, the upper level was assessed and documented. The light/ventilation ridge in the lower front mezzanine area loaded the back/ upper partition wall. This induced impact displaced and fractured the panel. A scuff mark on isle seat No. 26 (left side of car) was noted to the seatback support. An emergency exit window on the right side of the car, adjacent to seat No's 28/32 was partially pulled, but the window did not separate from its bonds or gasket. It appears that the passenger may have had difficulty removing the window or aborted this process when another route was potentially identified. The center table completely separated from its floor anchor bolts at seat No's 39/38 and 42/43 on the left side of the car. The emergency exit window on the left side along seat No's 47 & 51 was removed.

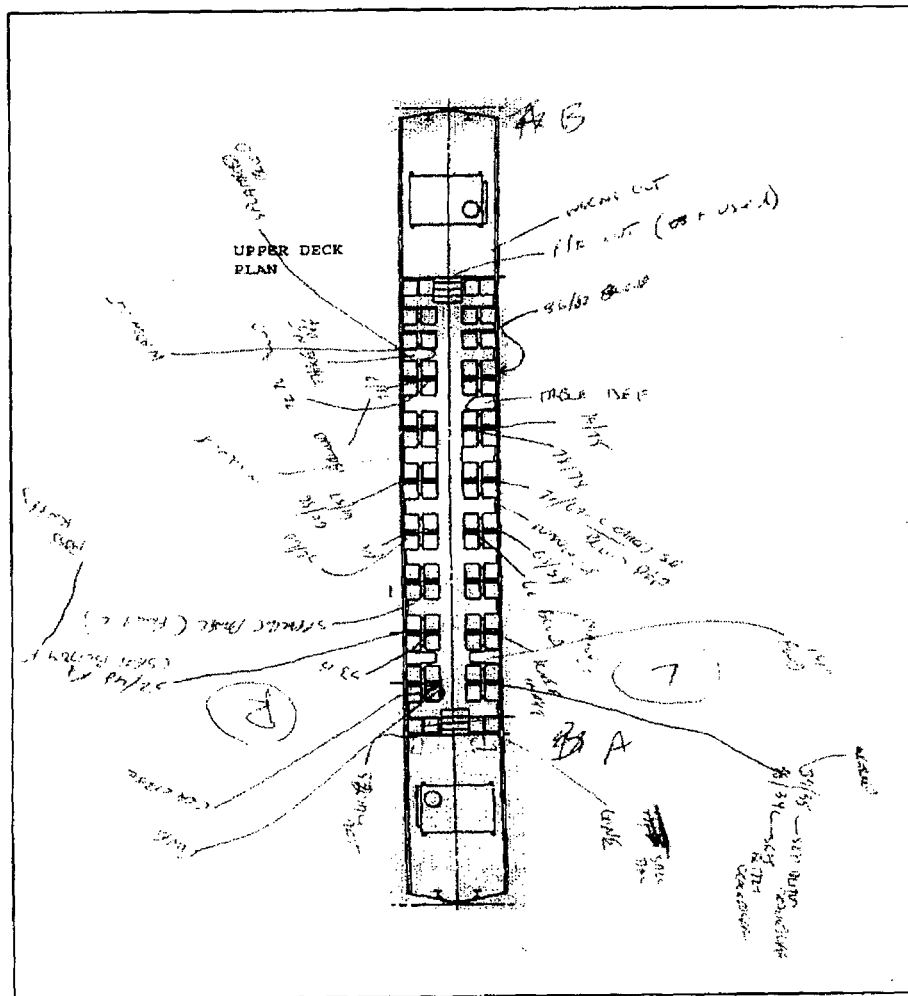
The fire extinguisher that was removed from above the rear stairwell was located on the floor between seated positions 81/80 (isle positions) and was utilized. A large blood deposit/body fluids was identified to seats 71/70 which are rearward facing seats (70 is an isle seat and 71 is a window seat). In addition, a sizeable blood deposit (pooling) was noted to the center arm rest area and the armrest was loaded and cracked. The seatback support to 71/67 was fractured or cracked. Blood smears were noted to isle seats 69/65 to the seatback support.

The emergency exit window on the right side, adjacent to seat No's 64 and 60 was removed. The seatback support to seat No. 64 is cracked and the emergency exit window across the center isle and adjacent to window seat No. 63/67 was removed. Blood deposits & spatters were noted to the seatback support of isle seat No. 62 (left side of car). Blood spatters and droplets were also noted to the head restraint to seat No. 57 (right side of car). The seatback support to the adjacent window seat was also fractured.
