**Douglas Aircraft Company Submission
to the
National Transportation Safety Board**

Delta Air Lines, Inc. MD-88 Uncontained Engine Failure Accident
Pensacola, Florida, 6 July 1996
DCA96MA068

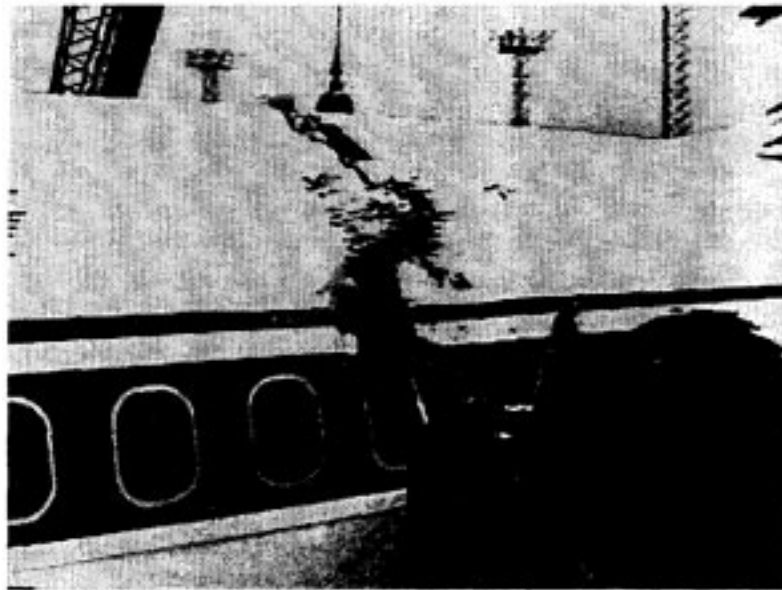
Figure 1. Fuselage Left Side Damage

As described in the *Structures/Systems Group Chairman's Factual Report*, the aft fuselage adjacent to the Number 1 (left) engine sustained puncture holes and tears from the uncontained first stage hub failure (Figures 1 and 2). This

damage was confined to above the cabin floor, and generally from the window belt area on the left side over the top of the fuselage structure to the window belt area on the right side. Numerous frames, longerons, and intercostals were severed, buckled, and/or cracked, and a large "gash" was torn in the left fuselage from the window belt to approximately left longeron 2. Most of the wires in a bundle near right side longeron 4, running fore and aft, were severed, including right generator differential protection loop wires. Damage to the differential circuitry caused the right generator to trip off-line, and the left engine failure brought the left engine generator off line, resulting in the loss of primary AC power (the APU generator was not on line because it was not operating at the time of the accident and would not be operating in flight) until the Emergency Power Switch was selected "ON."

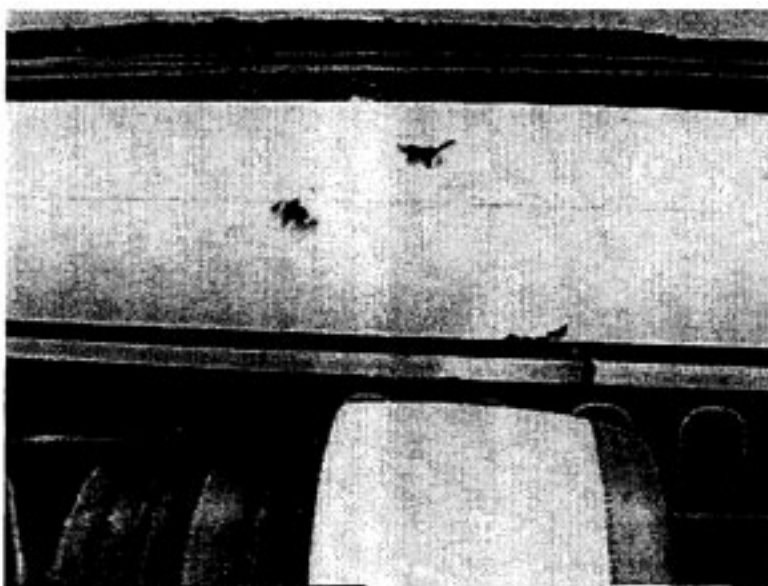
Figure 2. Right Side Fuselage Damage

gouges, skin wrinkling, and fastener “pull-through” is not included in this idealization unless it is believed to affect the load carrying capability of the residual primary structure. The damage to the right side of Fuselage 1524 (see Figure 2 above) consisted of two cut frames plus several widely scattered cuts. None of these cuts were considered individually significant (this assumption is supported by pre-existing MD-90 studies which showed that small cuts opposite a large cut have an insignificant effect on the overall fuselage stiffness and strength), and the cuts were sufficiently scattered such that it is believed that they would not have coalesced into a single (critical) crack.
