## **NATIONAL TRANSPORTATION SAFETY BOARD**

# **Enhanced Ground Proximity Warning System (EGPWS) Download**

**ANC17FA001**

Location: Togiak, AK  
Date: October 2, 2016  
Aircraft: Cessna 208B, Registration #: N208SD, Serial #: 208B0491  
NTSB IIC: Shaun Williams

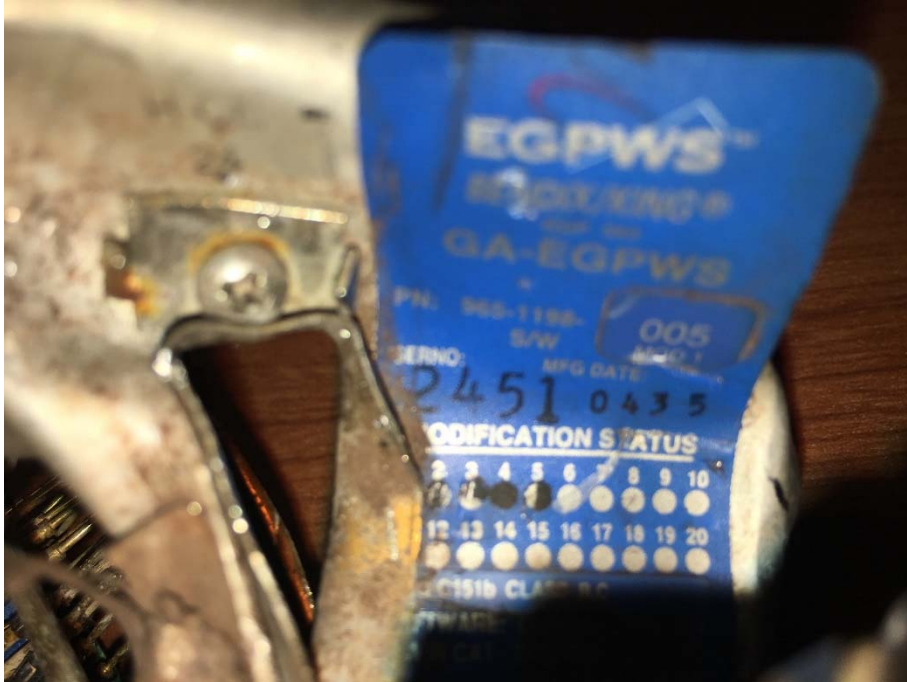
Figure 1: Photo of data plate

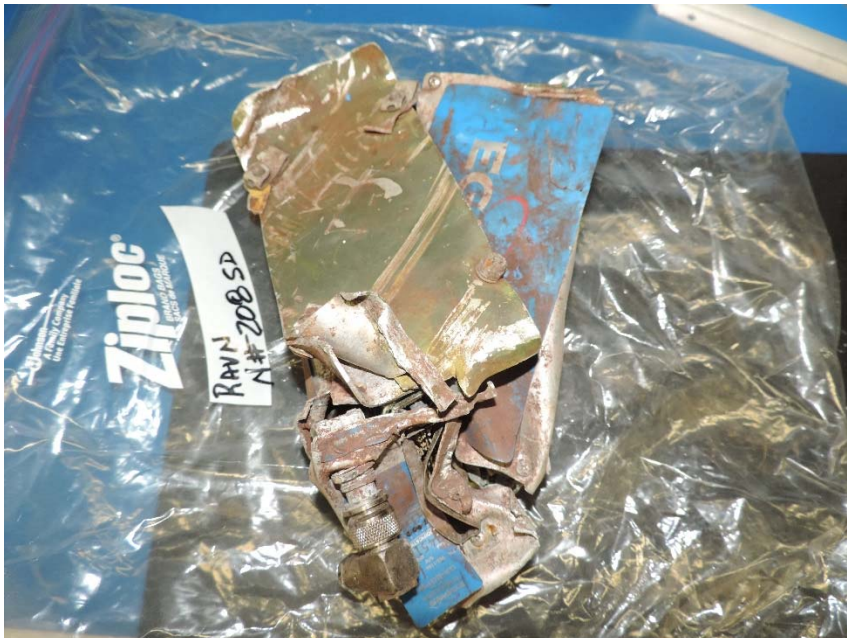
The outer box assembly was covered in dirt and was heavily crushed due to impact. The main data interface connector was also crushed and the main data plate panel was partially separated from the box assembly.

Figure 2: Damaged EGPWS

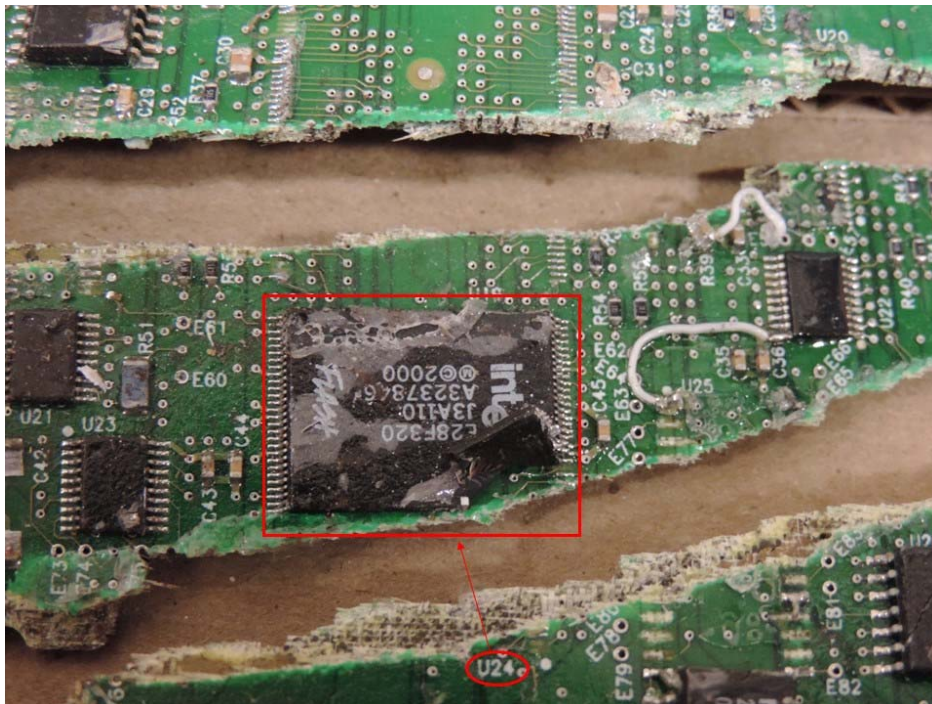
Download was unable to occur due to a damaged U24 chip, the flash memory for the flight data. The chip will be sent to Micron in Folsom, CA for further examination.

Figure 3: Damaged U24 chip
