NATIONAL TRANSPORTATION SAFETY BOARD
Vehicle Recorder Division
Washington, DC 20594

EGPWS Factual Report

Specialist's Factual Report
By Christopher Babcock

Location:	Moscow, Tennessee
Date:	July 11, 2012, 0907 Central Daylight Time (CDT) ¹
Aircraft:	Cirrus SR20
Registration:	N764RV
NTSB Number:	ERA12FA438

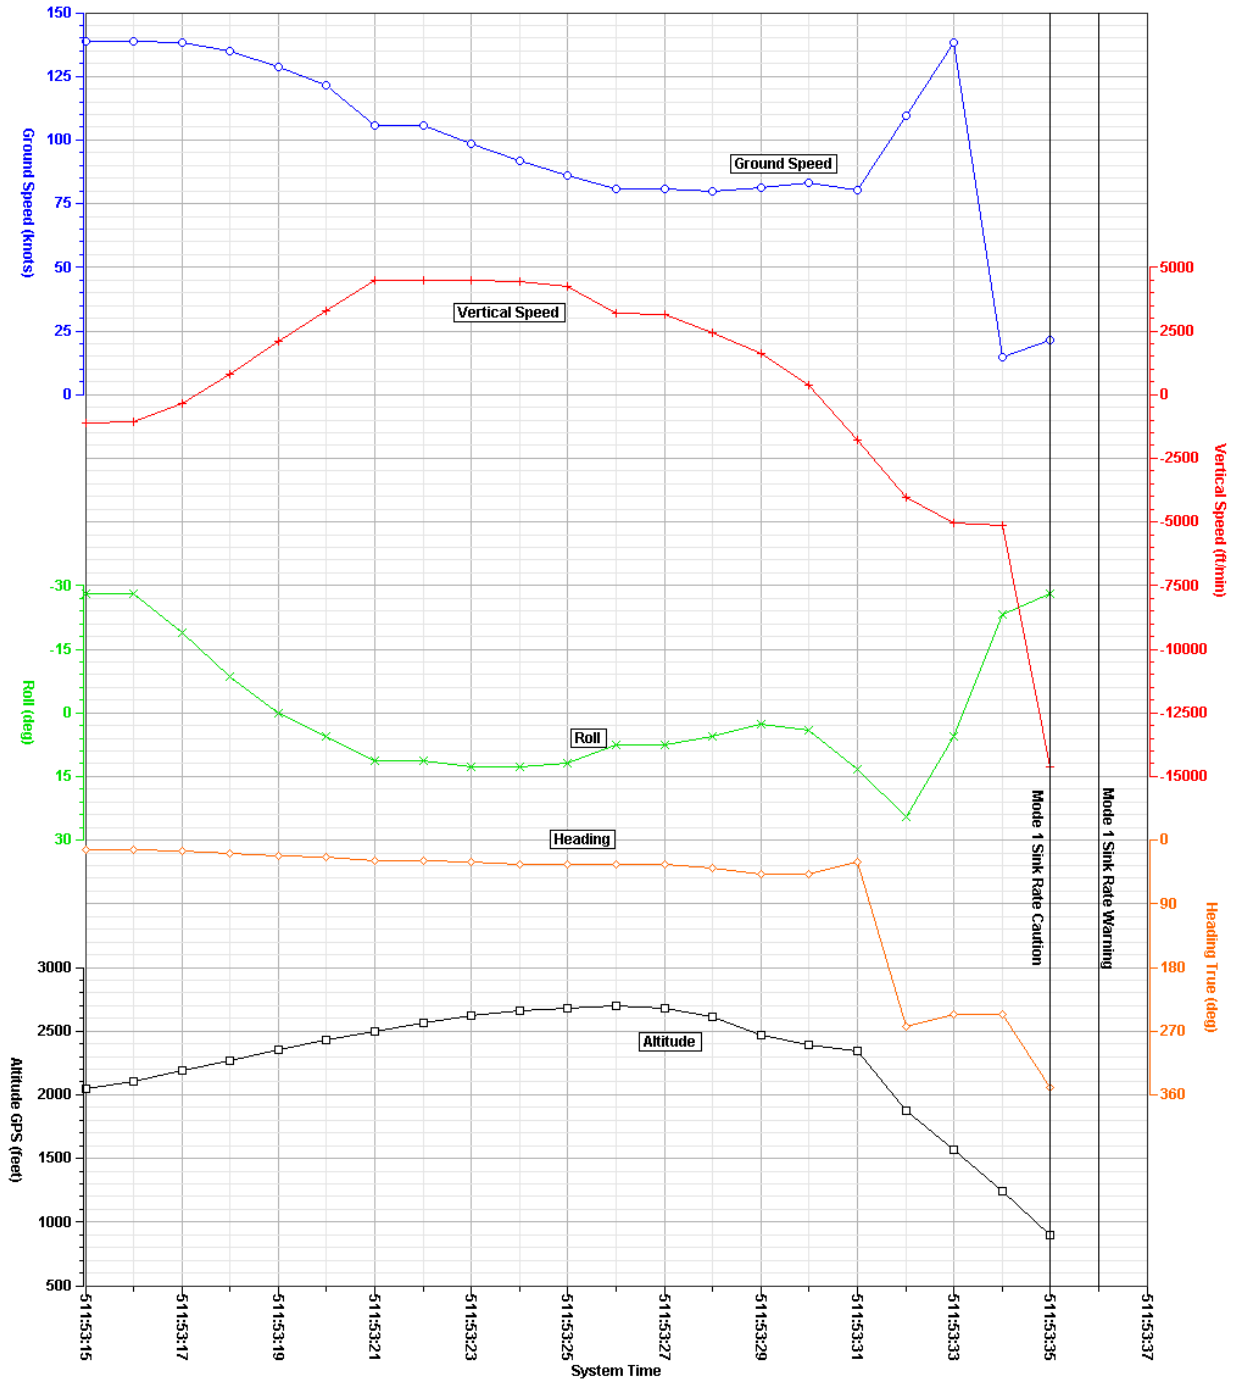
Figure 1. EGPWS data.

The accident aircraft experienced two EGPWS alerts during the accident sequence. A Mode 1 “Sink Rate” caution occurred at system time 511:53:35. A Mode 1 “Pull Up” warning occurred at system time 511:53:36. From the Honeywell KGP-560 Pilot’s Guide:

Figure 1 shows data recovered from the KGP-560 along with the timing of the two alerts. Figure 2 shows a slant-angle Google Earth overlay. Tabular data is available for the EGPWS data as a separate item in the public docket for this accident.
