NATIONAL TRANSPORTATION SAFETY BOARD
Office of Aviation Safety
Western Pacific Region

March 24, 2016

ELT EXAMINATION

Location: Biggs, CA
Date: December 15, 2015
Aircraft: Airbus AS350B3

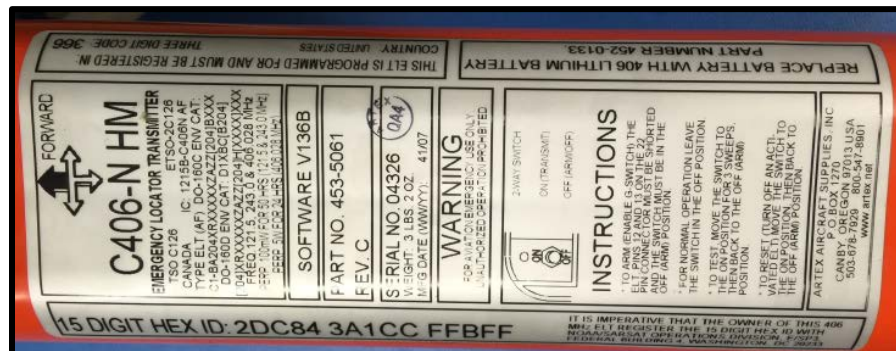
Picture #01: ELT in Accident Helicopter

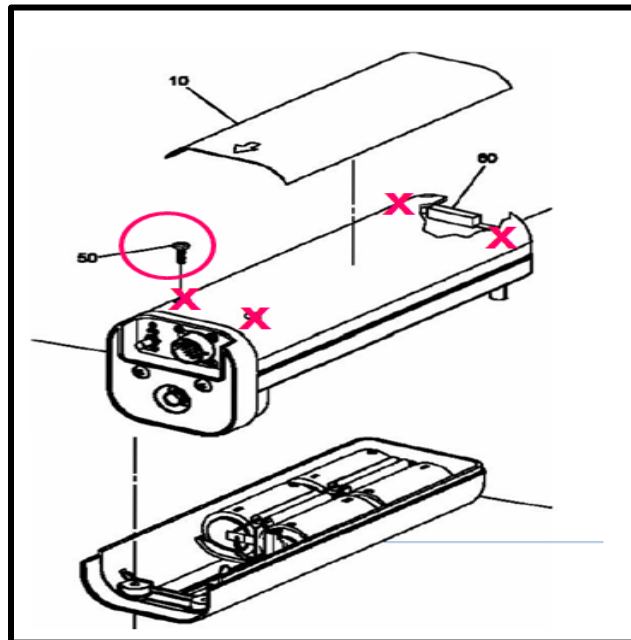
The ELT was removed from a sealed transport box and the NTSB security tape was in place; pictures of the box were taken by investigators. An external examination of the unit revealed that the protective top cover was not included with the shipment. Aside from a crack stretching the entire length of the back of the unit, there is no external damage noted. The torque seal on the 4 screws of the clamshell was green, consistent with that side having been removed since manufacturer. There was no writing on the casing to indicate that that side was not to be removed.

Picture #03: Screws with Green Torque Seal

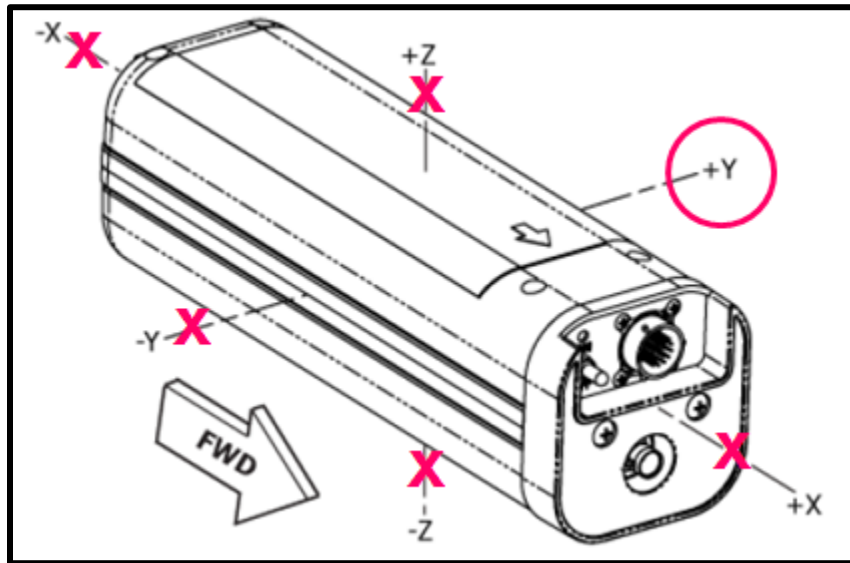
The unit was installed (velcroed) on a test centrifuge. The g-switch did not activate at 3.8g's (tested at 380 MHZ with no activation).

The unit was then tested as per item number 15 (below) by manual force on an office chair (drop test). These instructions are not given to the public. The unit only activated on one axis, the left (+y).

Picture #04: G-Switch Only Activated on One Axis

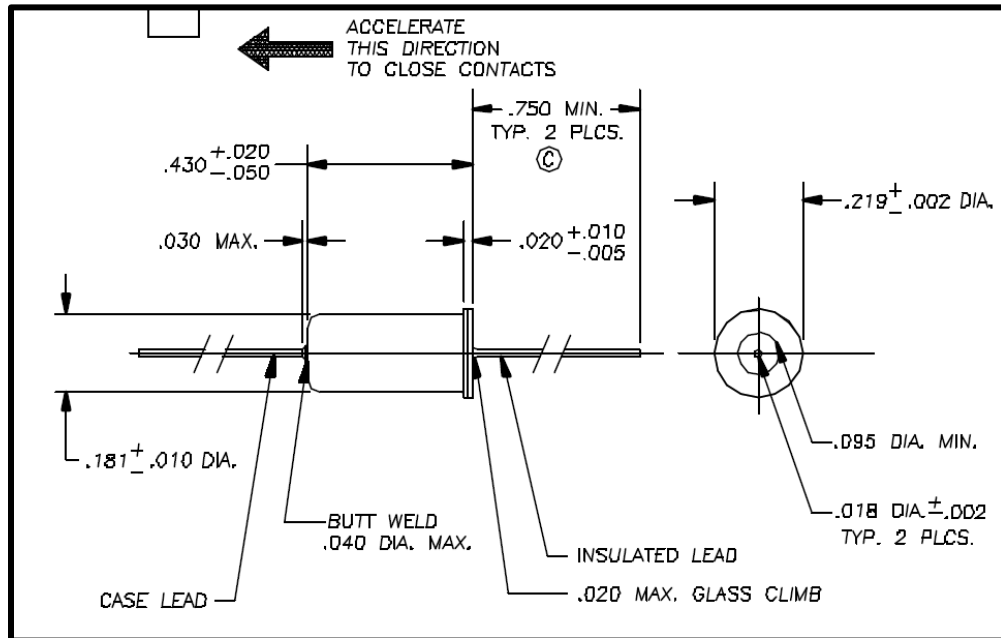
Picture #05: G-Switch

The g-switches are manufacturer by Select Controls from Long Island. It was opened in no discrepancies were noted. After the complete testing (as will be documented in the ACR complete report), the unit was violently hit against hard services numerous times. Eventually, operation of the G switches were obtained in all axis with the exception to the forward (+x) axis.
