SERVICE ENGINEERING REPORT NO: NTSB14AUG06-MX243442

SERVICE ENGINEERING REPORT

Report Title	<u>Motorpump Test Evaluation</u>
Eaton Motorpump Part Number	354744
Motorpump Model Number	AA-19089
Motorpump Serial Number	MX243442
Pump Model Number	PF24-3906-15BCE-S628-4
Pump Serial Number	AVM0217846
Electric Motor	EEMCO (Model No. D1291-1)
Customer	NTSB
NTSB ID:	WPR13LA310
Aircraft Registration:	XB-RSC
Eaton Report Number	NTSB14AUG06-MX243442
Date Prepared:	August 6, 2014
Prepared by:	John Schuerman

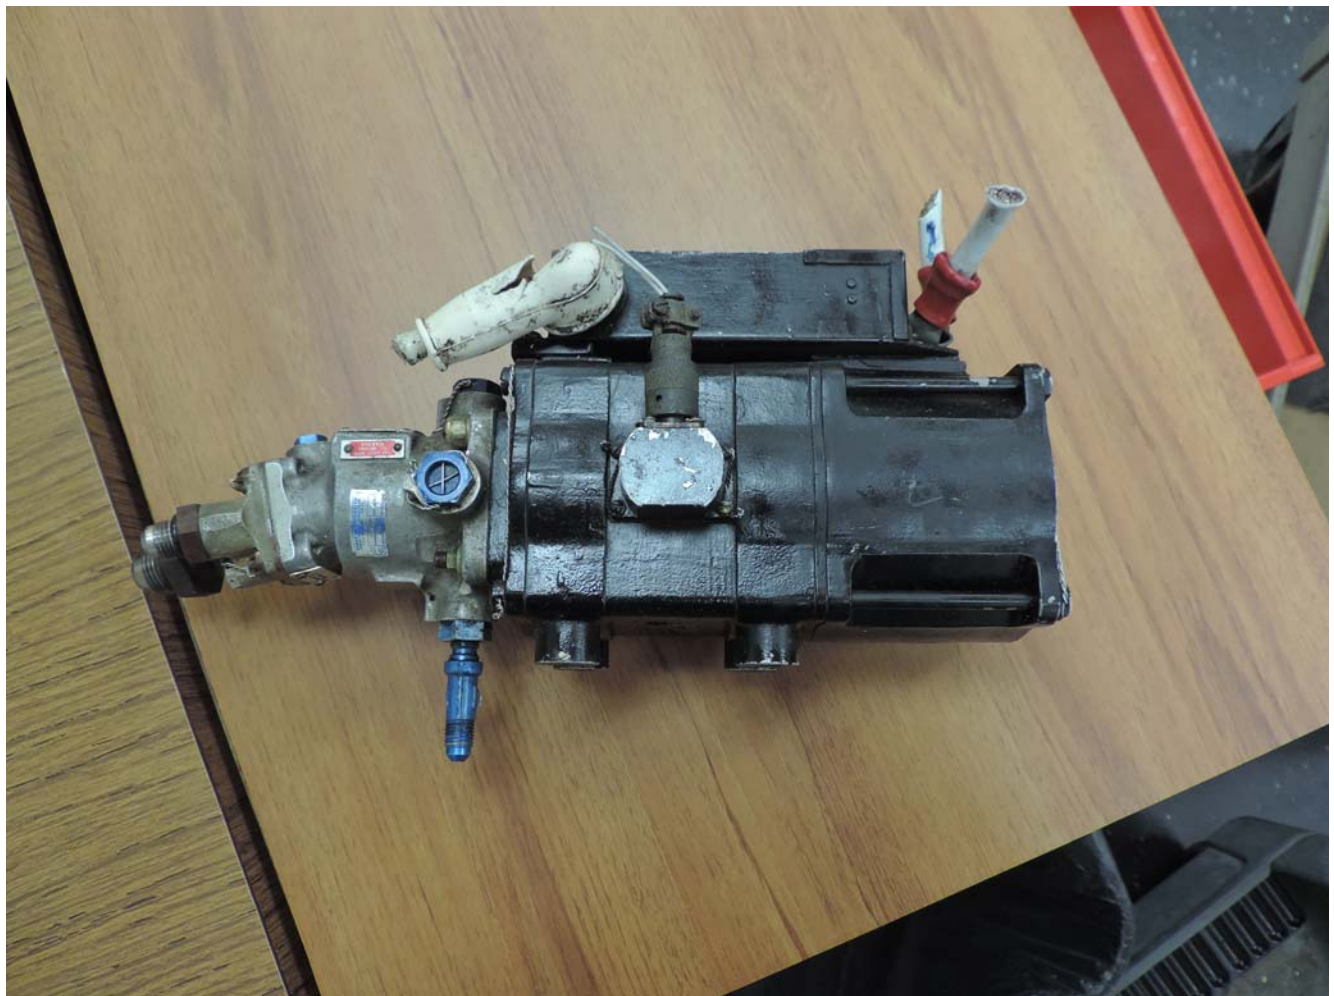
Figure 1 – AA-19089 Motorpump as Received

The motorpump was visually inspected and no obvious damage was noted, but some contamination was evident (See pictures 1-5 attached). The pump was separated from the electric motor and was flushed to remove any contamination. (a small stone was found in the pump inlet port). Both the pump and electric motor were checked for smooth operation and confirmed that there was not binding or unusual noises. The pump was then connected back to the electric motor.

The motorpump was removed by just cutting the power leads to the electric motor. There were no protective caps on ports to prevent contamination from getting into the pump.

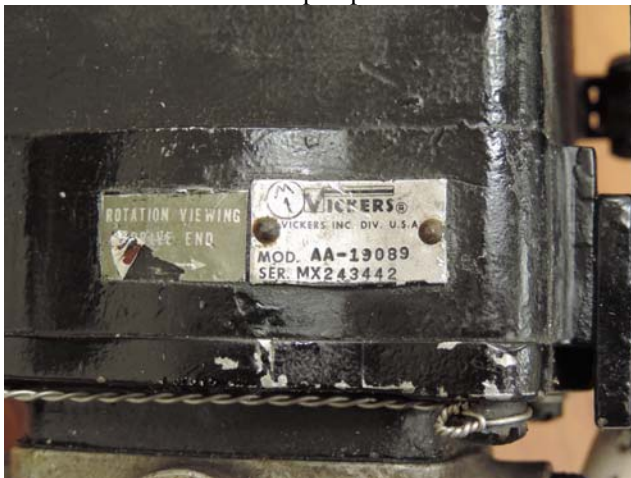
Photo 2 – Motorpump Identification

The motorpump ID plate was mounted on the electric motor.

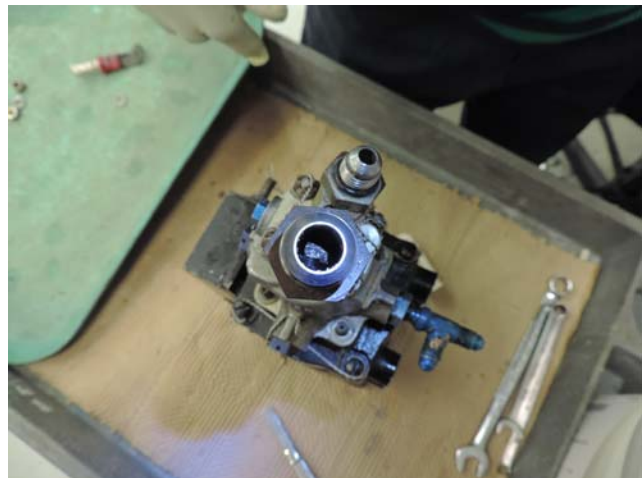
Photo 3 – Port Contamination

There was a small stone in the inlet port.

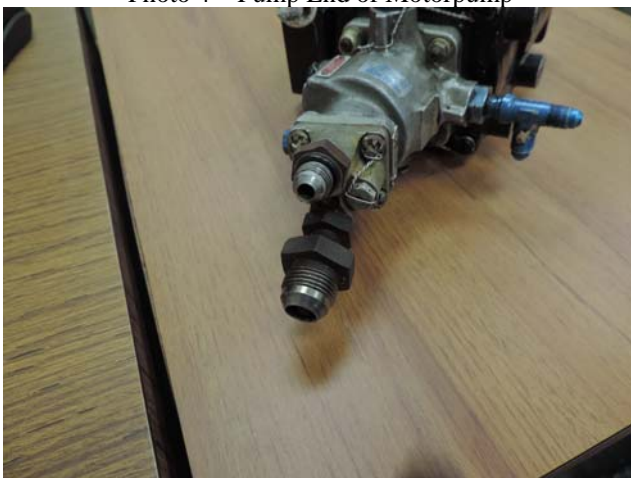
Photo 4 – Pump End of Motorpump

There was evidence of contamination on the ports – One of primary reasons for flushing the pump before test.

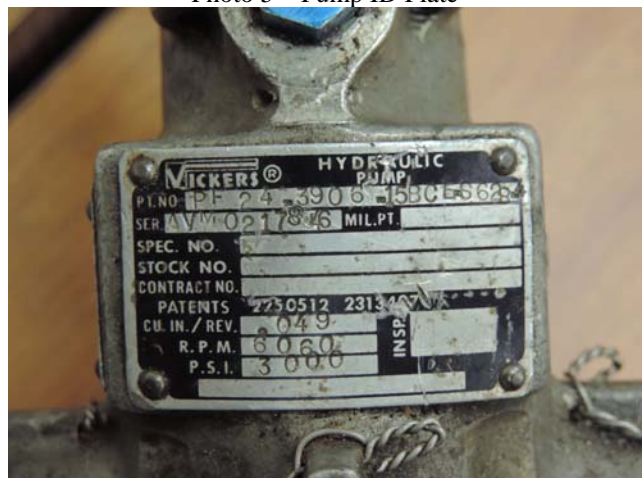
Photo 5 – Pump ID Plate

Pump serial number indicates the pump was manufactured approximately 50 years ago.
