Egyptian Delegation Presentation

Flight MS 990 Accident

April 28, 2000

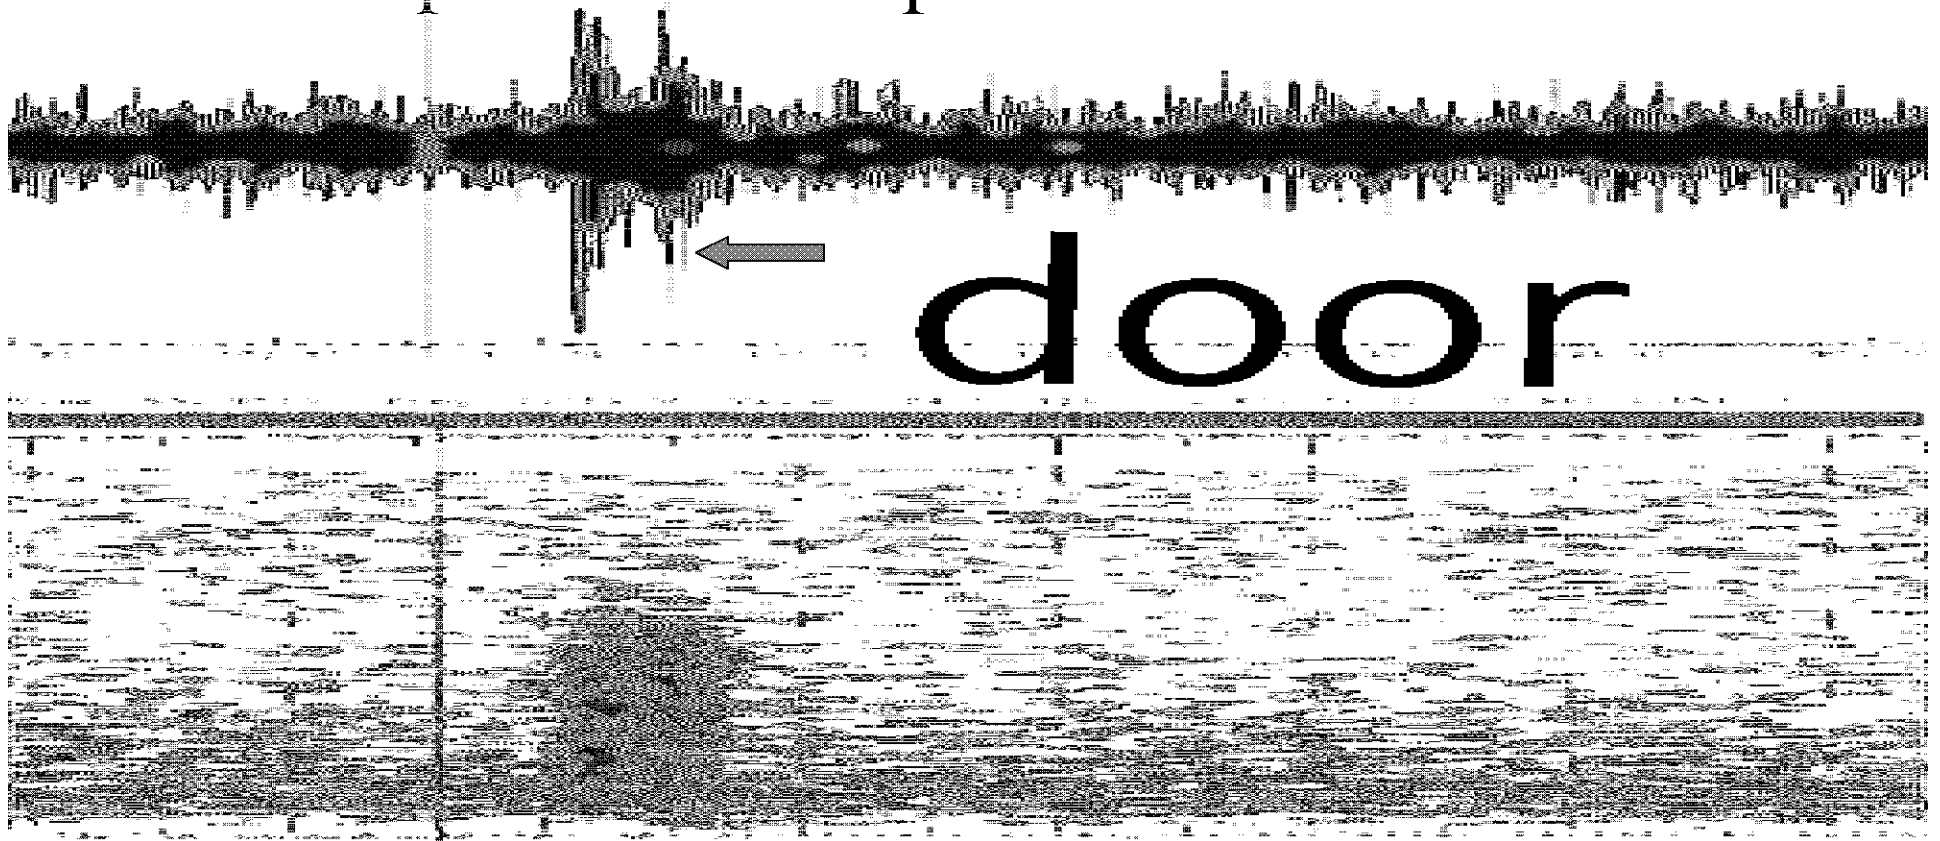
3.a- Cockpit door was opened

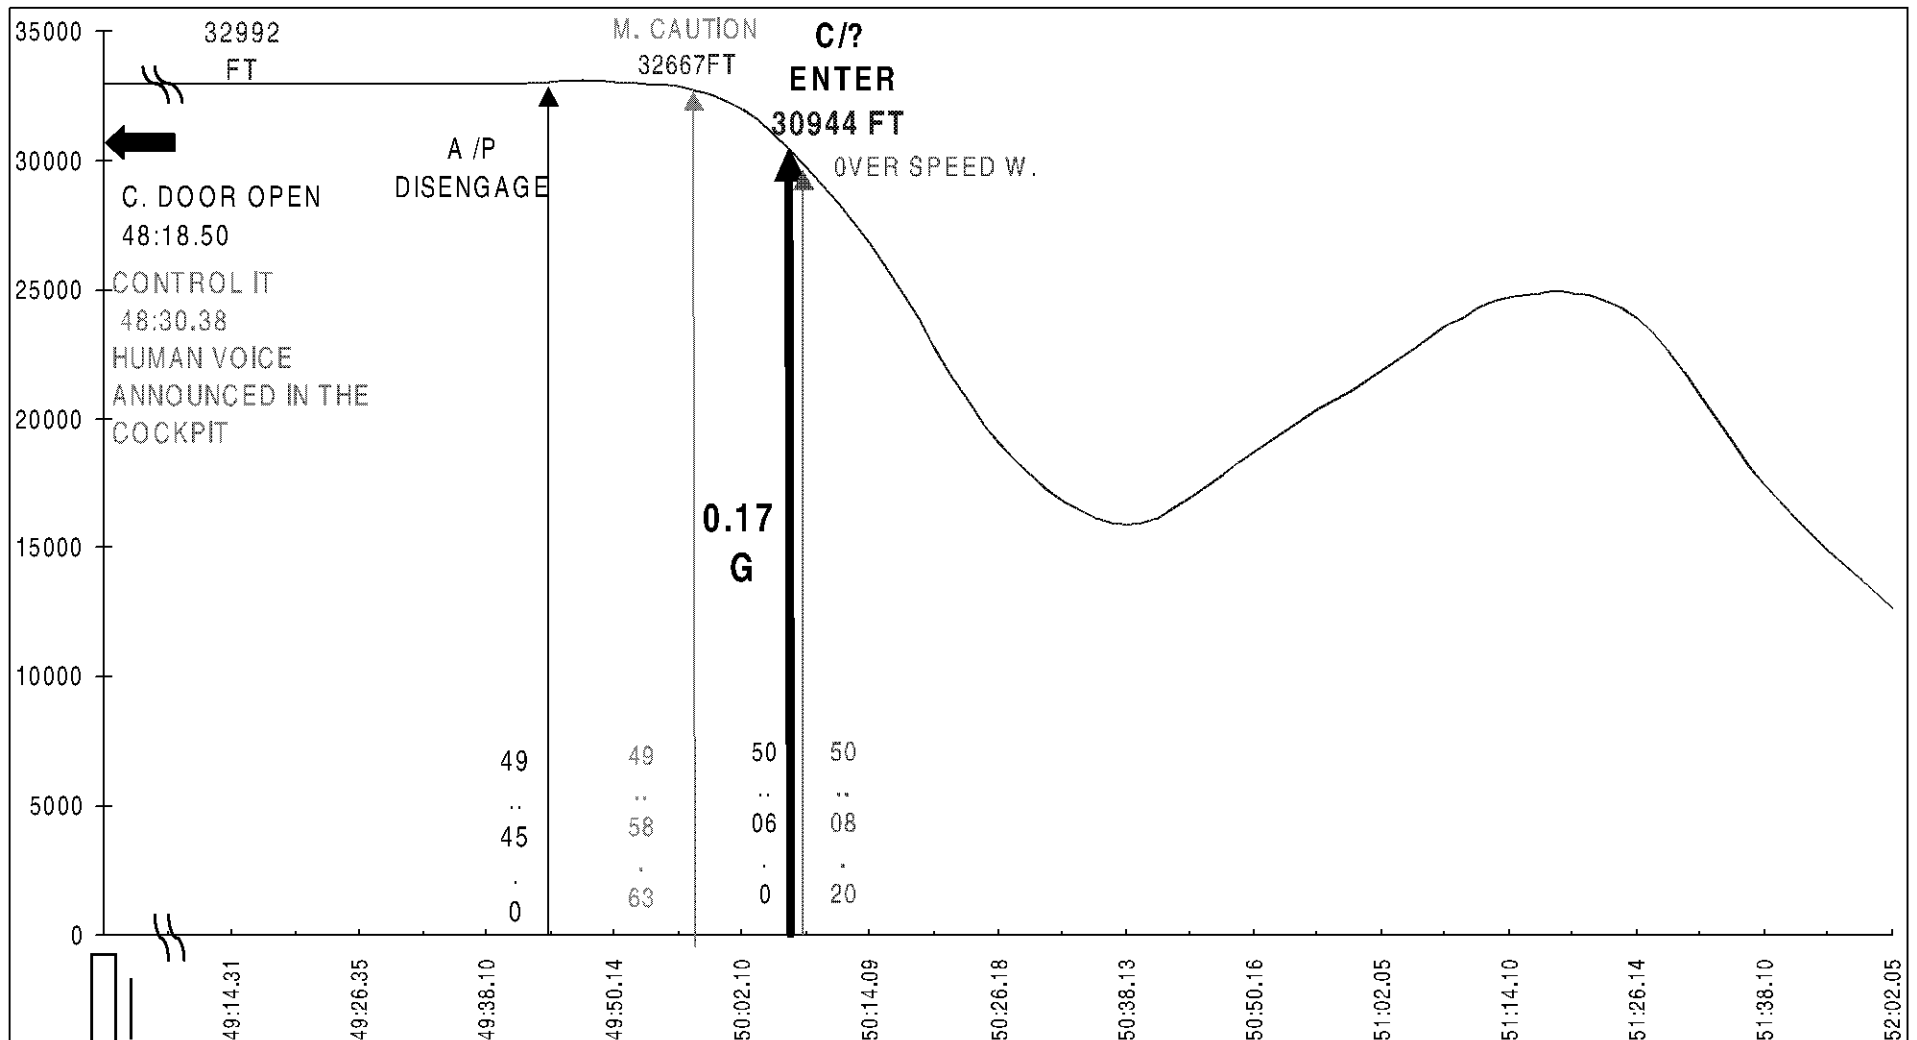
1-A Captain returned to cockpit very early in the event when the aircraft was about 31000 ft.

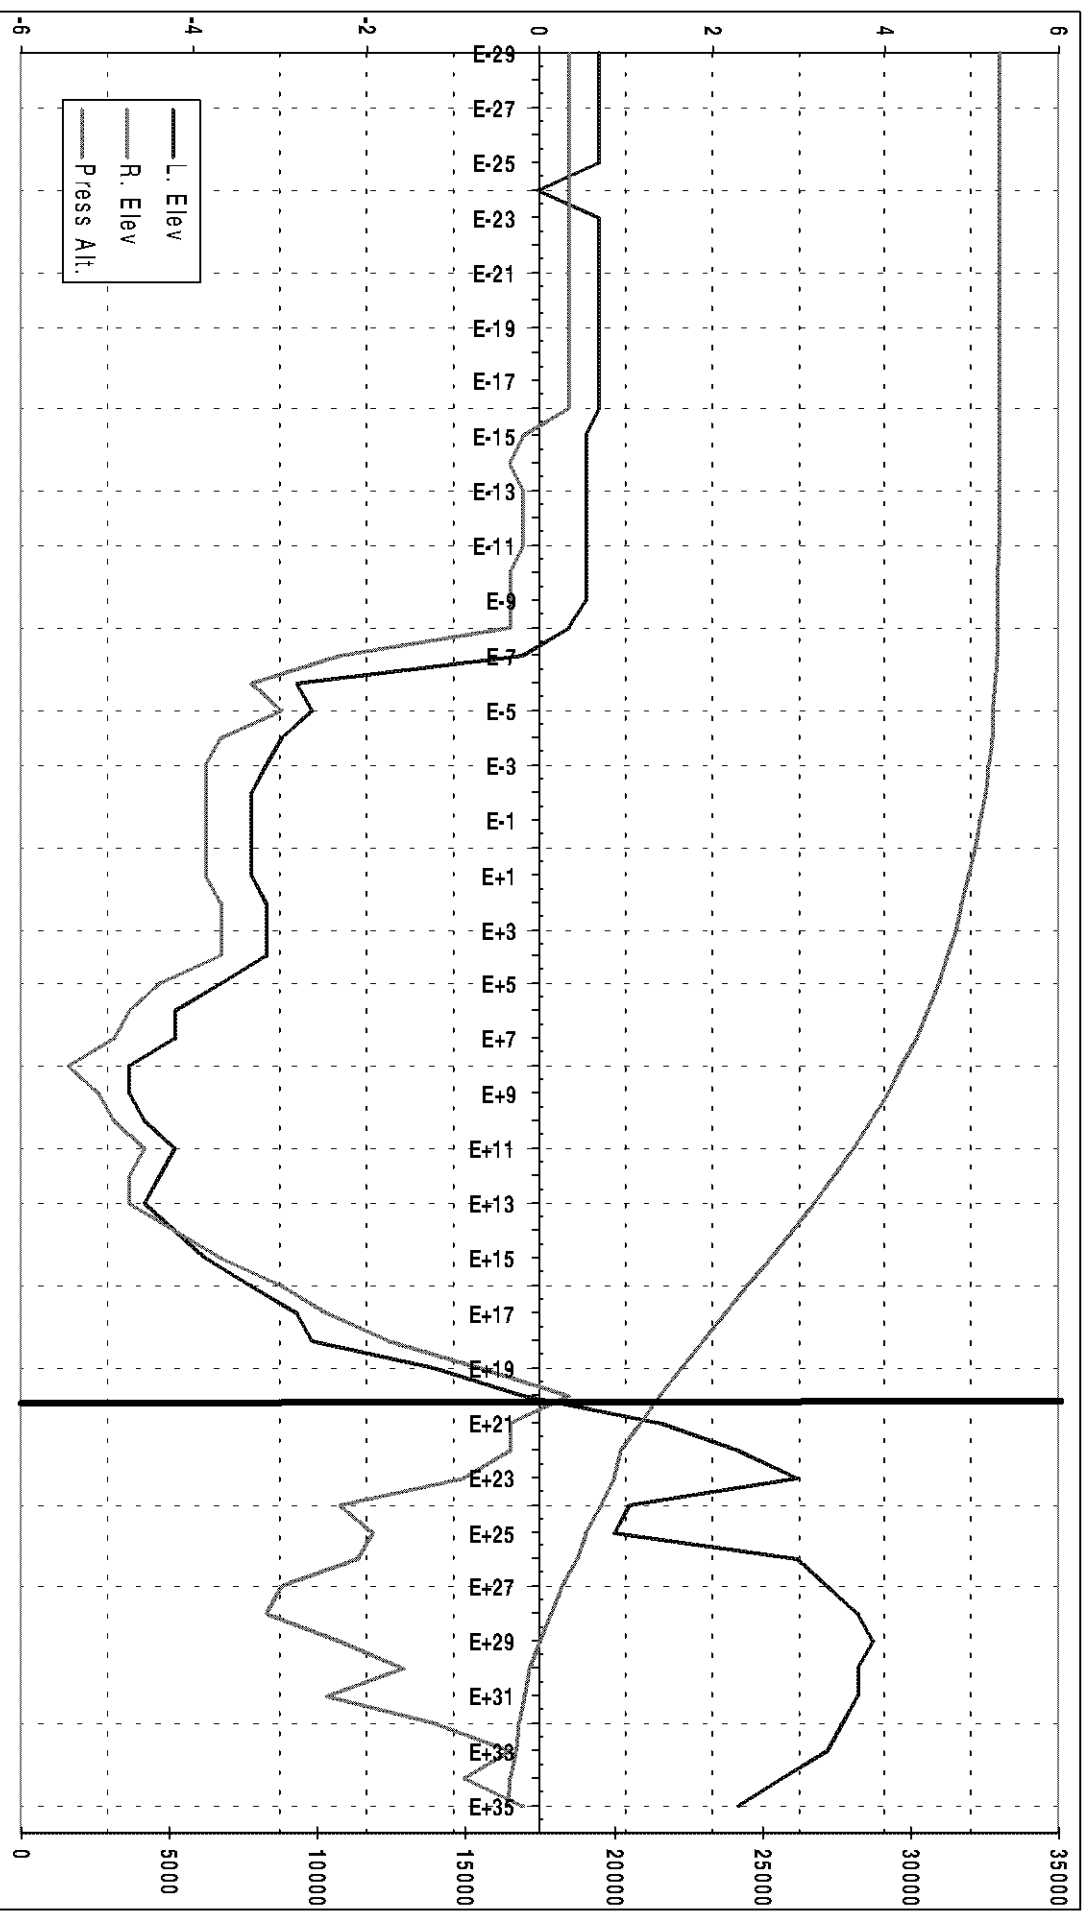
2-Both the elevators were moving simultaneously for the 1st 28 seconds of the dive

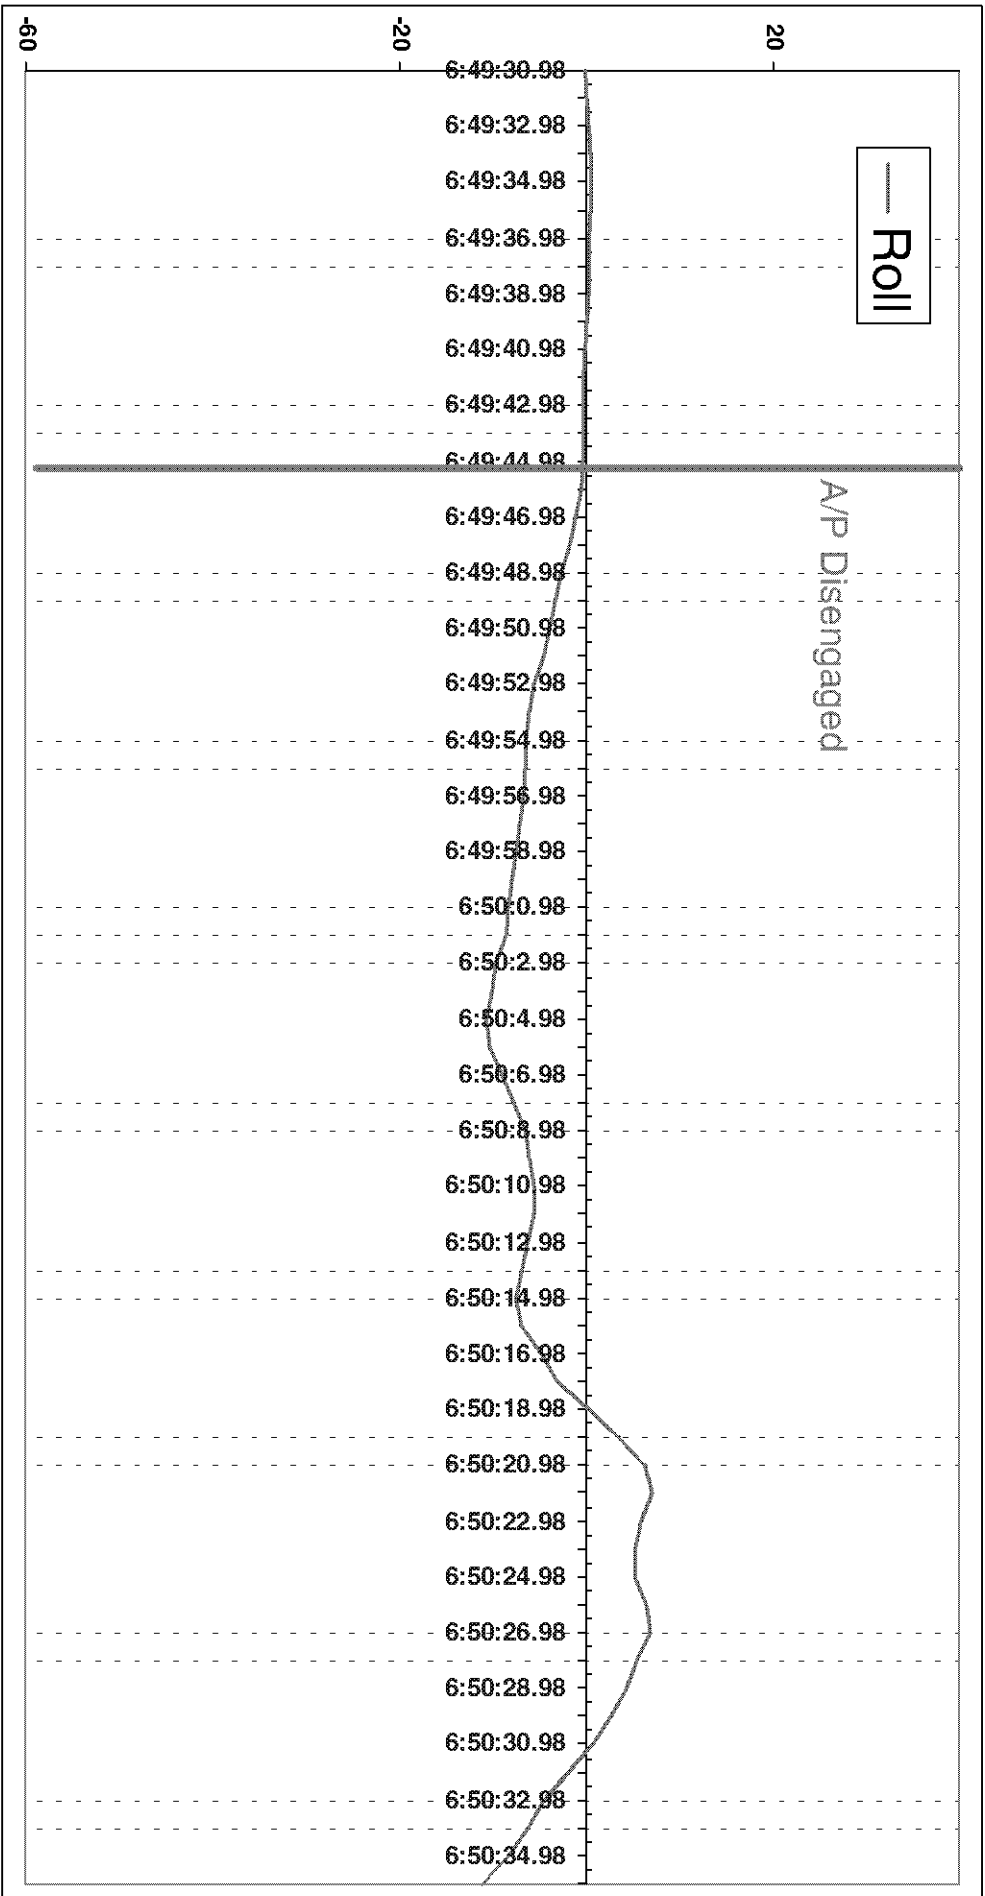
3-The bank angle was controlled throughout the dive

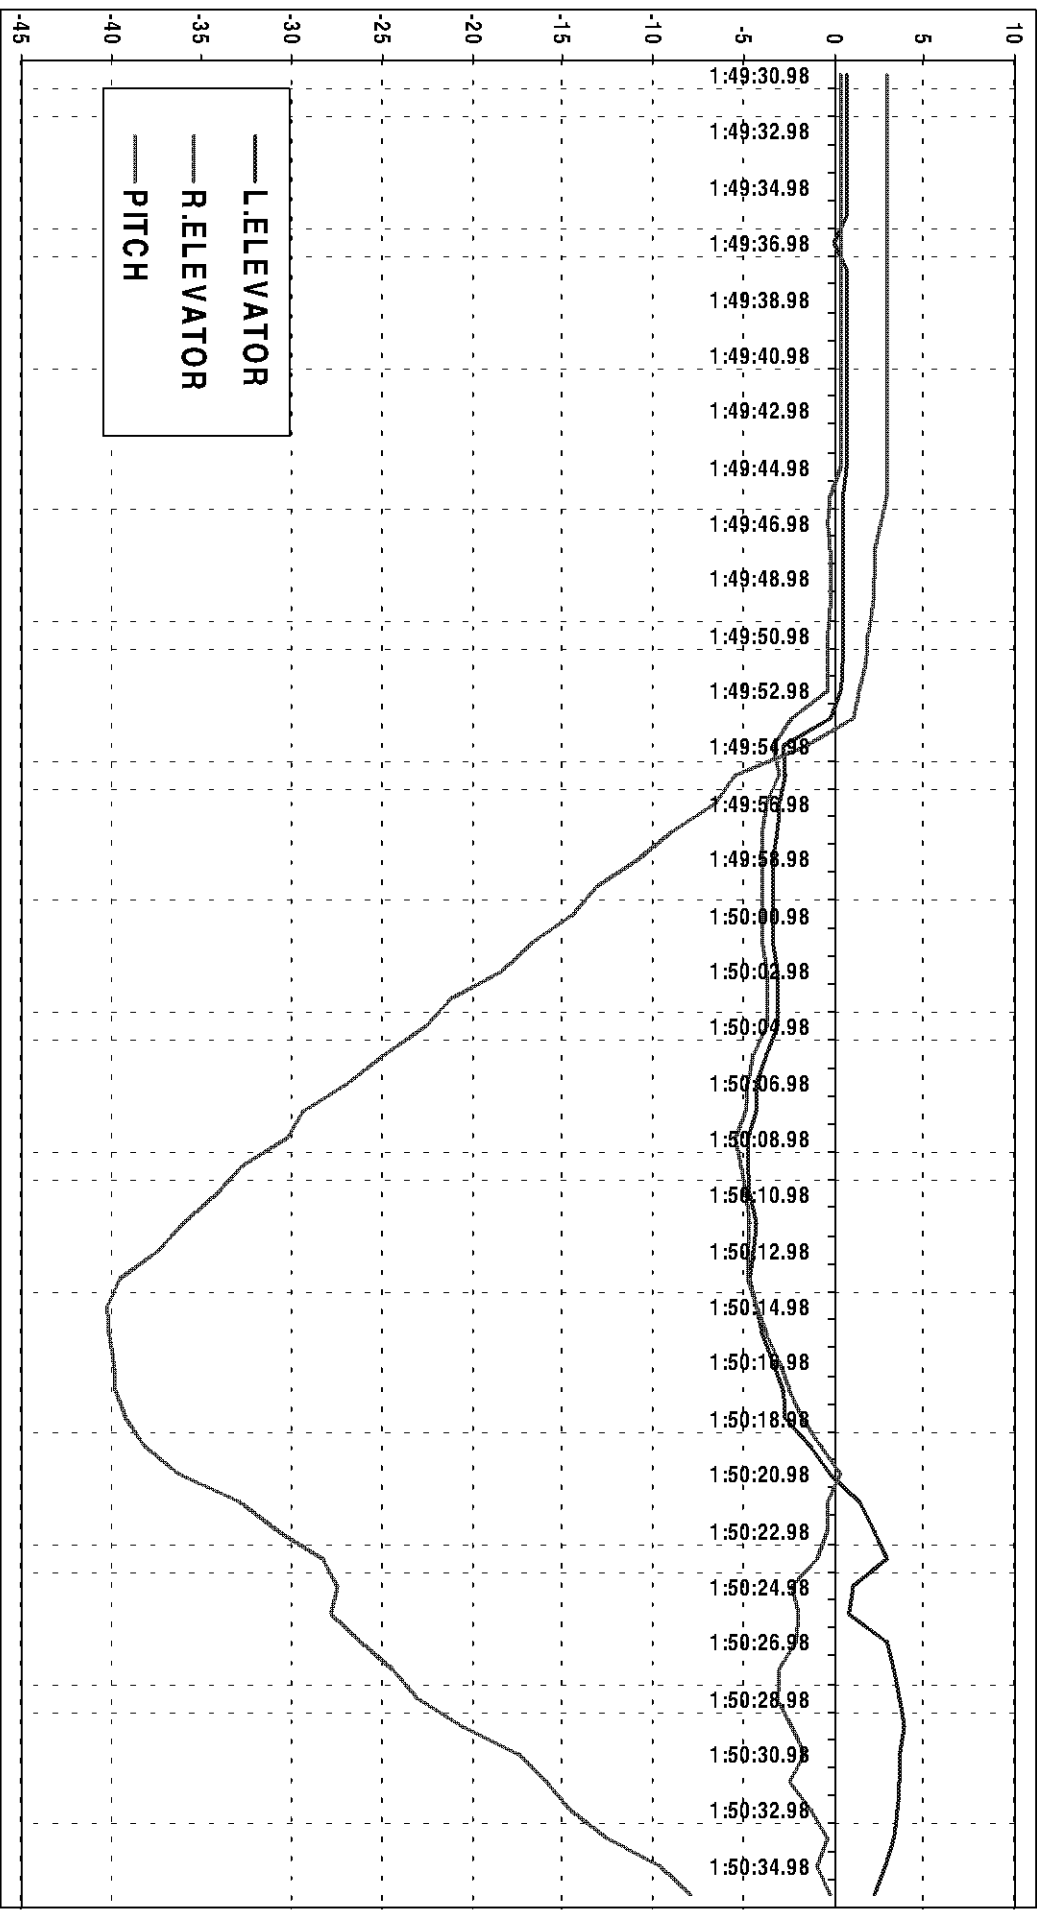
4-The elevators moved together as the nose came up, the dive was stopped, and aircraft control appeared to begin

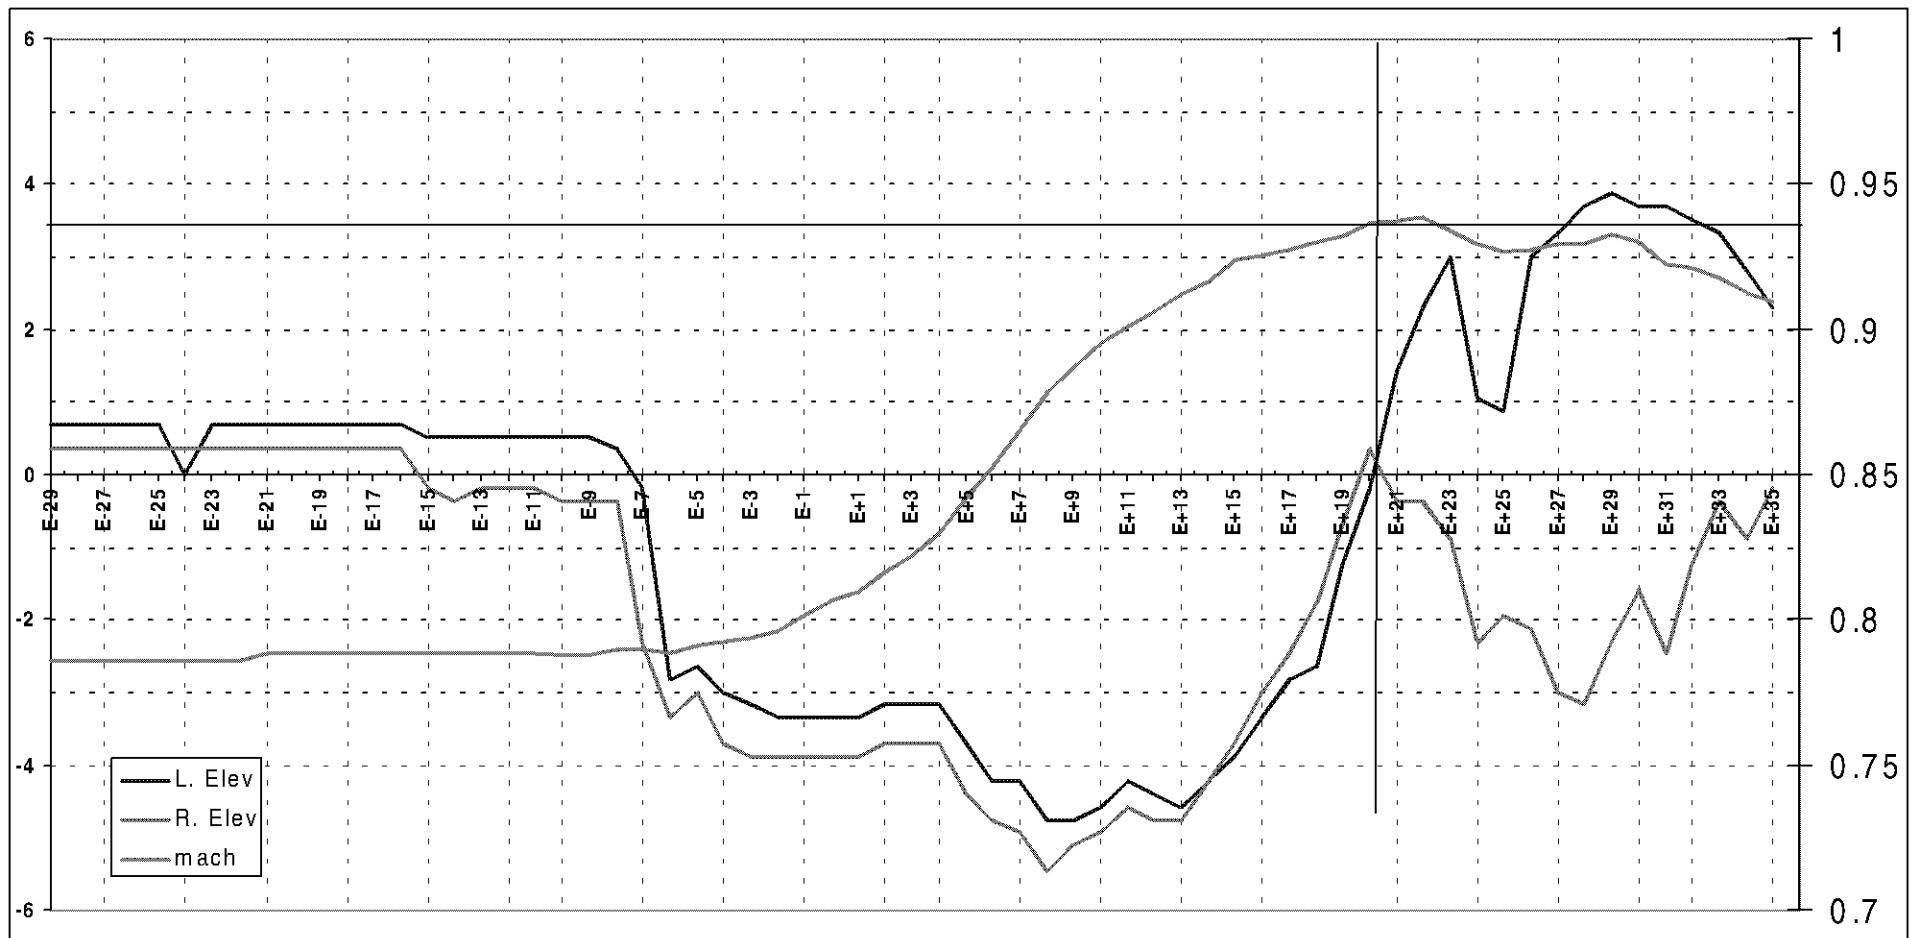
5-The elevator split does not appear until the last 15 seconds of the FDR data when the airplane was above 0.93 Mach. The airplane characteristics above Mach=0.91 is not available from manufacturer

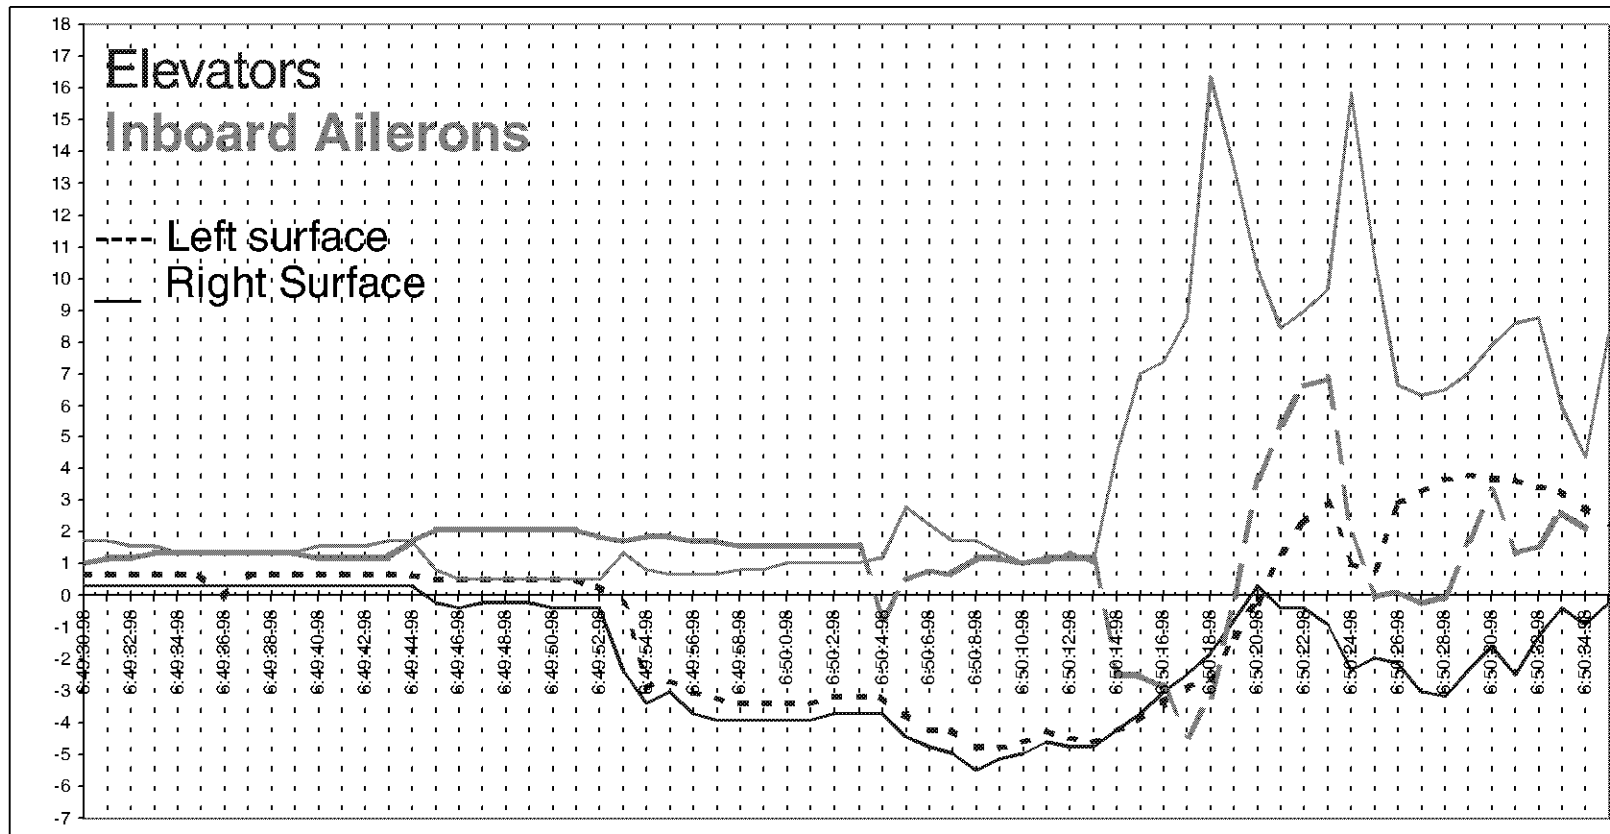
6-The elevator split at the end of the dive was incorrectly interpreted as a fight between the cockpit crew, at about the same time the elevators “split”, the aileron surfaces showed similar unexplained movement, again questioning the validity of the A/C performance in this Mach range

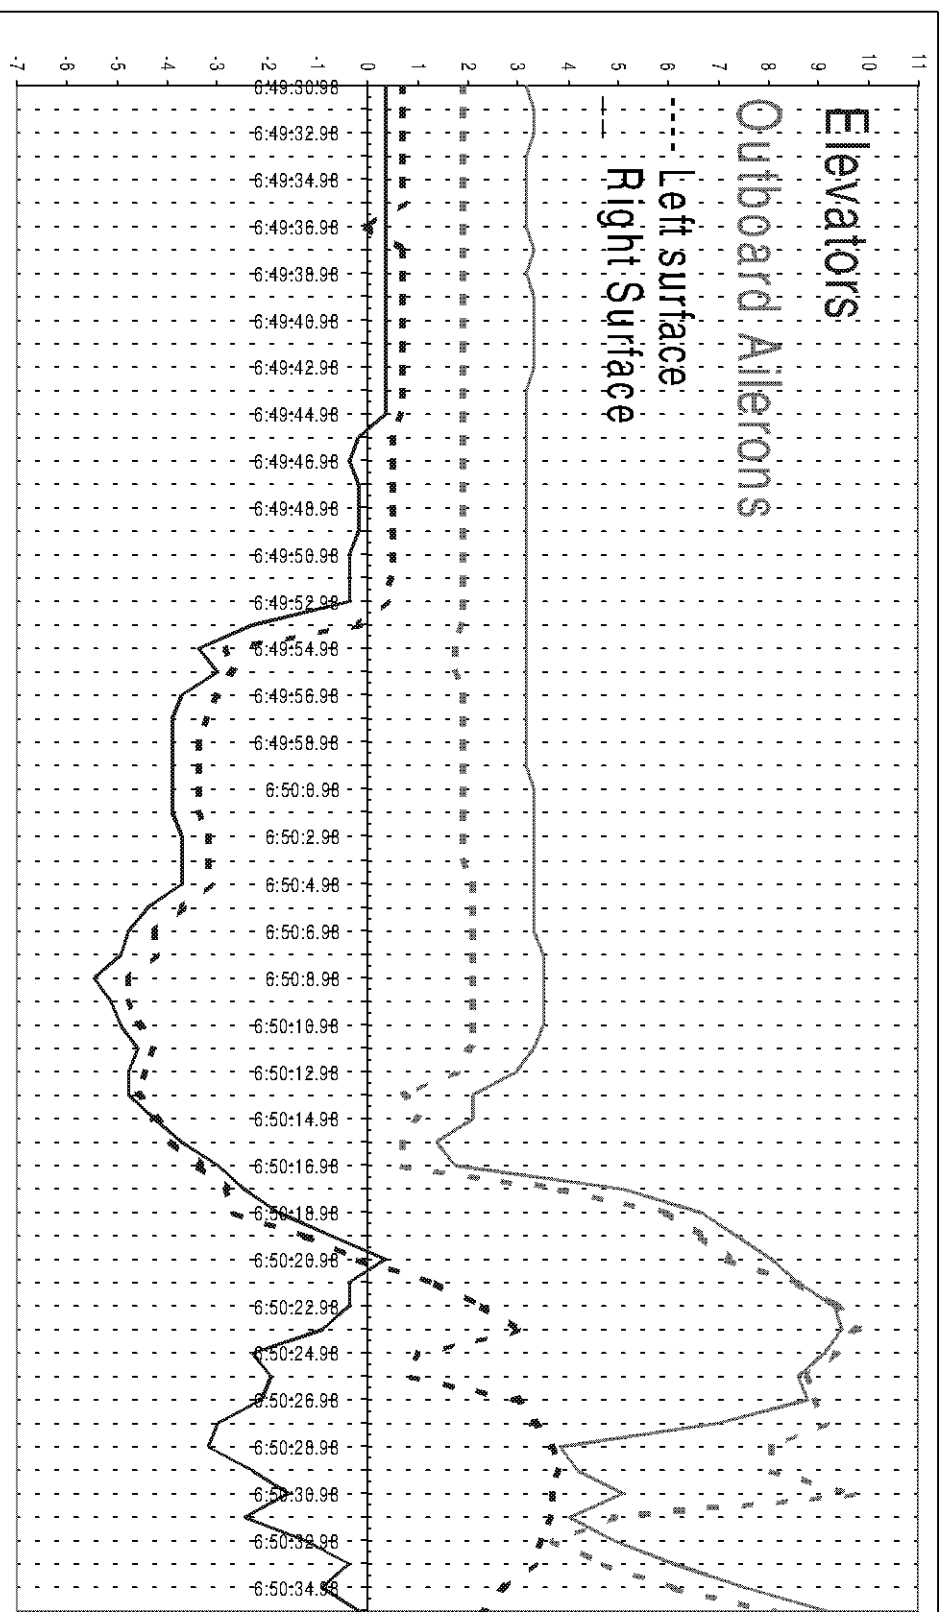
7-The elevator split at the end of the dive was incorrectly interpreted as a fight between the cockpit crew, at about the same time the elevators “split”, the aileron surfaces showed similar unexplained movement, again questioning the validity of the A/C performance in this Mach range

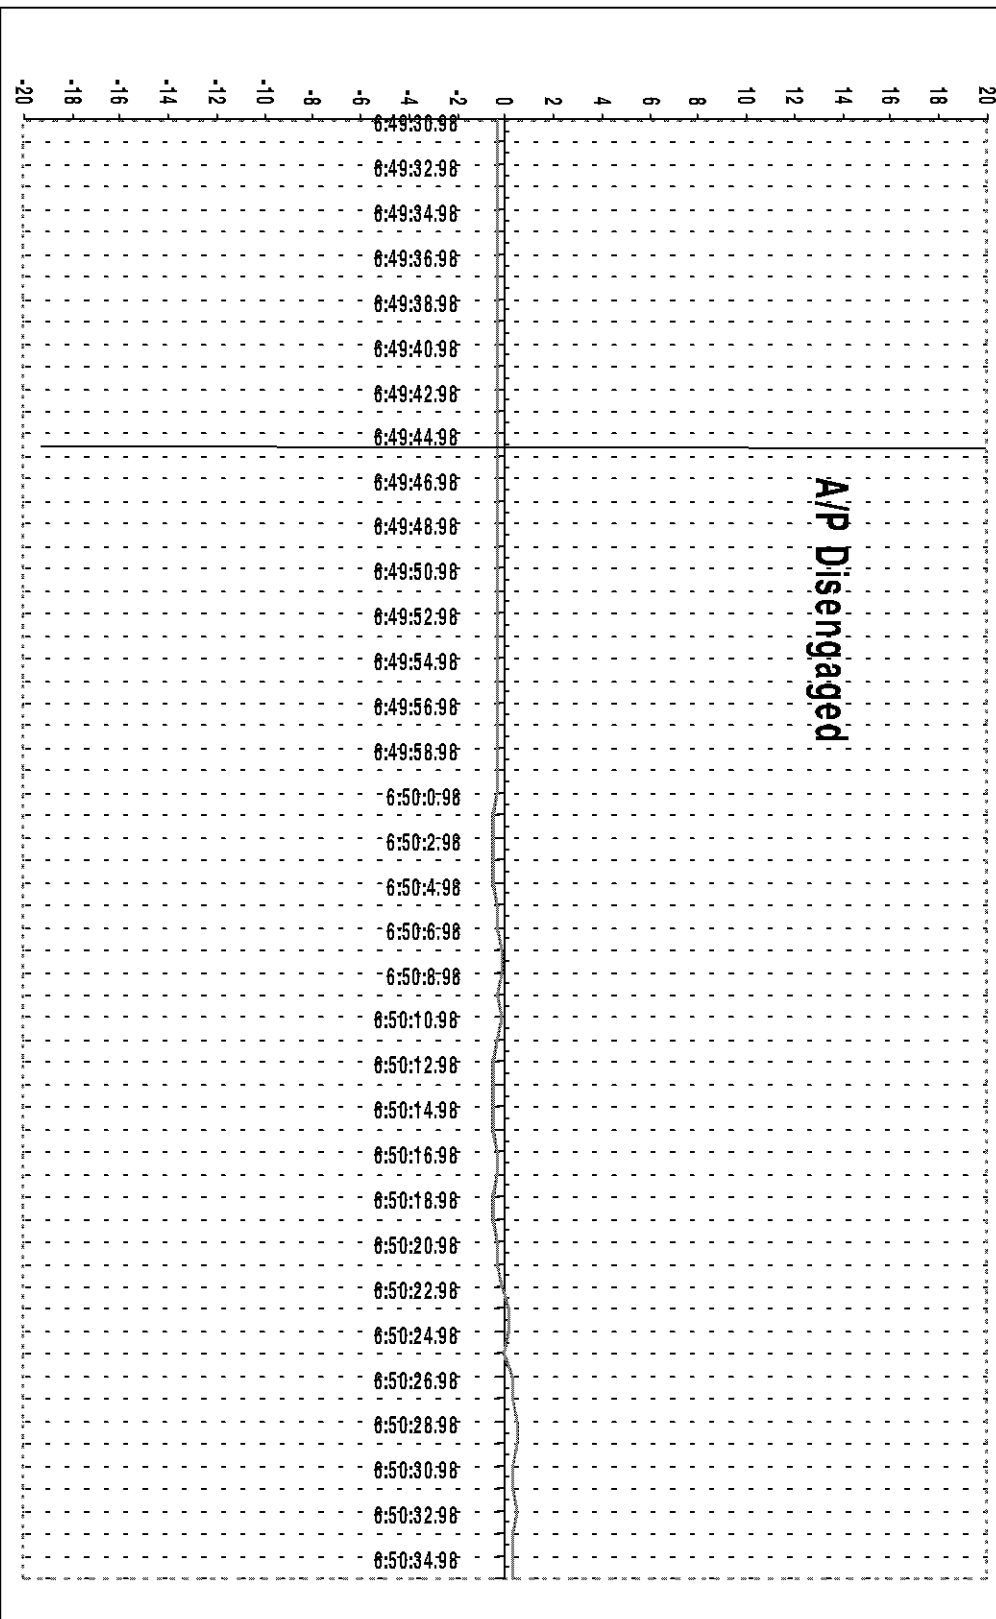
Rudder behavior before and during the dive:
The rudder did not show any significant abnormal
behavior before and during the dive

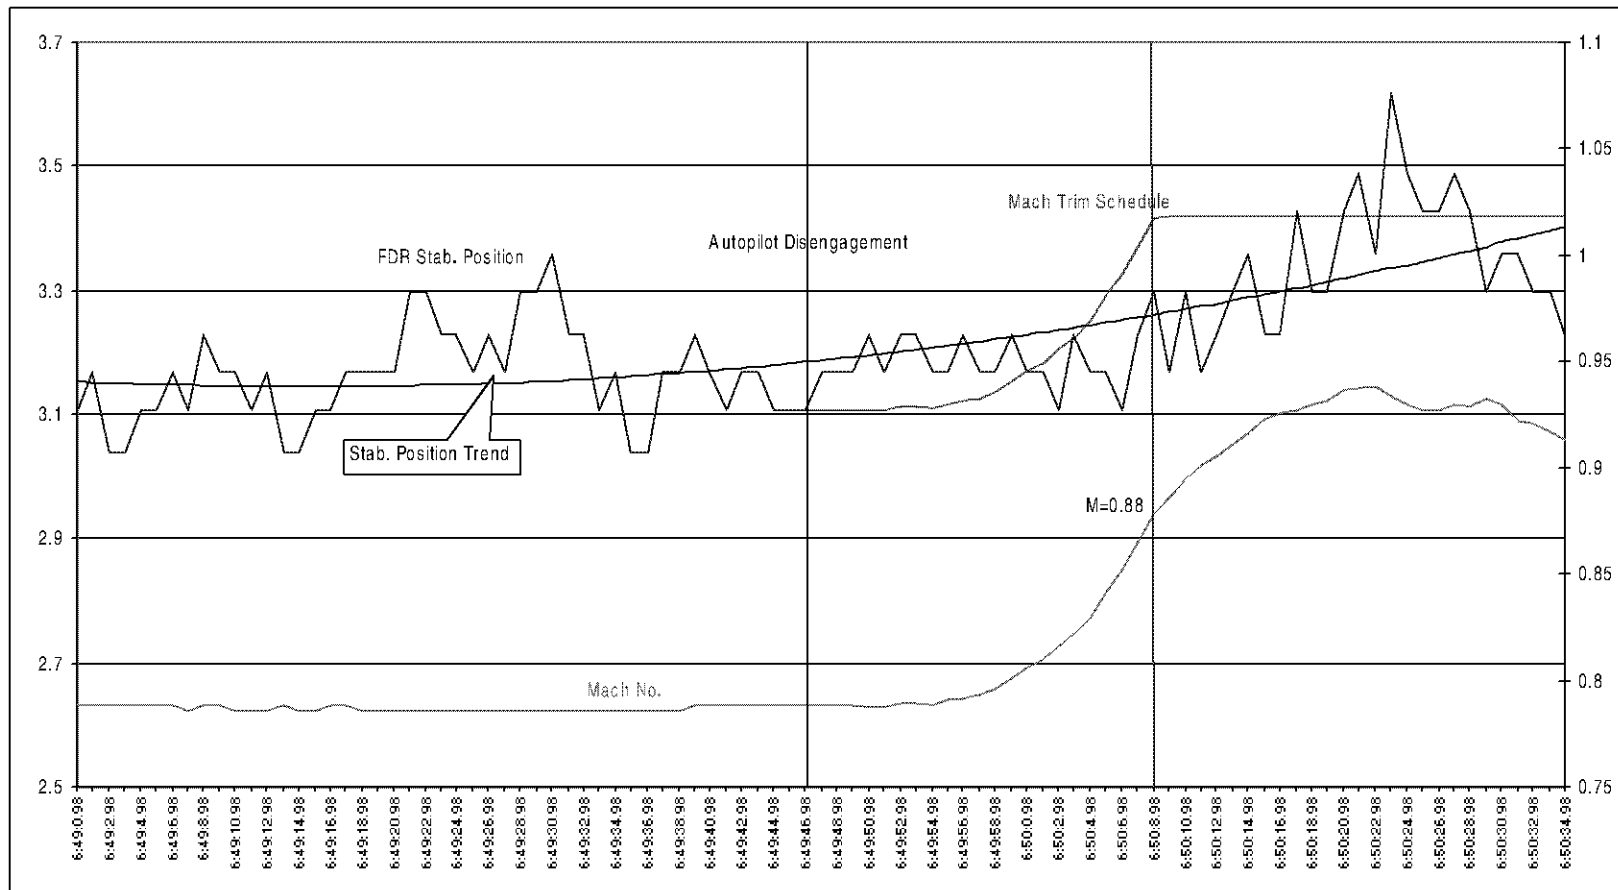
According to FDR data, stabilizer did not show significant movement to correct for the dive

Stabilizer should have moved under the command of the Mach trim to pitch up the A/C. FDR data did not show this movement. Mach trim operation analysis is ongoing

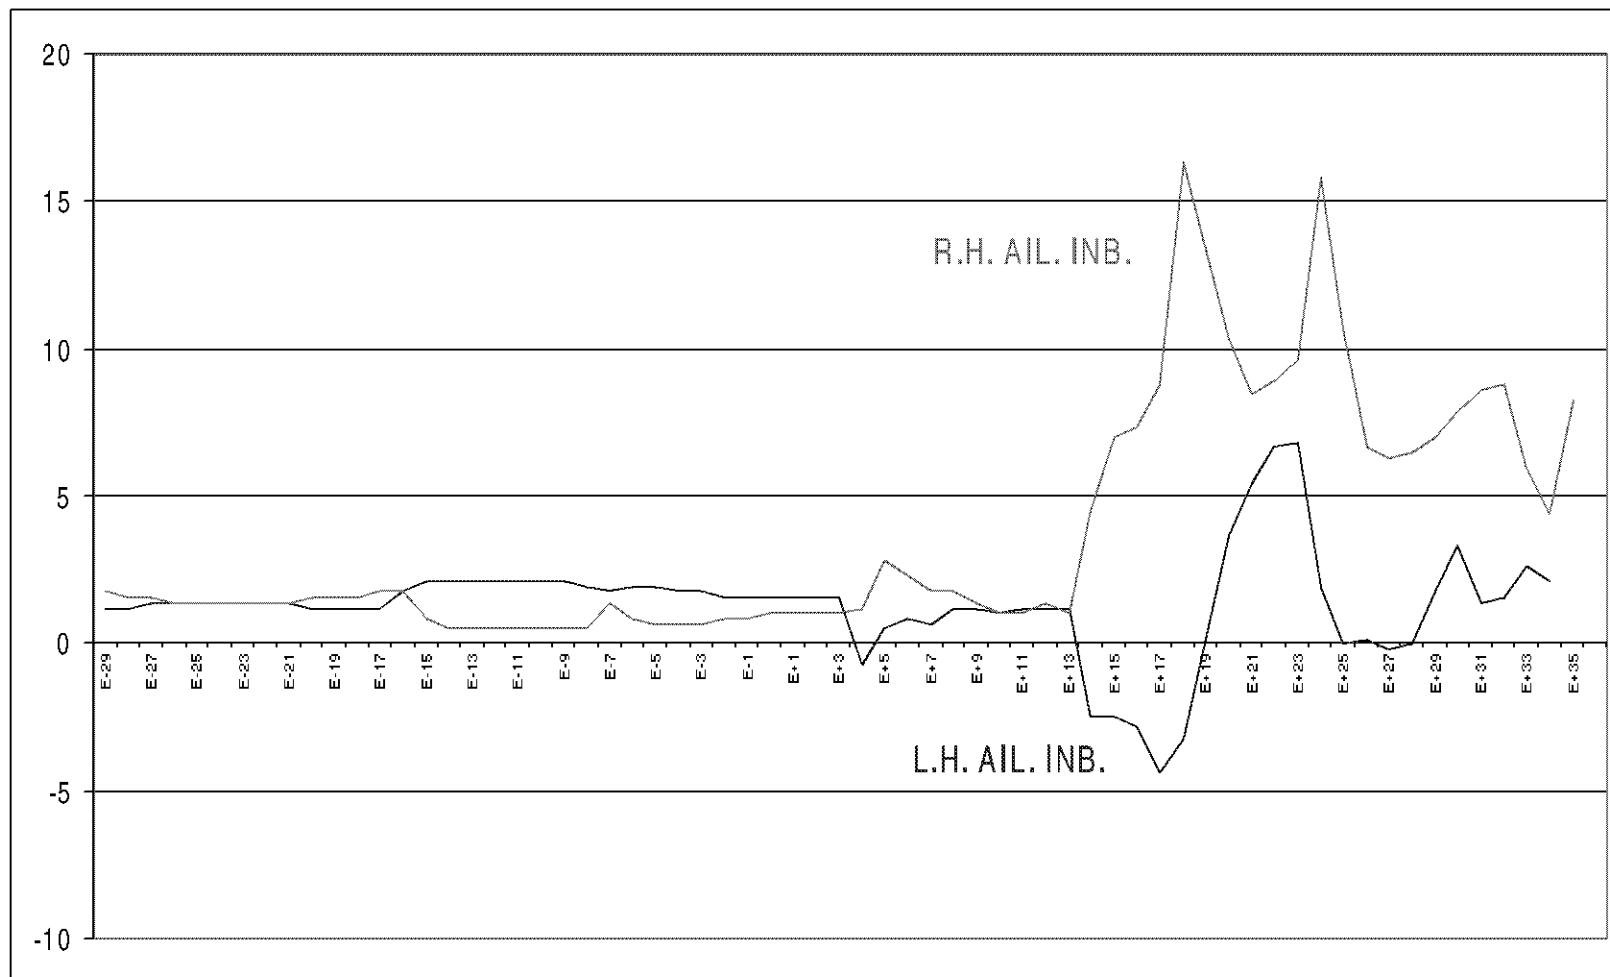
Both inboard ailerons moved significantly upward and then showed noticeable differential deflection (similar to what happened with the elevators).

Upward movement of the inboard ailerons would result in significant pitch down movement (acting as speed brakes)

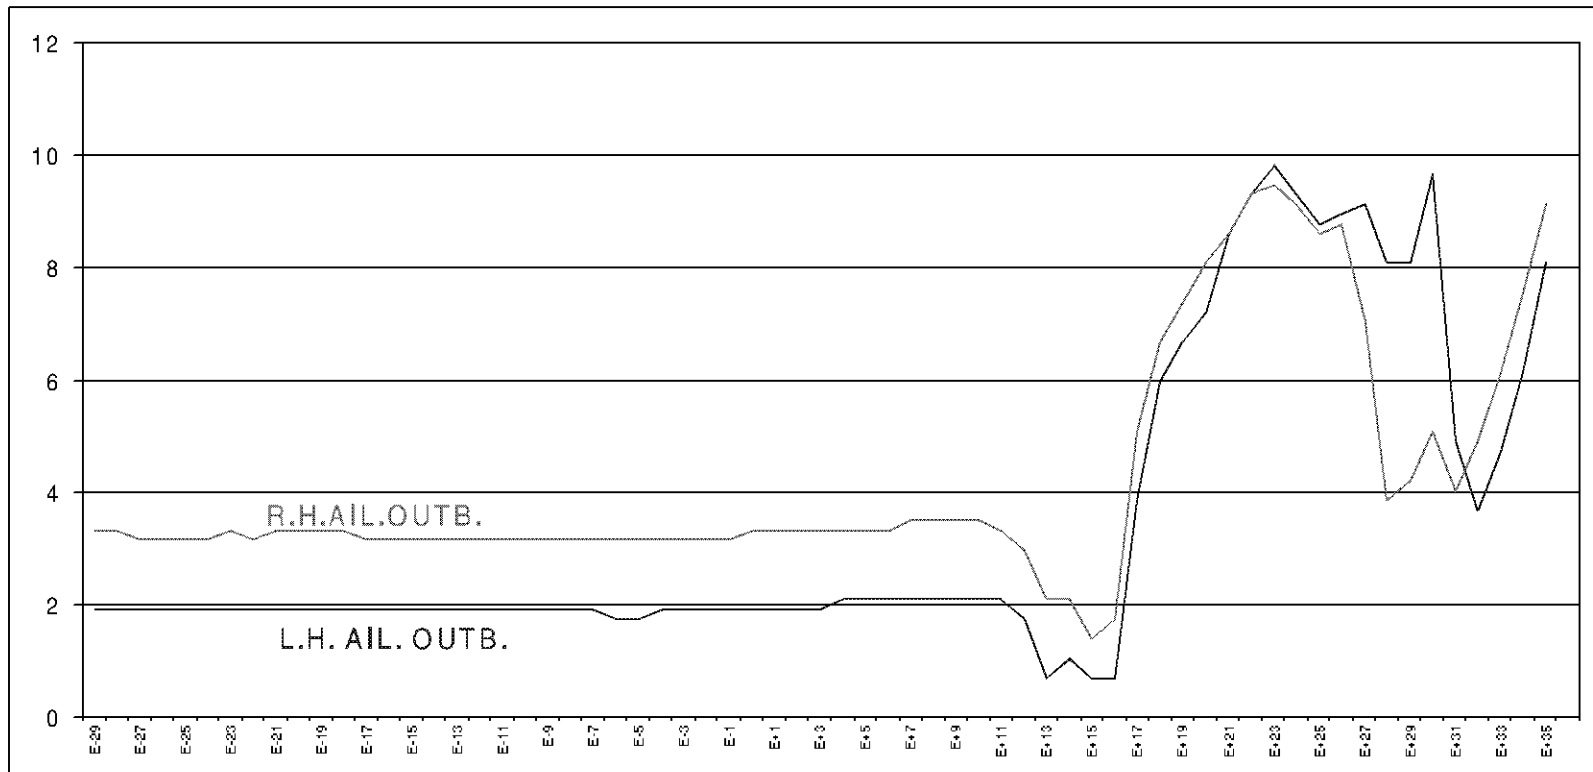
Both outboard ailerons(which are supposed to be locked during flight) moved significantly upward and then differentially(similar to what happened with the elevators).

Upward movement of the outboard ailerons would result in significant pitch down movement (acting as speed brakes)

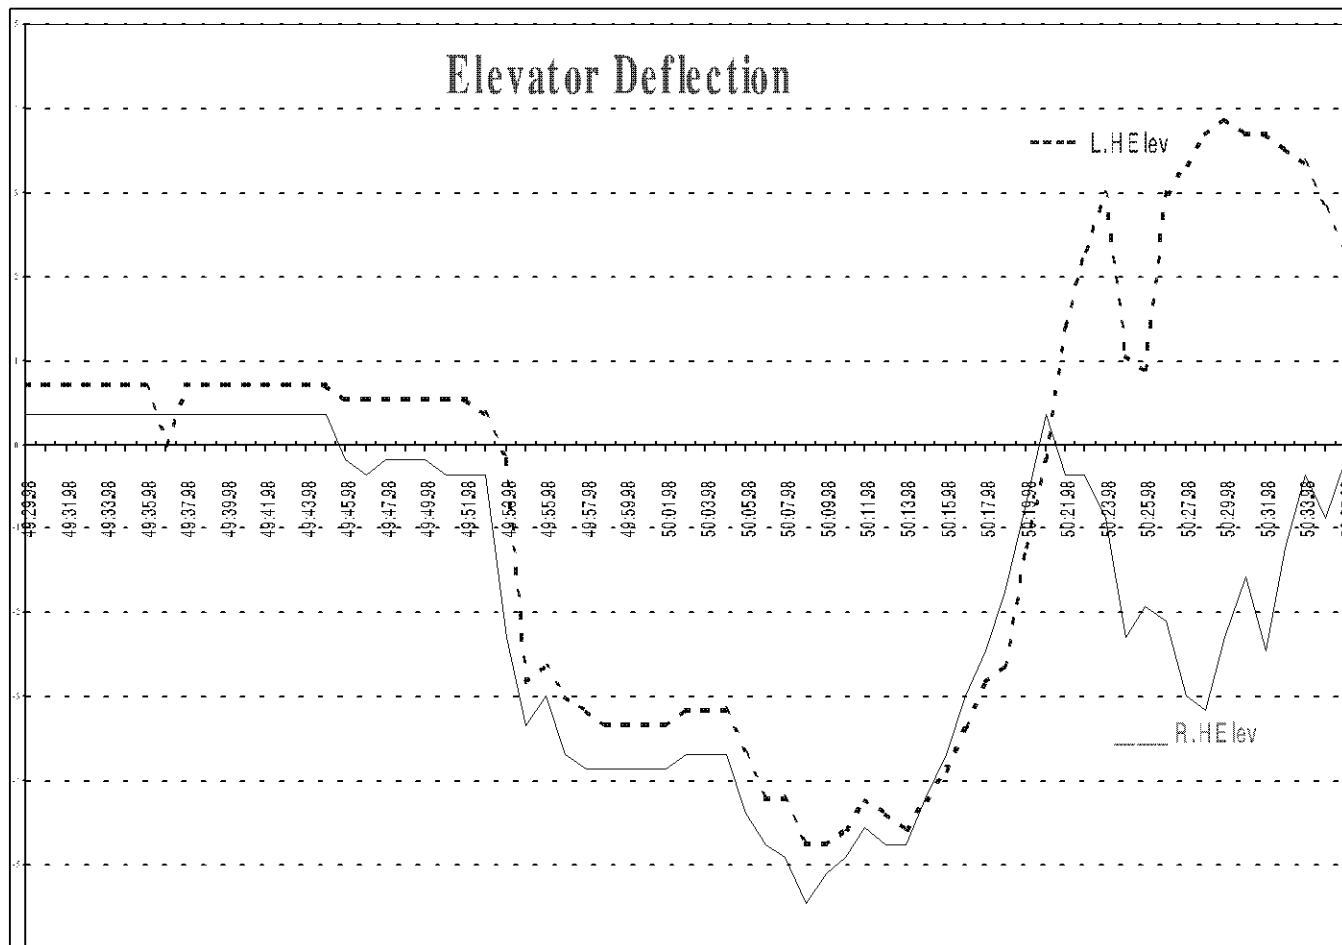
Elevators started moving up towards neutral position to recover the A/C from the dive at 6:50:09 UTC

Elevators moved differentially(Elevators Split) at 6:50:21 UTC for about 3 seconds, then the left elevator started to follow the right elevator followed by another split for 3 seconds, then both elevators started to move towards the neutral position.
