Egyptian Delegation Presentation

Flight MS 990 Accident

April 28, 2000

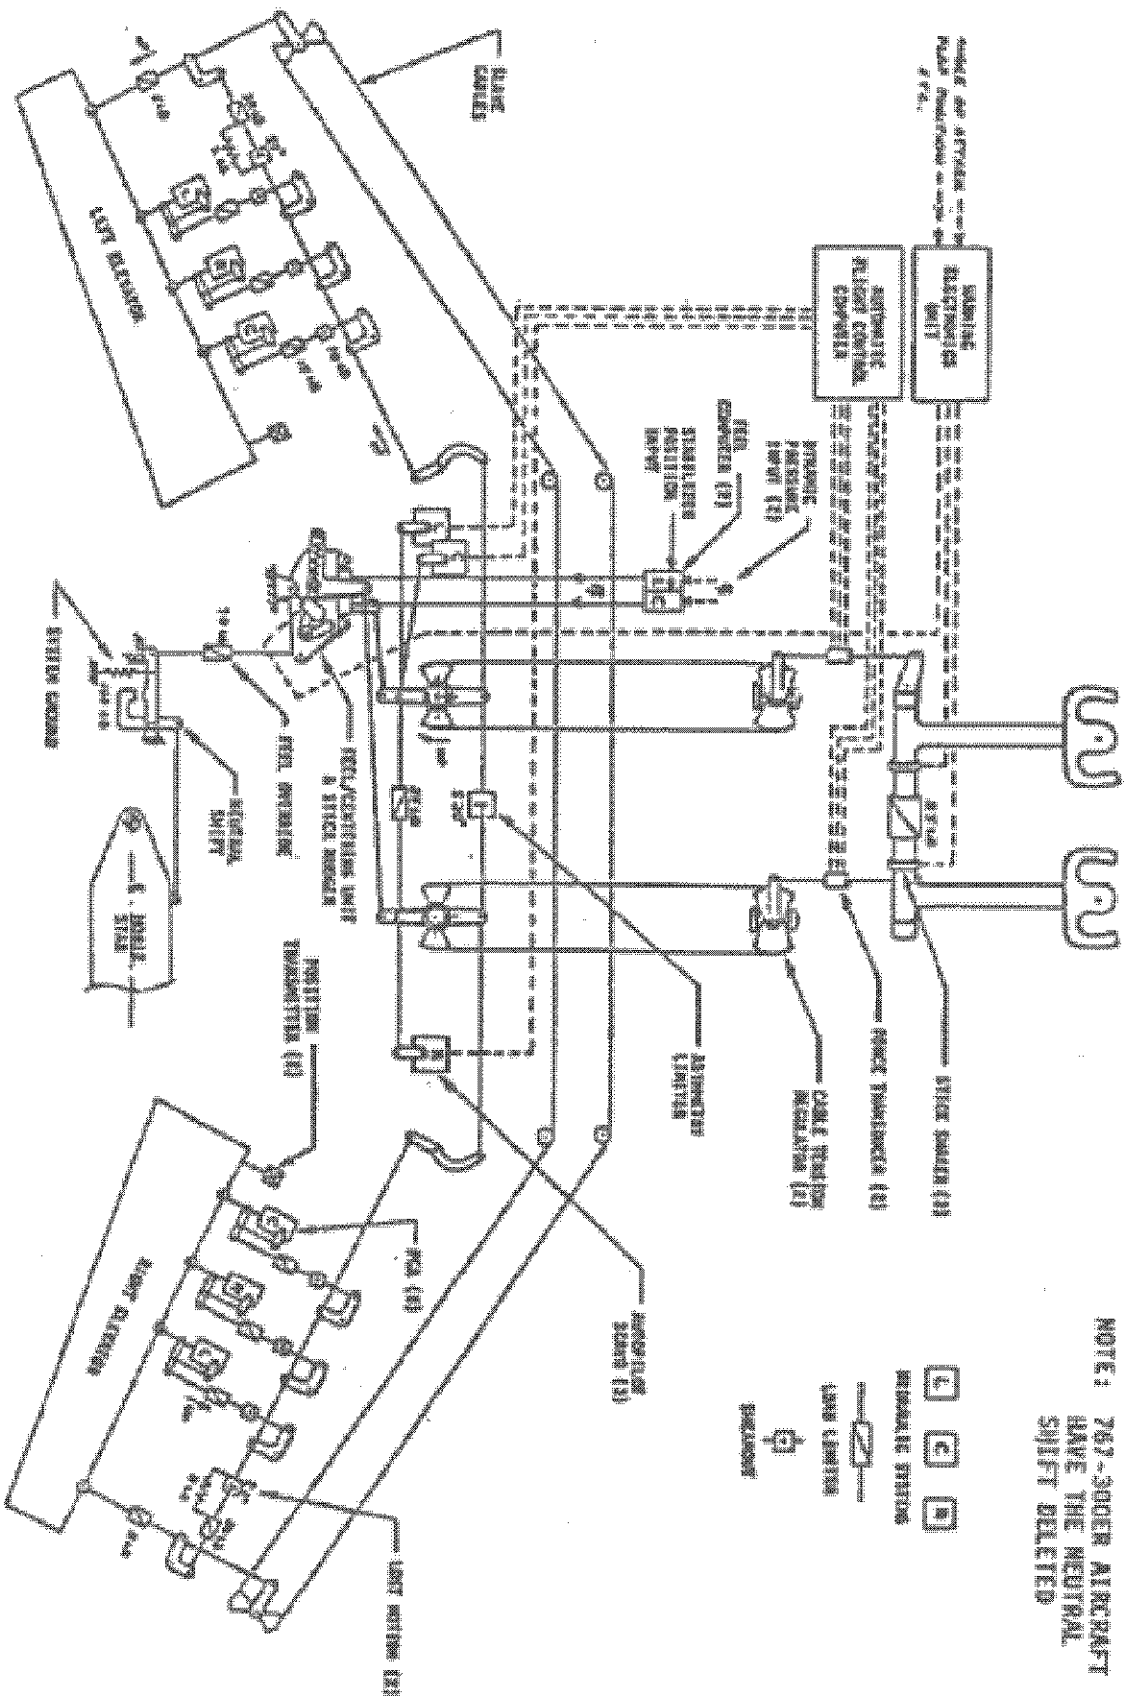
Figure 3.1-3. Elevator Control Schematic

- Dual PCA valve jam on one elevator
- Dual PCA valve disconnect on one elevator
- Combined PCA valve disconnect, valve jam on one elevator

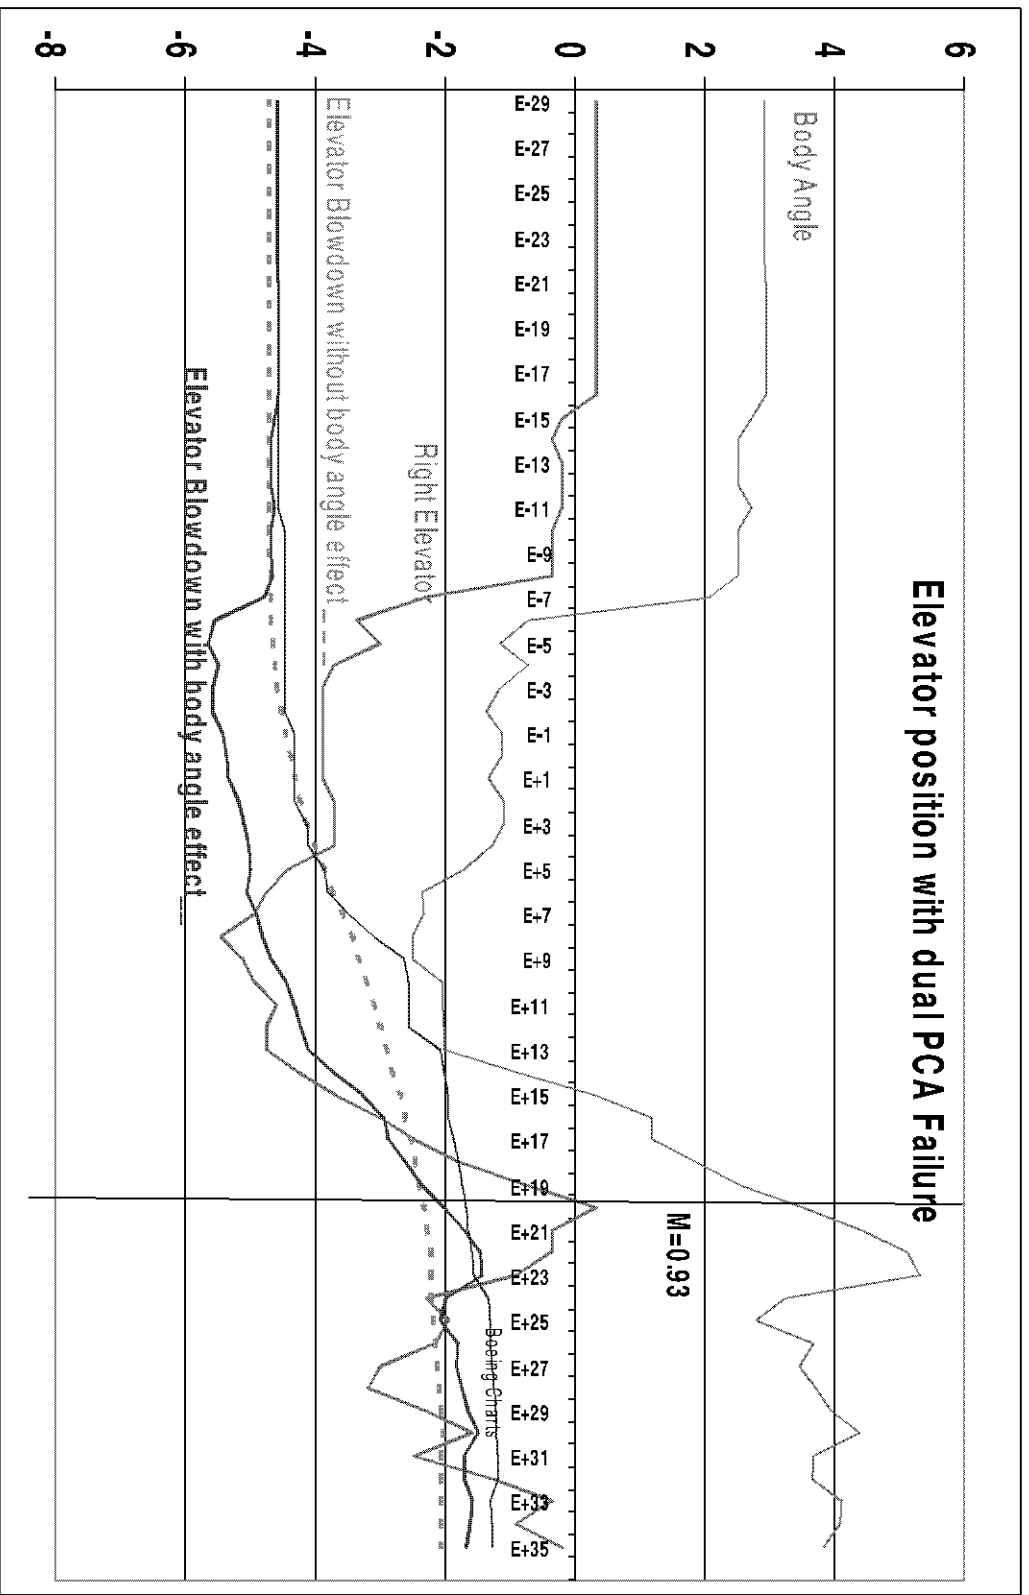
- The results obtained by the three means are not similar and lies within a band of a thickness reaching about 2 degrees
- This band is very close to R.H elevator deflection as shown by FDR data

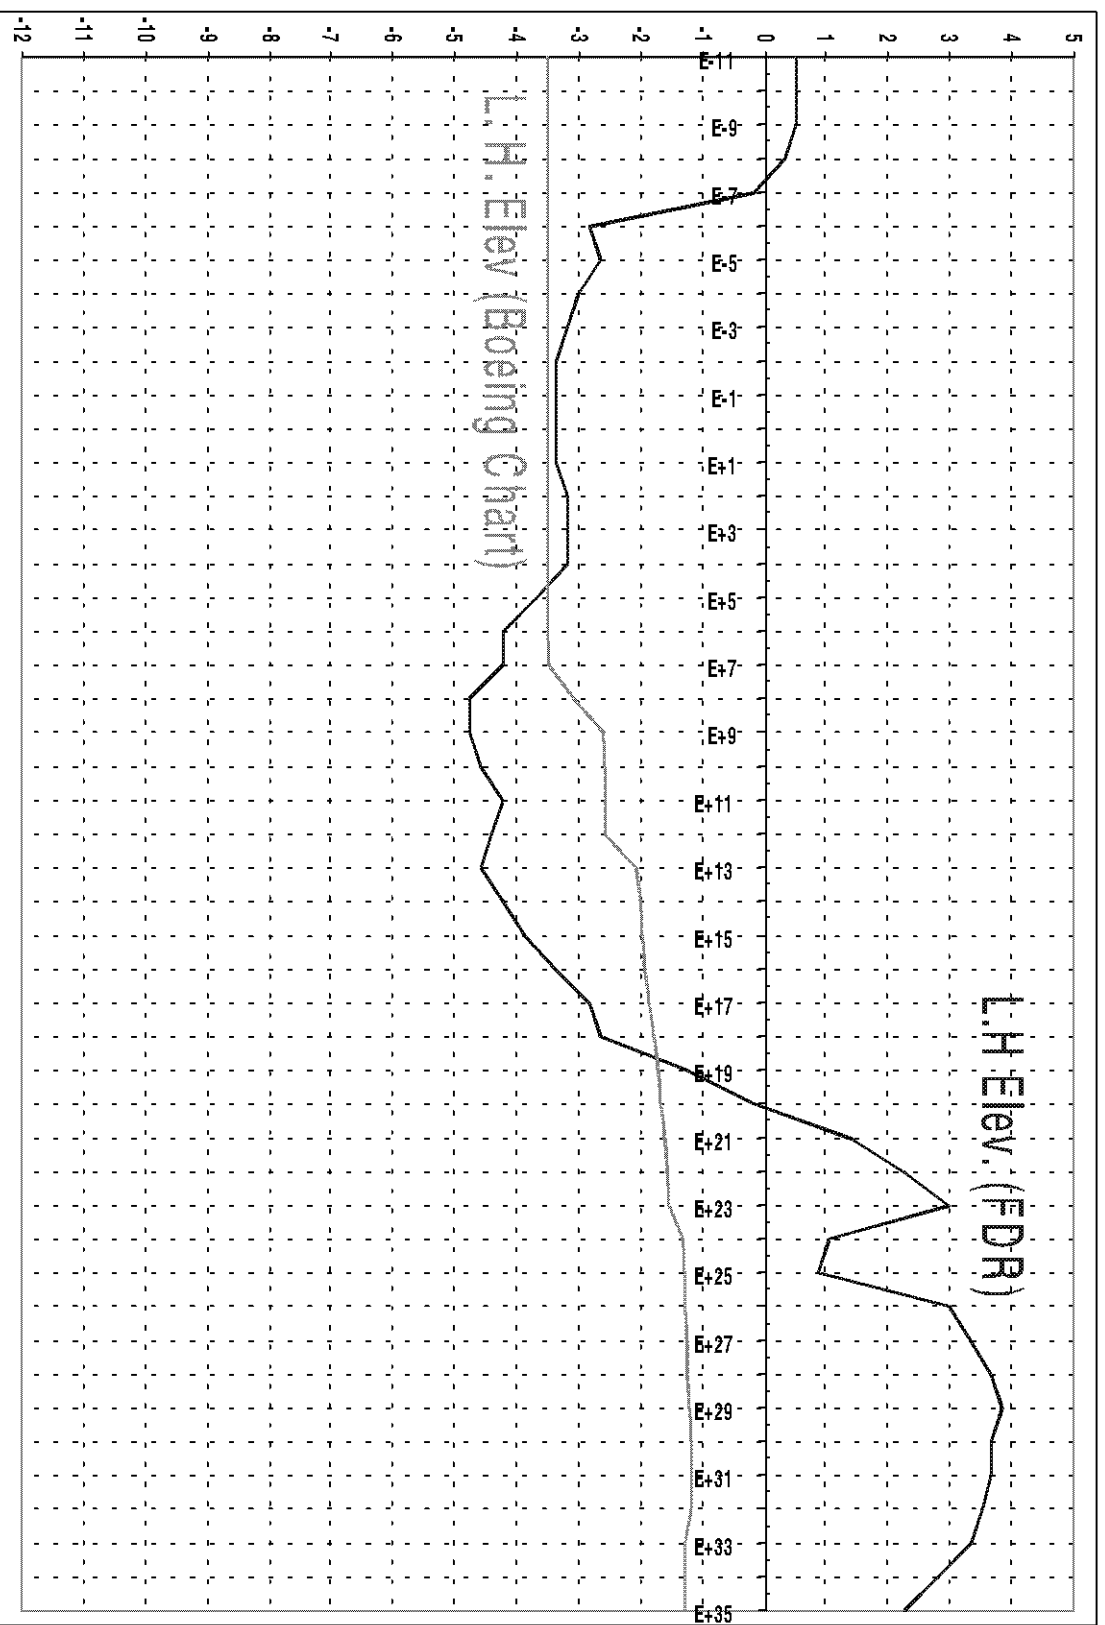
Analysis results as obtained from Boeing Force vs deflection Chart, considering effect of Mach no increase

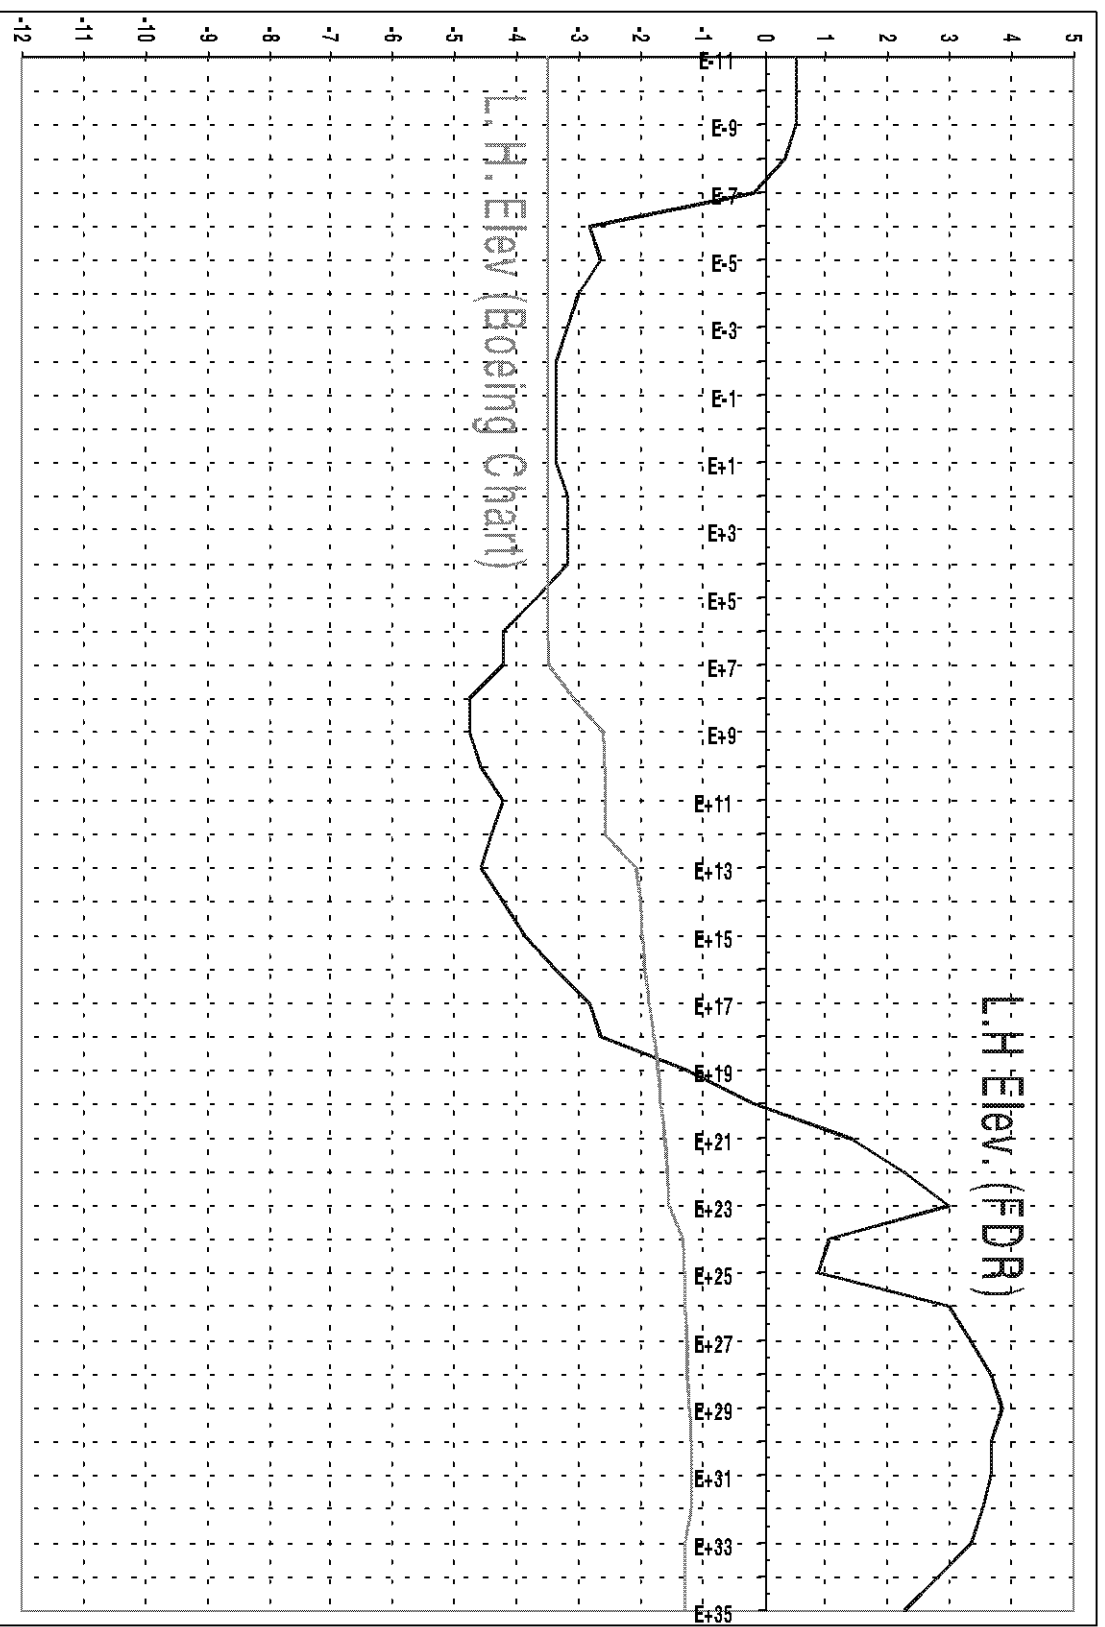
Note: The left elevator is still under control, pulling the control column aft will result in elevator upward movement

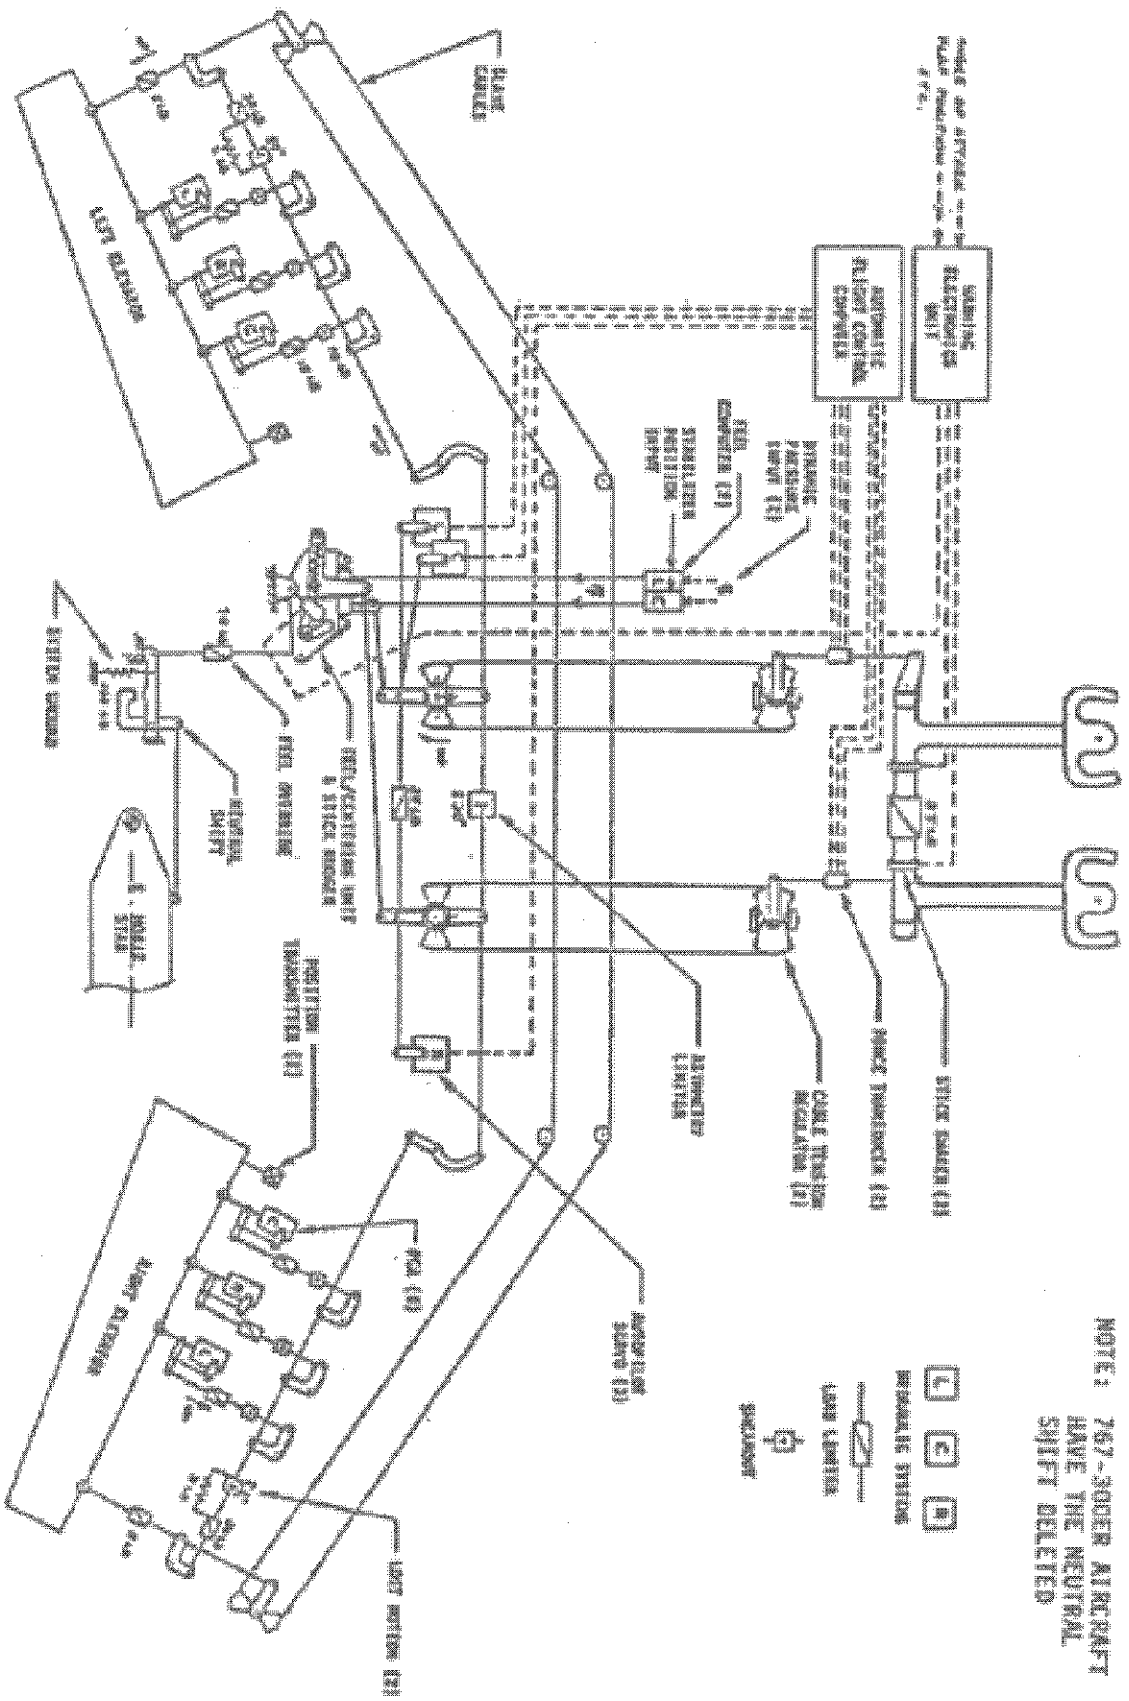
Figure 3.1-3. Elevator Control Schematic

- The internal slide spring cap was found separated from the slide in the servo valve for the right elevator outboard PCA through the rolled rivet. This was the only servo valve in which this cap was found separated.
- The right elevator outboard and center PCA bell crank linkage were sheared as if the bell crank arms were moving to a lower relative angle, while the other three bell cranks (the inboard of the right elevator and two of the left elevator) were sheared as if the bell crank arms were moving to a higher relative angle.

- Require a cockpit indication in the Boeing 767 that will alert the flight crew to a condition of abnormal PCA operation where in a single fault in the elevator could result in uncommanded elevator movement. Until such a cockpit indication is installed require operators of B767 airplanes to perform daily check of the elevator system as now performed in the 400 hr inspection to isolate faults in the elevator system
- Review the B767 elevator control system design and conduct further examination of the causes of the reported discrepancies found in the elevator actuator bell crank, and
- In conjunction with the Boeing Company develops cockpit crew procedure that will aid the crew during flight in identifying, isolating and negating an uncommanded elevator hard over condition
