NATIONAL TRANSPORTATION SAFETY BOARD

ELECTRICAL POWER SUPPLY EXAMINATION

**NTSB Accident: WPR13FA294
Accident Date: June 27, 2013**

Location: Birdseye, UT
Date: June 27, 2013
Aircraft: Cessna 172, N4459R, Serial # 17263201
NTSB IIC: Michael Huhn

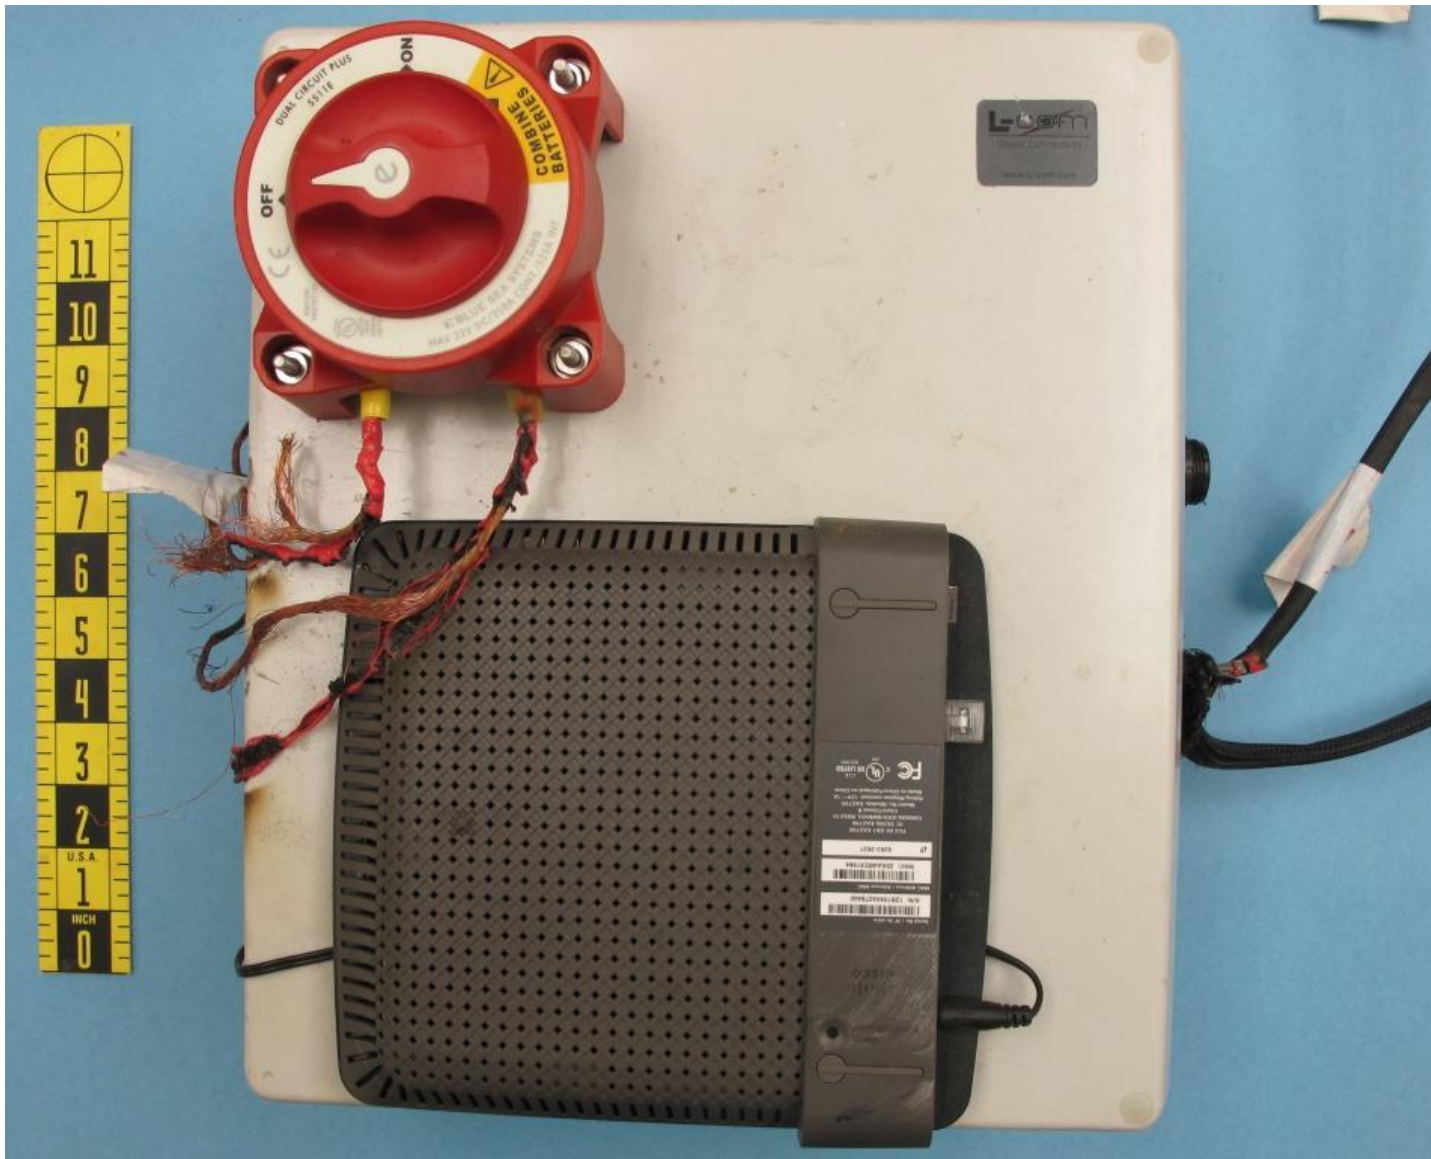
Figure 1 - Top View of Power Distribution Box, With Red Switch and Modem

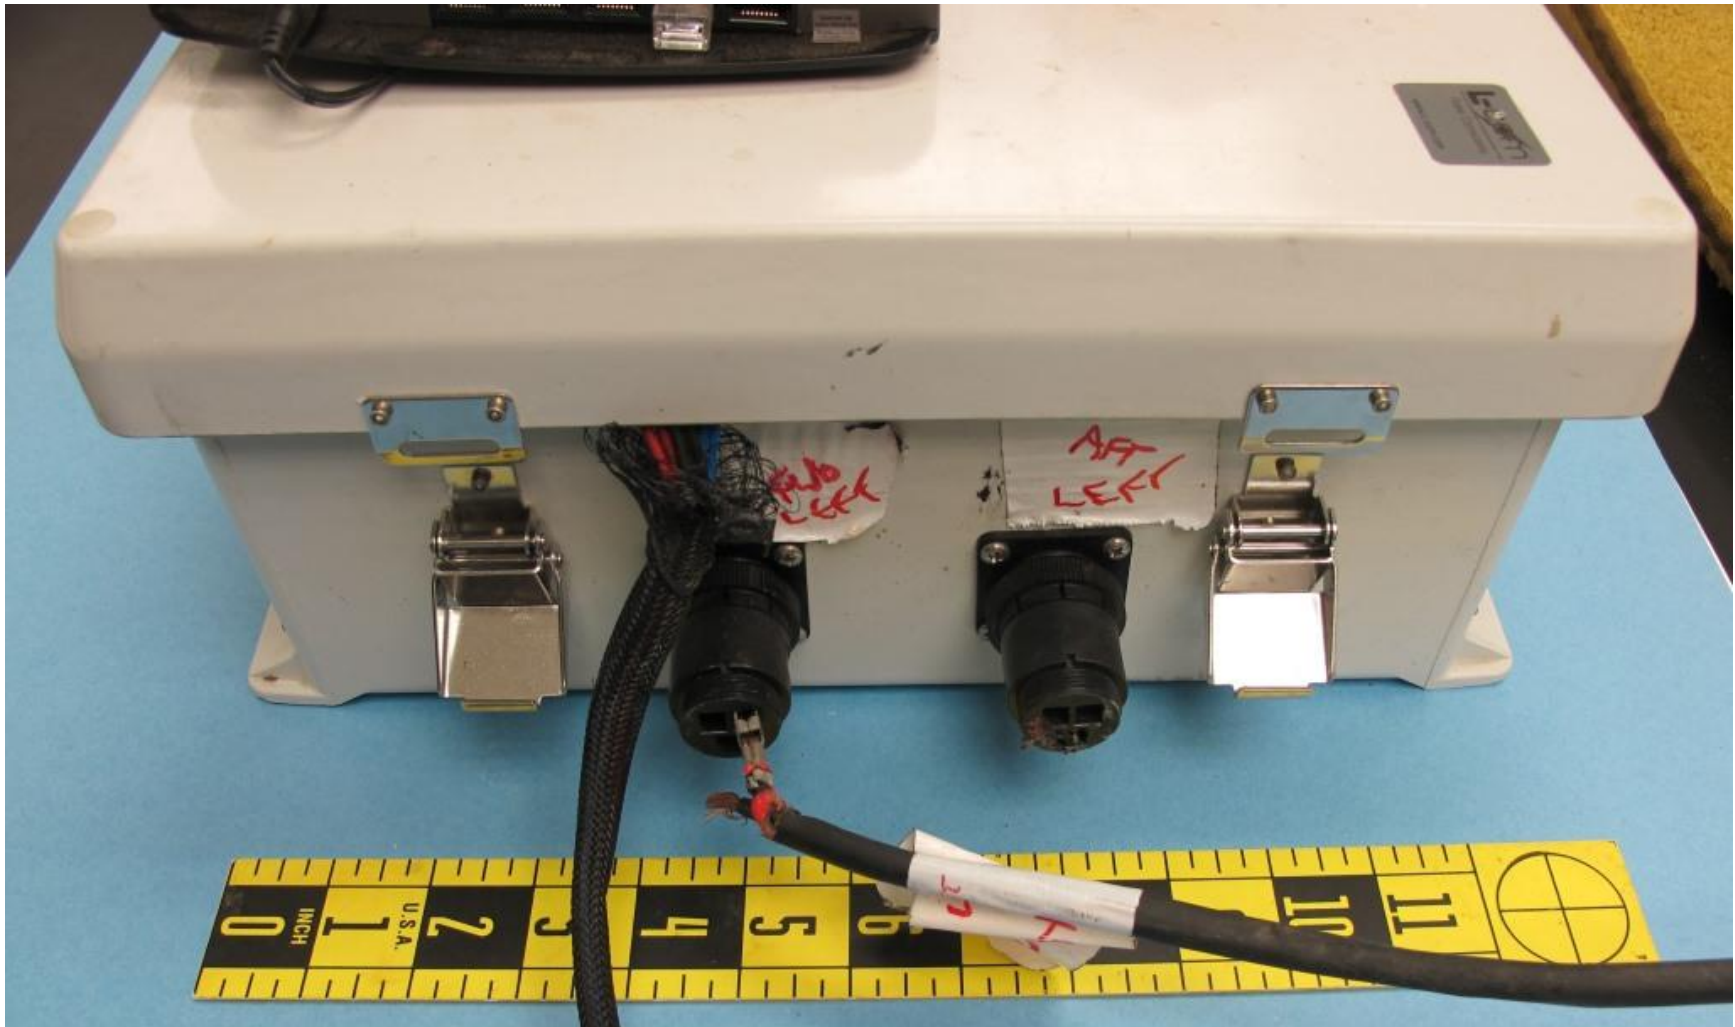
Figure 2 - Left Side of Power Distribution Box

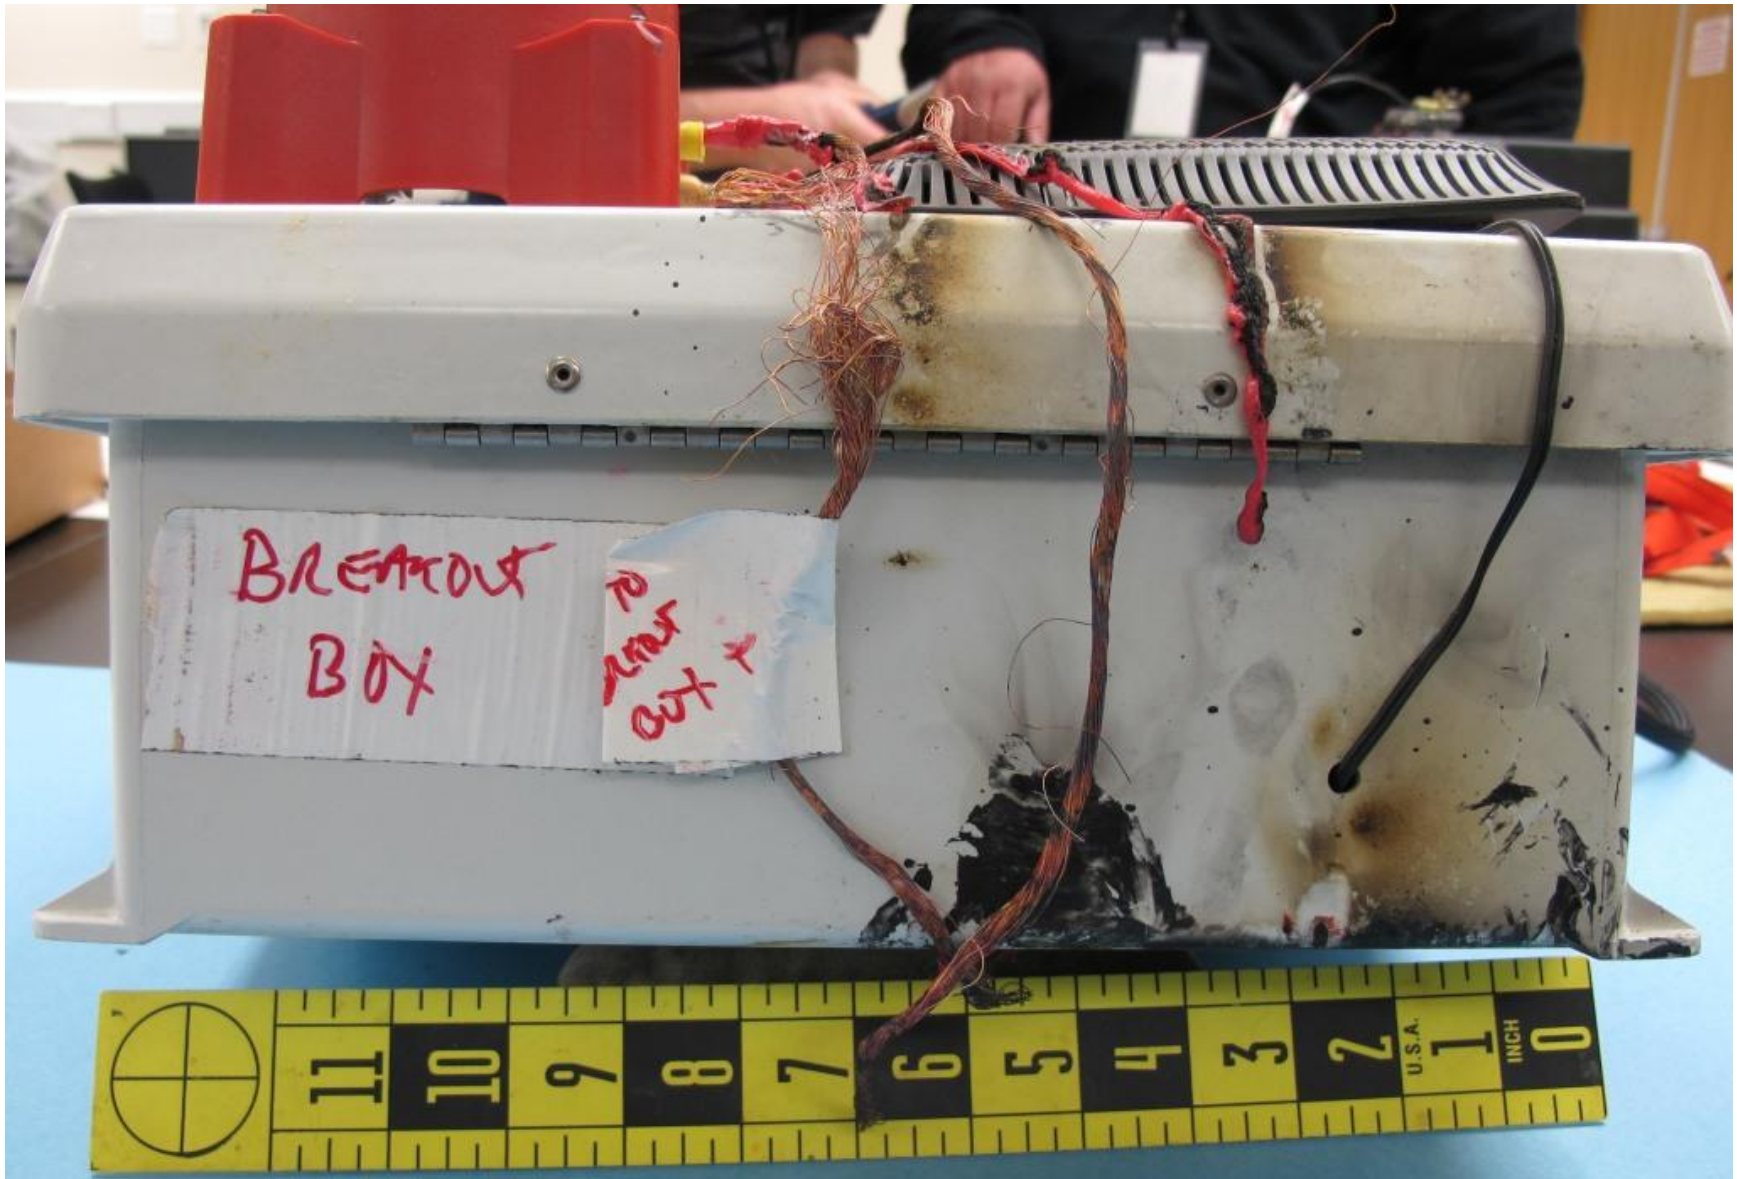
Figure 3 - Right Side of Power Distribution Box

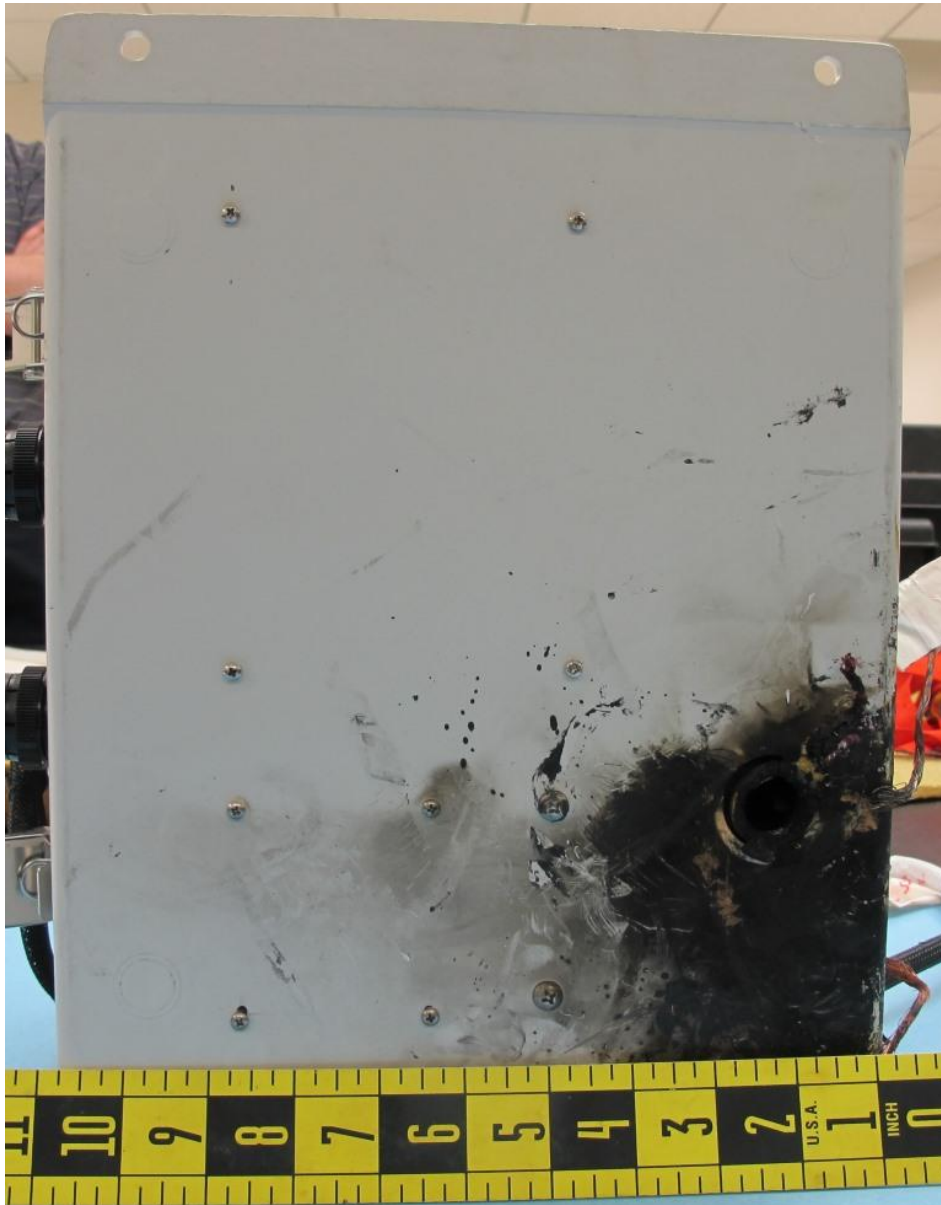
Figure 4 - Bottom of Power Distribution Box

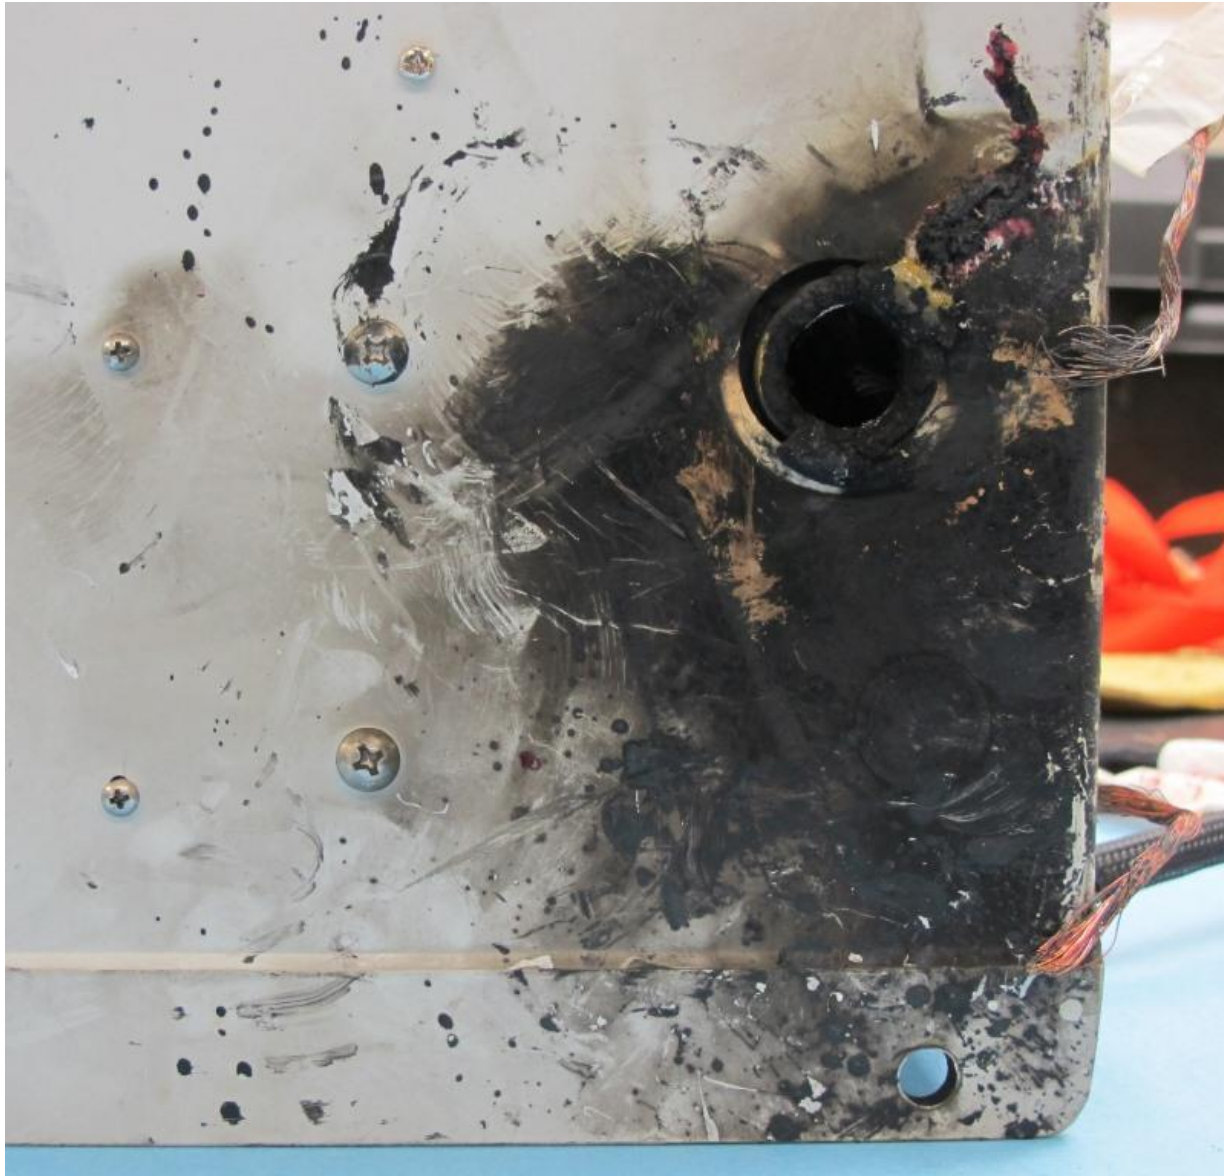
Figure 5 - Closeup of Grommeted Hole in Bottom of Power Distribution Box

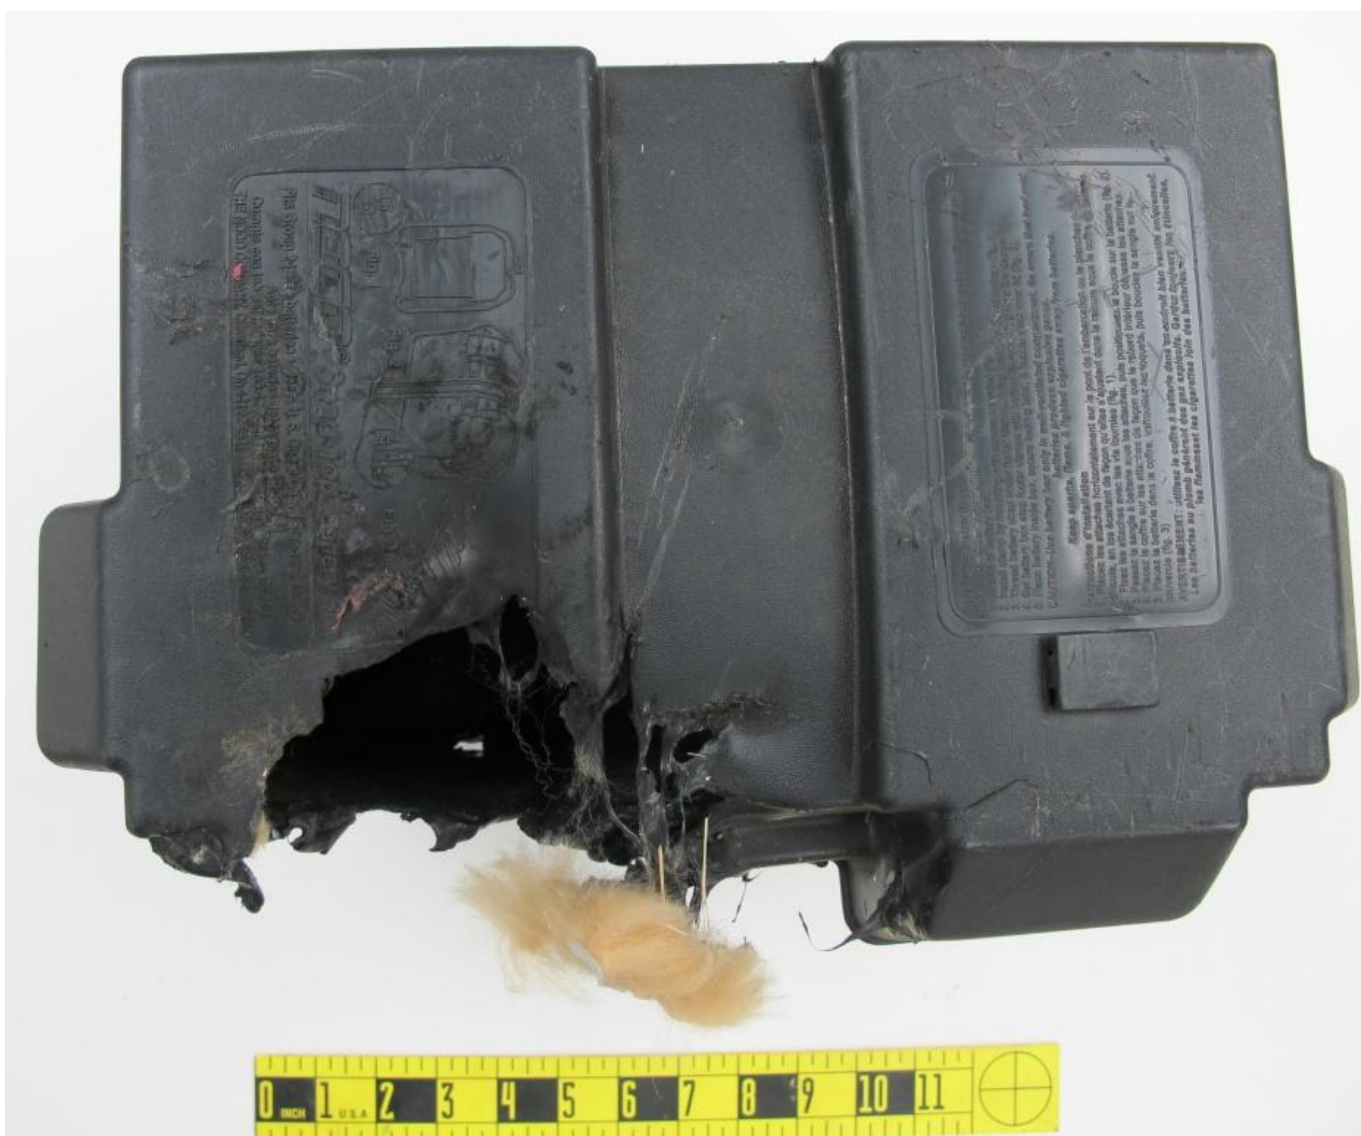
Figure 6 - Top View of Battery Box

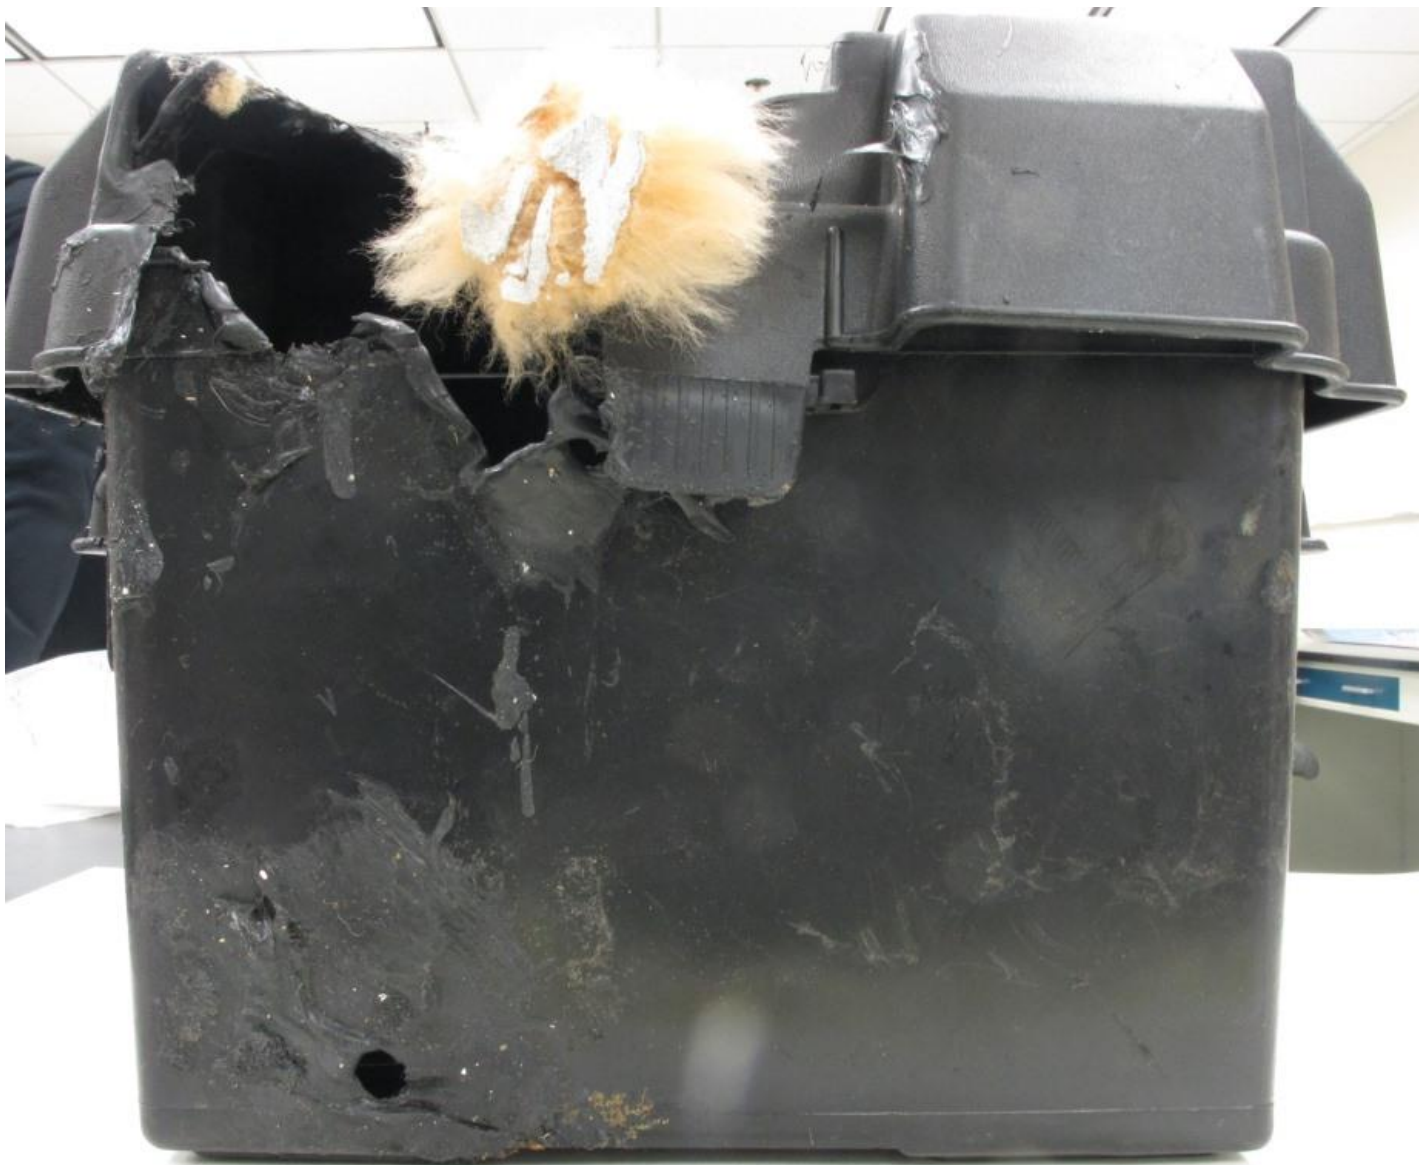
Figure 7 - Front Side of Battery Box

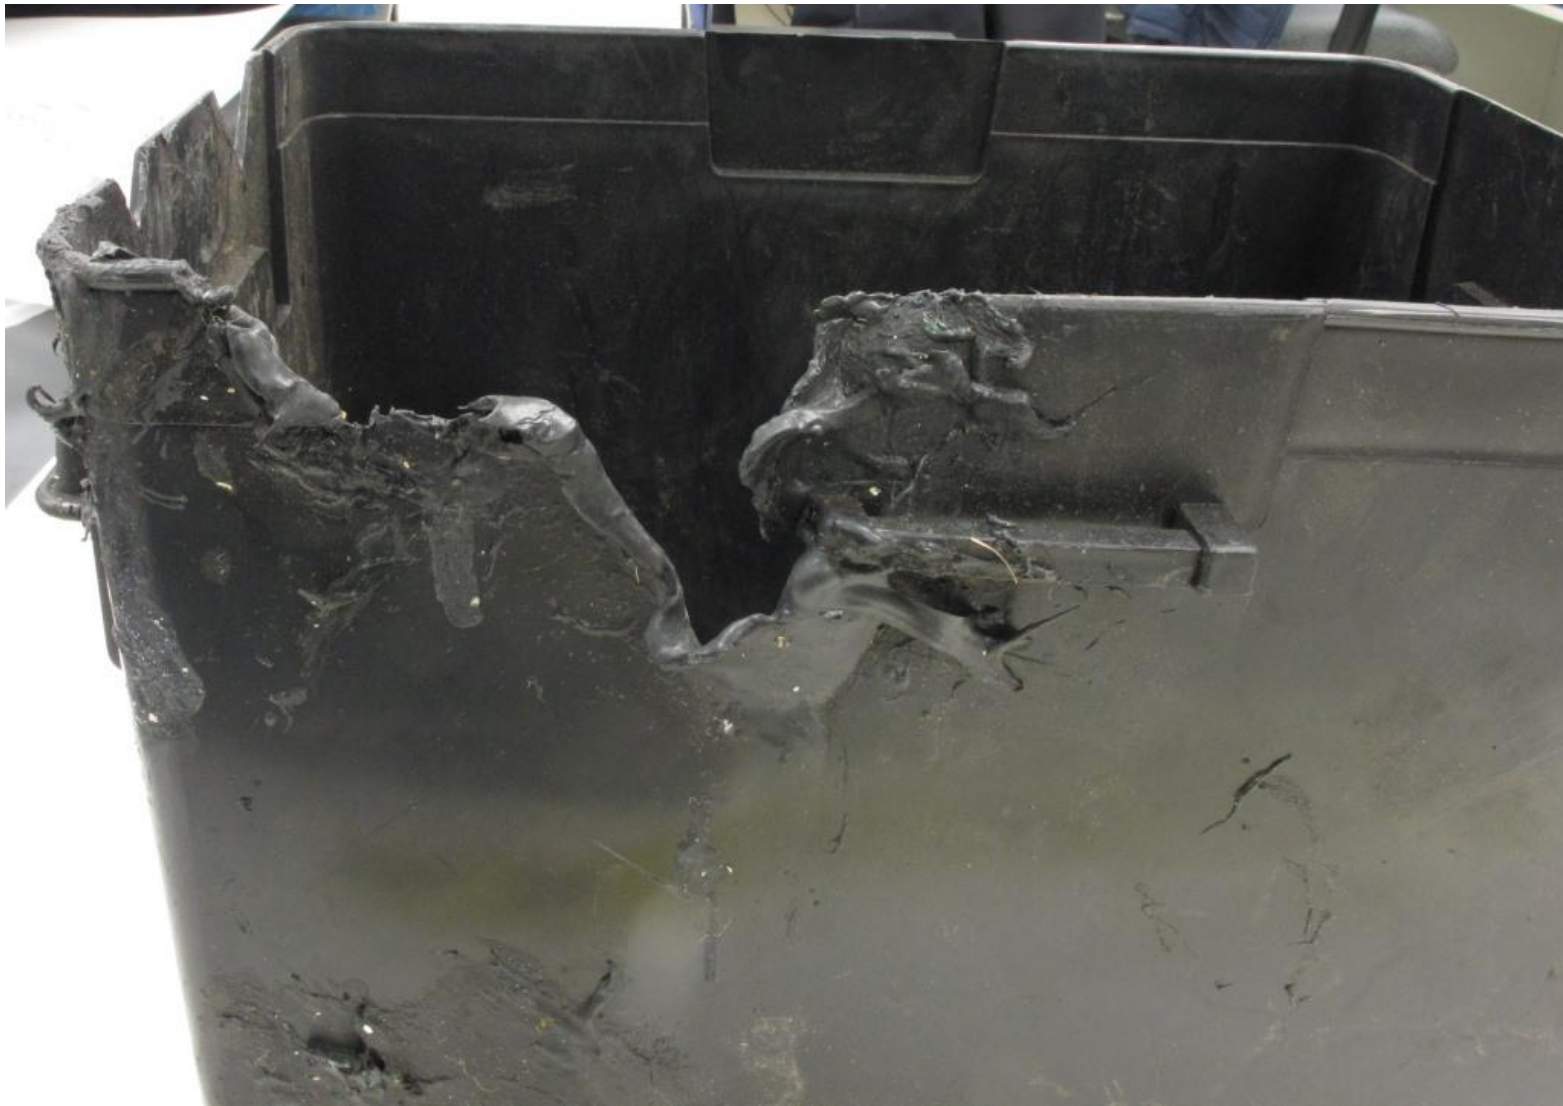
Figure 8 - Closeup of Front Side of Battery Box Melted Area

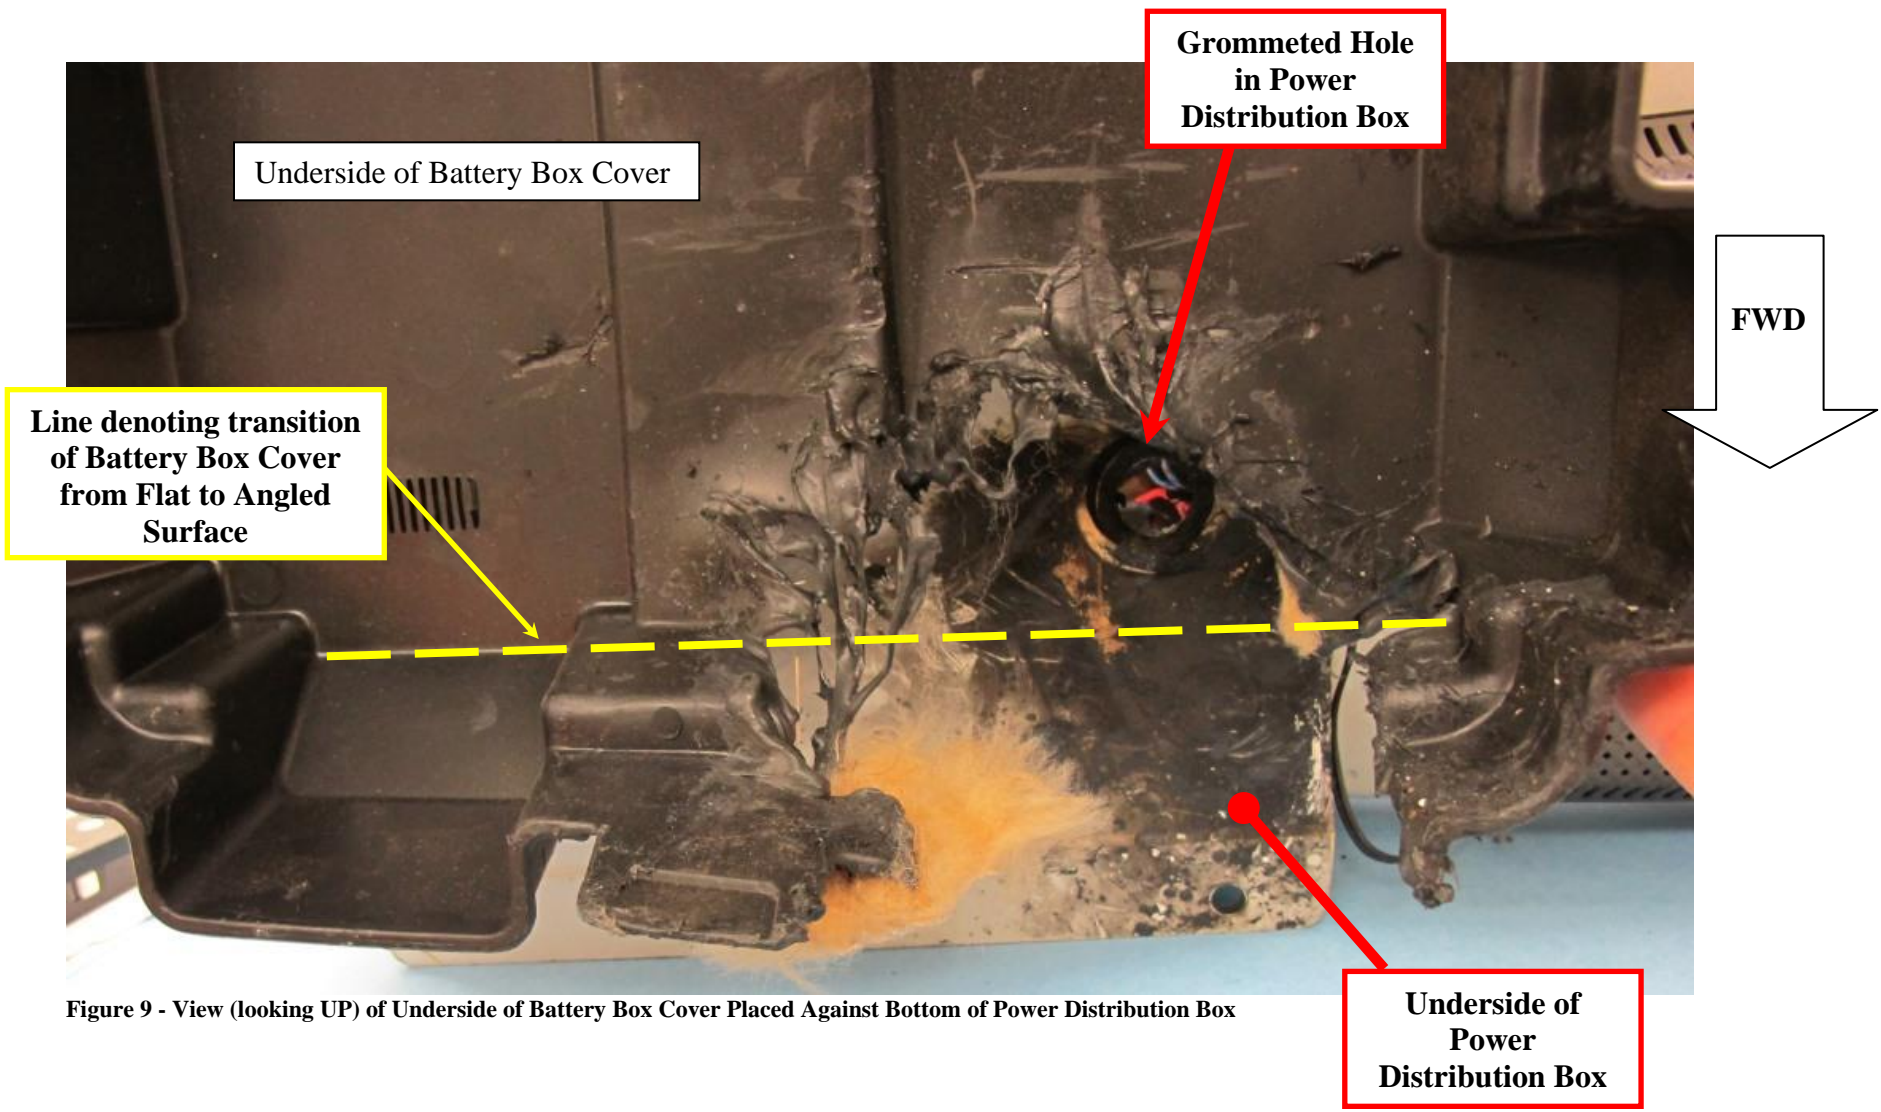
Figure 9 - View (looking UP) of Underside of Battery Box Cover Placed Against Bottom of Power Distribution Box

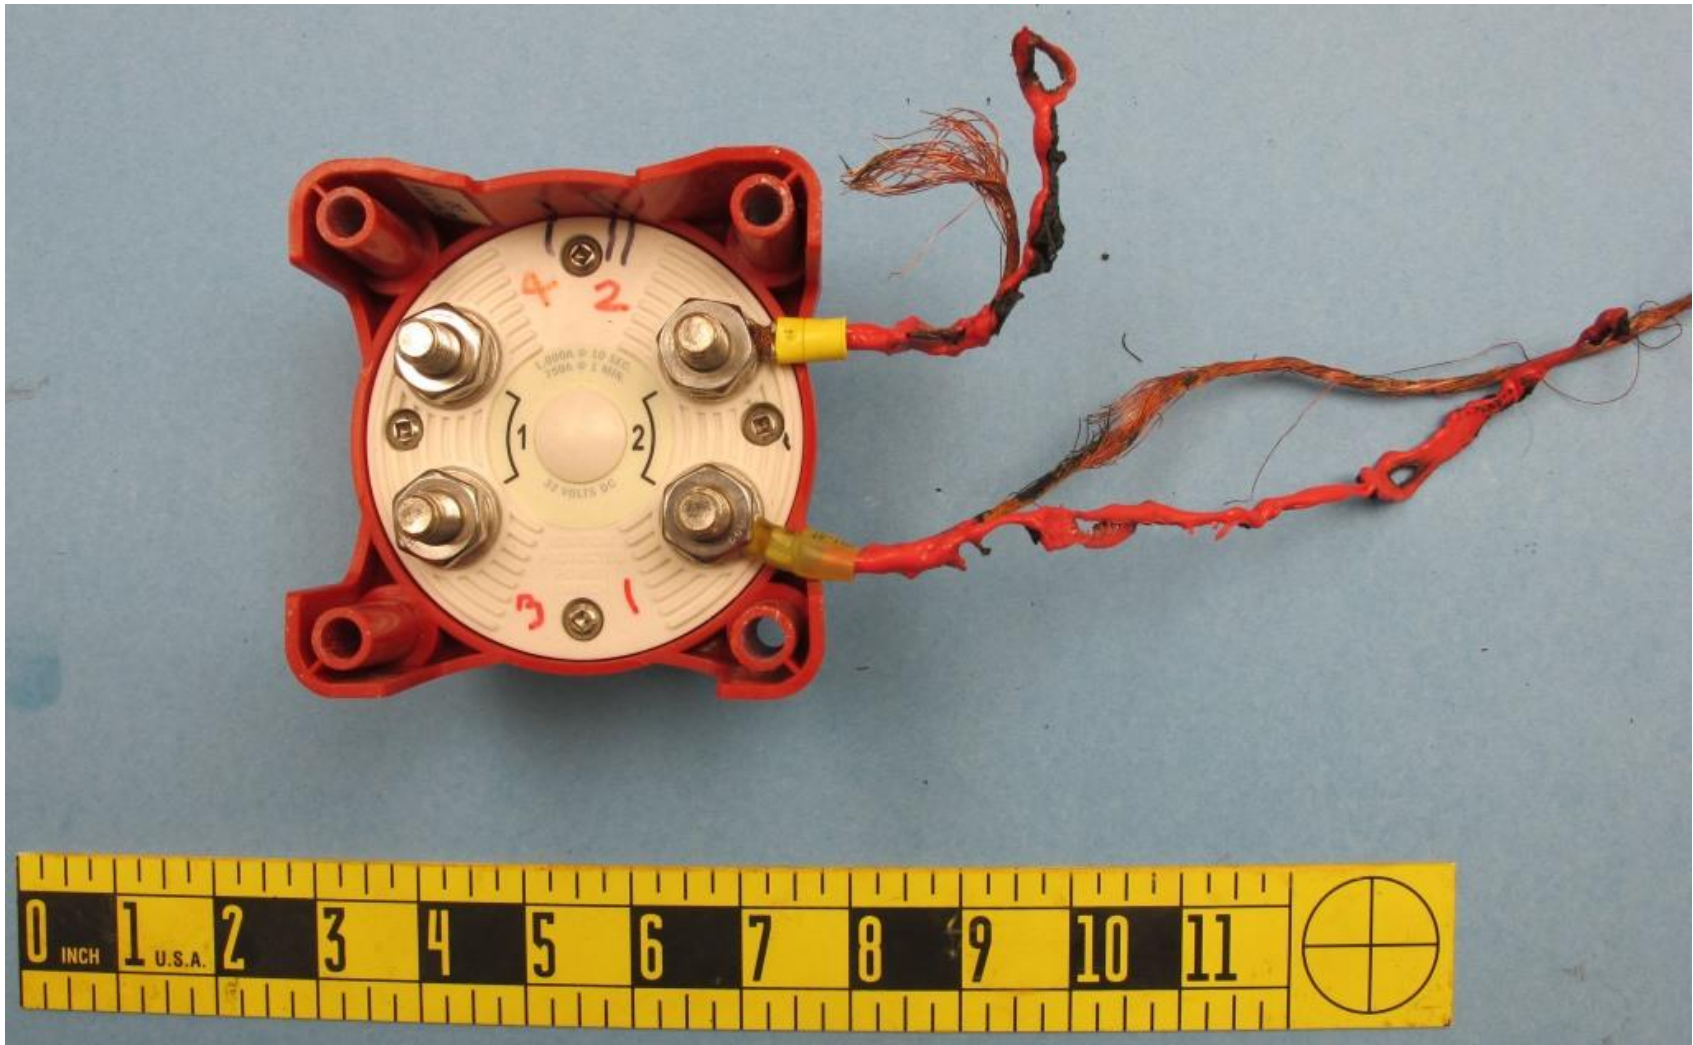
Figure 10 - Underside of Red Switch (with terminal numbers)

The four terminals on the underside of the red switch were numbered 1 - 4 as shown in Figure 10. Terminal 1 was wired to the isolator (E), and Terminal 2 was wired to the power distribution box (C). Terminals 3 and 4 were unused. Continuity checks via ohmmeter between the four terminals were conducted for the switch in each of its 3 positions (OFF, ON, COMBINE). Those results were as follows:

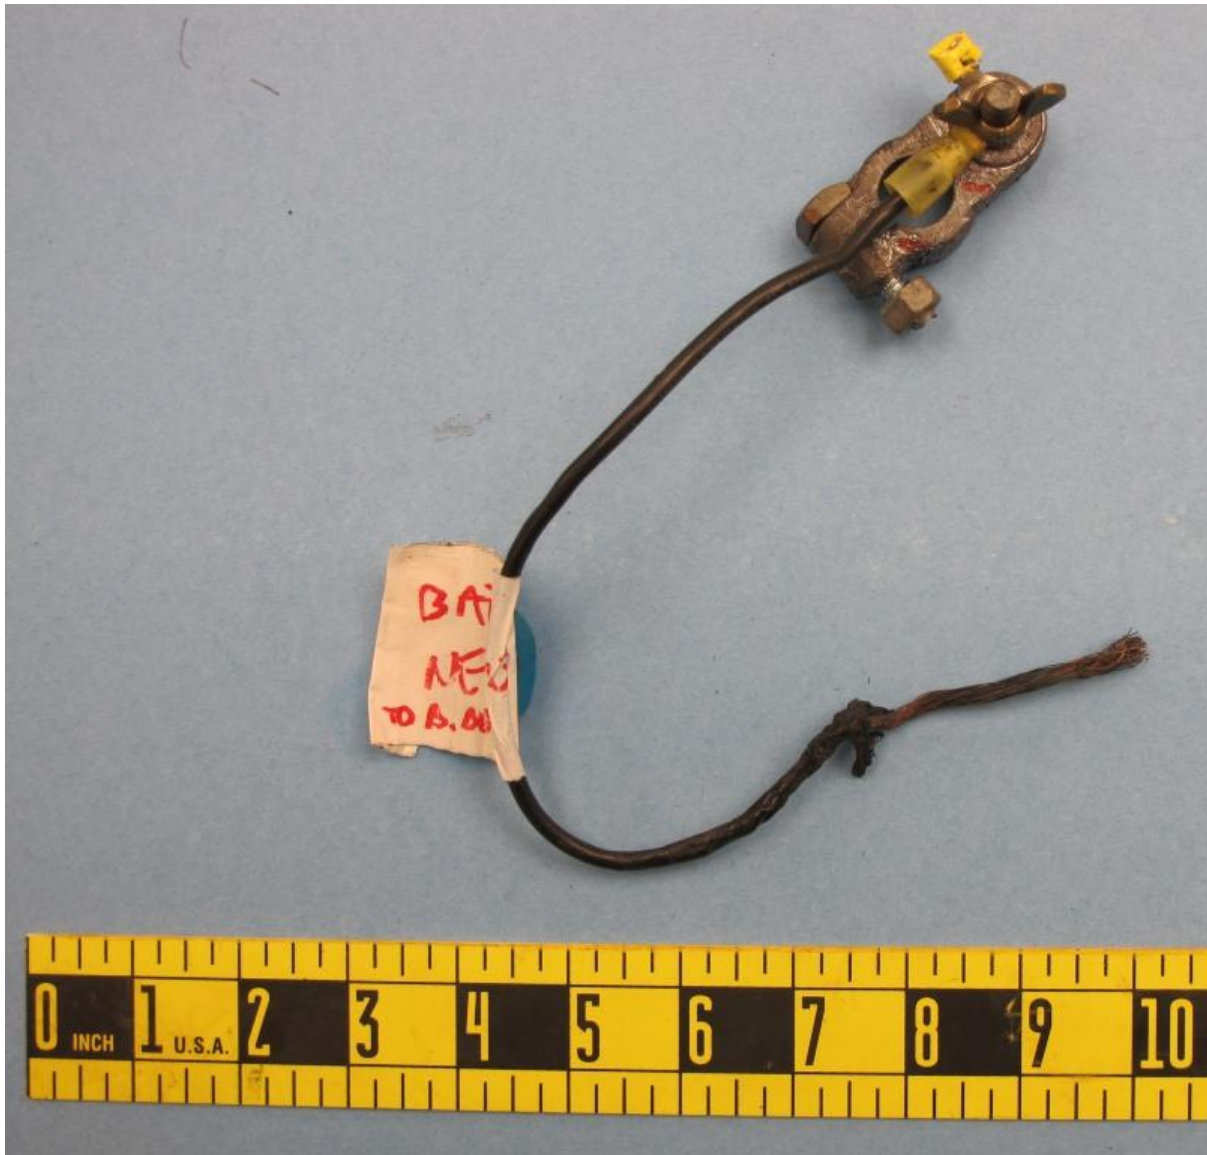
Figure 11 - Negative Battery Terminal and Lead

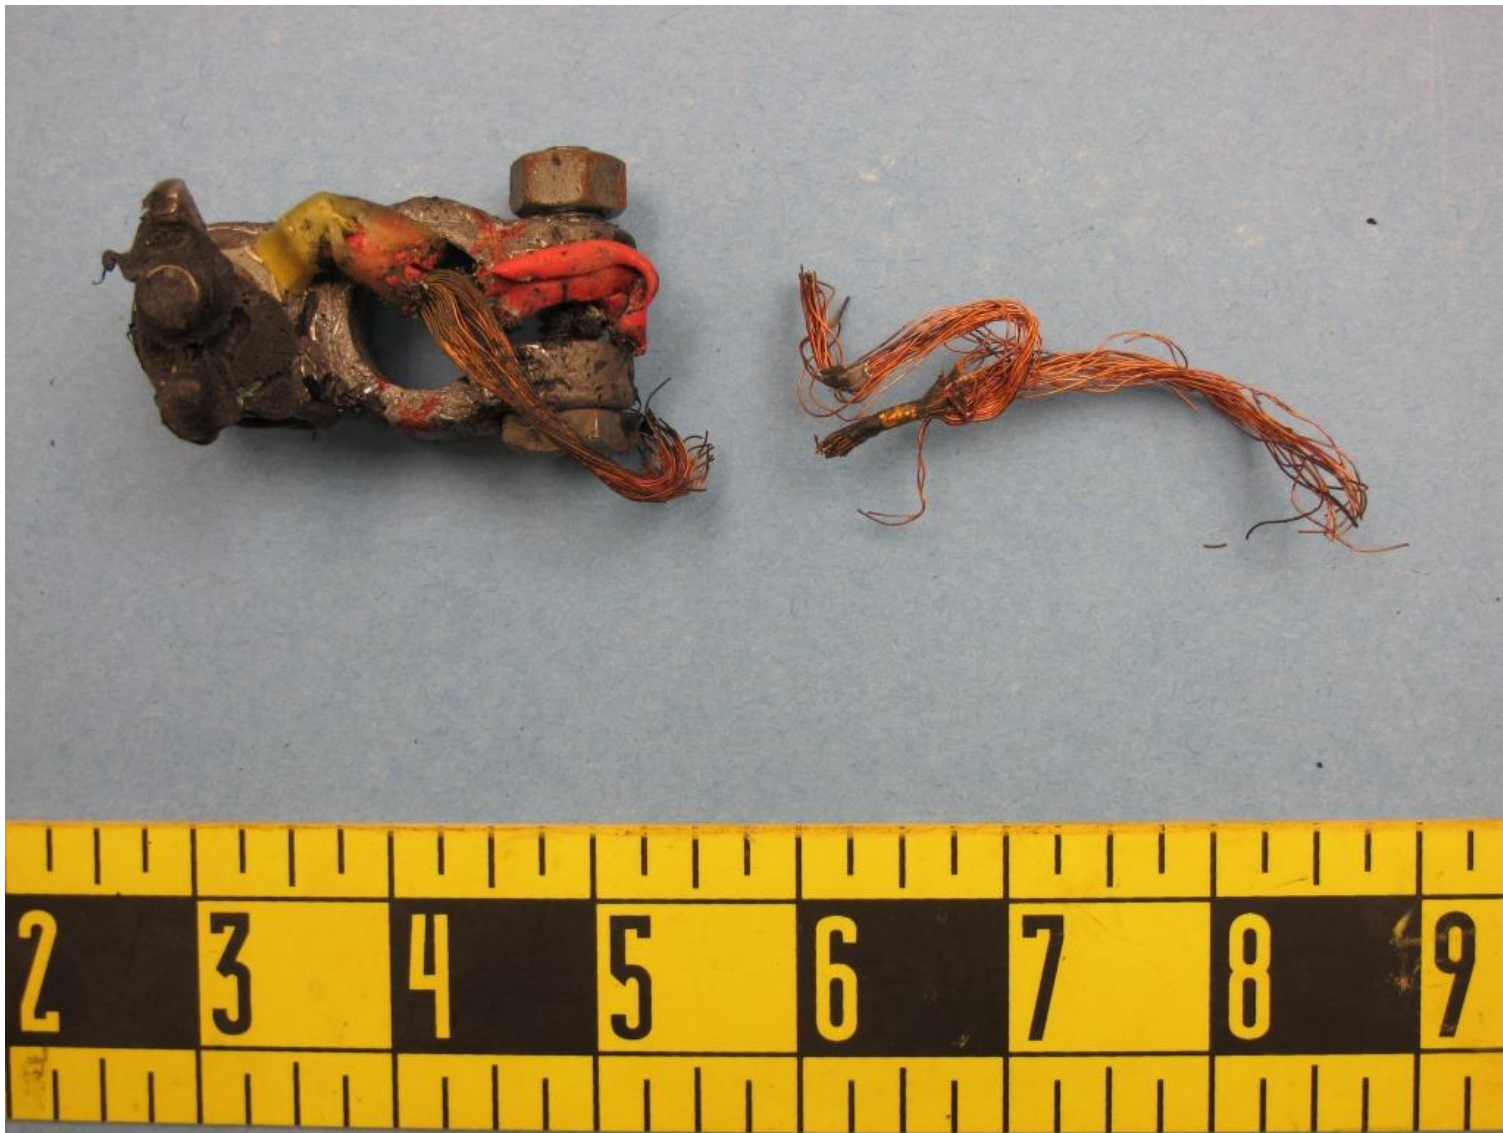
Figure 12 - Positive Battery Terminal and Lead

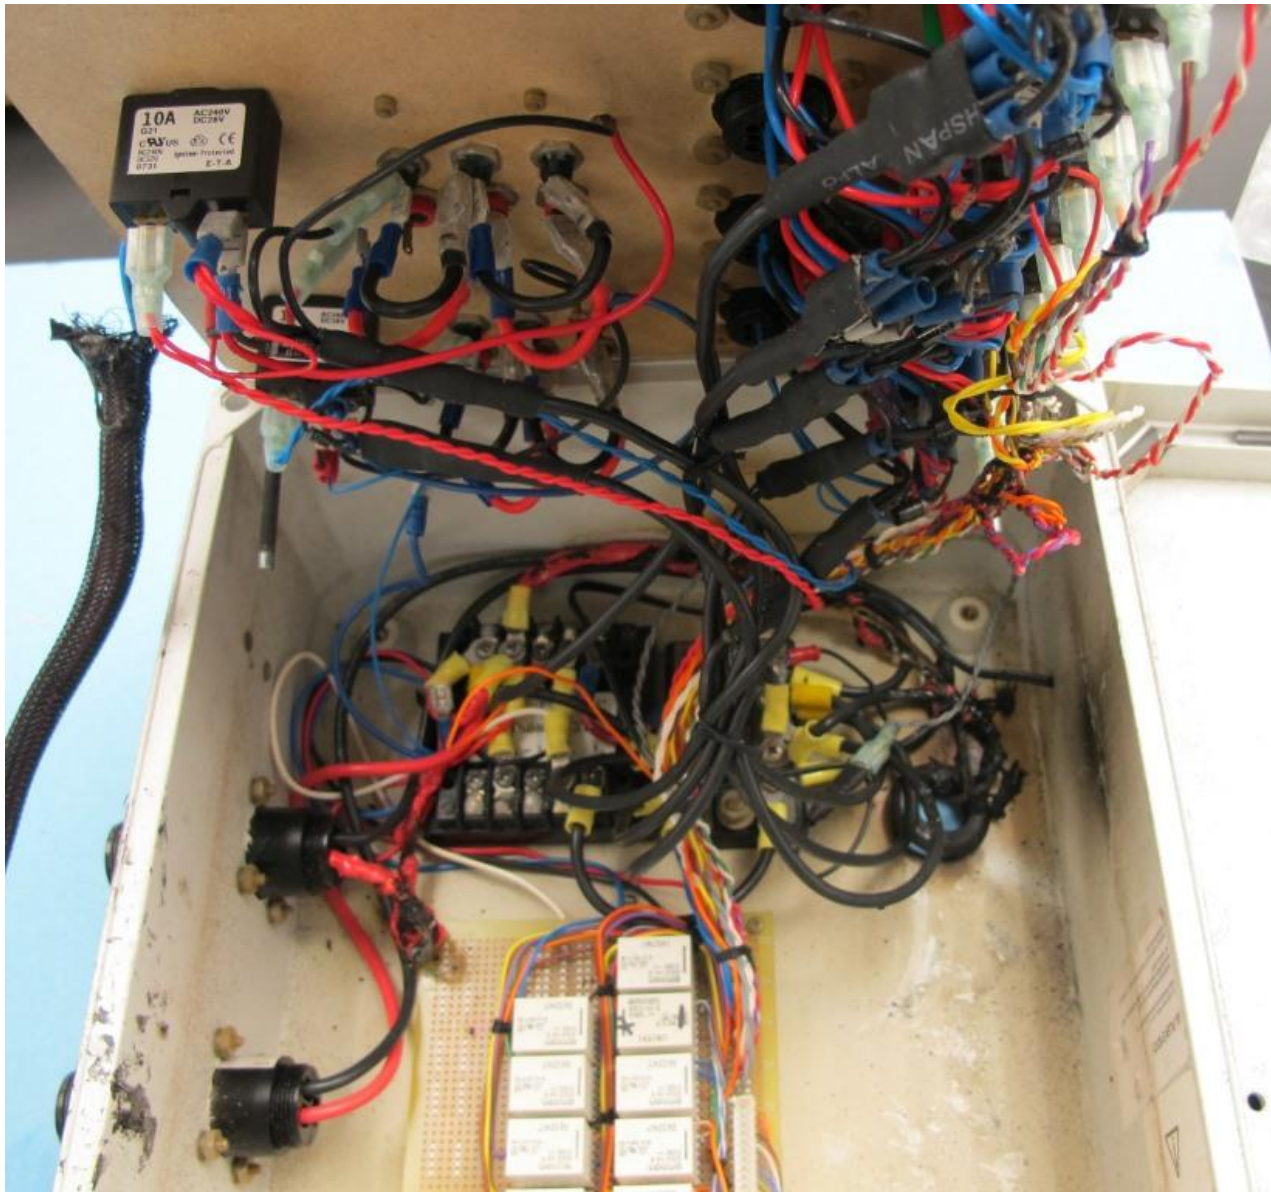
Figure 13 - Inside of Power Distribution Box
