NATIONAL TRANSPORTATION SAFETY BOARD

ELECTRICAL POWER SUPPLY EXAMINATION

**NTSB Accident: WPR13FA294
Accident Date: June 27, 2013**

Location: Birdseye, UT
Date: June 27, 2013
Aircraft: Cessna 172, N4459R, Serial # 17263201
NTSB IIC: Michael Huhn

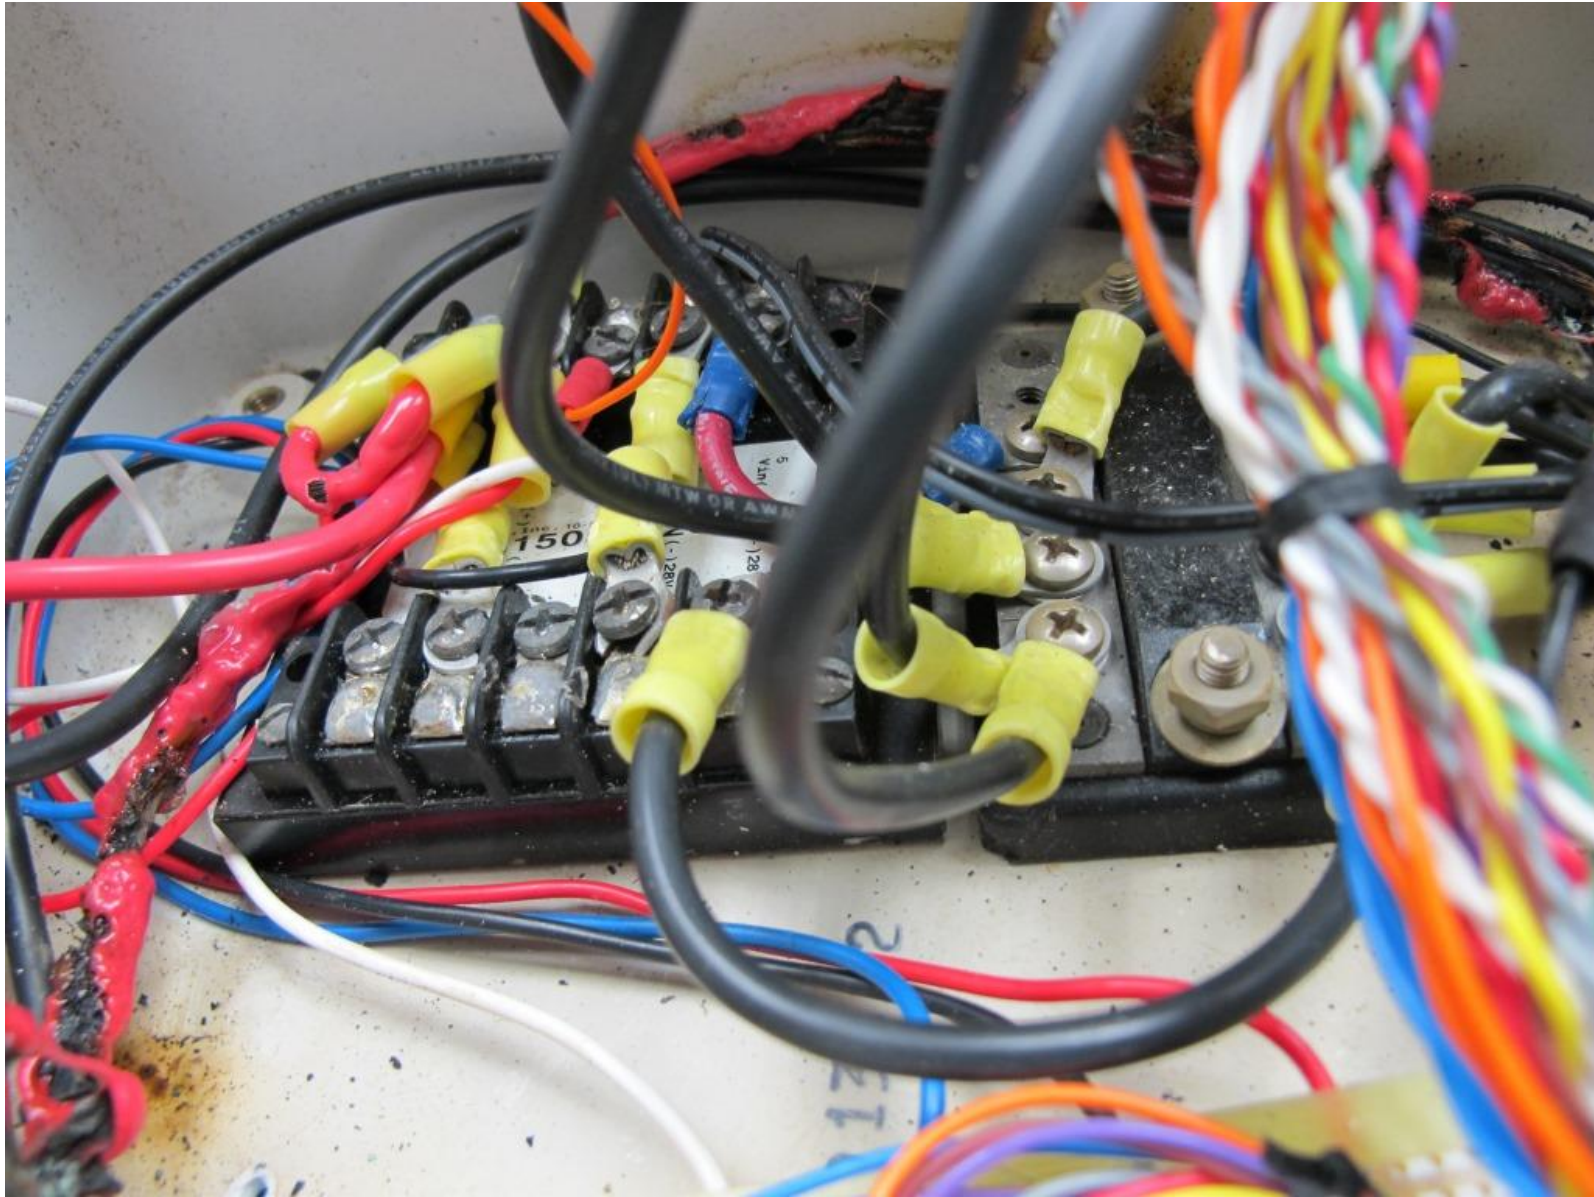
Figure 14 - Closeup of Step Up Transformer

C-1	Step up transformer	Removed and function-checked OK. Per design dwg, terminals 1-2 were internally linked, but tested intermittent.
C-2	Negative Buss Bar	Not Tested. Visually intact, all connections secure
C-3	Relay breadboard	Verified wiring pin connections per design dwg
D	Red Switch	Not damaged. Opened prior to rotating switch, no internal damage or arcing observed. Re-assembled and tested continuity for 3 switch positions (OFF, ON, COMBINE) Function checked OK. See test matrix below
E	Isolator; Relay	Not tested. Visually undamaged.
F	Remote Switch Box	Not tested. Appeared undamaged, as did wires to this device.
G	Circuit Breaker Panel	Impact damage but no thermal damage. 40A breaker toggle switch fracture-separated. Other breaker rating not determined, and breaker 'button' fell out of breaker housing. Neither unit tested, but as-found wiring congruent with design dwg.
H	DC-AC inverter	Red lead from "forward left" cannon plug port of 'C' to this unit was thermally damaged. Unit opened; minor impact damage but no thermal damage noted, Function checked OK

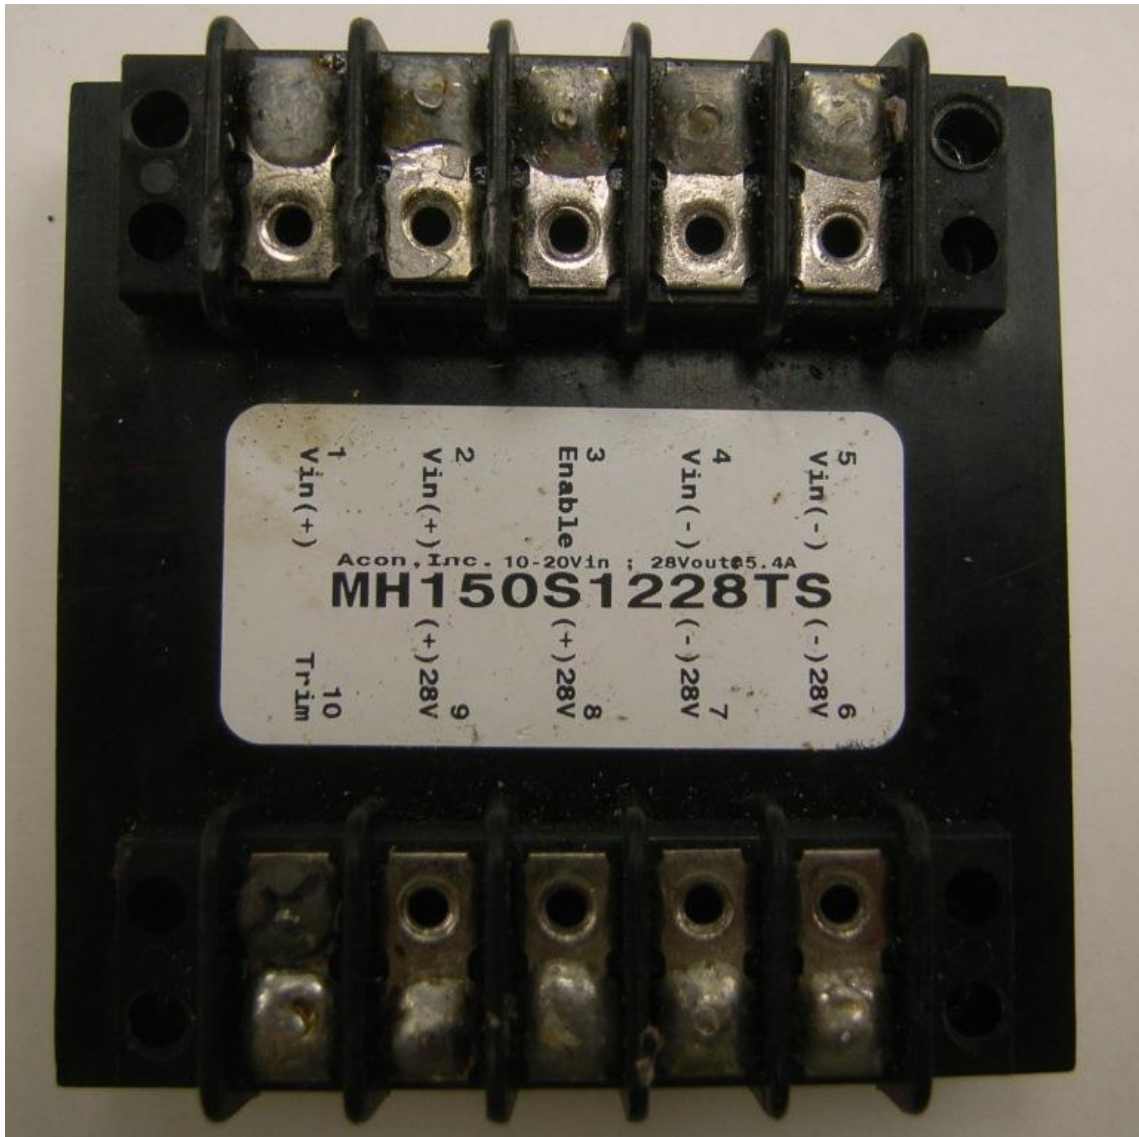
Figure 15 - Step Up Solid State Transformer

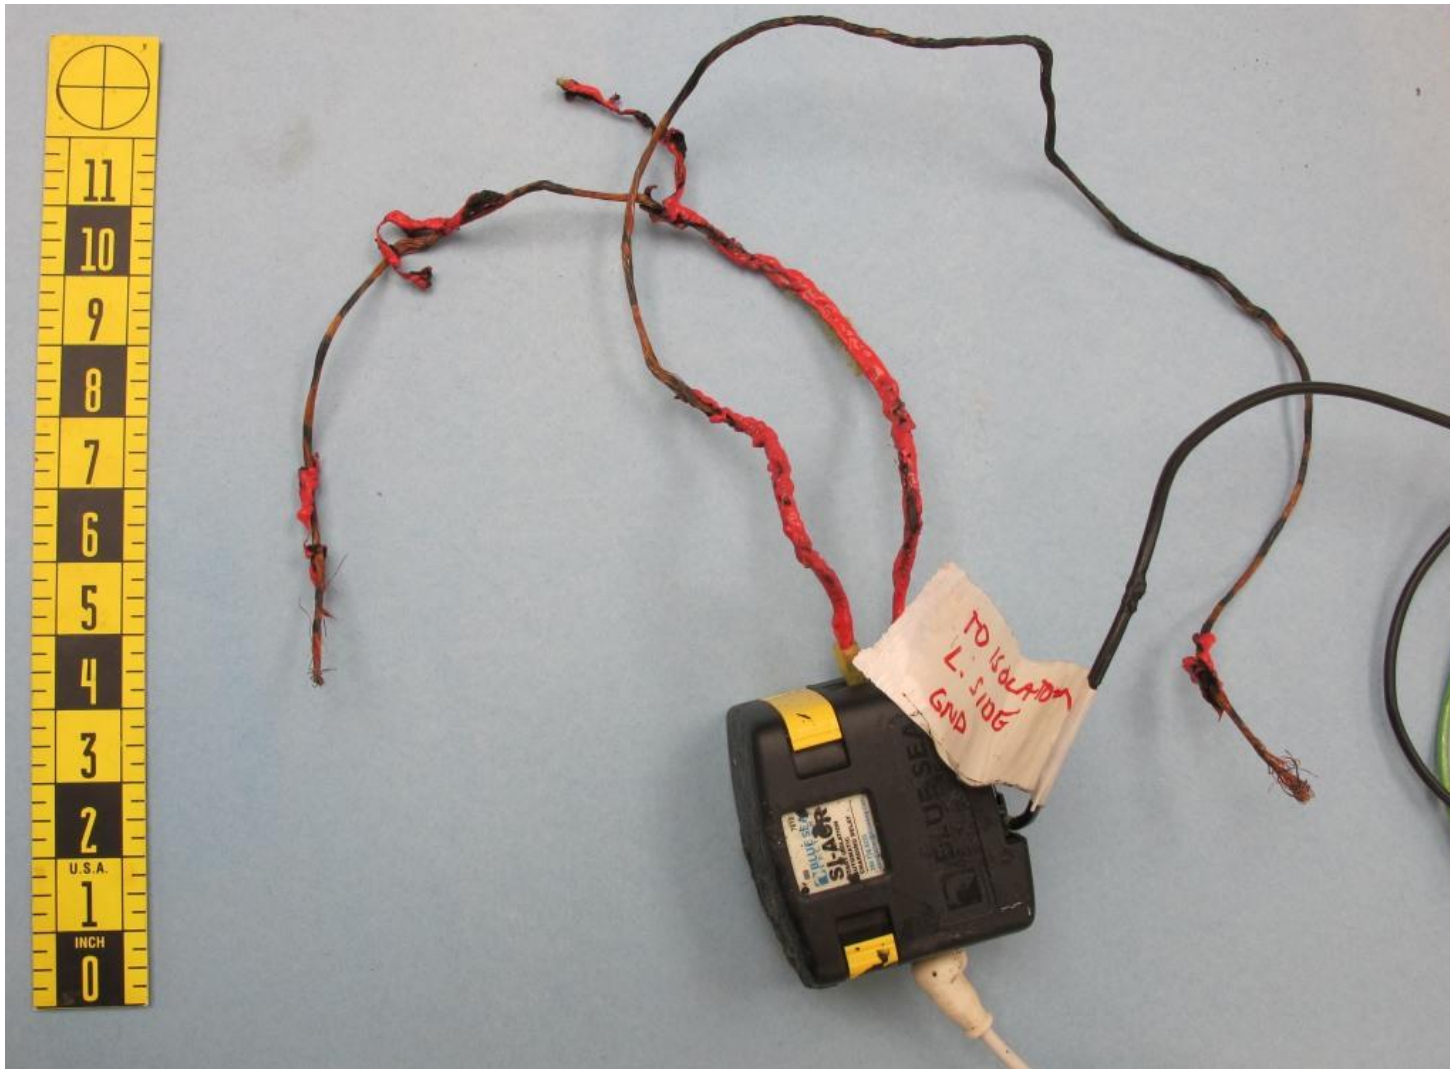
Figure 16 - Isolator Relay Box

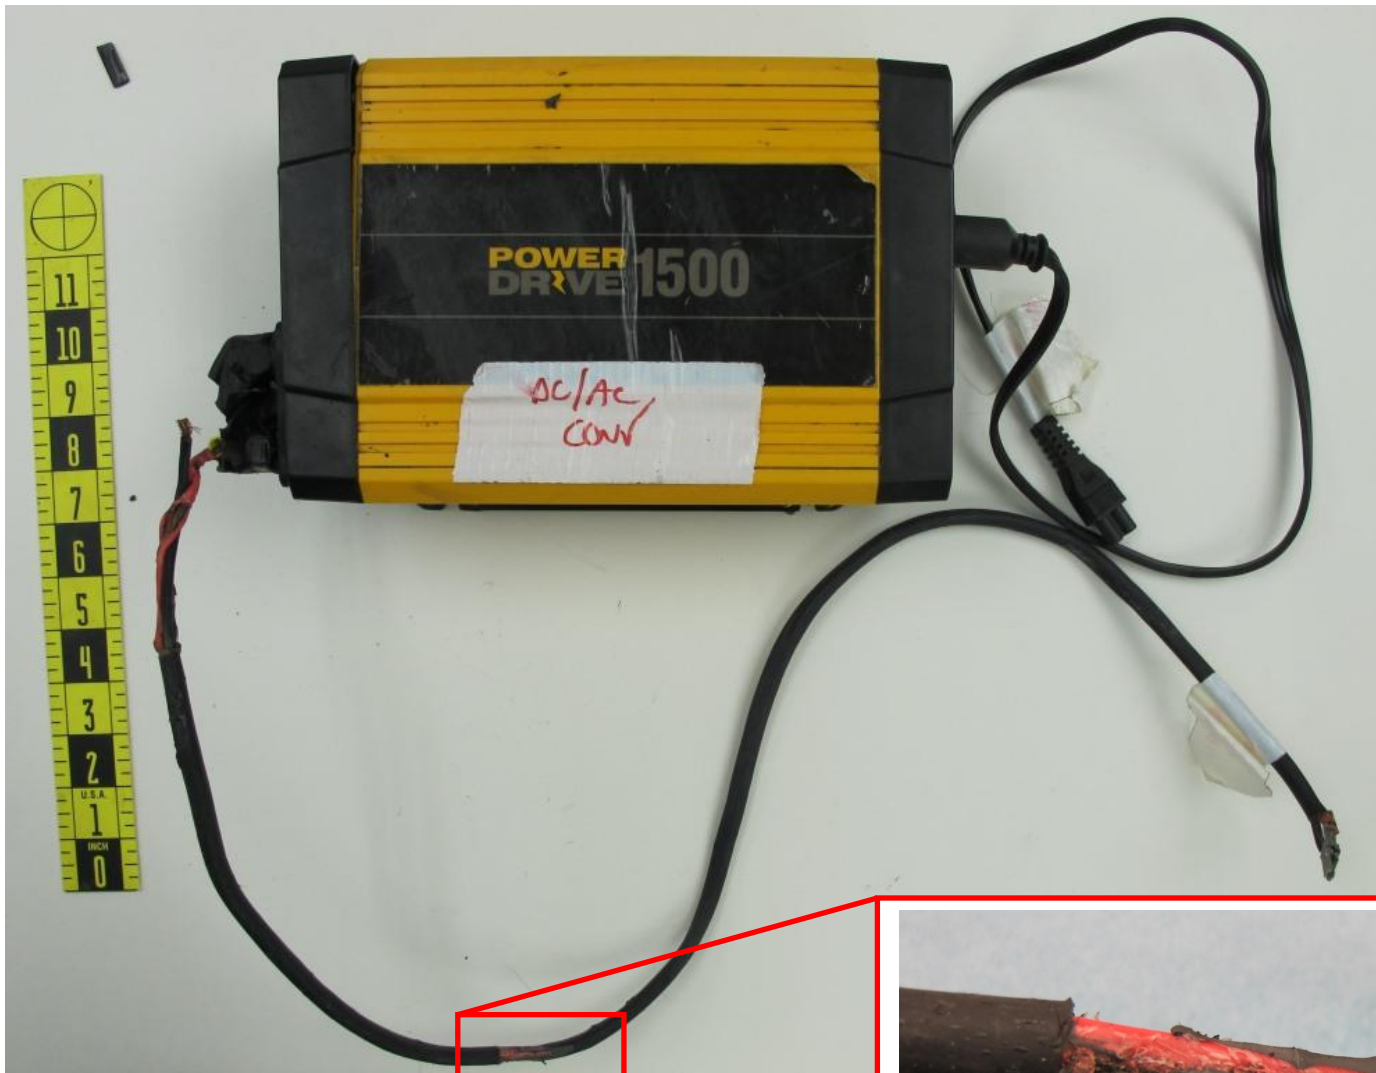
Figure 17 - Inverter
