NATIONAL TRANSPORTATION SAFETY BOARD
Vehicle Recorder Division
Washington, D.C. 20594

Electronic Control Modules

Specialist's Factual Report By Ben Xu

Location: Chesterfield, New Jersey
Date/Time: February 16, 2012 / 0800 EST
Vehicle/ID: 2004 Mack CV713 / 1M2AG11C54M012315
Operator: Herman's Trucking Inc.
NTSB Number: HWY12MH007

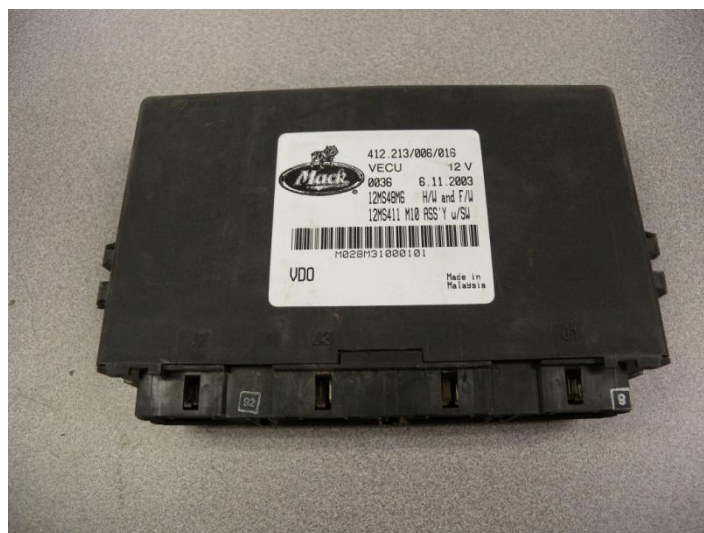
Figure 1: VECU (S/N M028M31000101)

The VECU and EECU were in good condition as seen in Figures 1 and 2, respectively. Data in the modules was imaged by an approved Mack service provider under the supervision of NTSB staff.
