NATIONAL TRANSPORTATION SAFETY BOARD

Electronic Device Factual Report

Location: Wahiawa, Hawaii
Date: August 27, 2013
Aircraft: Champion 8KCAB
Registration: N413JJ
Operator: Private
NTSB Number: WPR13LA389

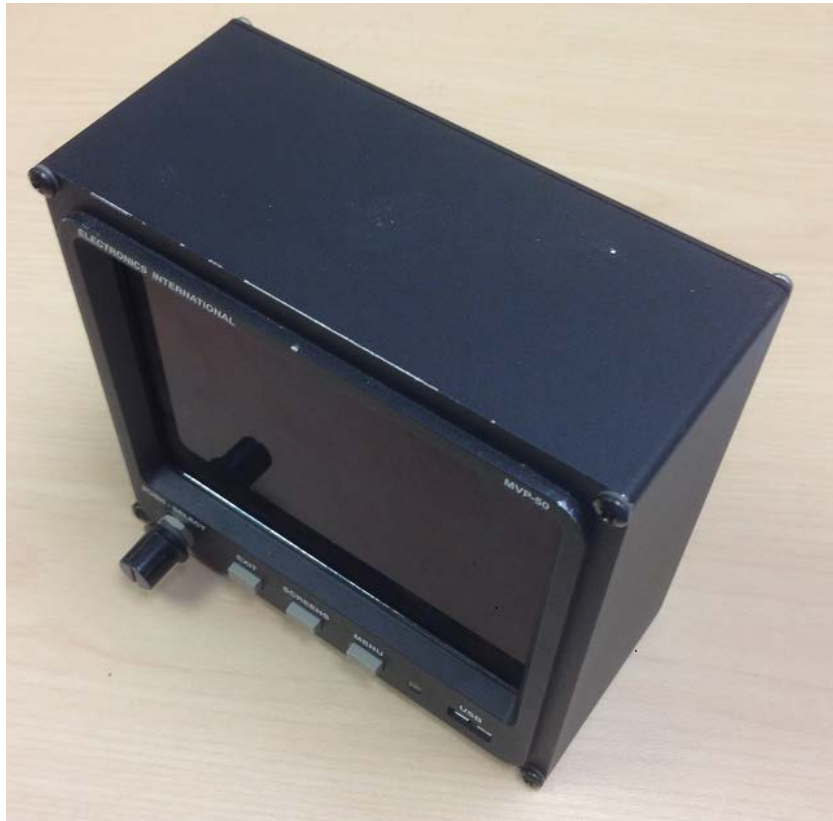
Figure 1. Photo of EI MVP-50P.

Upon arrival at the Vehicle Recorder Laboratory, an exterior examination revealed the unit had not sustained any damage, as shown in figure 1. The dataplate on the rear of the unit, shown in figure 2, indicated the unit was a TSO'd version. Power was applied to the unit and the last 50 recording sessions were downloaded normally, without difficulty. The MVP-50P download screen is shown in figure 3.

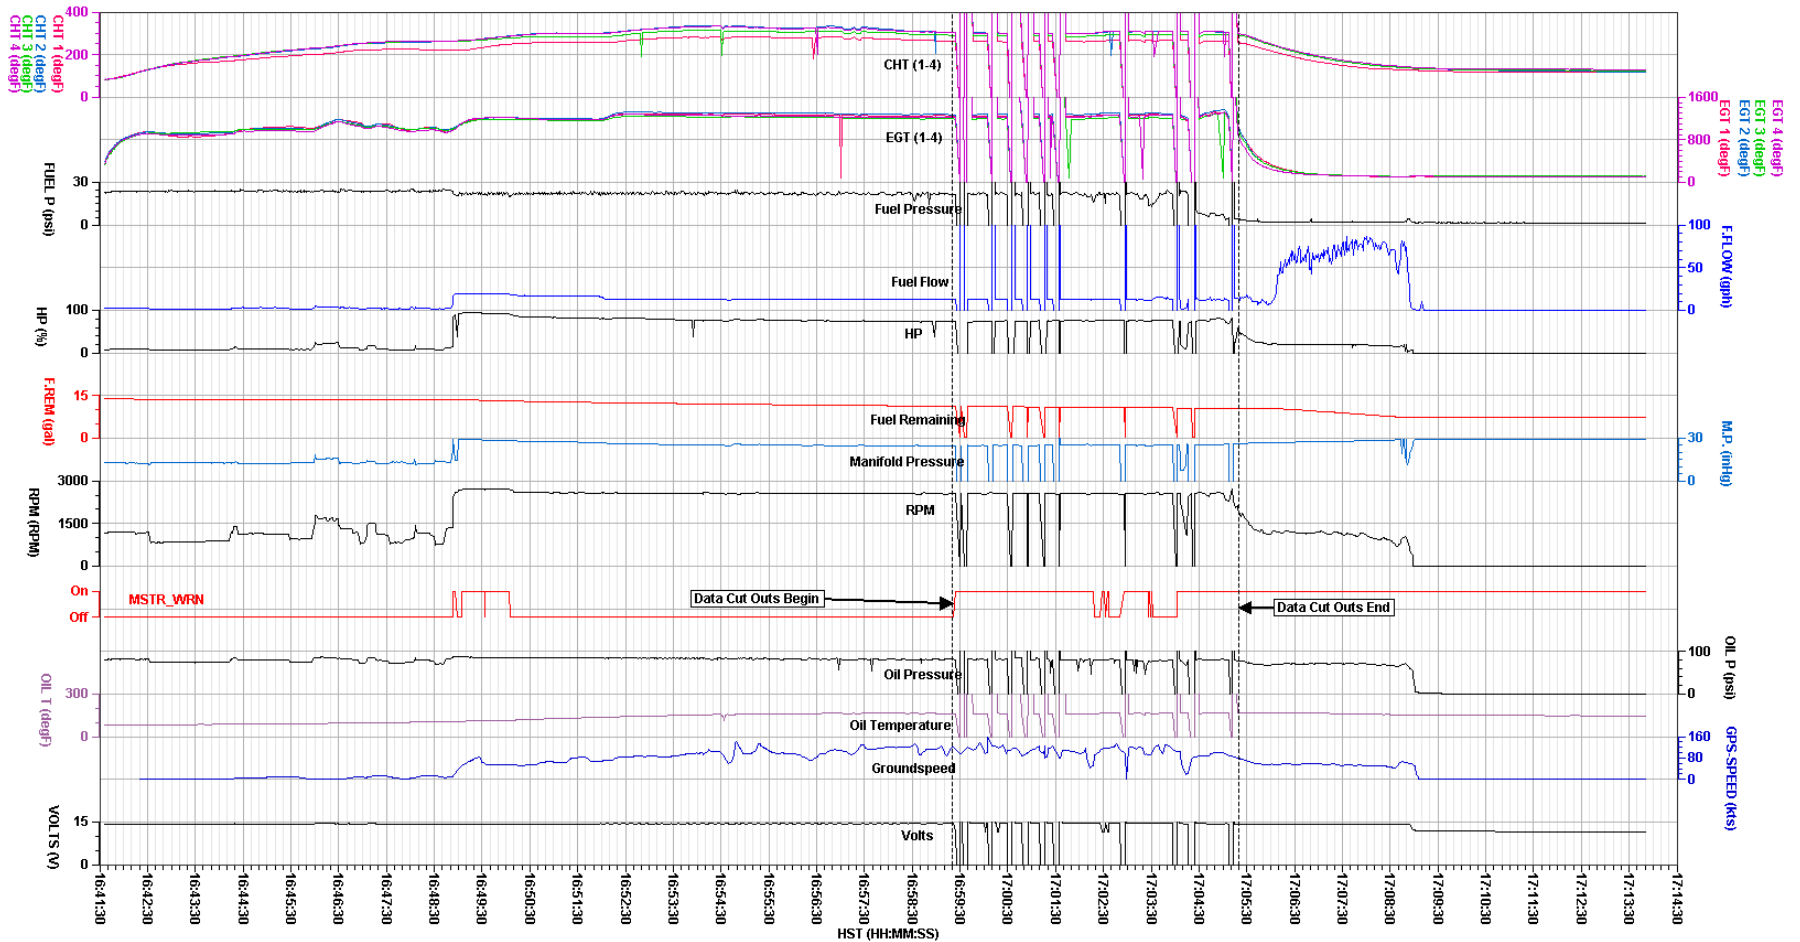
Figure 4. Accident flight on 8/27/2013 – flight 857.

Figure 4 shows a plot of recorded values for the accident flight, flight 857. The power increased at about 1649 HST. Coincident with the power increase, a master warning began and continued for about a minute before stopping.

At about 1659:24 HST, the master warning began and continued for about 3 minutes, then fluctuated on and off for about the next 1 minute 45 seconds, then was on continuously until the end of the recording. When the master warning began, all the other engine related parameters began to experience data cutouts; only the groundspeed and master warning seemed not to experience data cut outs. These data cut outs continued until 1705:19 HST.

During the data cut out timeframe, there were periods of valid data. The valid data suggests the RPM began to decrease as early as 1705:00 HST, at about the time the manifold pressure began a slight increase. By 1705:19 HST, the CHT, EGT, and RPM were decreasing and the fuel pressure decreased. At about 1706:04 HST, the fuel flow increased to values significantly higher than those observed in other flights (i.e., greater than 50 gph) and remained high for about the next 2 minutes and 45 seconds, then decreased to 0. Shortly after the fuel flow decreased to 0, at about 1708:51 HST, the oil pressure, RPM, and groundspeed decreased to 0, along with a slight decrease in voltage.

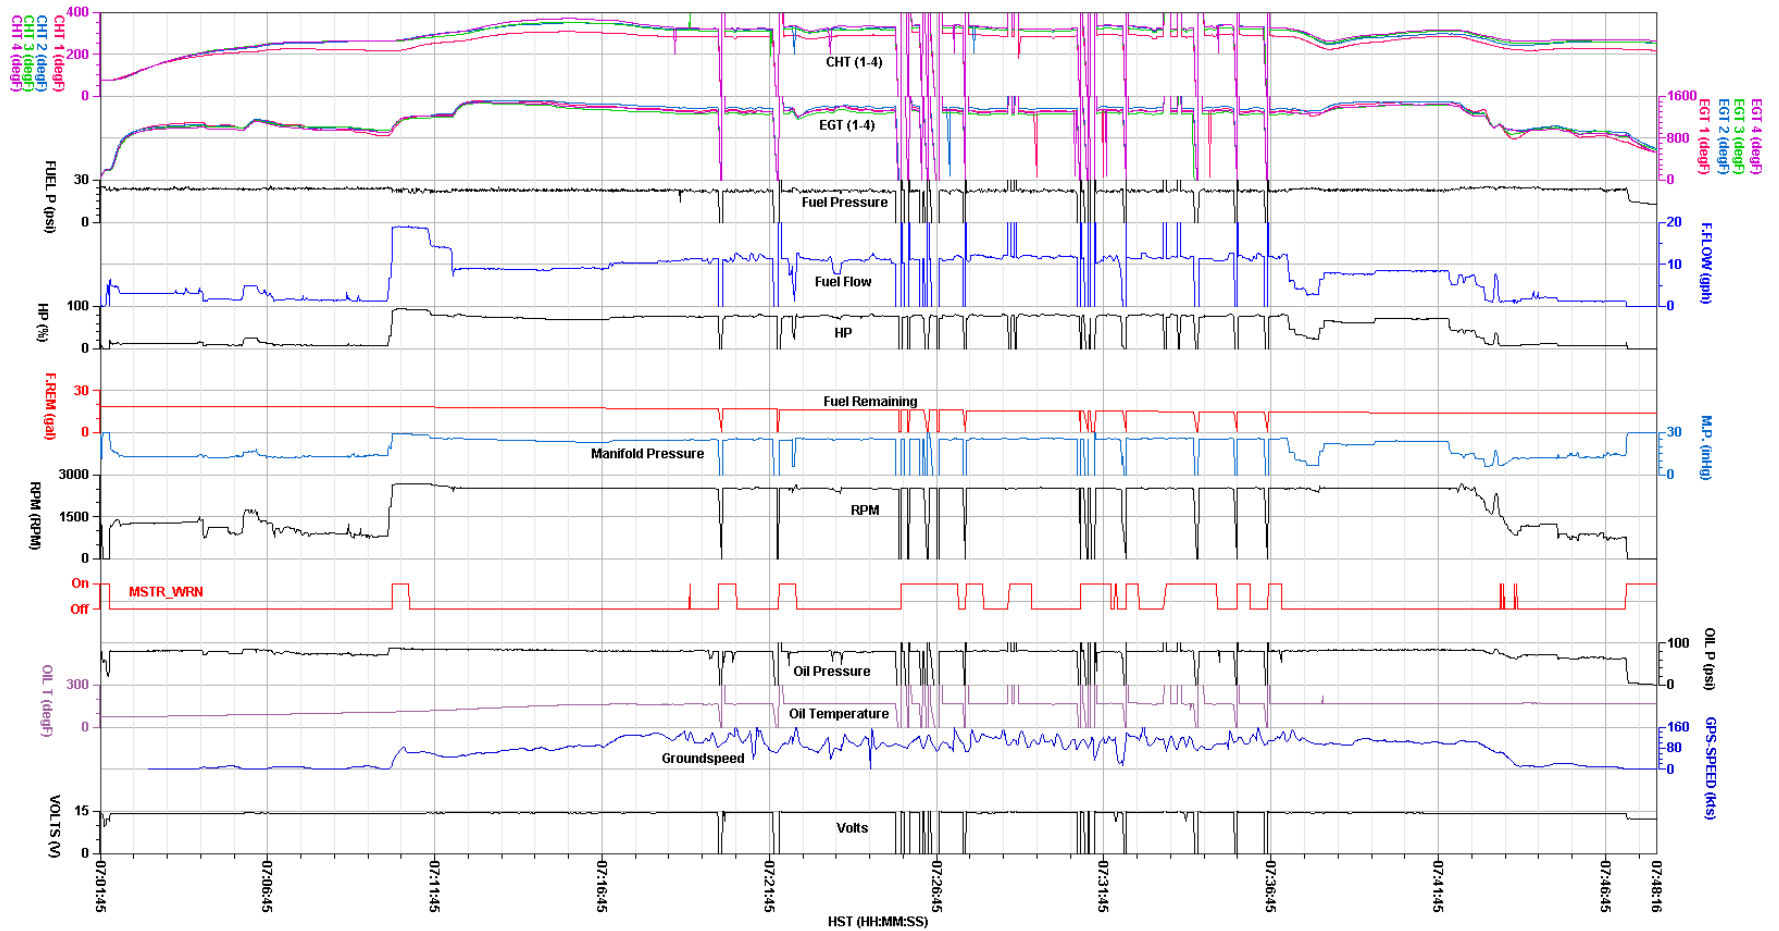
Figure 5. First part of flight on 8/26/2013 – flight 856.

Figures 5 and 6 show plots of the flight prior to the accident flight, flight 856, on August 26, 2013. The flight is shown in two plots, as no data was recorded between about 0748:17 HST and 0759:00 HST. Figure 5 shows the first part of the flight experienced data cut outs similar to those of the accident flight. Figure 6 does not contain any data cut outs.

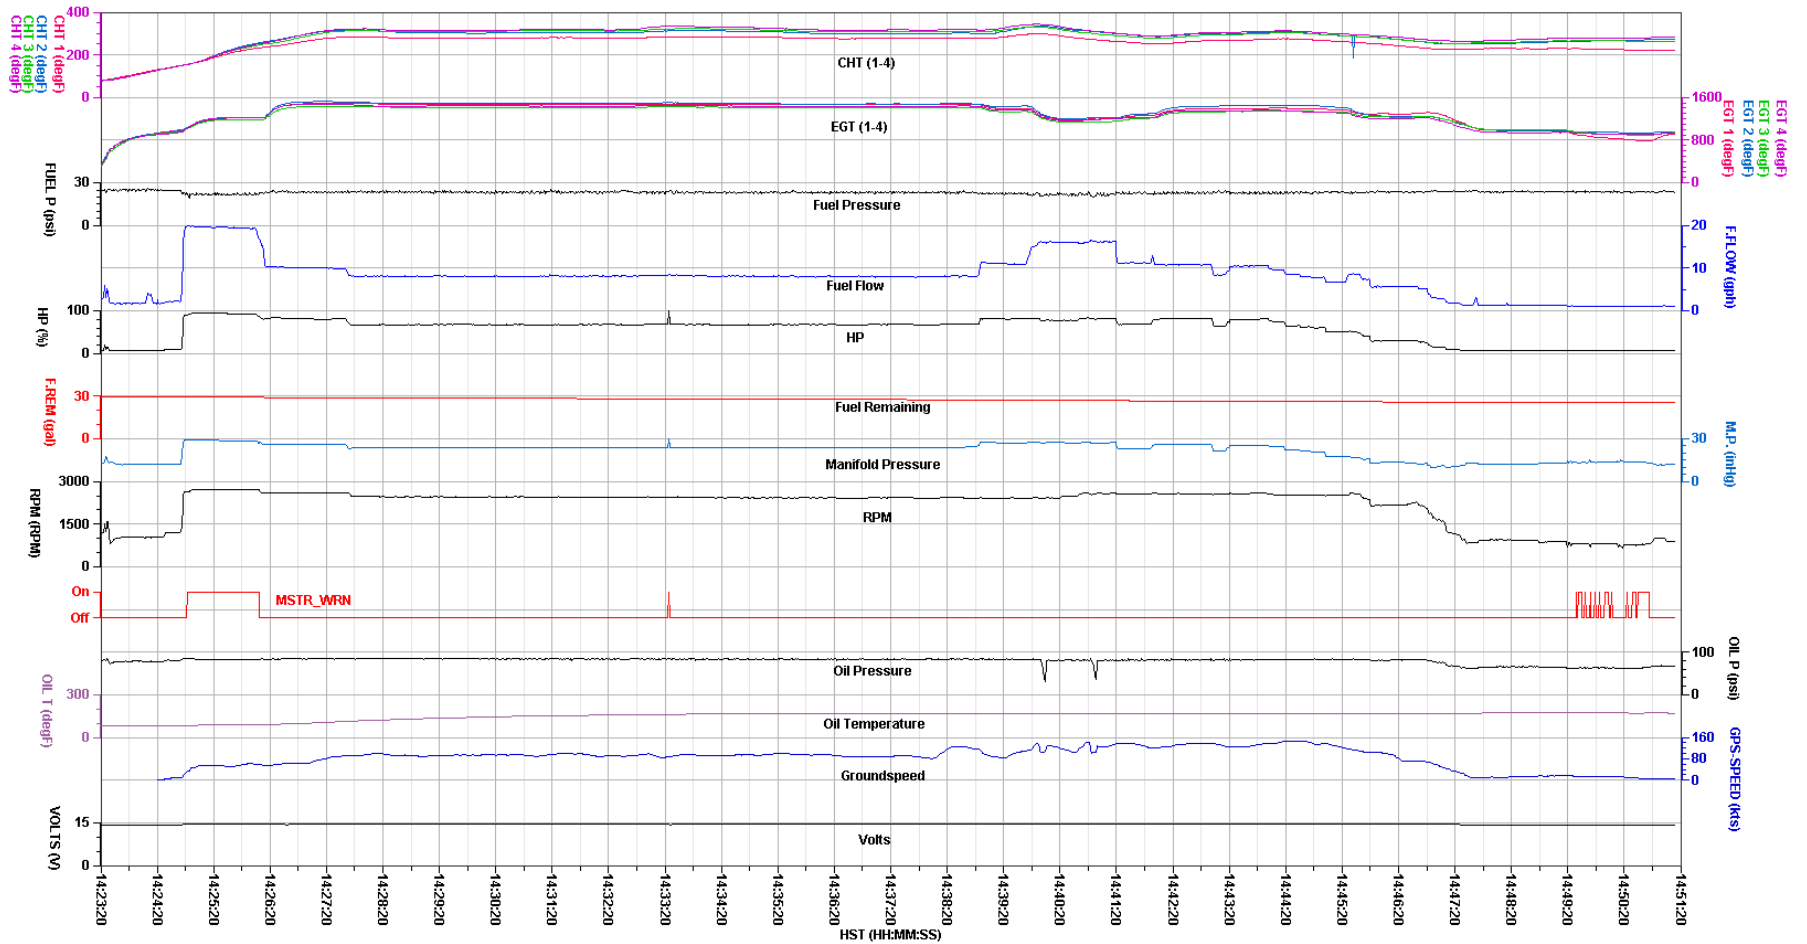
Figure 7. Flight on 7/13/2013 – flight 837.

Figure 7 shows a plot of flight 837 on July 13, 2013. This flight contains no data cut outs during the 28 minute recording.

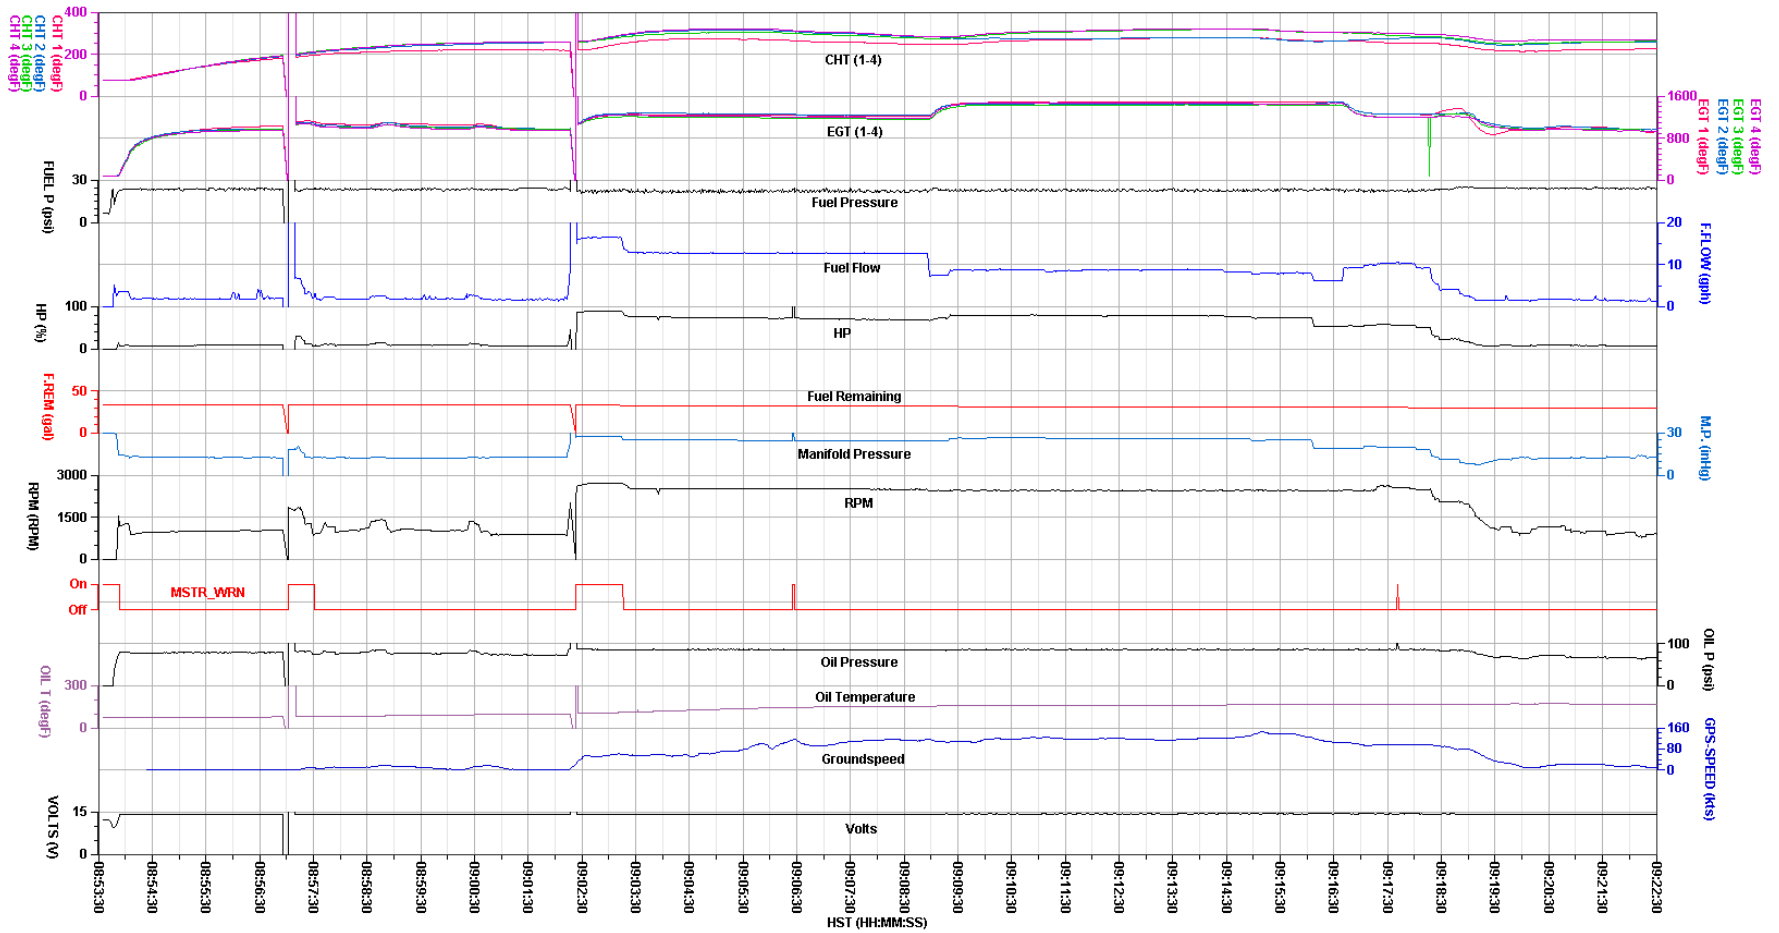
Figure 8. Flight on 7/3/2013 – flight 806.

Figure 8 shows a plot of flight 806 on July 3, 2013. This was the oldest flight data downloaded for this investigation.

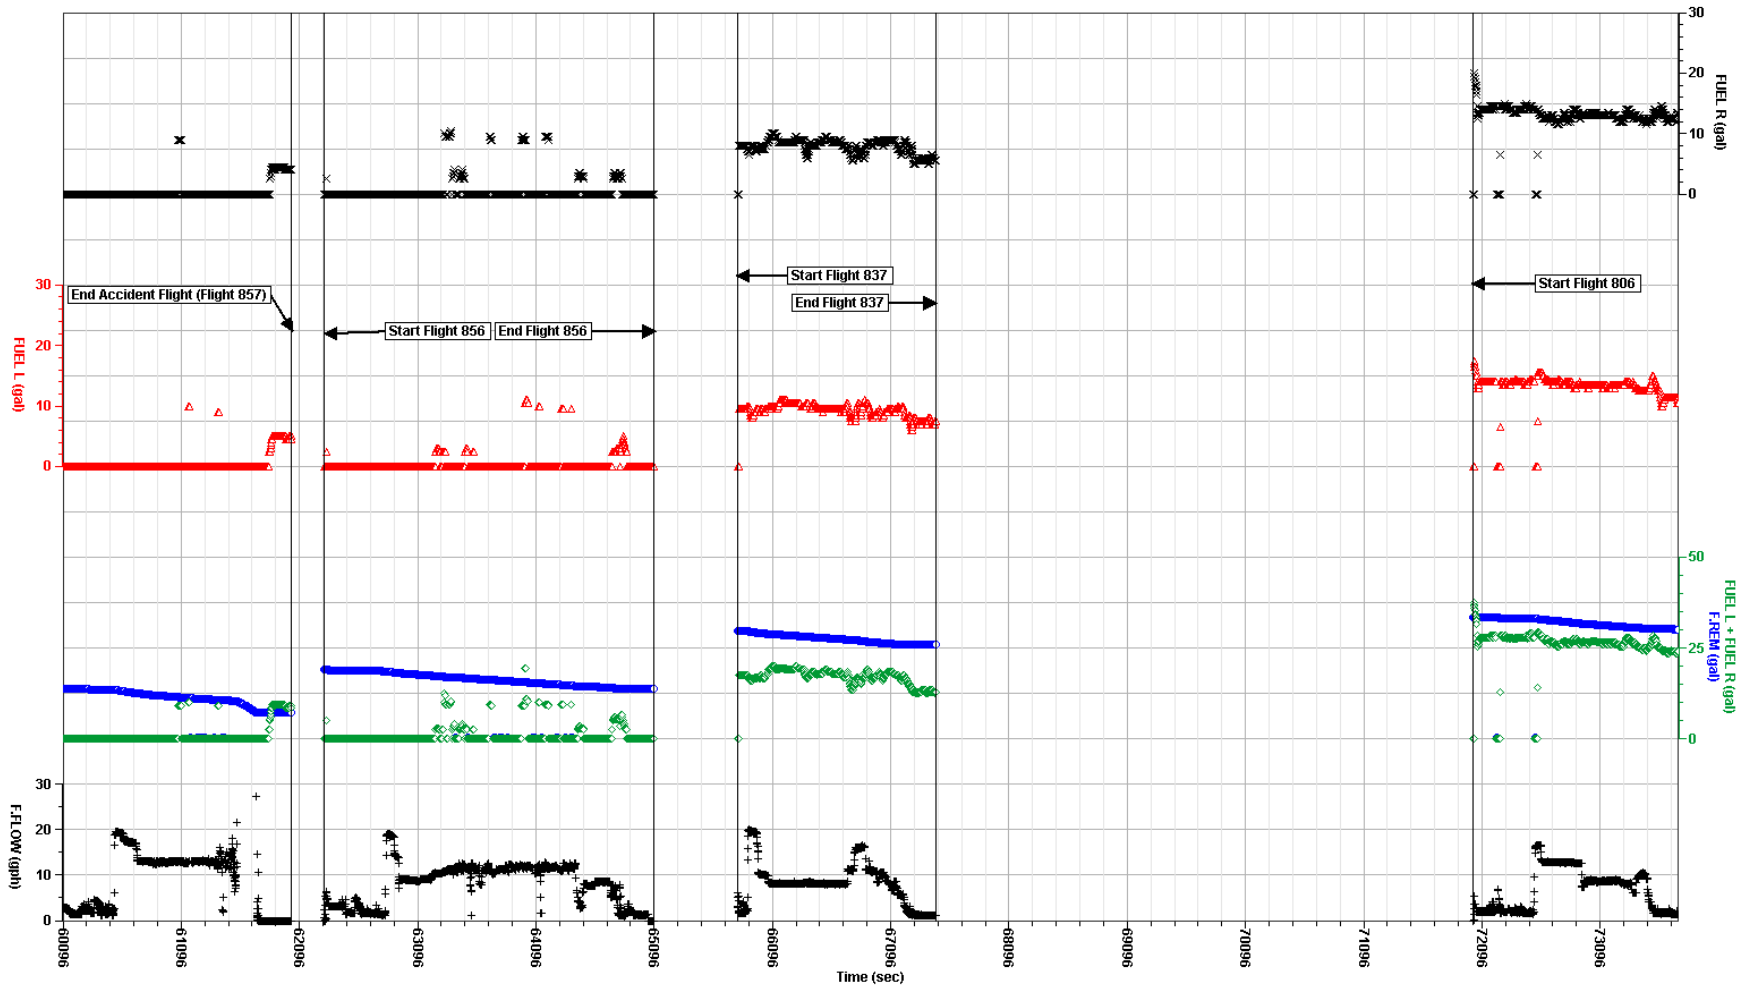
Figure 9. Fuel level related parameters across all flights.

Figure 9 shows a plot comparing the fuel level related parameters across all four recording sessions. The plot omits invalid data and only shows data points without connecting lines. For comparison purposes, the left and right fuel values are summed and shown on the same scale as the fuel remaining parameters. The accident flight

(857), and the flight prior to the accident flight (856), both have inconsistent values of fuel remaining compared to summed left and right fuel values. Flights 837 and 806 have differing values of fuel remaining and summed fuel values; however, both fuel level methods have similar trends in the rate of fuel reduction.
