NATIONAL TRANSPORTATION SAFETY BOARD

Electronic Devices Factual Report

1. EVENT

Location: Bolingbrook, Illinois
Date: September 25, 2013
Aircraft: Cirrus SR20
Registration: N406DC
Operator: Private
NTSB Number: CEN13FA558

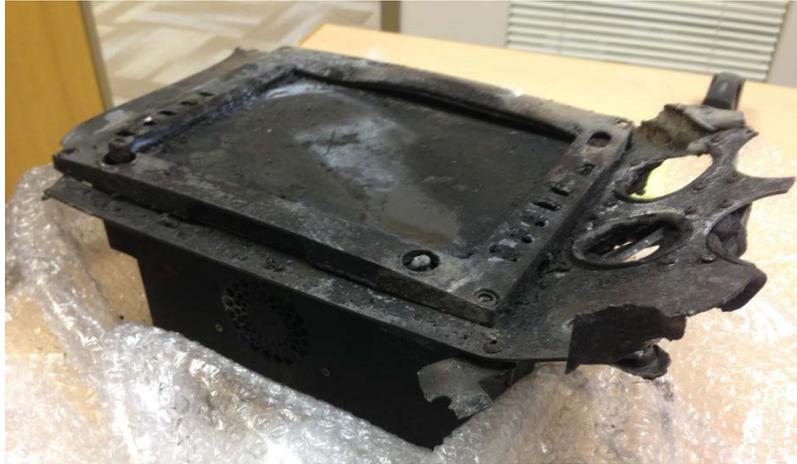
Figure 1. Avidyne unit as received.

Upon arrival at the Vehicle Recorder Laboratory, an exterior examination revealed the unit had sustained significant heat and structural damage, as shown in figure 1. It was determined the damage made recovery efforts impossible.

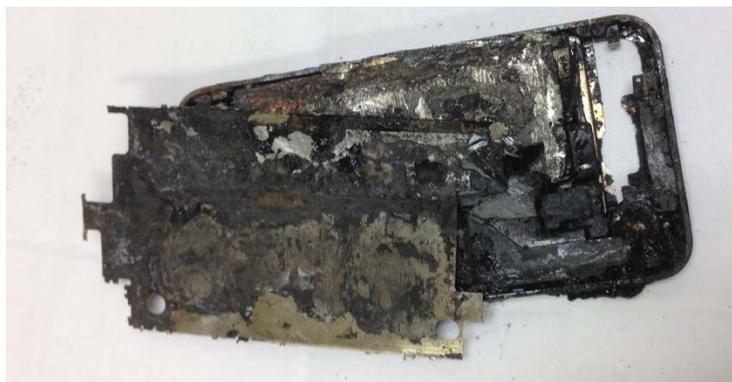
Figure 2. Apple iPhone as received.

Upon arrival at the Vehicle Recorder Laboratory, an exterior examination revealed the unit had sustained significant heat and structural damage, as shown in figure 2. It was determined the damage made recovery efforts impossible.
