NATIONAL TRANSPORTATION SAFETY BOARD
Vehicle Recorder Division
Washington, D.C. 20594

17 – Electronic Device Factual Report

Location: Pukoo, Hawaii
Date: November 10, 2011
Aircraft: Eurocopter EC130 B4
Registration: N11QV
Operator: Blue Hawaiian Helicopters
NTSB Number: WPR12MA034

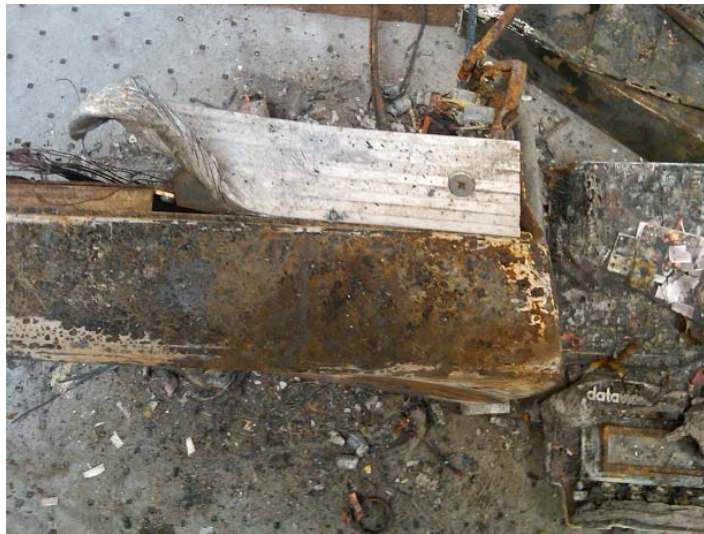
Figure 1. Datavideo device.

Upon arrival at the Vehicle Recorder Laboratory, an exterior examination revealed the units had sustained major damage from heat and fire (figures 1 and 2). It was concluded that accident damage had rendered the units and their memory irreparable.

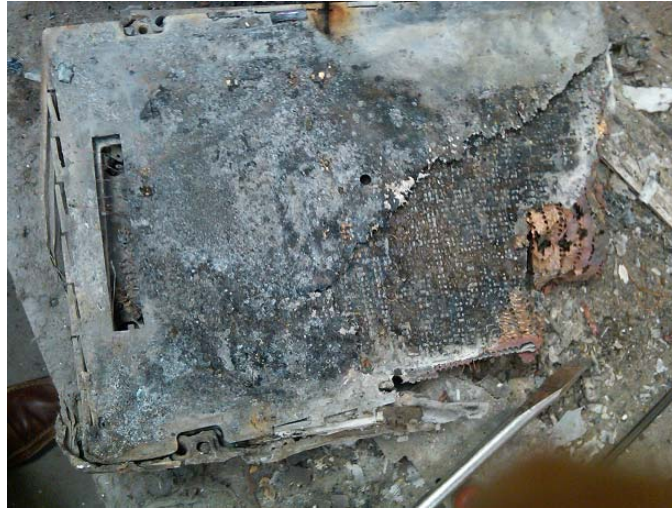
Figure 3. Digital engine control unit.

Upon arrival at the Vehicle Recorder Laboratory, an exterior examination revealed the unit had sustained major damage from heat and fire (figure 3). It was concluded that accident damage had rendered the unit and its memory irreparable.

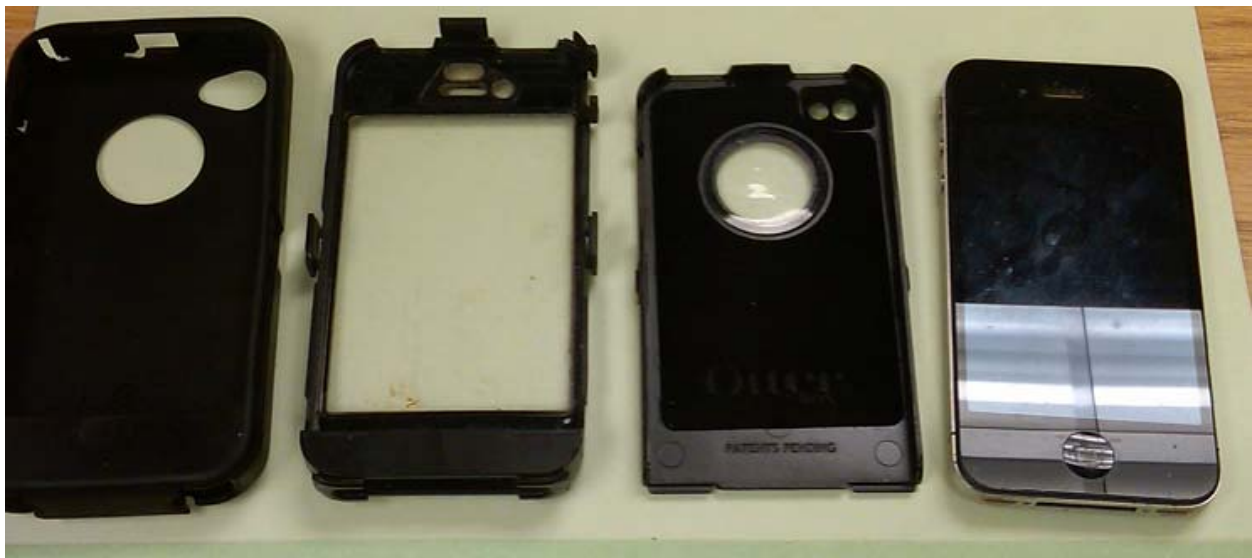
Figure 4. iPhone and case.

Upon arrival at the Vehicle Recorder Laboratory, an exterior examination revealed the unit had sustained minimal damage (figure 4). Examination of data on the phone revealed no information pertinent to the investigation.
