NATIONAL TRANSPORTATION SAFETY BOARD

17 – Electronic Device Factual Report

Specialist's Factual Report by Bill Tuccio

Location:	Morgantown, West Virginia
Date:	June 22, 2012
Aircraft:	Raytheon Aircraft Company C90GT
Registration:	N508GT
Operator:	Oz Gas LLC
NTSB Number:	ERA12FA409

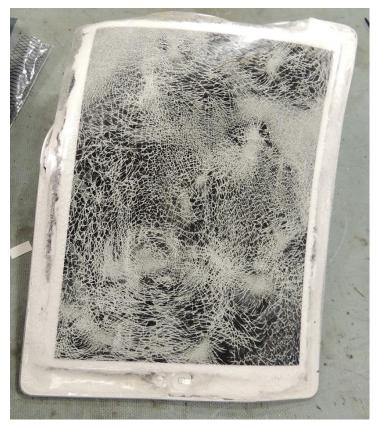
Upon arrival at the Vehicle Recorder Laboratory, an exterior examination revealed that the unit had sustained significant impact damage, as shown in figures 1 and 2. The unit was disassembled revealing the main circuit board, as shown in figure 3. The main circuit board was removed, as shown in figure 4. A microscopic examination revealed some electrical components were damaged, however the main board was installed in a functional surrogate iPad 2 and power was applied. No indications of operation were observed. No further recovery attempts were attempted.

Figure 1. Apple iPad 2 damage - front.

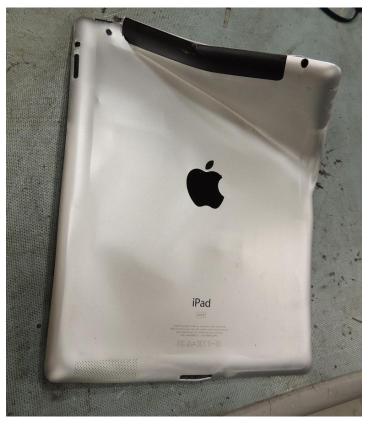
Figure 2. Apple iPad 2 damage – back.

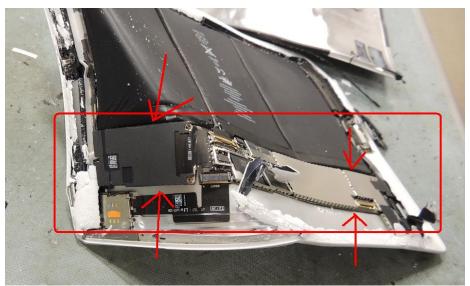
Figure 4. Apple iPad 2 main circuit board removed.

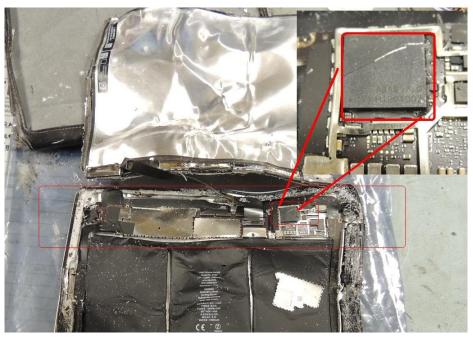
Upon arrival at the Vehicle Recorder Laboratory, an exterior examination revealed that the unit had sustained significant impact damage, as shown in figures 5 and 6. The unit was disassembled revealing the main circuit board, as shown by the annotated photo in figure 7. The extent of the damage prevented the insertion of the main circuit board in a surrogate unit. No further recovery attempts were made.

Figure 7. Apple iPad 3 main circuit board with chip photo inset.
