NATIONAL TRANSPORTATION SAFETY BOARD

Electronic Devices Factual Report

Location: Fort Lauderdale, Florida
Date: November 19, 2013
Aircraft: Learjet 35
Registration: XA-USD
Operator: Aero JL SA de CV
NTSB Number: ERA14FA045

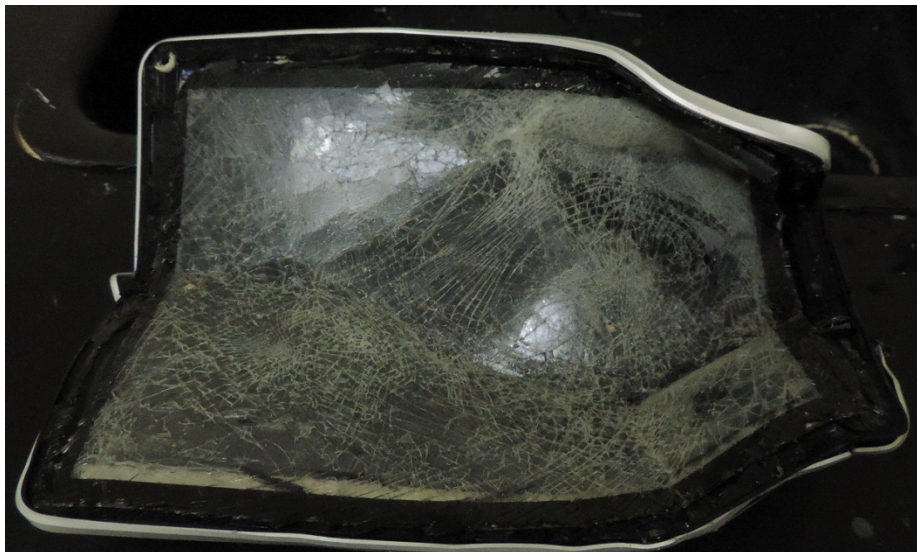
Upon arrival at the Vehicle Recorder Laboratory, an exterior examination revealed both Apple iPads (figures 1 and 2) and the Apple iPhone 4S (figure 3) had sustained extensive structural and/or sea water damage. Each device was disassembled and rinsed with tap water. The internal component boards were rinsed with alcohol and scrubbed with a brush, then dried with compressed air. The boards were then placed in a heated vacuum oven at 40 degC at -0.05 MPa for about 12 hours. One of the dried iPad boards was placed in a surrogate unit, but would not start. The other iPad and iPhone boards were too damaged to attempt further repairs.

Figure 1. First Apple iPad.

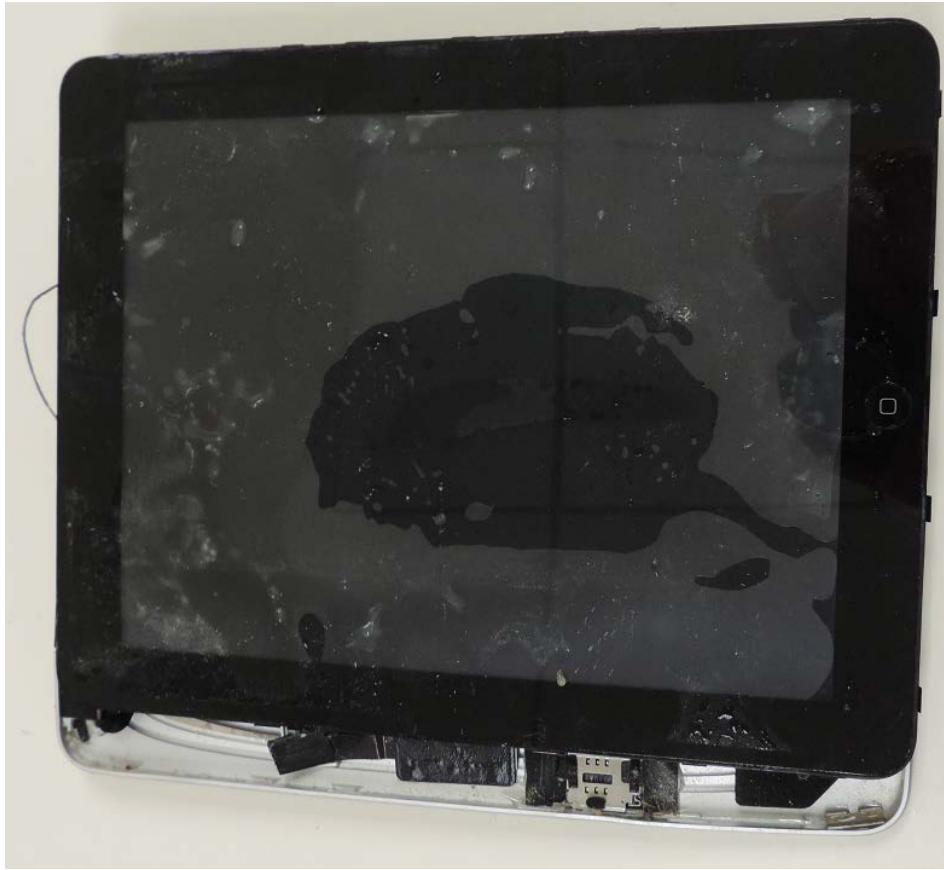
Figure 2. Second Apple iPad.

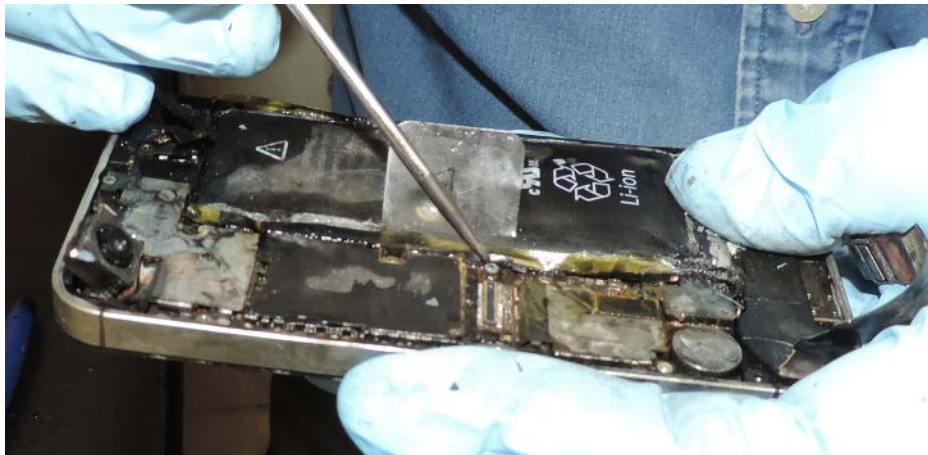
Figure 3. Apple iPhone 4S (screen removed).

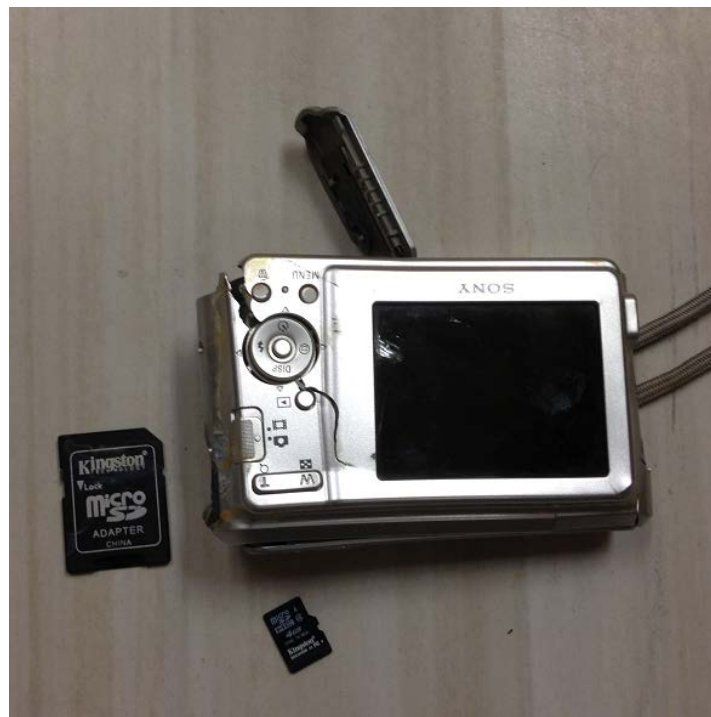
Upon arrival at the Vehicle Recorder Laboratory, an exterior examination revealed the Sony Cybershot had sustained significant impact and sea water damage. The internal microSD card and SD to microSD converter were removed from the unit, as shown in figure 4. The microSD card was cleaned with tap water and dried. The contents of the microSD card were read normally, without difficulty.

Figure 4. Sony Cybershot with microSD card and SD converter.
