NATIONAL TRANSPORTATION SAFETY BOARD

Electronic Devices Factual Report

Location: Clayton, Oklahoma
Date: October 18, 2013
Aircraft: Cessna 177
Registration: N30495
Operator: Private
NTSB Number: CEN14FA010

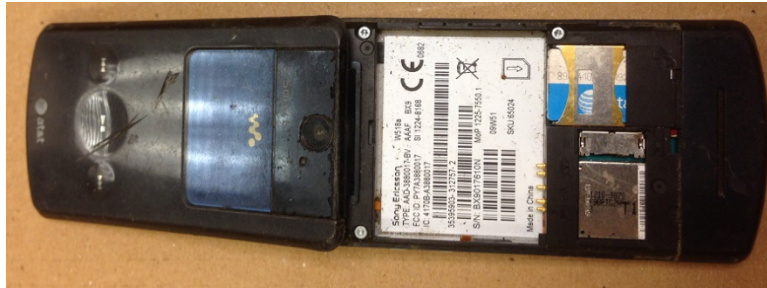
Figure 1. Sony Ericsson cell phone.

Upon arrival at the Vehicle Recorder Laboratory, an exterior examination revealed the unit had sustained minor damage. The battery was missing and there was no SD card,

as shown in figure 1. A replacement battery was obtained and the phone started normally.

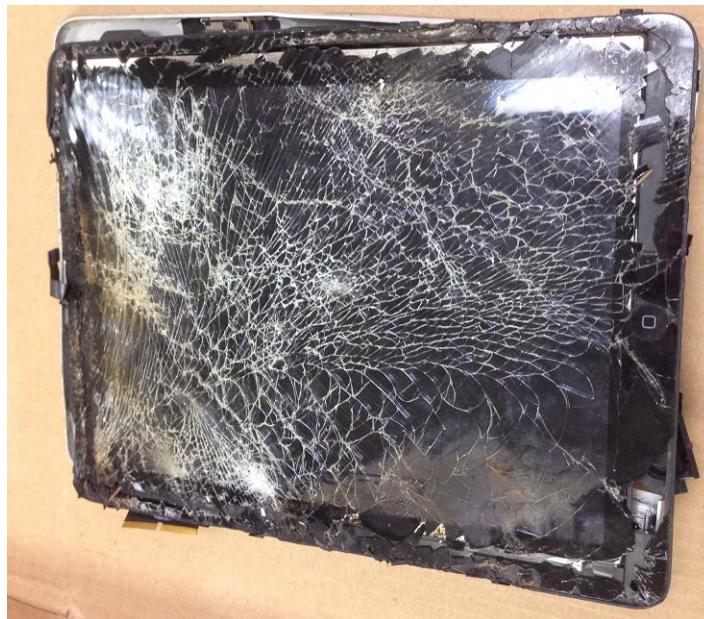
Figure 2. Apple iPad.

The Apple iPad is touchscreen capable tablet device. Upon arrival at the Vehicle Recorder Laboratory, an exterior examination revealed the unit had sustained significant structural damage, as shown in figure 2. An internal inspection revealed some of the connectors had been damaged and had evidence of short-circuiting, as shown in figure 2. Due to the damage, no data was recovered from the device.
