NATIONAL TRANSPORTATION SAFETY BOARD

**Specialist's Factual Report
by Christopher Babcock**

Location: Lake Berryessa, California
Date: May 8, 2017
Aircraft: Icon A5
Registration: N184BA
Operator: Icon Aircraft Inc.
NTSB Number: WPR17FA101

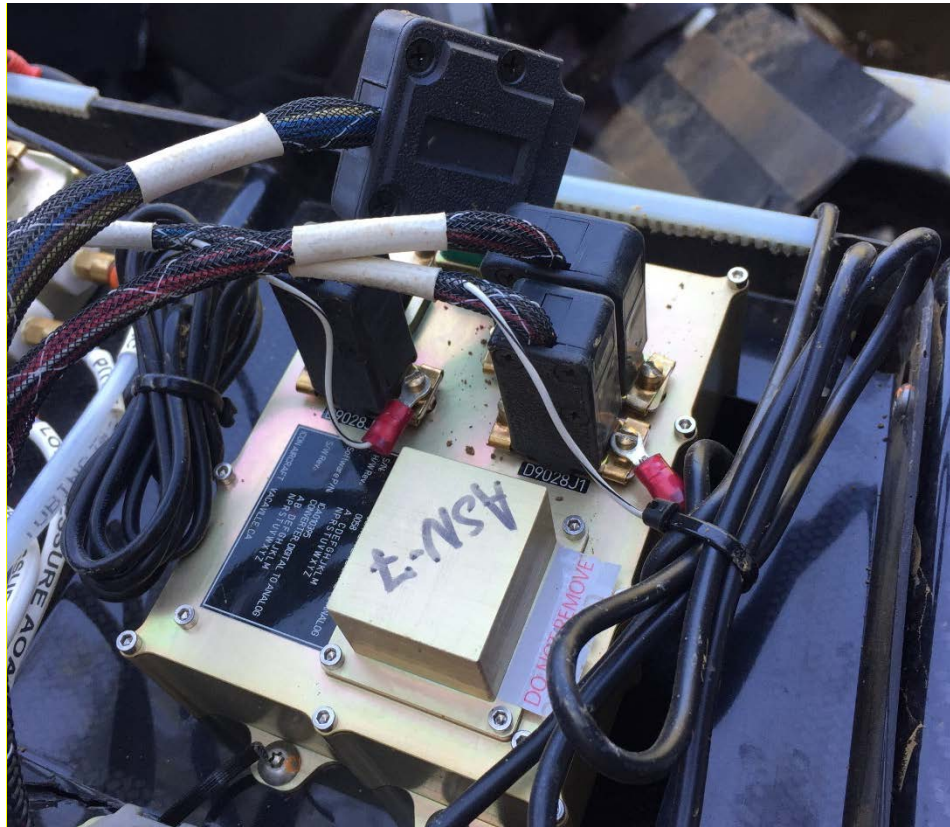
Figure 1. FDM device.

Although not required by regulation, the Icon A5 was equipped with a flight data monitoring device (FDM) (Figure 1).

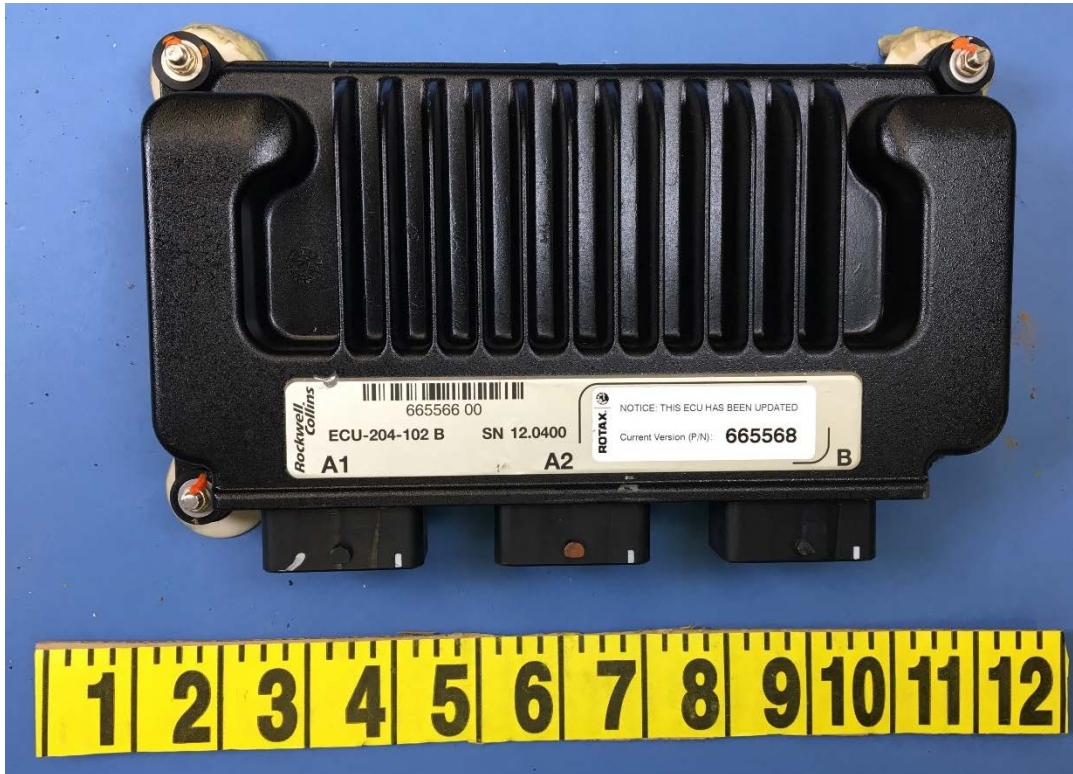
Figure 3. Rotax ECU, as received.

Upon arrival at the Vehicle Recorder Laboratory, an exterior examination revealed the unit had not sustained any damage and information was extracted using the manufacturer's software normally, without difficulty (Figure 3).

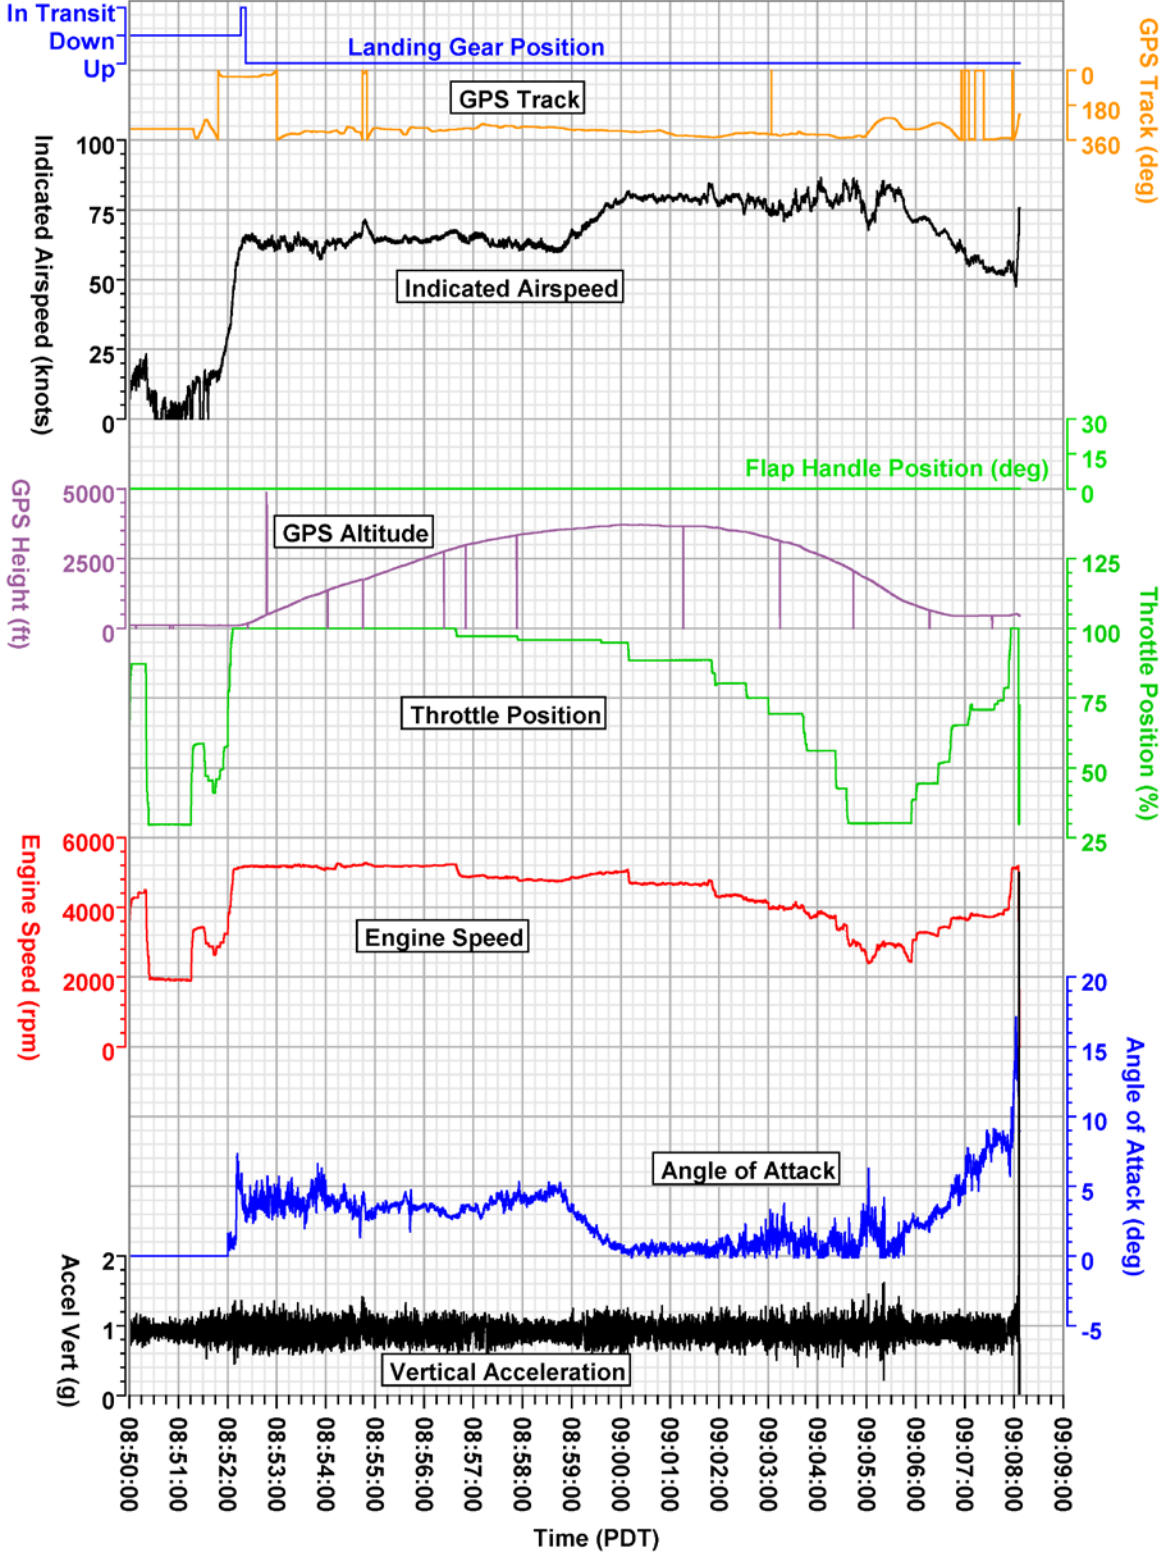
Figure 4. Flight data recorded over entire accident flight.

The ECU data indicate that the engine was started at 8:39:34 PDT. At 8:50:05 PDT, new ECU logs for both lanes A and B were created, consistent with the pre-takeoff lane check. At 8:52:00 PDT, the aircraft departed runway 2 at the Nut Tree Airport, Vacaville, CA, and proceeded north. The aircraft reached a maximum GPS altitude of about 3700 feet at about 9:00:00 PDT and began to descend shortly thereafter. At 9:05:25 PDT, the aircraft turned to the west, crossed the shore of Lake Berryessa near the Monticello Dam, and continued to descend. By 9:06:44 PDT, the aircraft descended to about 450 feet GPS altitude and turned to the north, staying over the water between the shorelines. At 9:07:30 PDT, the aircraft entered Little Portuguese Canyon at about 450 feet GPS altitude and 54 knots indicated airspeed. At 9:07:50 PDT, the aircraft increased power and began to climb. The aircraft turned slightly to the east before turning back to the west. The aircraft reached a maximum altitude of 506 feet GPS altitude at 9:08:03 PDT before beginning to descend. The aircraft struck terrain at about 9:08:06 PDT at 470 feet GPS altitude and 66 knots indicated airspeed.

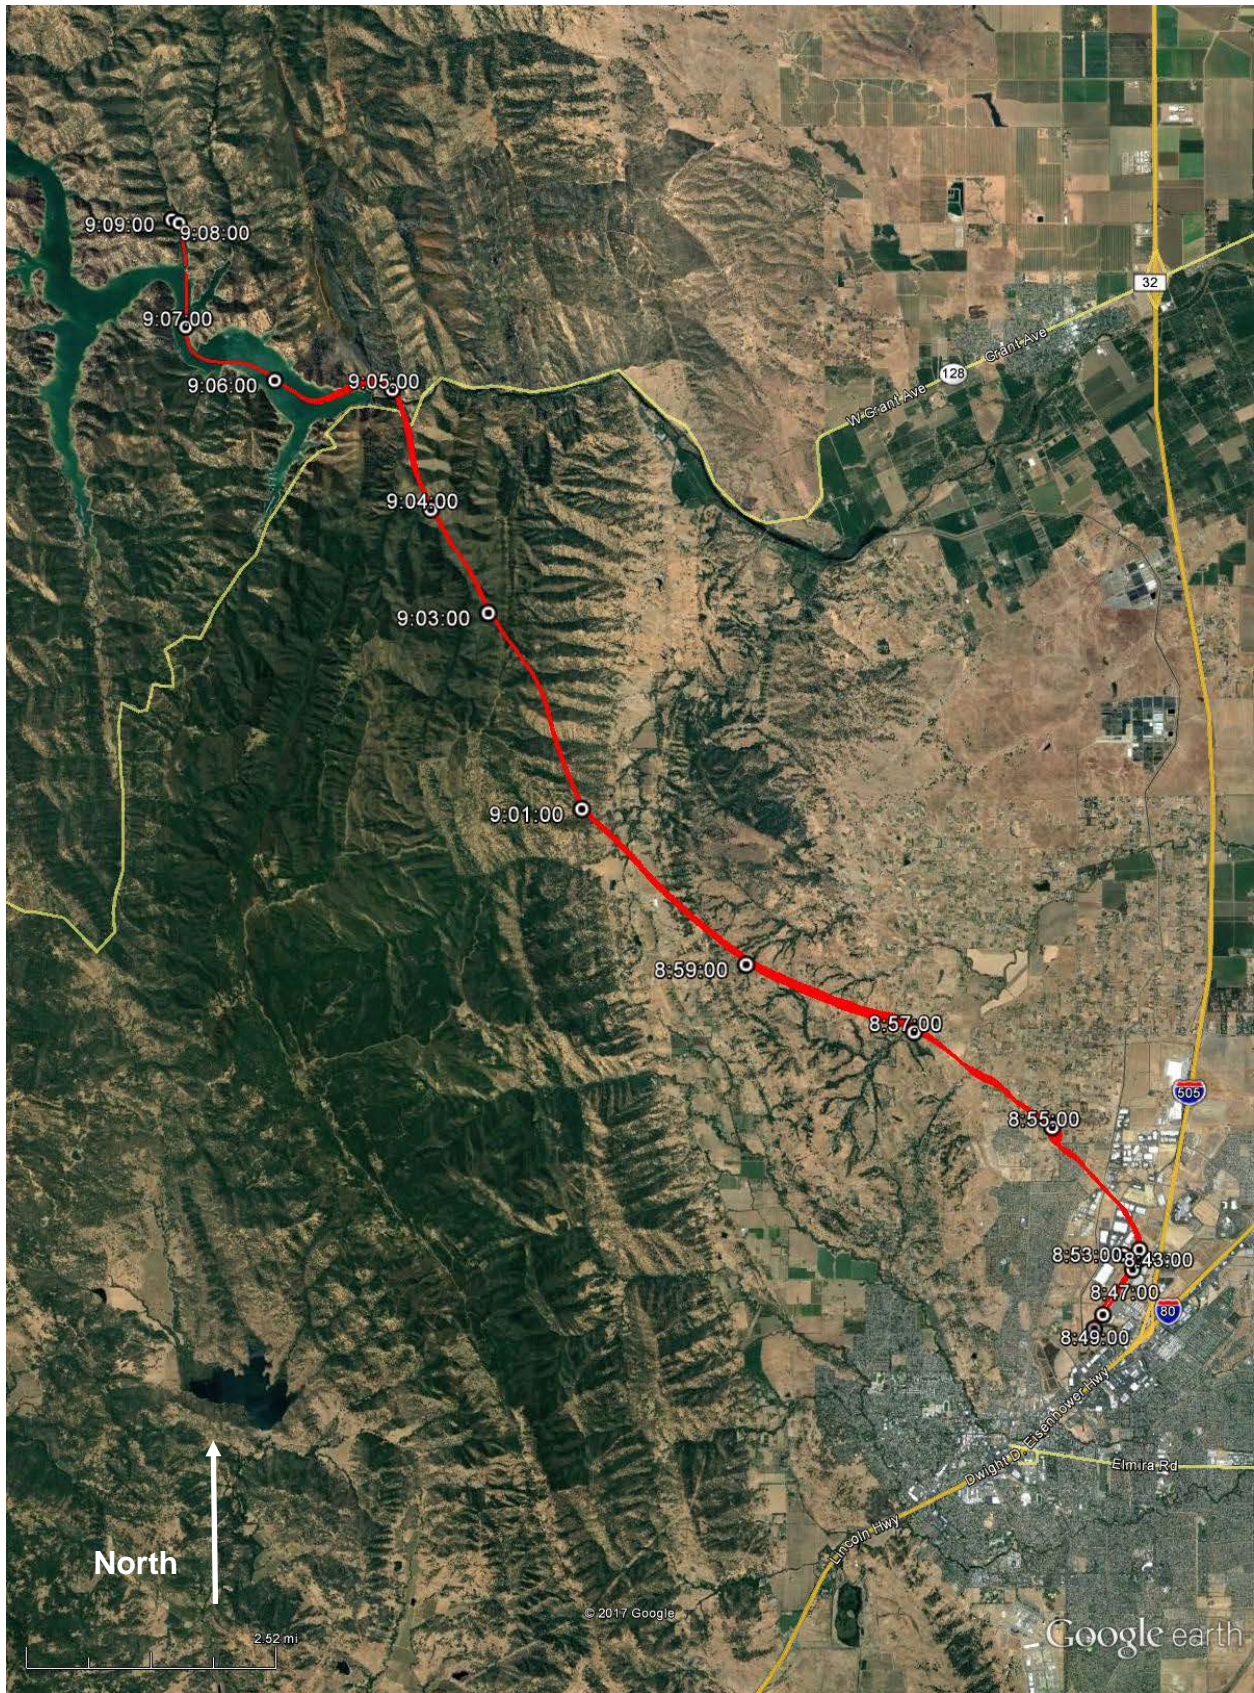
Figure 10. Overview of accident flight.

Figures 10-14 show the aircraft's flight path overlaid on satellite imagery using Google Earth. At times between 9:06:40 and 9:07:50, the recorded GPS altitude was below the Google Earth terrain elevation model and the aircraft's trackline disappeared.
