NATIONAL TRANSPORTATION SAFETY BOARD

Electronic Devices

Specialist's Factual Report
by Bill Tuccio, Ph.D.

Location: Lolo Pass, Idaho
Date: July 28, 2014
Aircraft: Meyer-Lancair, Legacy
Registration: N29MM
Operator: Private
NTSB Number: WPR14FA316

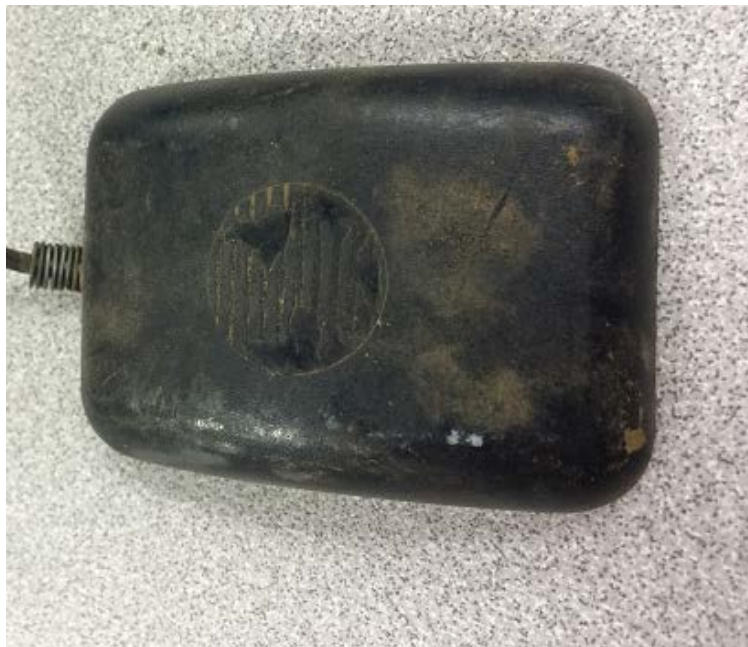
Figure 1. Garmin GA-27C.

The following damaged devices were determined to contain no recorded information: Garmin GA-27C (figure 1), PS Engineering PMA 7000 (figure 2), and SPOT Personal Tracker (figure 3). The Garmin GNS 480 (figure 4) sustained minor impact damage; attempts to start the device were unsuccessful and no information was recovered¹.

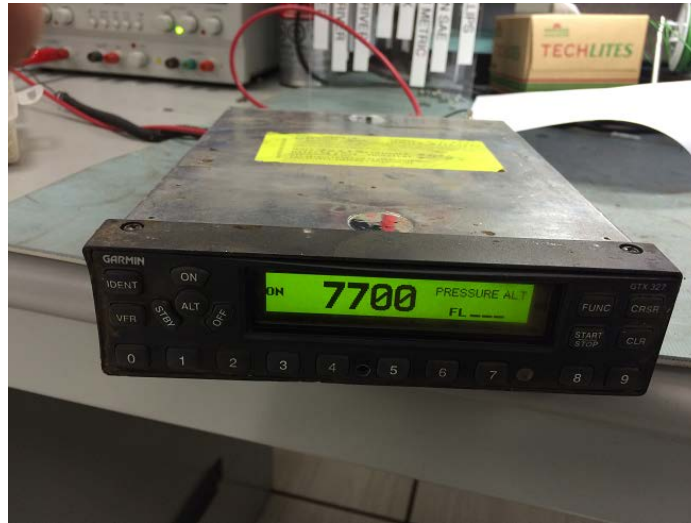
Figure 5. Garmin GTX 327 transponder.

Upon arrival at the Vehicle Recorder Laboratory, an exterior examination revealed the unit had sustained minor impact damage. The device was powered on, as shown in figure 5.

The transponder indicated a last code of 7700. According to the Aeronautical Information Manual (AIM), “When a distress or urgency condition is encountered, the pilot of an aircraft with a coded radar beacon transponder, who desires to alert a ground radar facility, should squawk Mode 3/A, Code 7700/Emergency and Mode C altitude reporting and then immediately establish communications with the ATC facility” (July 2012, Section 6-2-2).

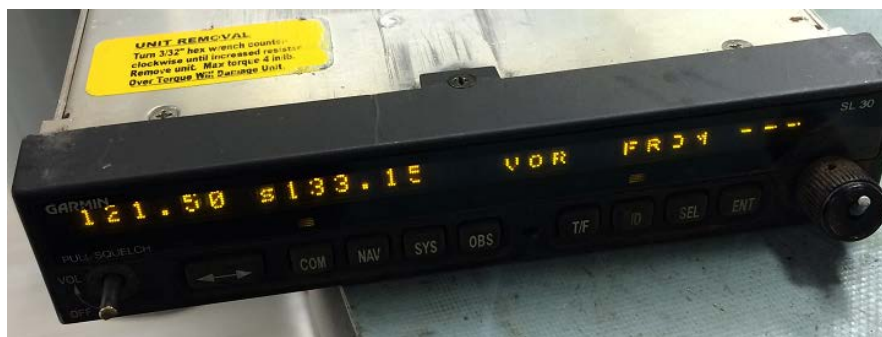
Figure 6. Garmin SL30 nav/com.

Upon arrival at the Vehicle Recorder Laboratory, an exterior examination revealed the unit had sustained minor impact damage. The device was powered on, as shown in figure 6. The last navigation and communication frequencies were observed; however, due to knob selector damage the last 10 frequencies used could not be retrieved.

The last active navigation frequency was “112.8” and the last standby navigation frequency was “108.40.” The last active communication frequency was “121.5” and the last standby communication frequency was “133.15.” According to the AIM, “Pilots are encouraged to monitor 121.5 MHz and/or 243.0 MHz while inflight to assist in identifying possible emergency ELT transmissions” (July 2012, Section 6-2-5) and “Although the frequency in use or other frequencies assigned by ATC are preferable, the following emergency frequencies can be used for distress or urgency communications, if necessary or desirable: (1) 121.5 and 243.0 MHz. Both have a range generally limited to line of sight. 121.5 MHz is guarded by direction finding stations and some military and civil aircraft” (July 2012, Section 6-3-1).

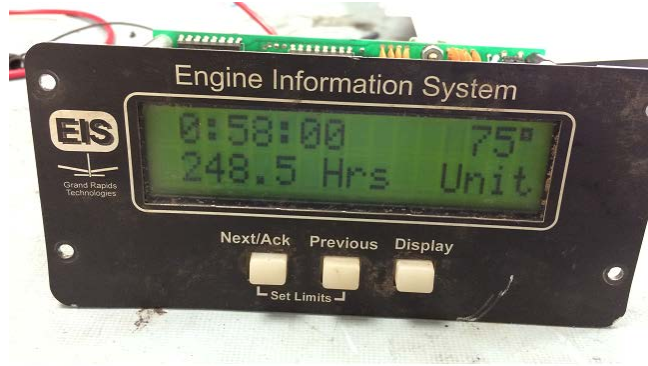
Figure 7. GRT EIS 6000.

Upon arrival at the Vehicle Recorder Laboratory, an exterior examination revealed the unit had sustained minor impact damage. The device was powered on, as shown in figure 7. During power on, the unit displayed a “Check Entries” message, which indicates retained information may be suspect.

The screen shown in figure 7 was pertinent to the accident investigation. It showed the last flight time was 58 minutes and the accumulated engine time was 248.5 hours.

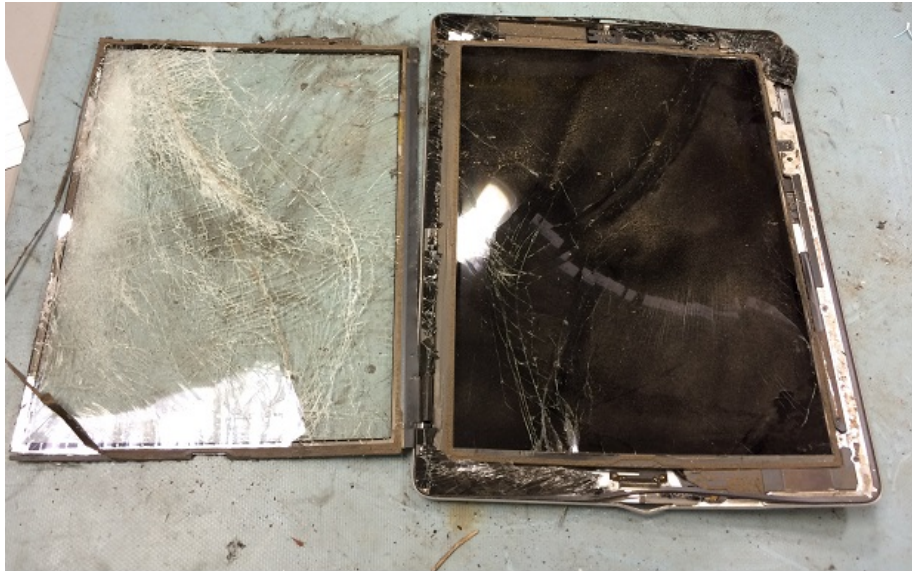
Figure 8. Apple iPad 2.

Upon arrival at the Vehicle Recorder Laboratory, an exterior examination revealed the unit had sustained significant impact damage, as shown in figure 8. The unit was

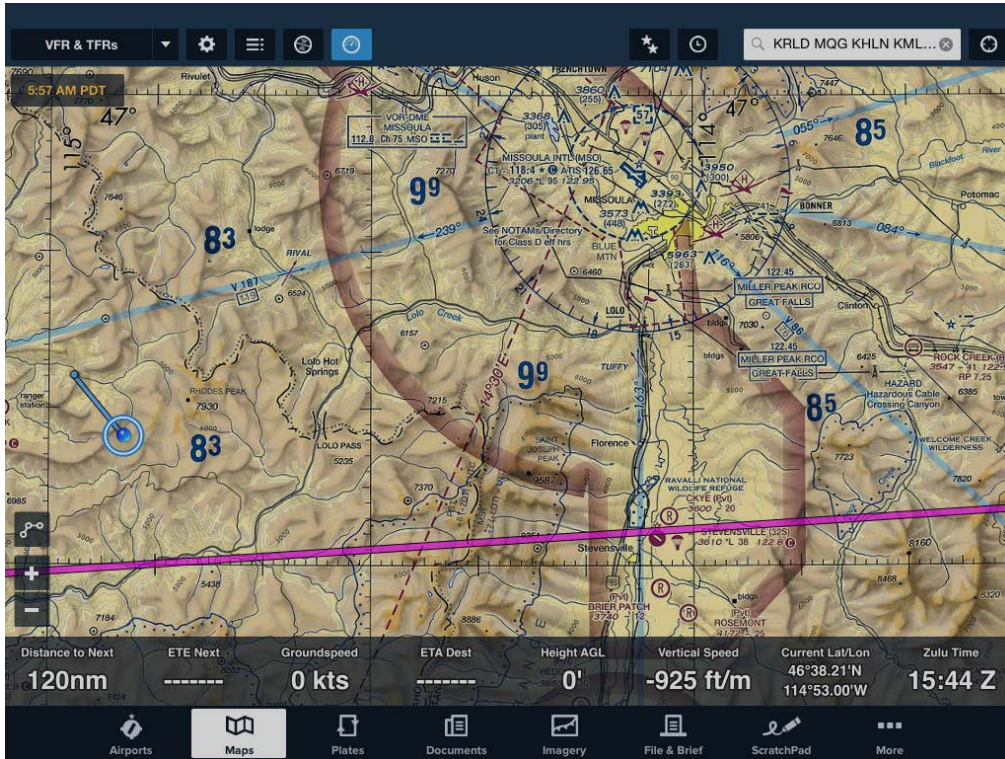
Figure 11. iPad generated ForeFlight screen capture at 08:44:54 PDT.

Figure 11 shows an iPad internally generated ForeFlight screen capture. The image was captured at 08:44:54 PDT and is similar to the opening map page shown in figure 10. Details observed in figure 11 include: the last time the weather was updated by ForeFlight (05:57 PDT); the aircraft current position, shown by the blue dot; vertical speed of -925 feet per minute; and GPS time of 15:44 Zulu.

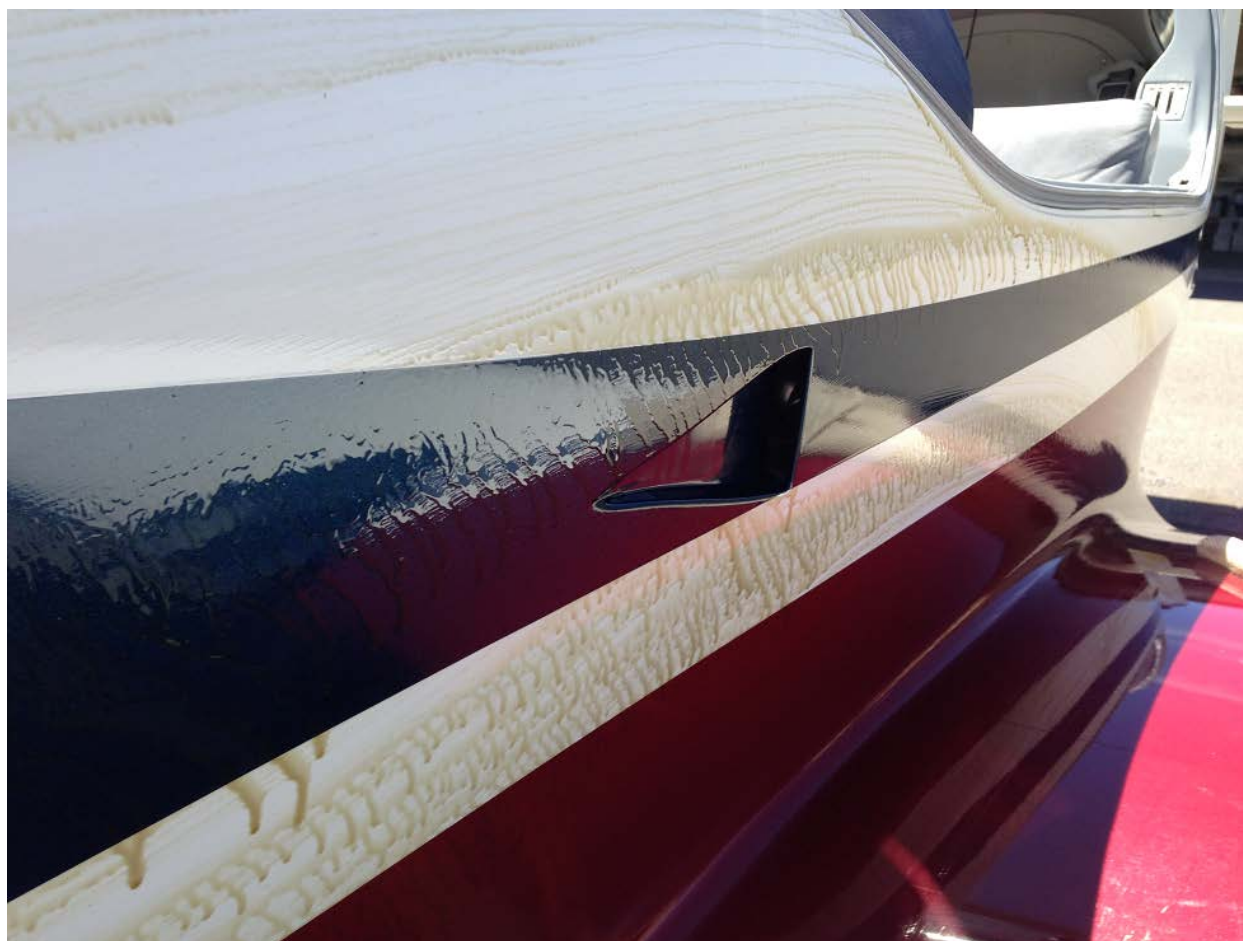
Figure 13. Picture referenced in 7/1/14 text message at 16:51:28 PDT.

A text message conversation about an oil "dump" on July 1 and July 2, 2014, is shown in table 1. The photo exchanged at the start of the email conversation is expanded in Figure 13, which shows oil spray over a white/blue/white/red painted nose section of an airframe with a triangular air inlet.

Direction	Date/Time	Content
Outgoing	July 1, 16:51:28 PDT	Dumped Qt overboard Still running tests Likely front crankcase seal with reduced power during approaches ^a

Outgoing	July 1, 16:53:36 PDT	Breather dumps oil sometimes
Incoming	July 2, 13:37:20 PDT	Most likely breather.
Incoming	July 2, 13:37:20 PDT	Crank case seal would make a mess all of the inside of cowling.
Outgoing	July 2, 13:48:00 PDT	This is breather but why ?
Incoming	July 2, 13:50:02 PDT	You don't have an air oil separator.
Outgoing	July 2, 13:51:58 PDT	Correct This time I was doing instrument approaches I have a pressure sensor installed but still have not captured event
Outgoing	July 2, 13:52:16 PDT	Hope u have a great 4 th
Outgoing	July 2, 13:52:16 PDT	I will continue to track
Incoming	July 2, 13:53:45 PDT	You as well!
