DCA15MA019

Attachment #3 to Group Chairman's Electronic Devices and Flight
Data Factual Report

Integrated Electronics Engineering Center (IEEC) Report

December 11, 2014

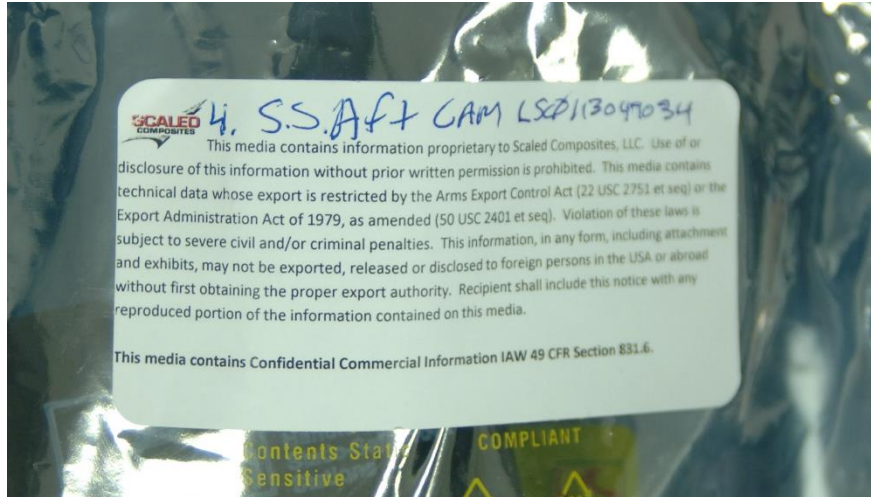
Bag 1: Casing and Connector

Casing badly bent,
components inside
badly fractured

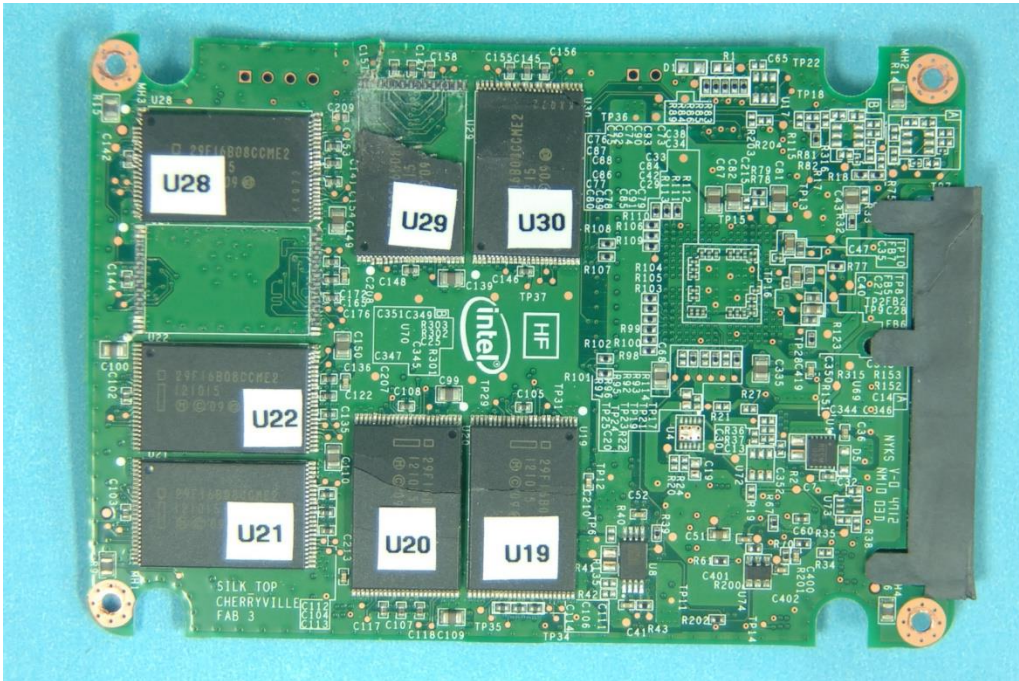
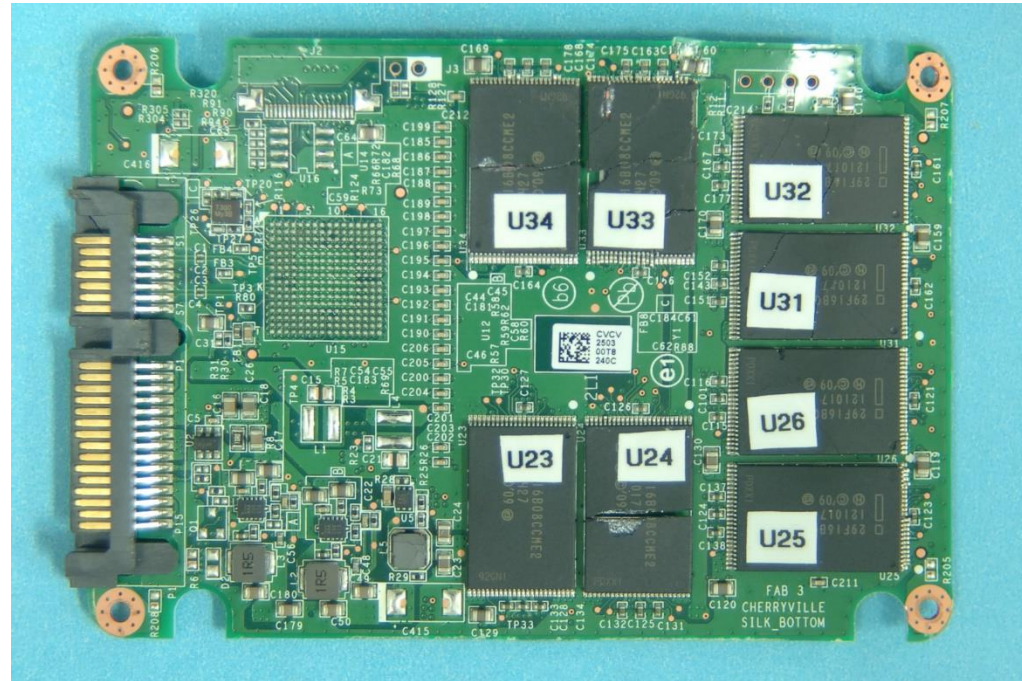
Layout of the Card

- U15 was separated completely from the card
- U27 was separated completely from the card
- U29 was broken and partly separated from the card
- The degree of damage to the card precludes using it as is for data recovery
- A module by module assessment was performed to determine if data could be recovered from certain modules

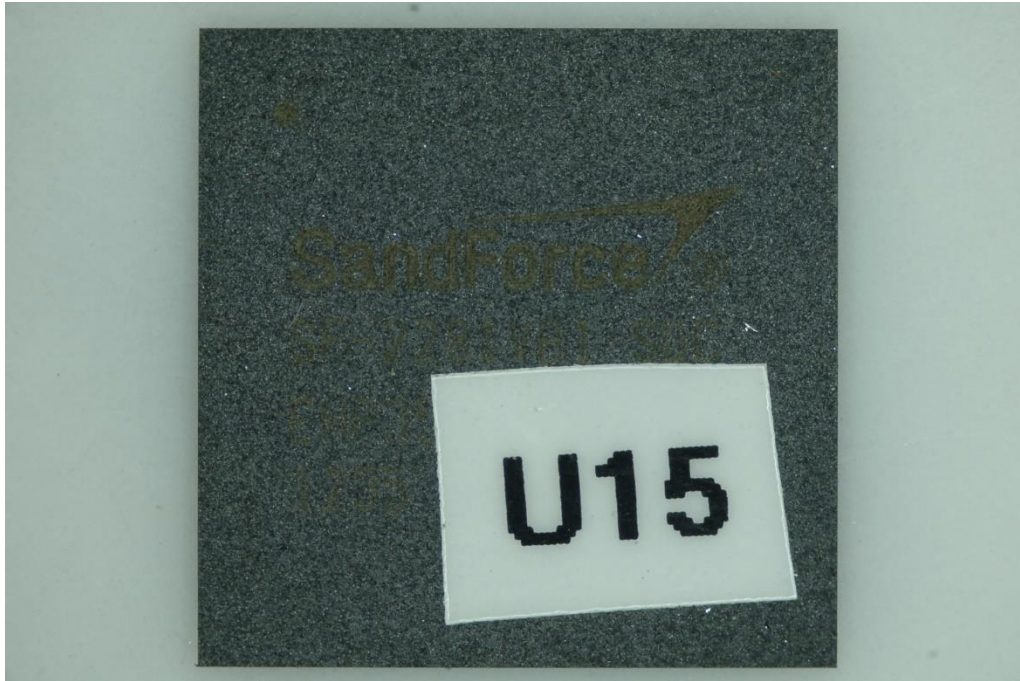
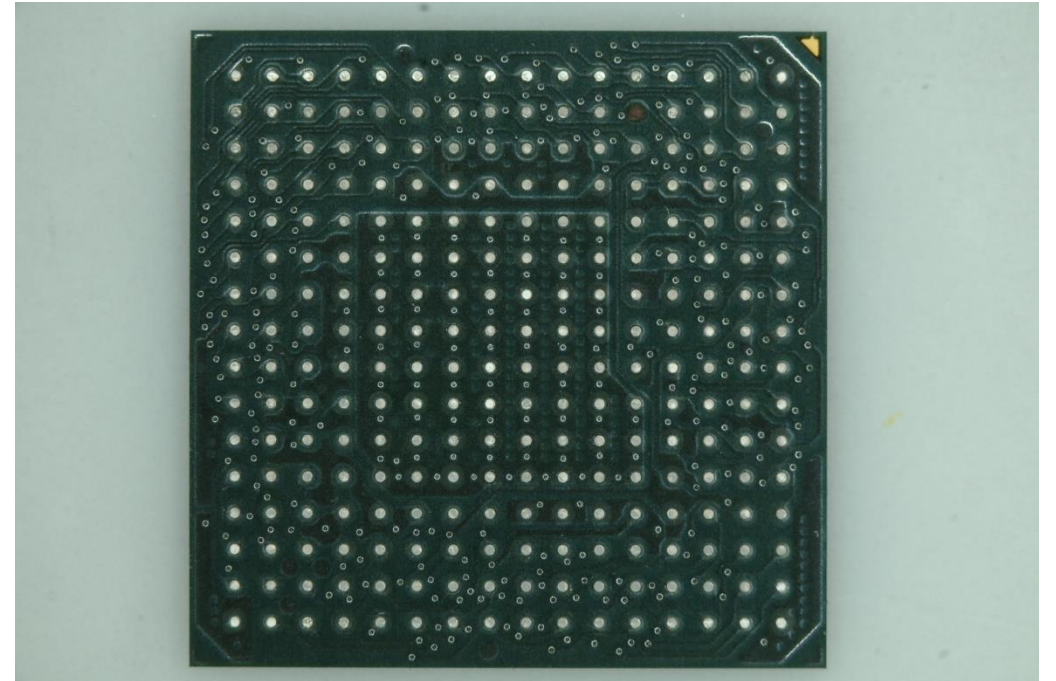
Module U15 Photos

Other than separation from the card, there is no visual evidence of damage to the module

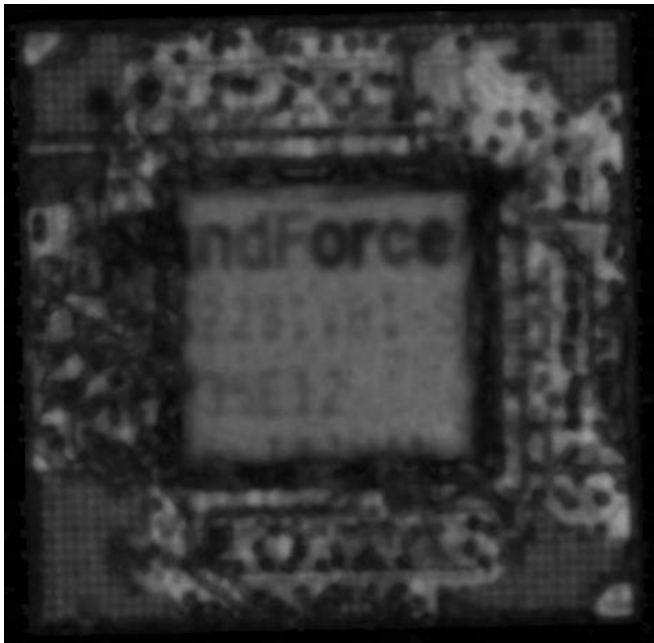
Module 15 C-SAMs

No evidence of cracking or delamination

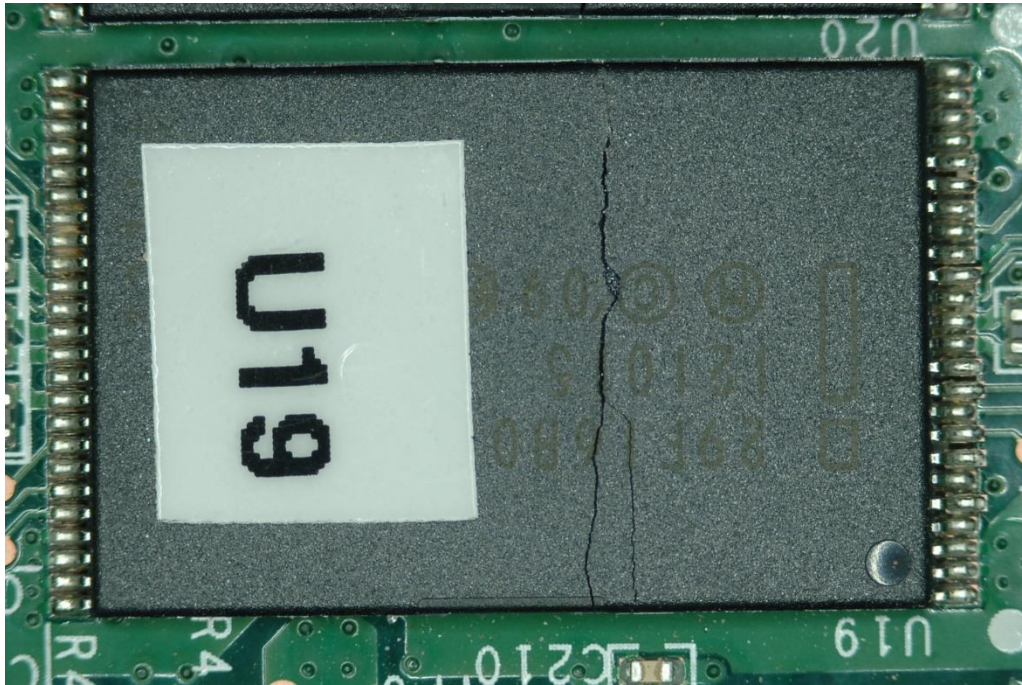
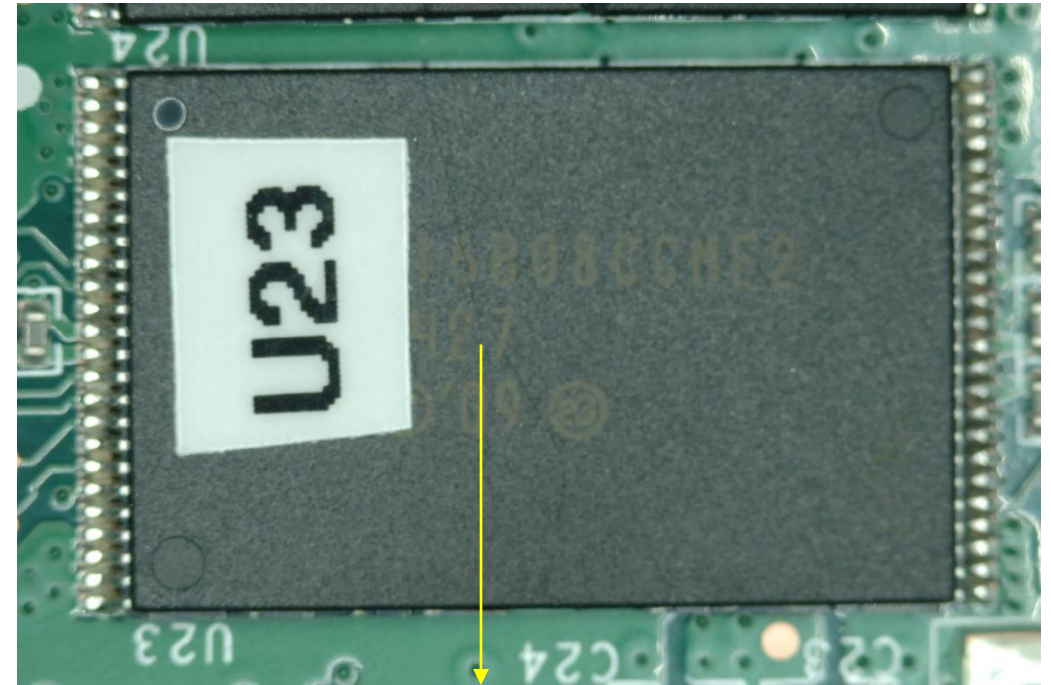
Module U19 / U23 Pair - Photos

Obvious crack in U19
Subtle crack in U23

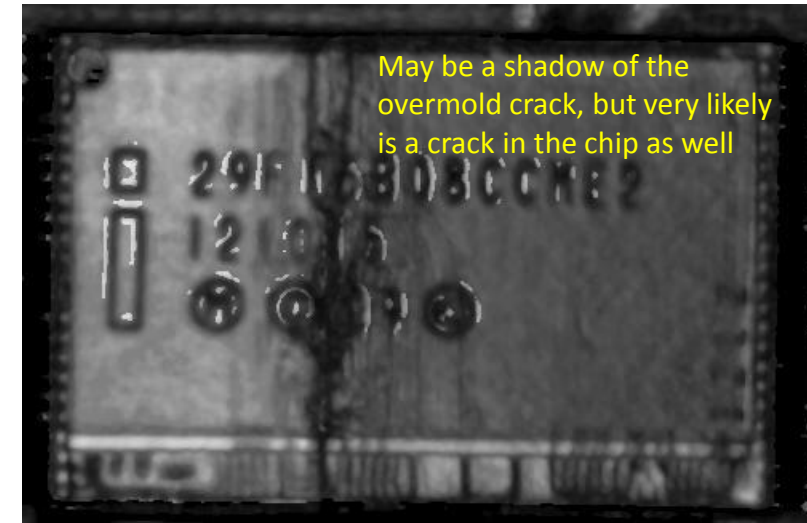
Module U19 C-SAMs

Given the flex of the module, the C-SAM anomaly is probably from a crack in the chip, not just a shadow of the crack in the overmold

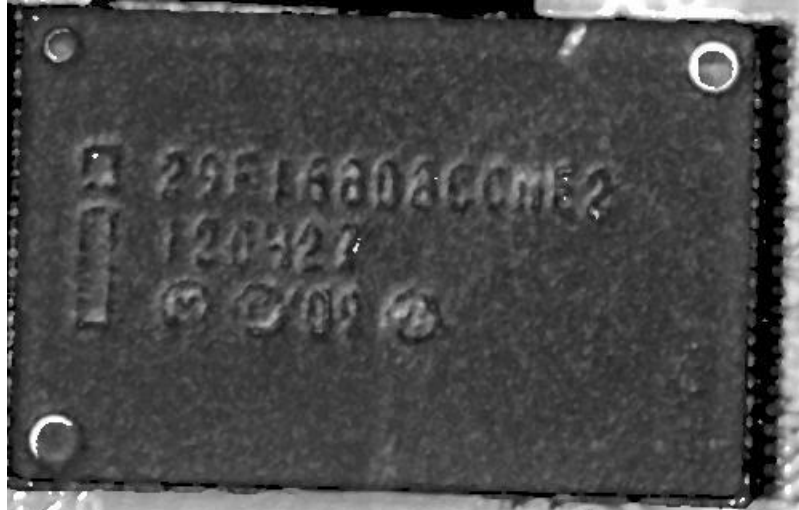
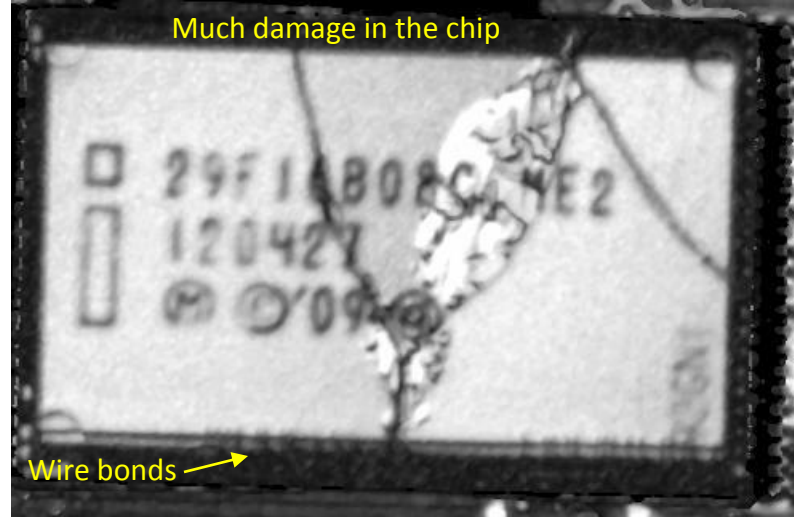
Module U23 C-SAMs

Chip is badly damaged from the flexing

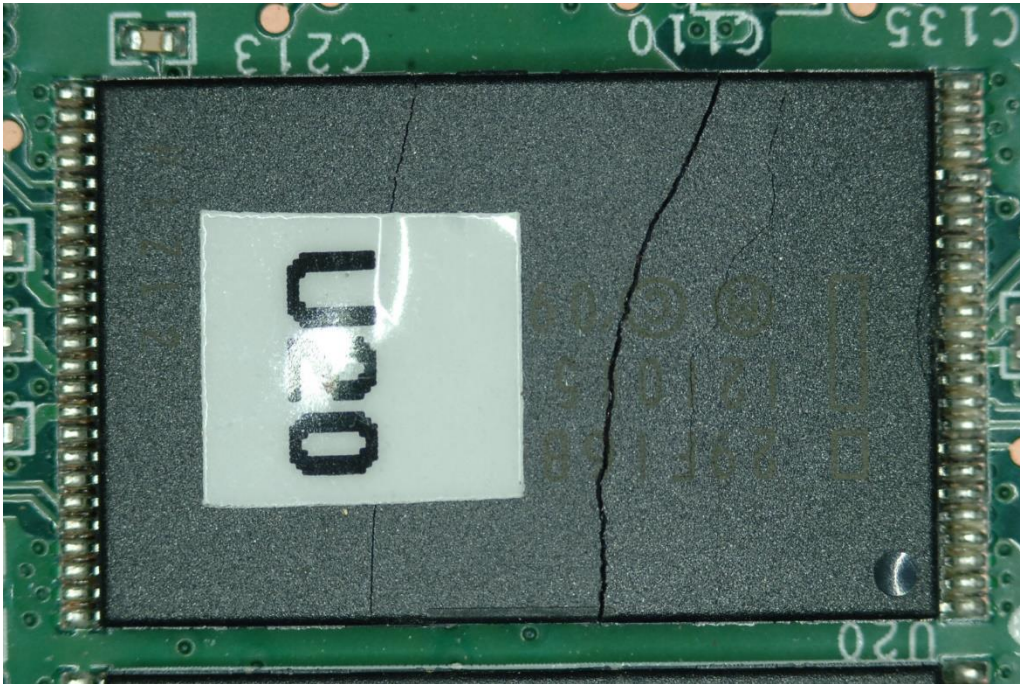
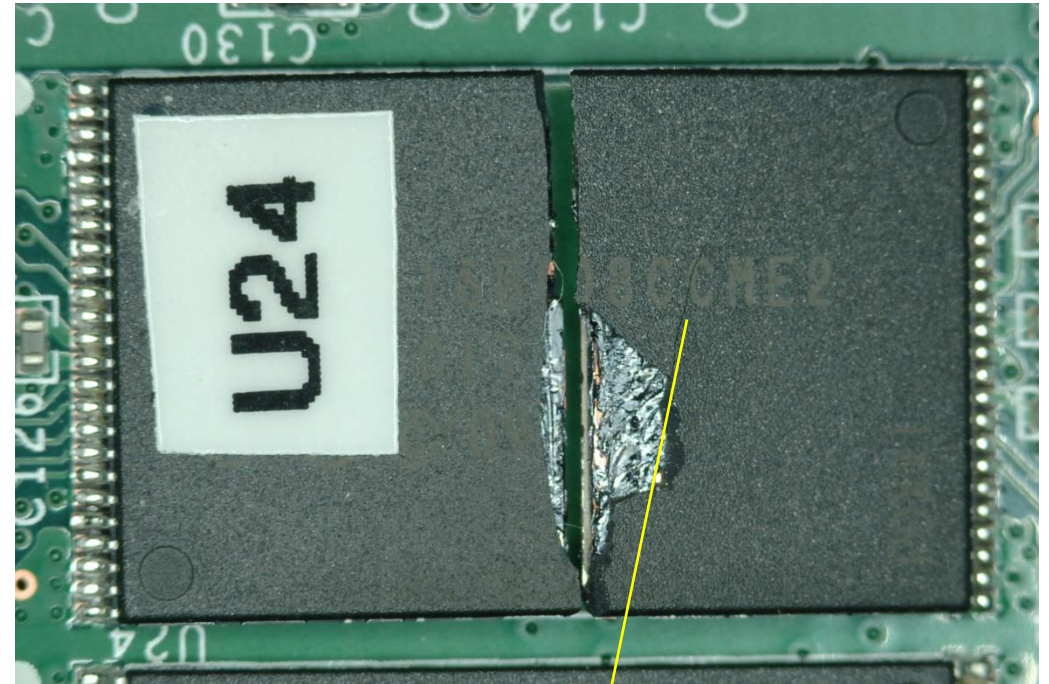
Module U20 / U24 Pair - Photos

Obvious cracks in U20
U24 broke apart

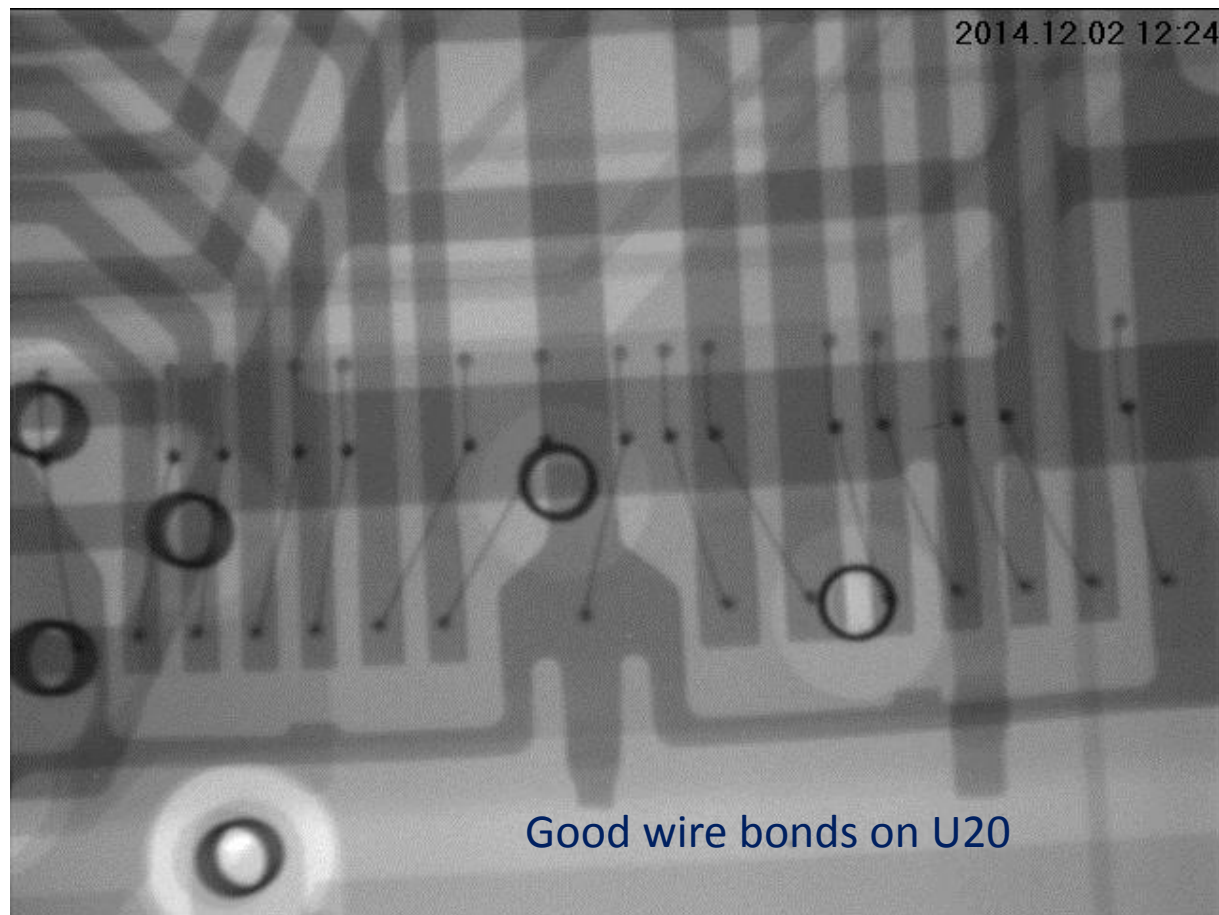
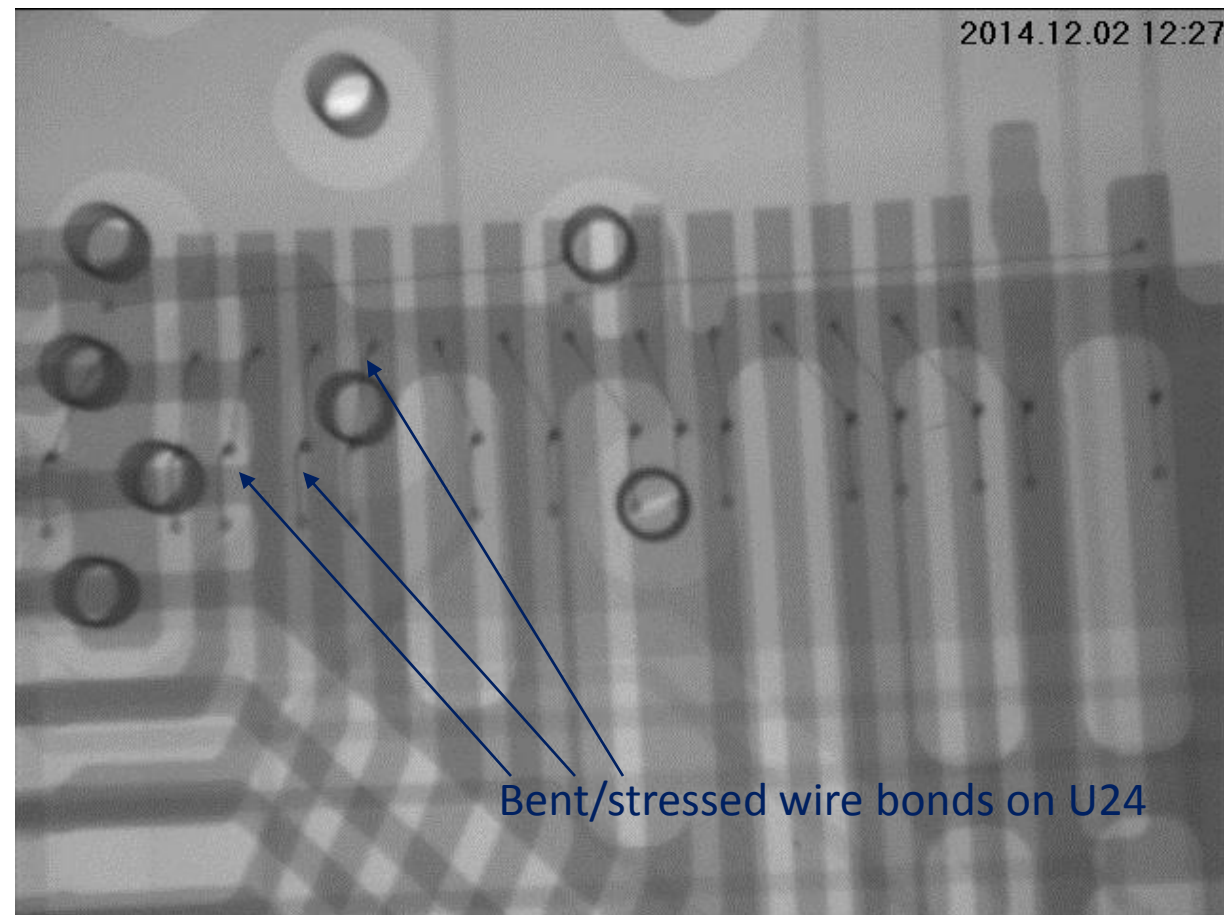
Module U20 / U24 Pair – X-rays

X-rays show good integrity of wire bonds on one side (U20), but evidence of stress and displacement on the other side (U24). The complete fracture of U24 missed the wire bonds in that module. Wire bonds on U20 are all good

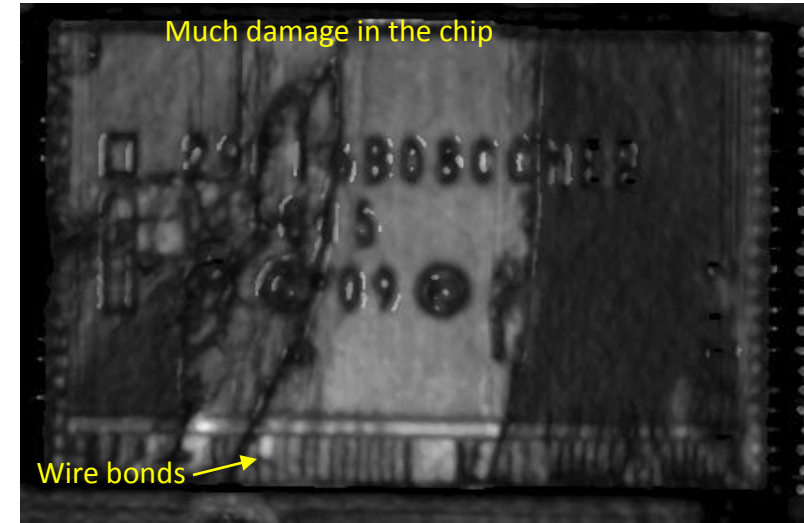
Module U20 C-SAMs

Chip is badly damaged from flexing

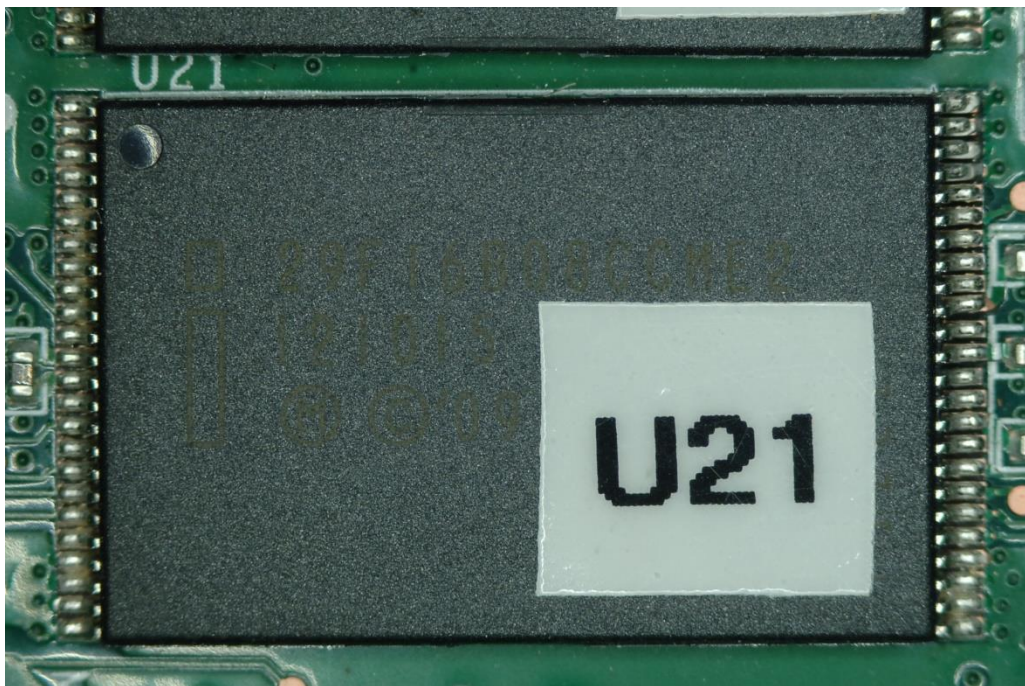
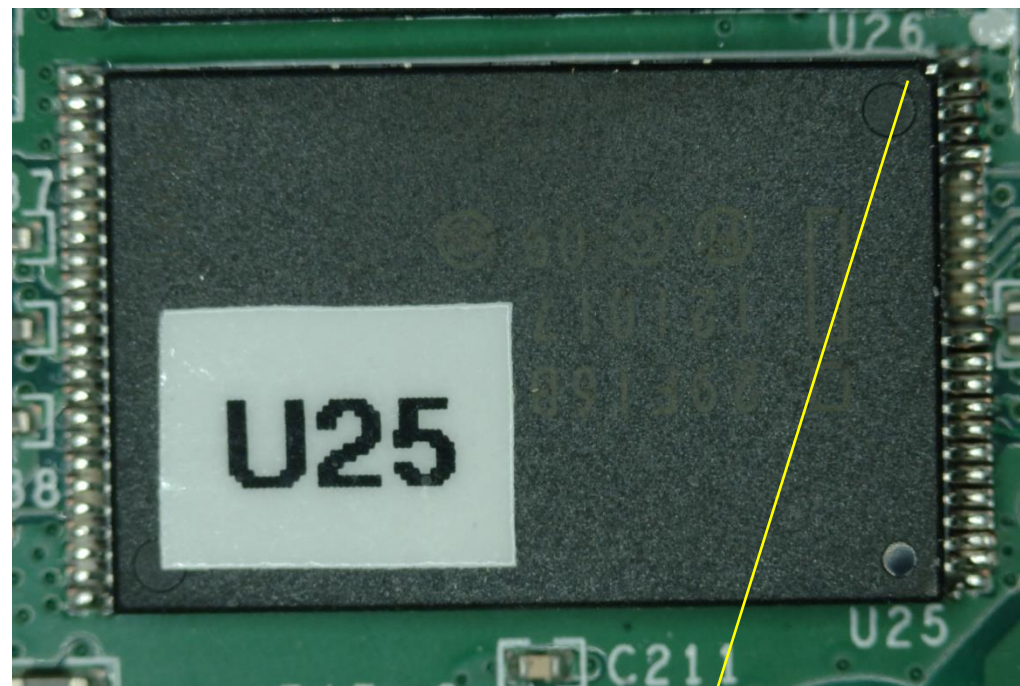
Module U21 / U25 Pair - Photos

Cracks were not found in either module
U25 pulled pads from the card

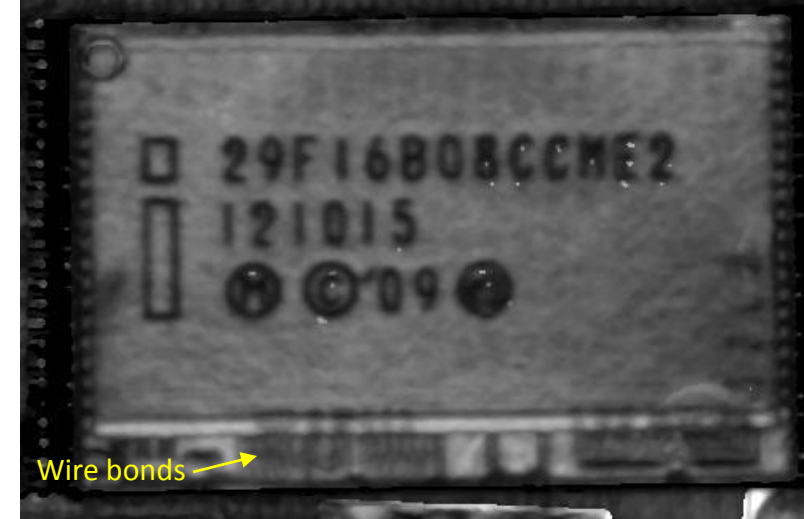
Module U21 C-SAMs

Chip appears to be in tact – no evidence of cracking or catastrophic delamination

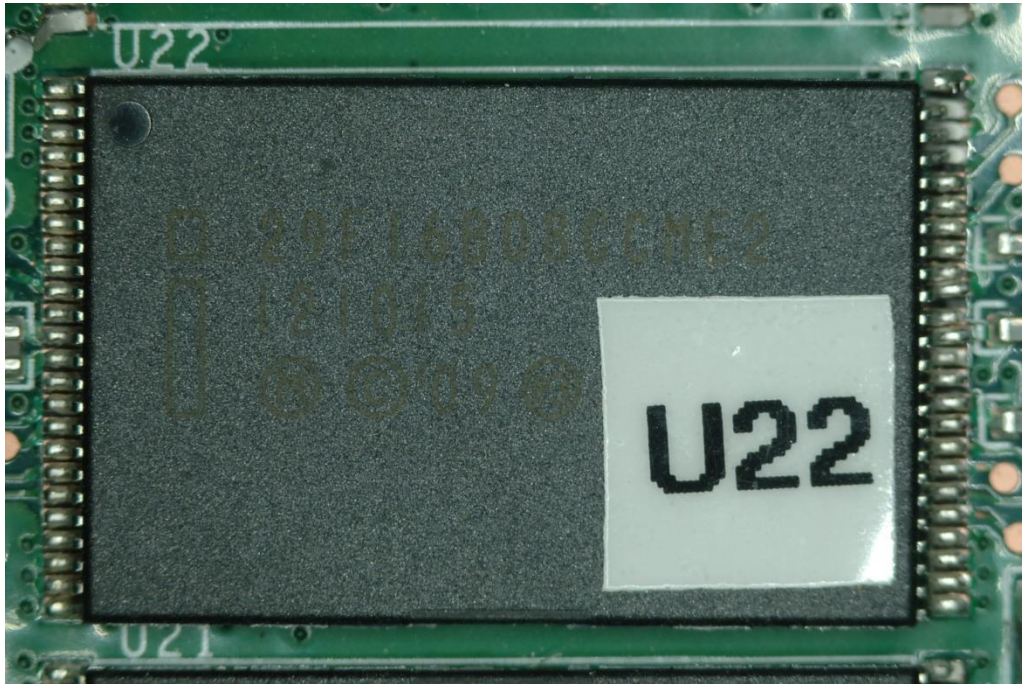
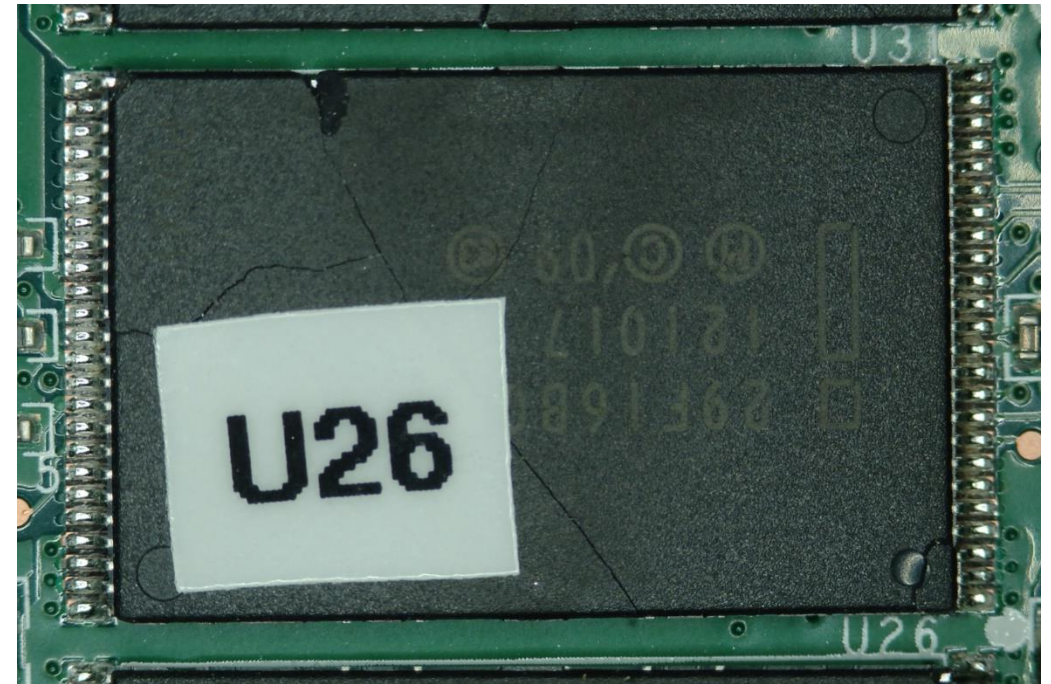
Module U22 / U26 Pair - Photos

No cracks in U22
Obvious cracks in U26

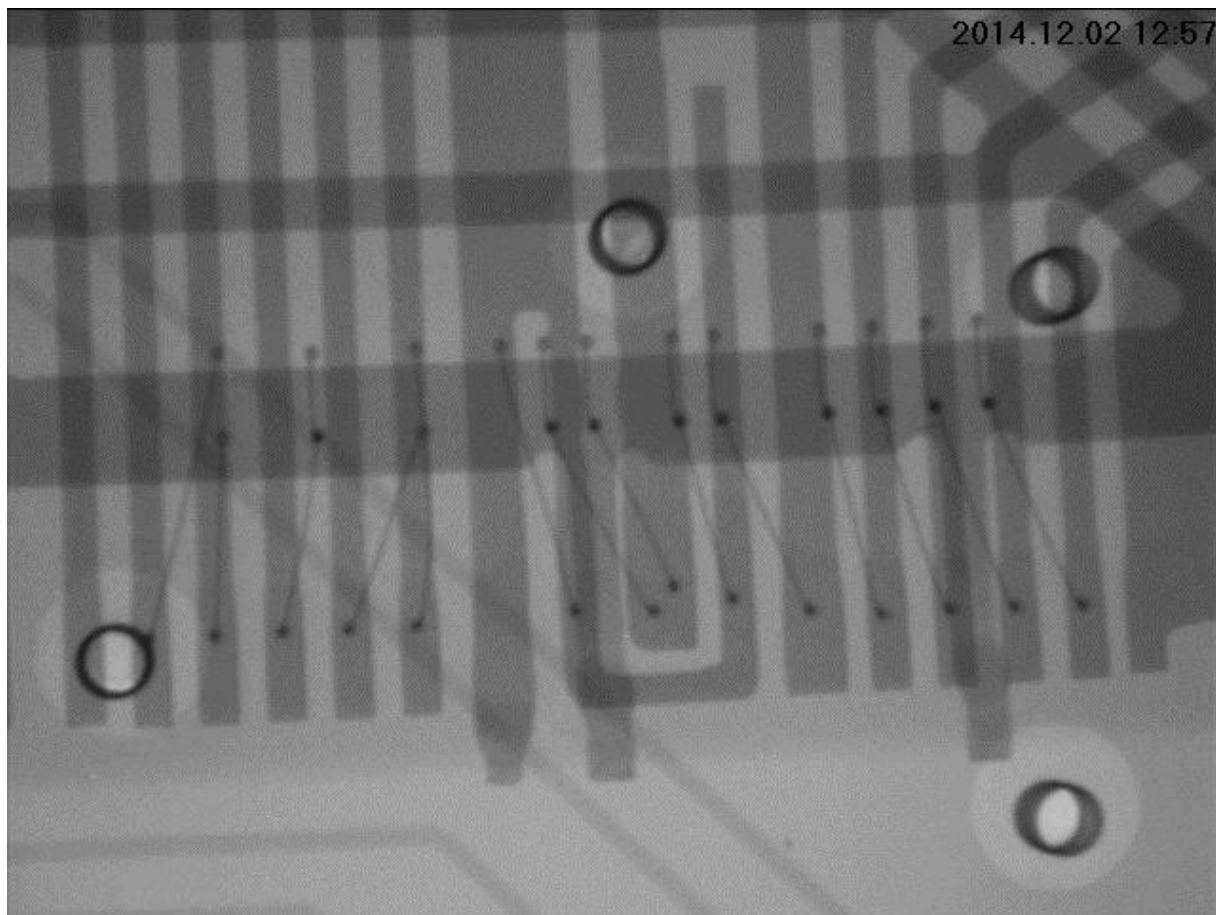
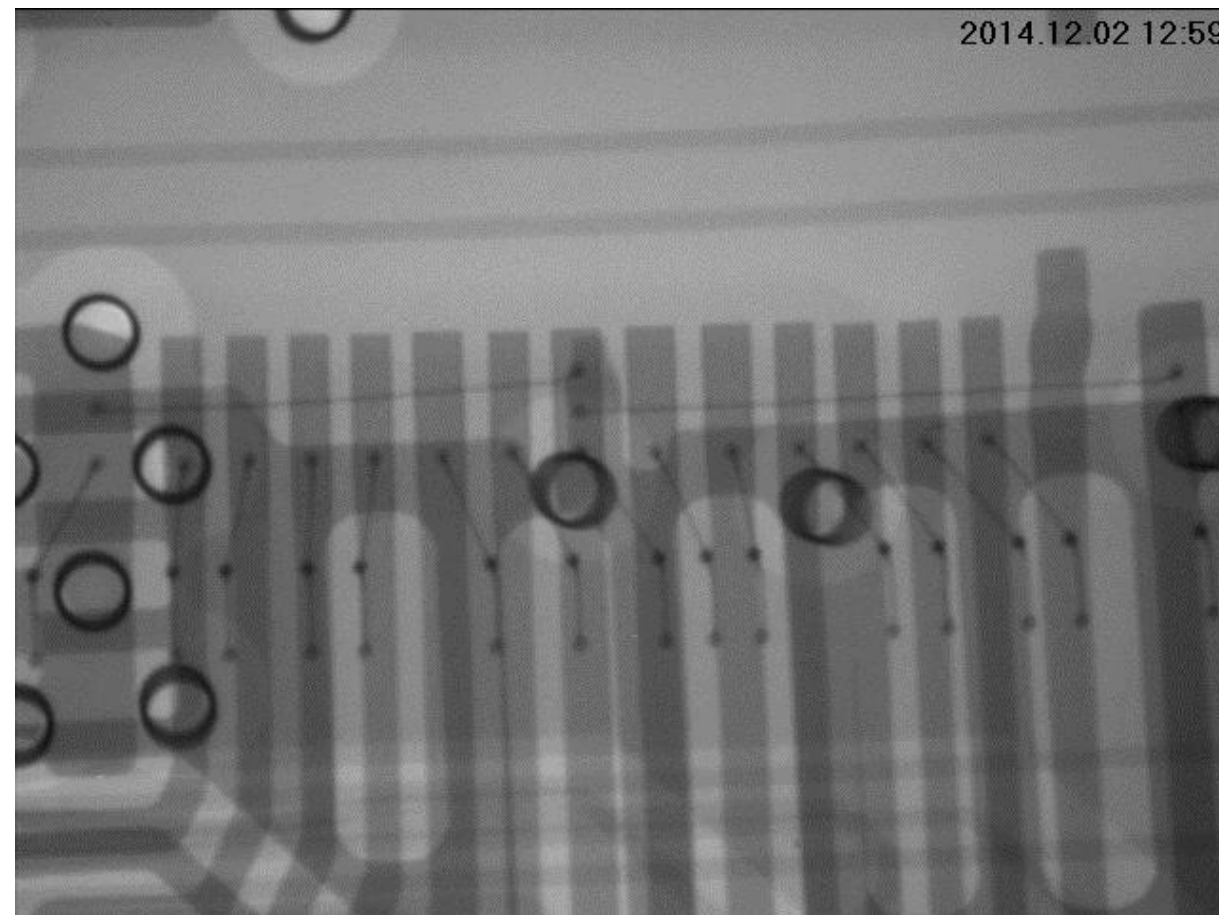
Module U22 / U26 Pair – X-rays

X-rays (typical ones are given above) show good integrity of wire bonds on both modules (wire bonds are on one side of the module, hence appear on opposite edges in the back to back configuration on the card)

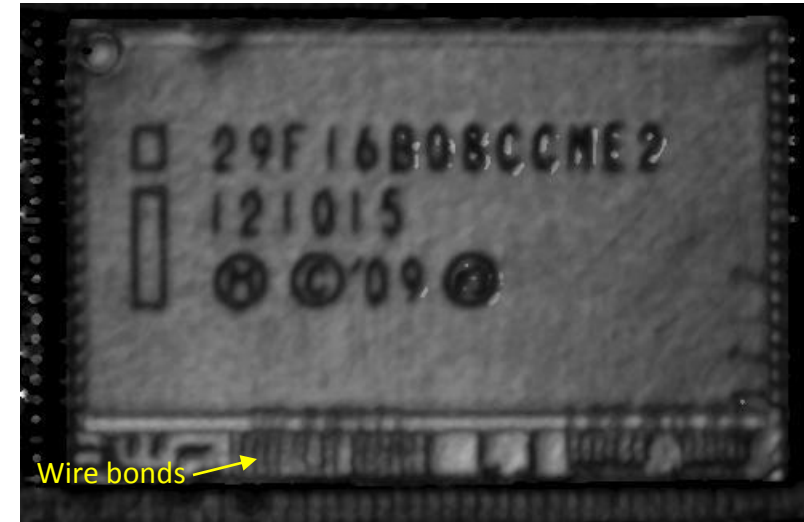
Module U22 C-SAMs

Chip appears to be in tact – no evidence of cracking or catastrophic delamination

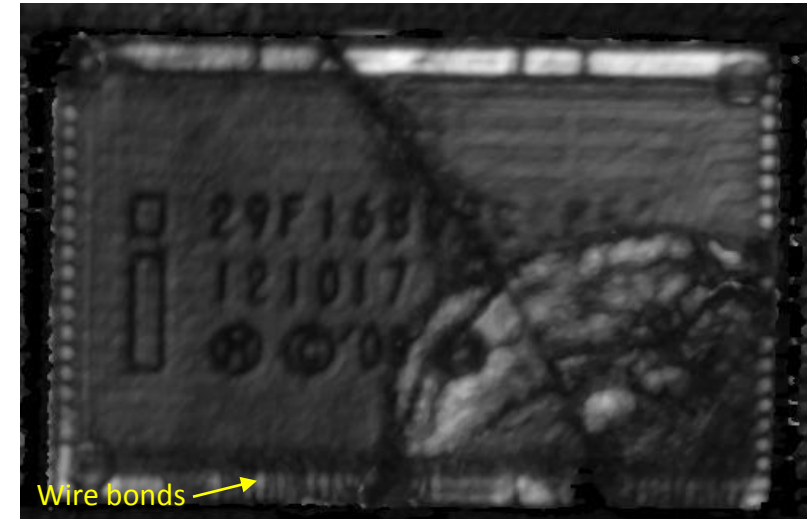
Module U26 C-SAMs

Chip is cracked, and the corner of the chip is crushed from flexing

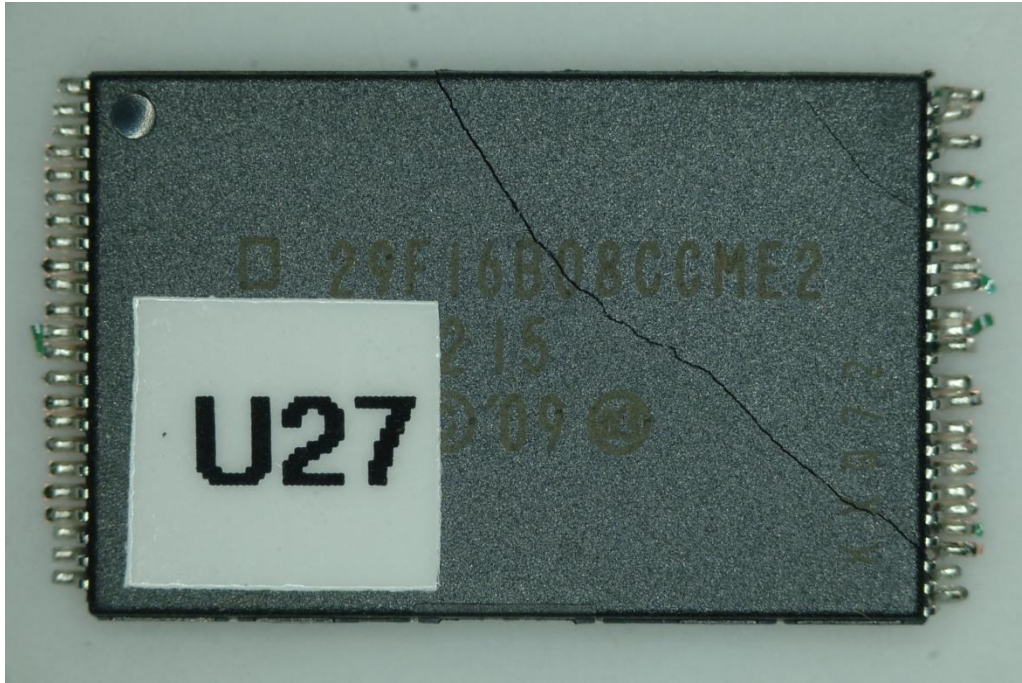
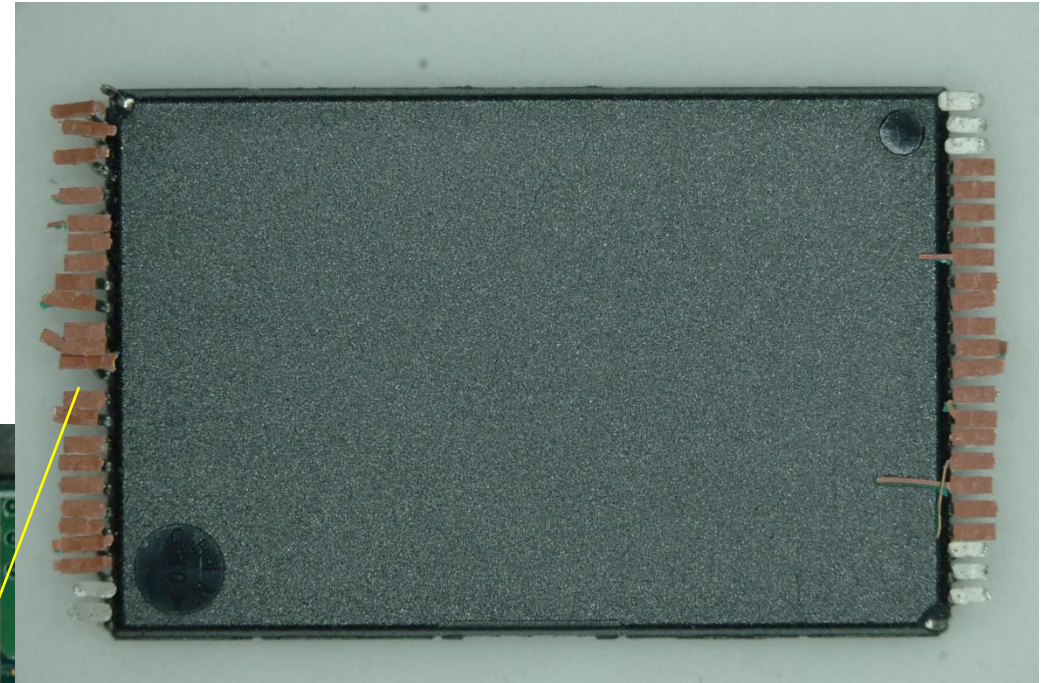
Module U27 - Photos

Cracks in the top side
No cracks on the bottom side

Solder pads
torn from
the card

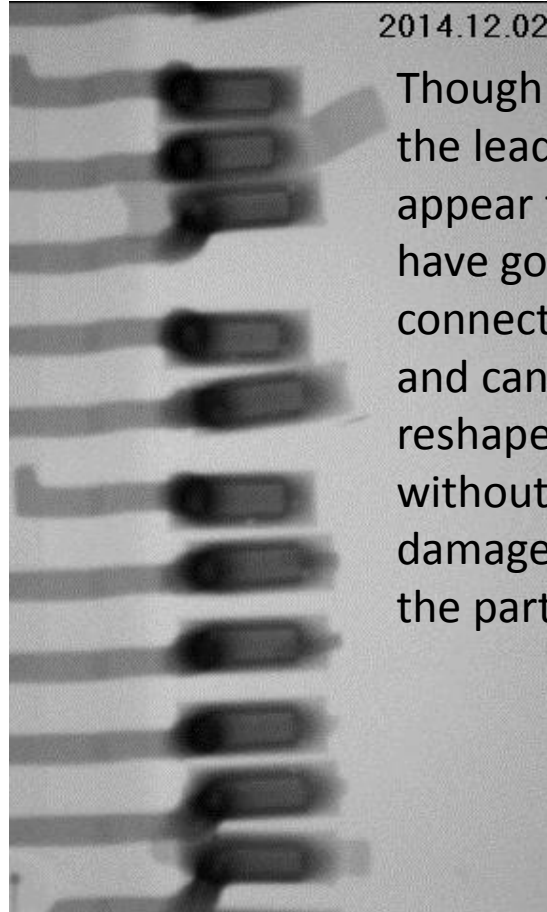
2014.12.02
Though bent,
the leads
appear to
have good
connectivity,
and can be
reshaped
without
damage to
the part

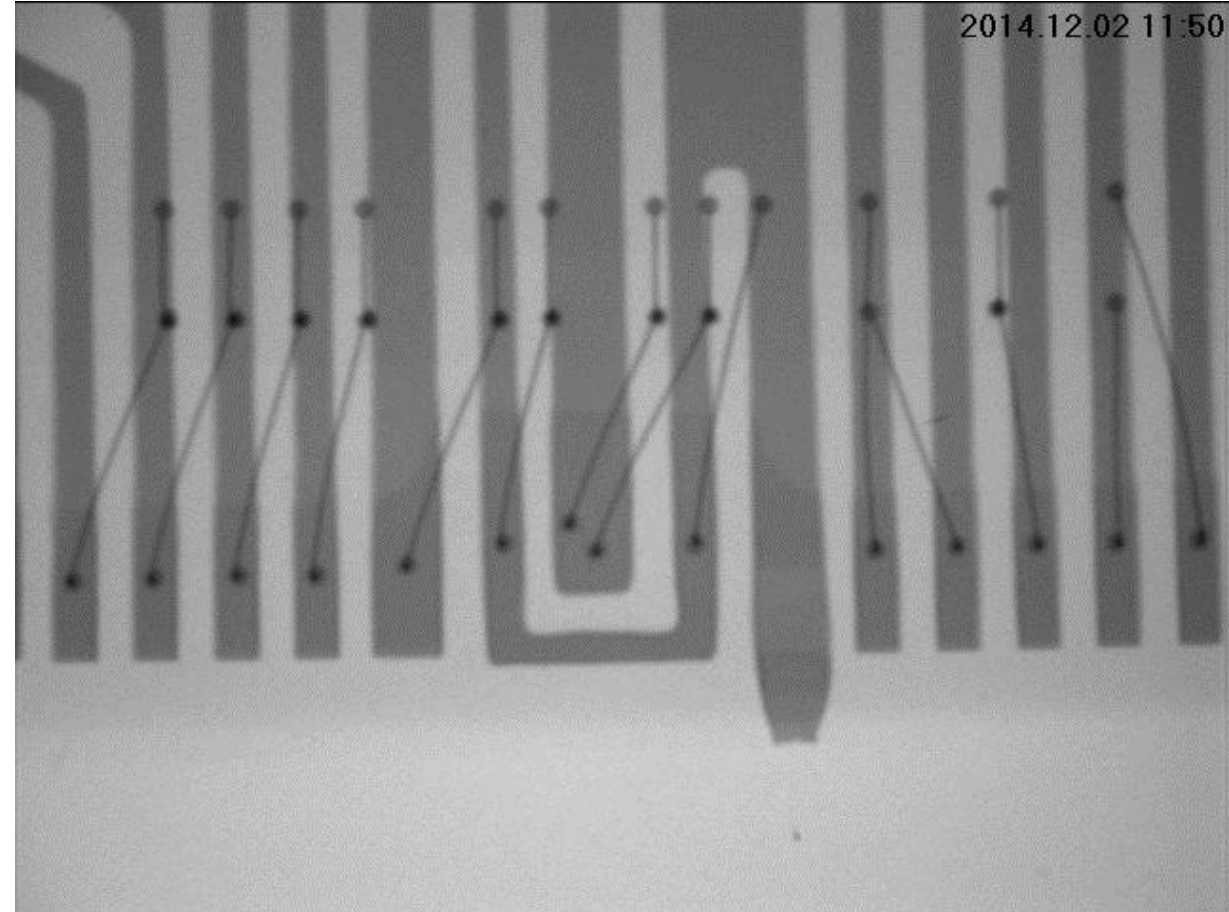
Module U27 – X-rays

Typical X-rays show good integrity of wire bonds

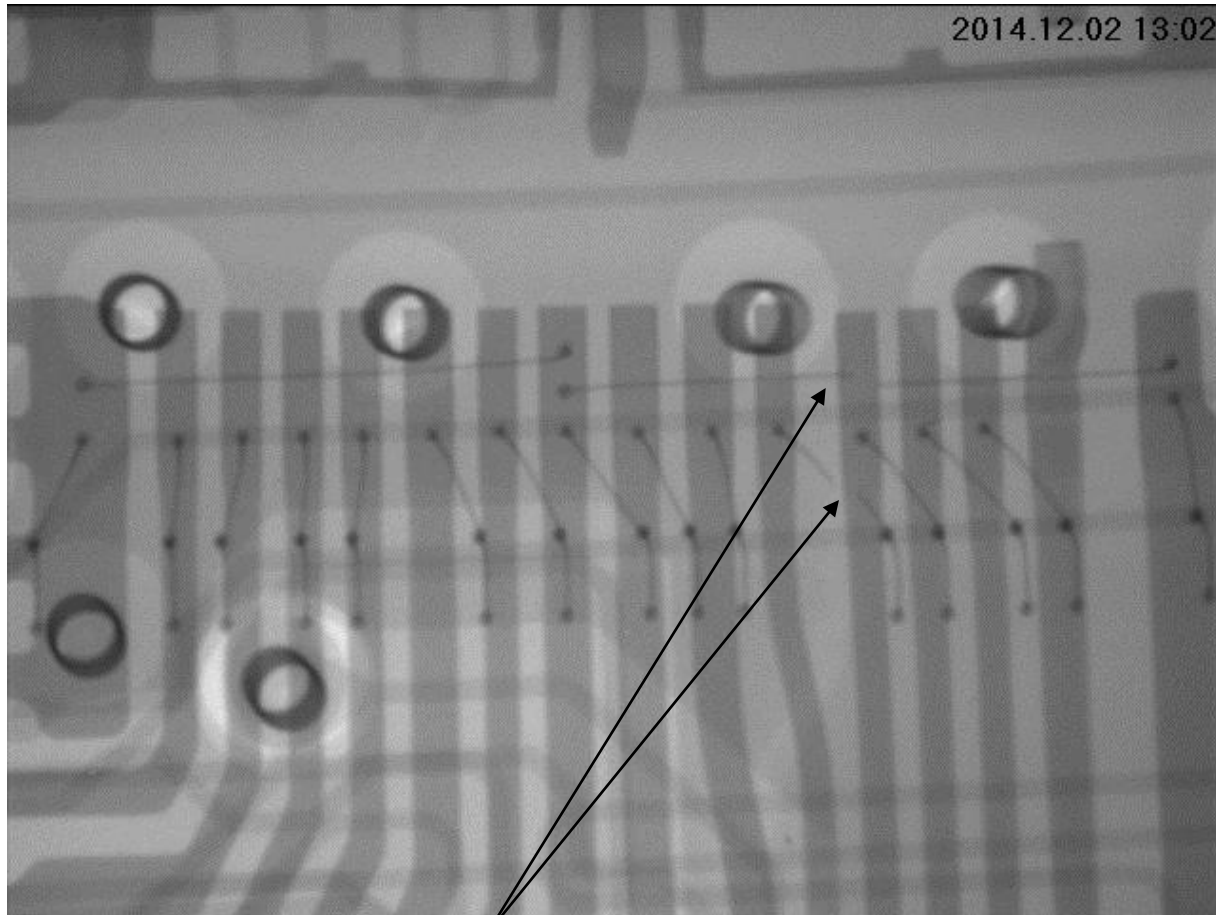
Module U31 – X-rays

Broken wires

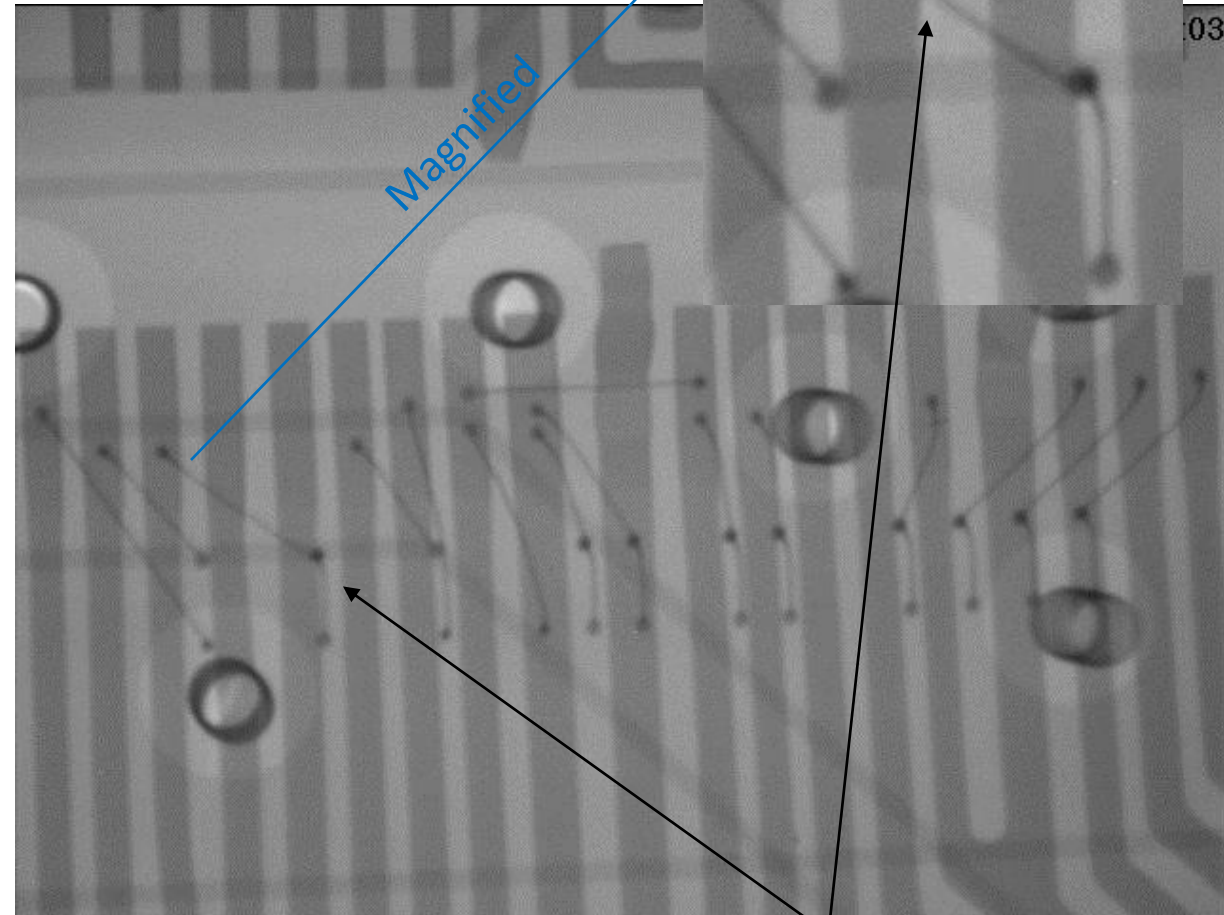
Broken wire
