DCA15MA019

Attachment #3 to Group Chairman's Electronic Devices and Flight
Data Factual Report

Integrated Electronics Engineering Center (IEEC) Report

December 11, 2014

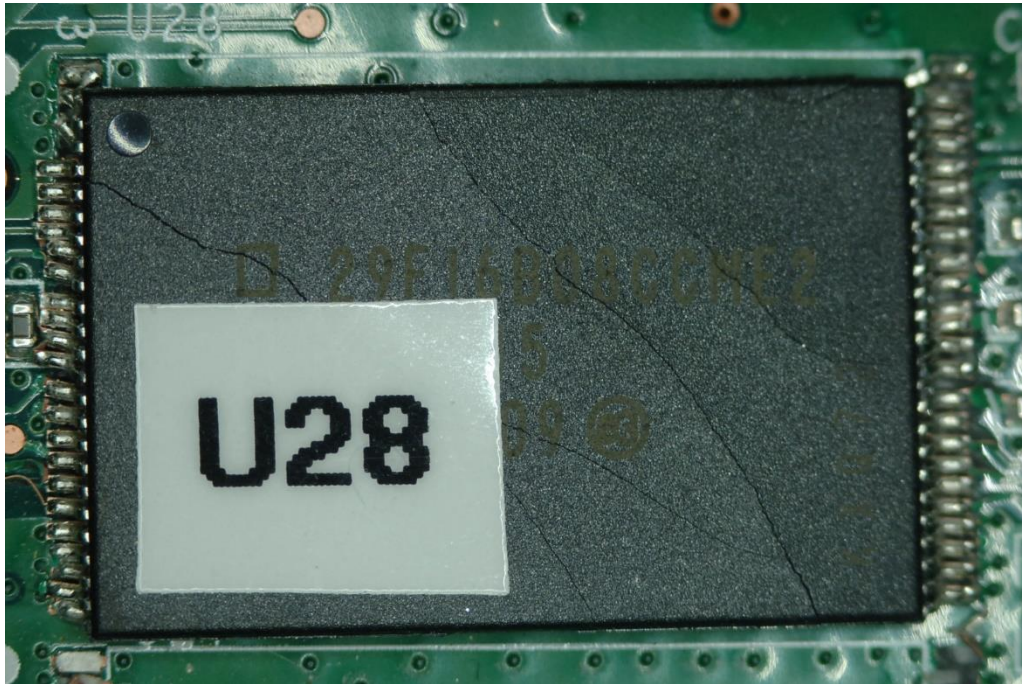
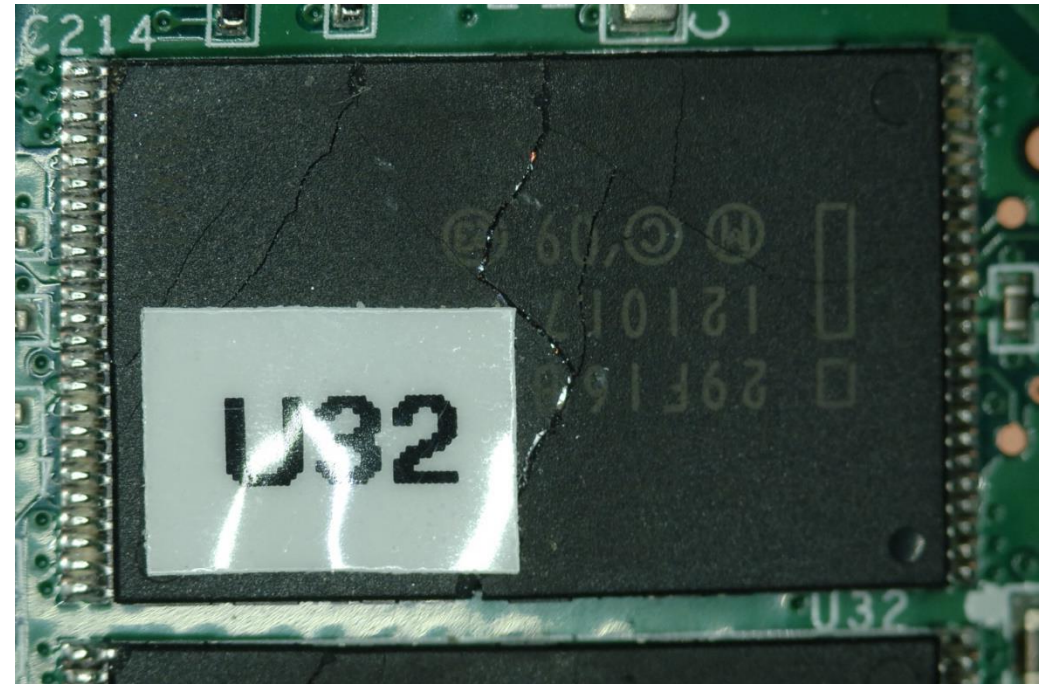
Module U28 / U32 Pair - Photos

Obvious cracks in U28
Cracks in U32 expose internal features

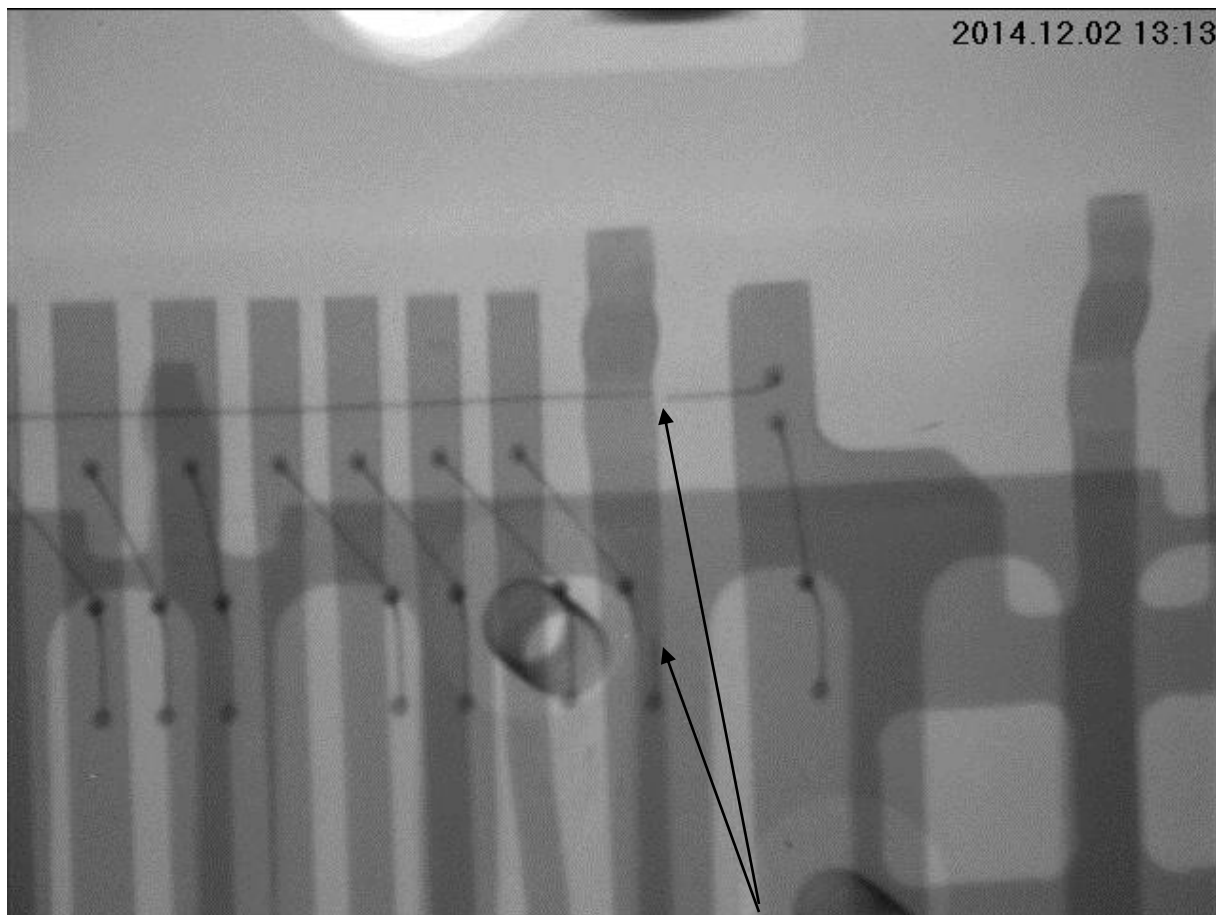
Module U28 / U32 Pair – X-rays

Broken wires (U32)

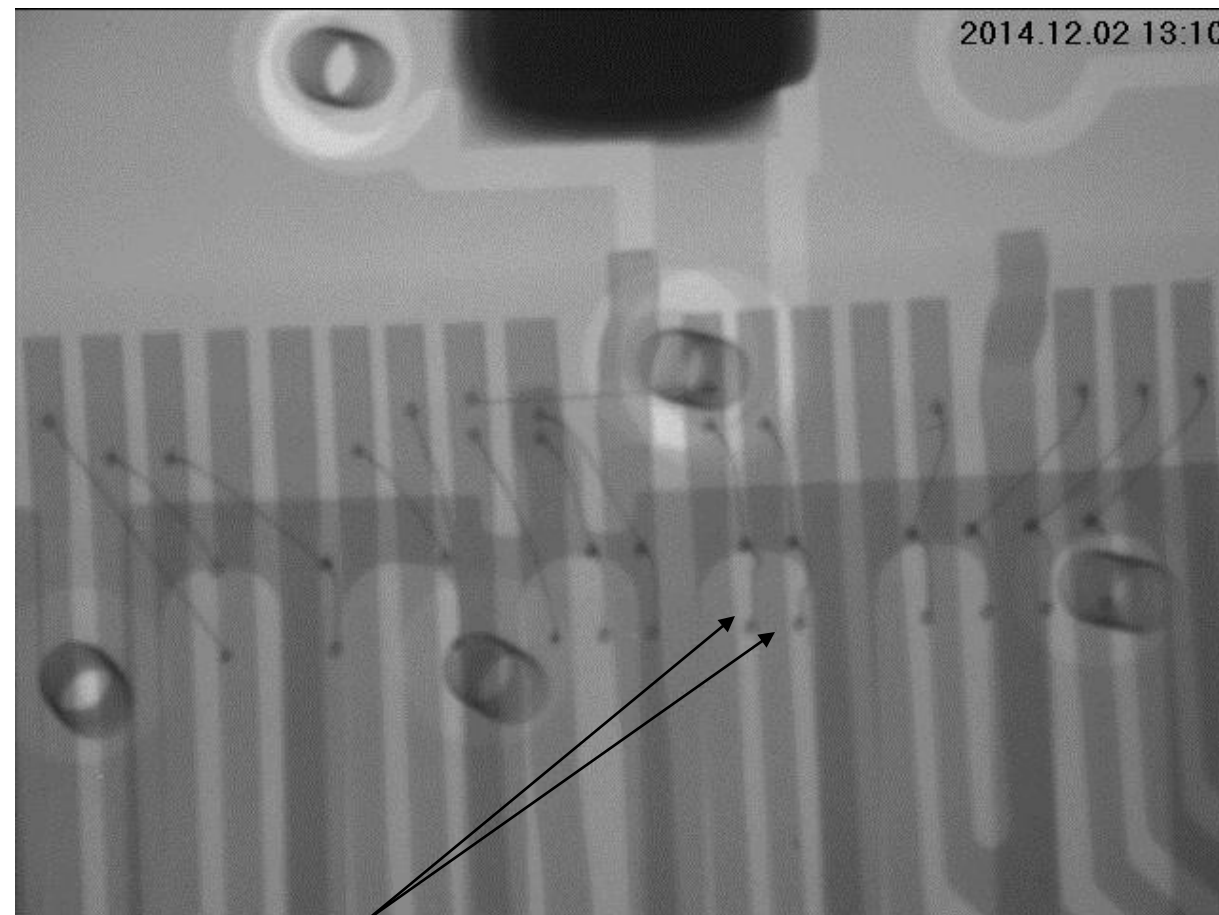
Kinked and likely broken wires (U32)

Wire bonds on the other side (U28 – X-rays not shown here) are good

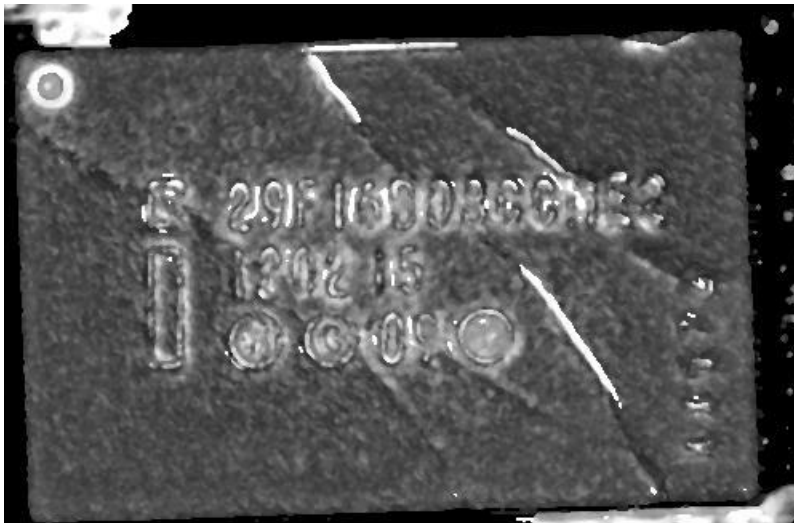
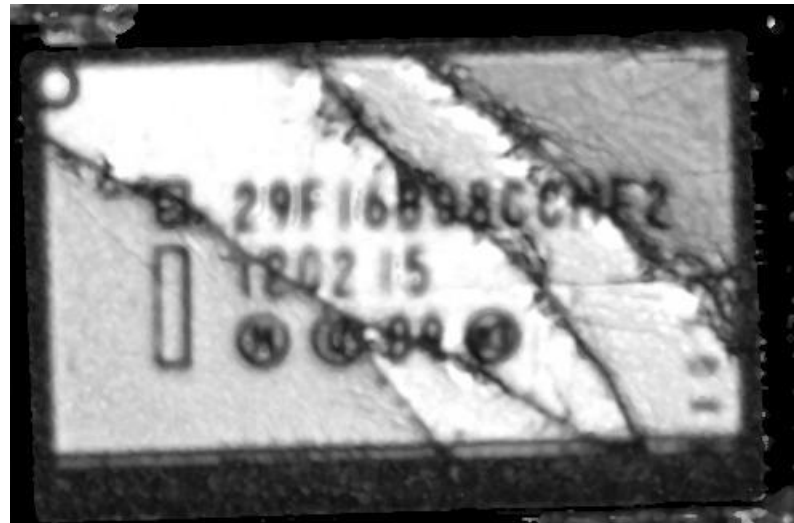
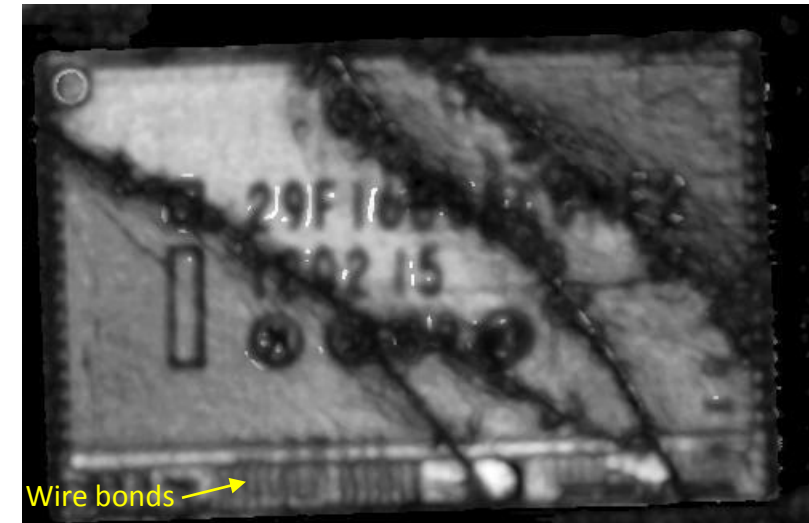
Module U28 C-SAMs

Given the flex of the module, the C-SAM anomaly is probably from a crack in the chip, not just shadows of the cracks in the overmold

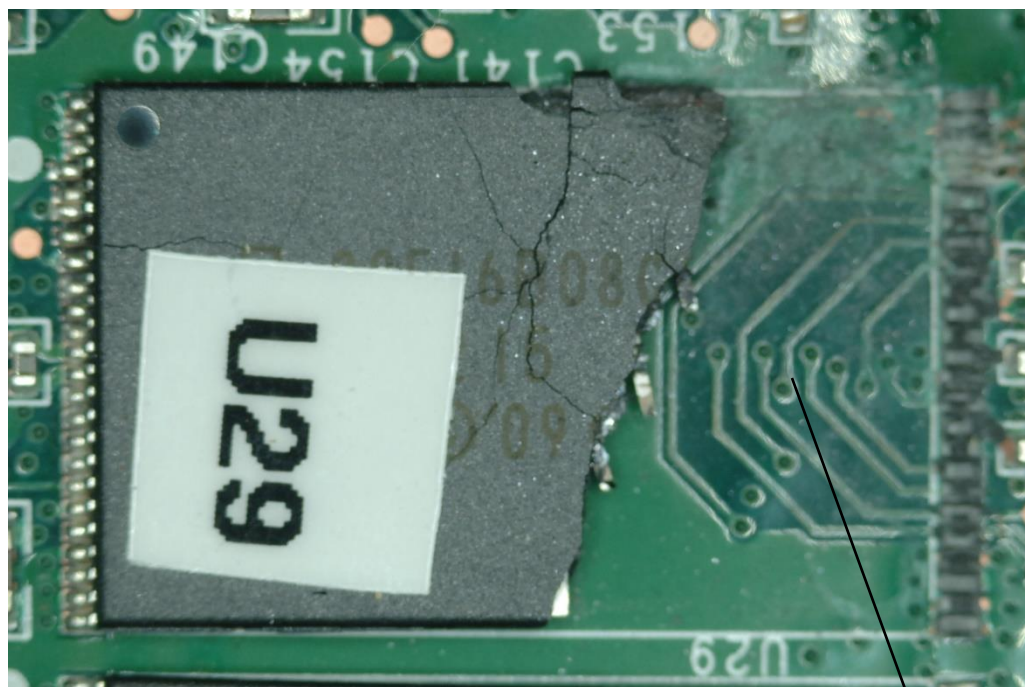
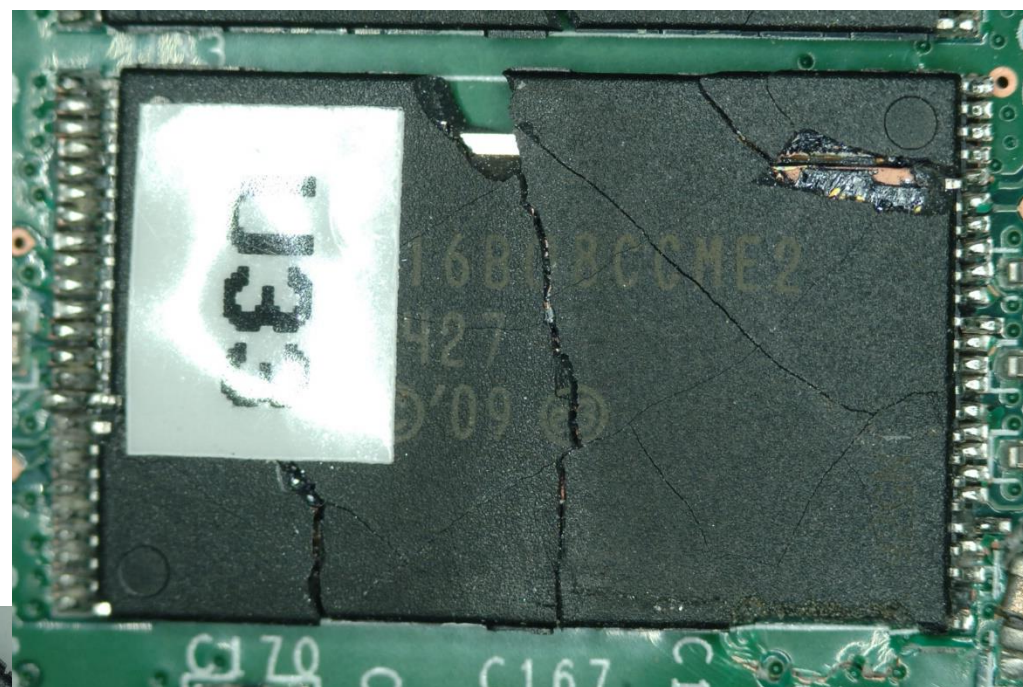
Module U29 / U33 Pair - Photos

U29 is broken into 2 parts
U33 is badly cracked, exposing
internal features

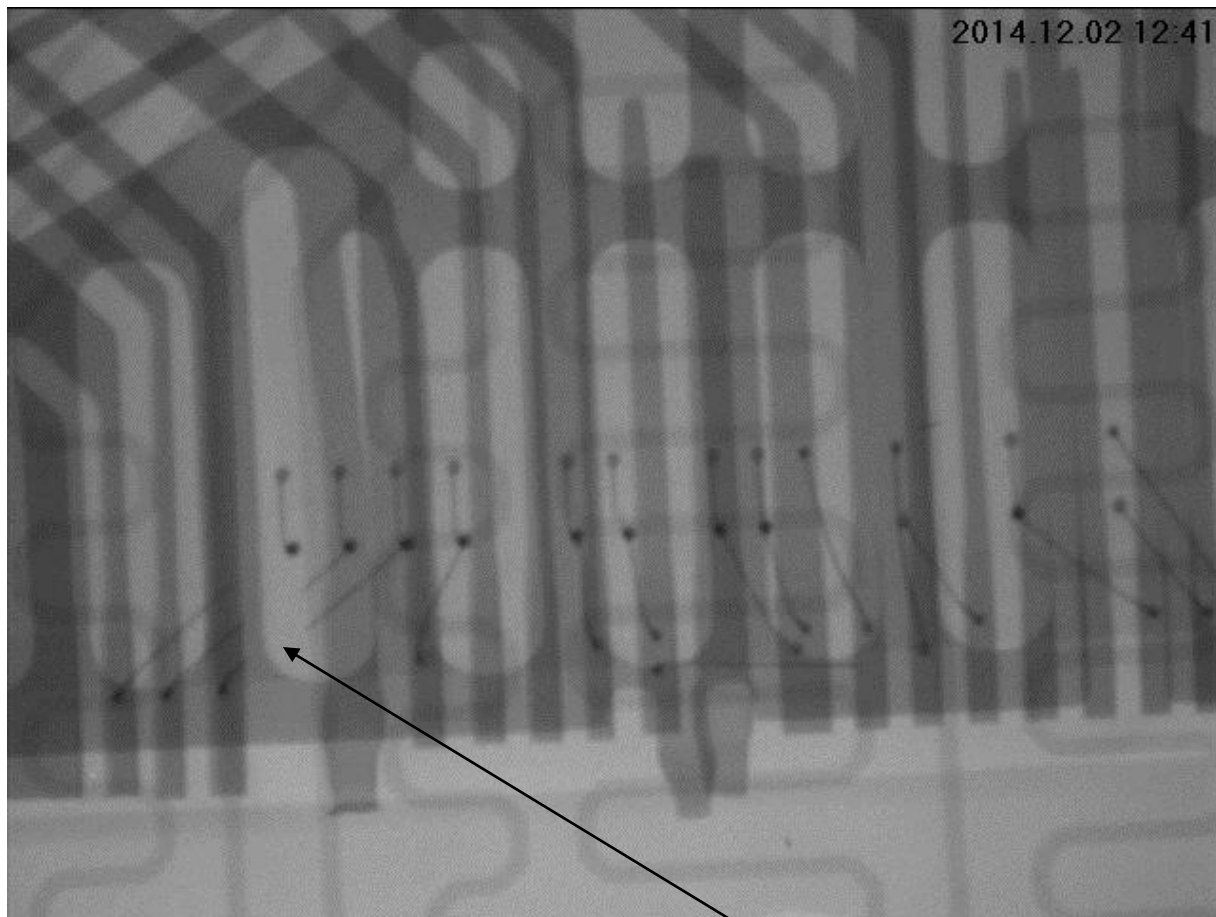
Module U29 / U33 Pair – X-rays

Broken wires in U33

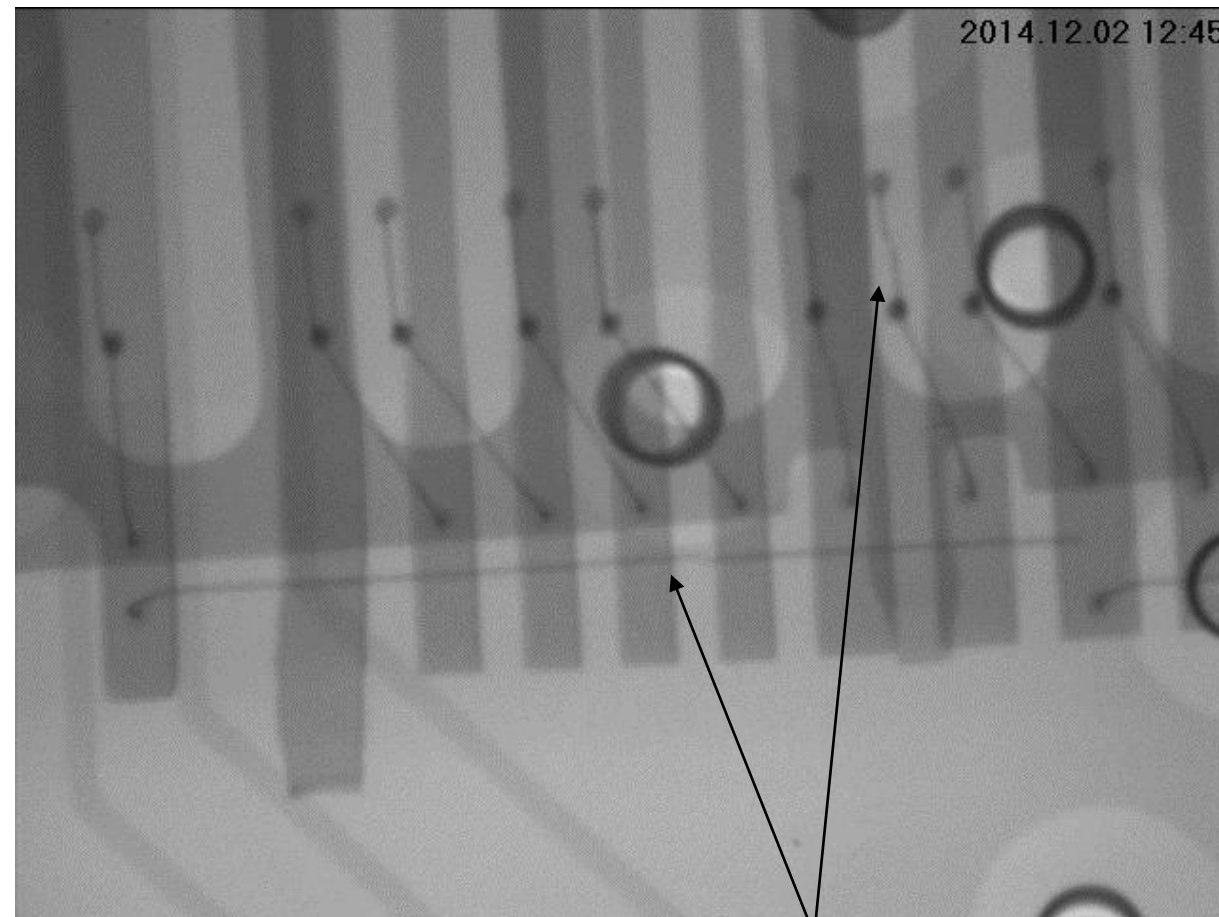
Broken wires in U33

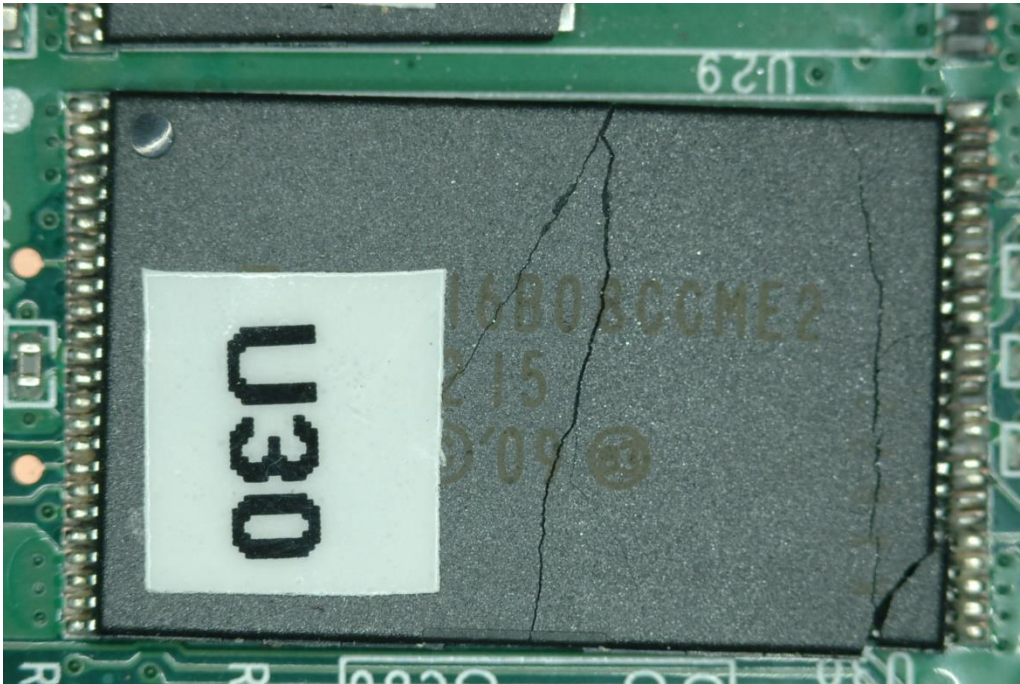
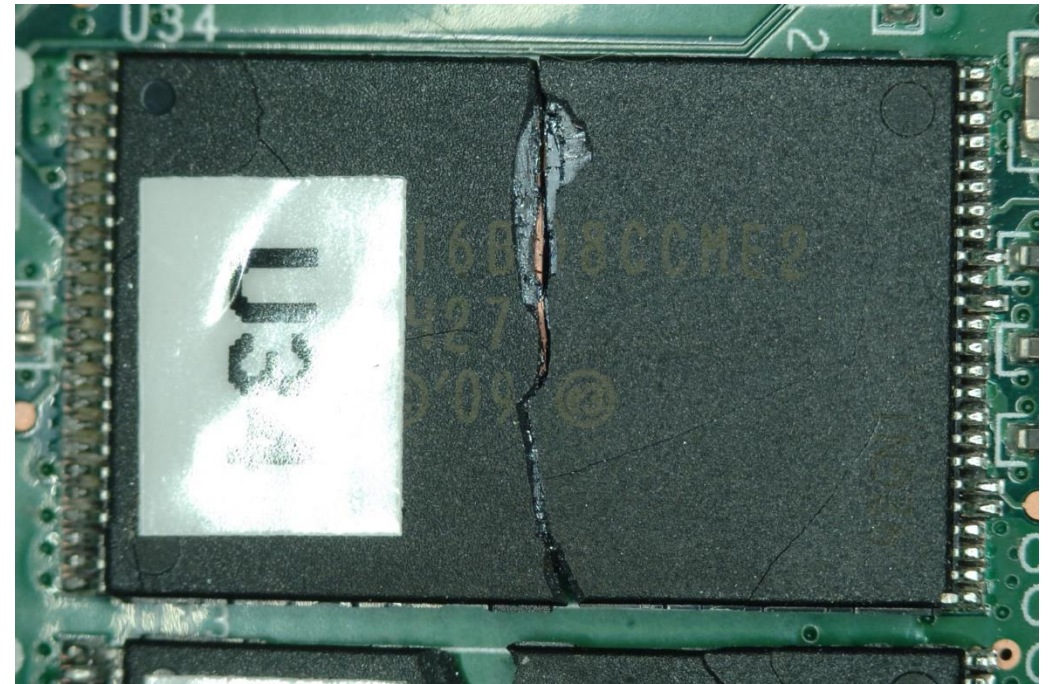
Module U30 / U34 Pair - Photos

Obvious cracks in U30
U34 is badly cracked, exposing internal features

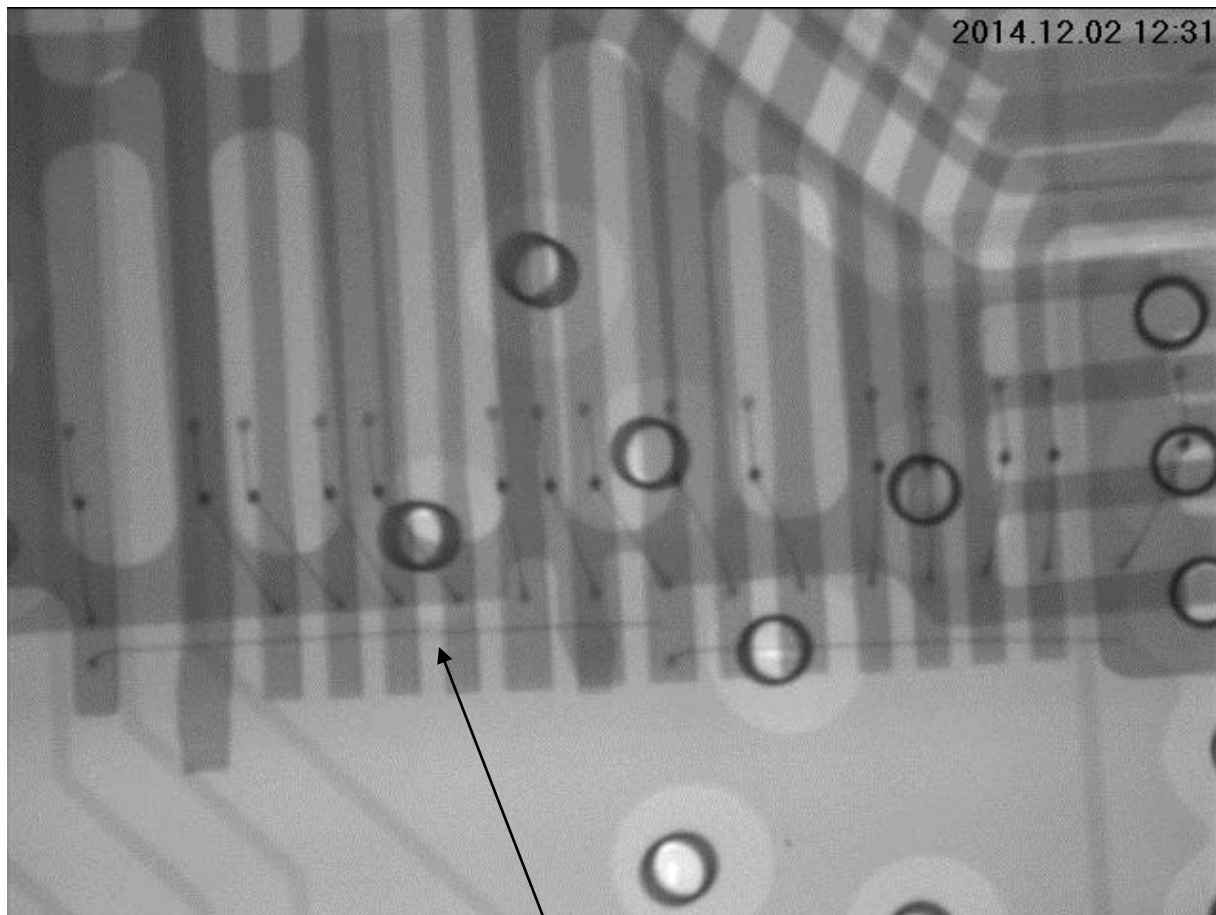
Module U30 / U34 Pair – X-rays

Broken wire in U34

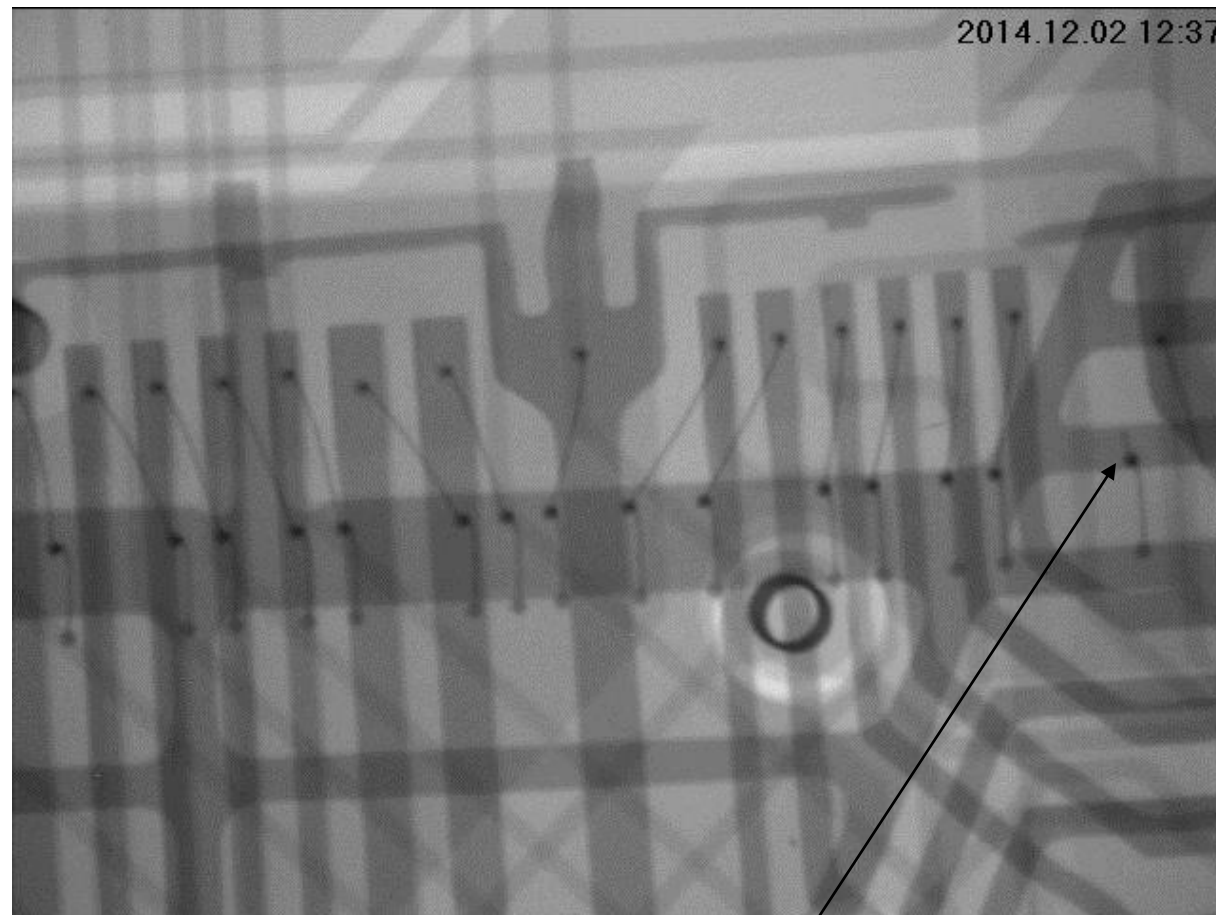
Broken wire in U30

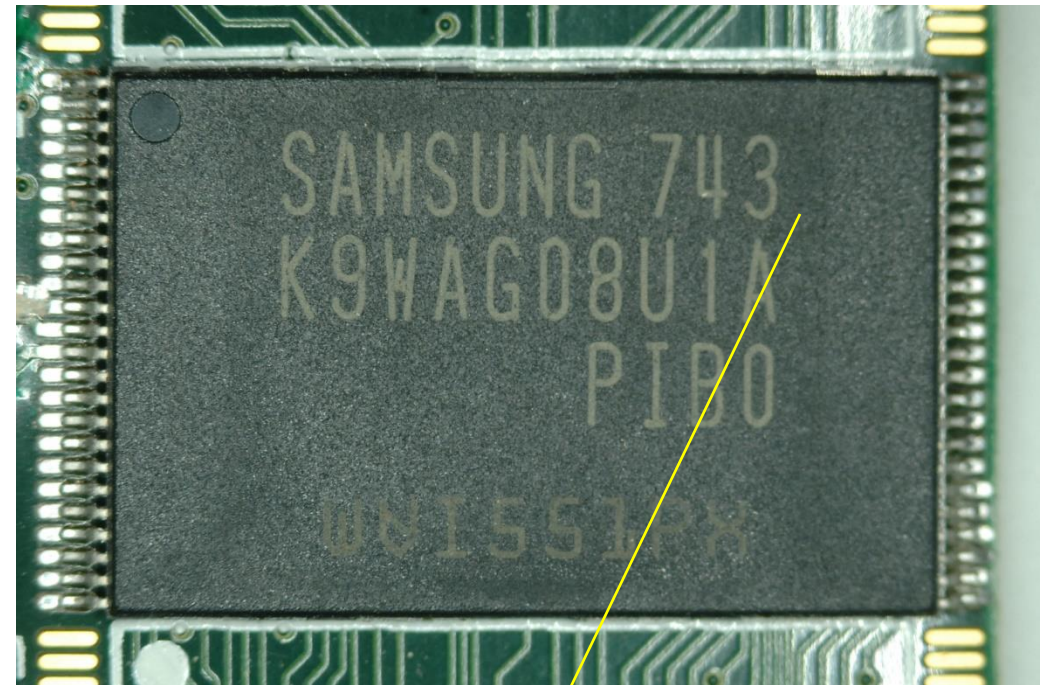
Micrographs of U1 and U3

Subtle crack

No cracks in U1, solder pads pulled from card
Very fine crack in overmold of U3

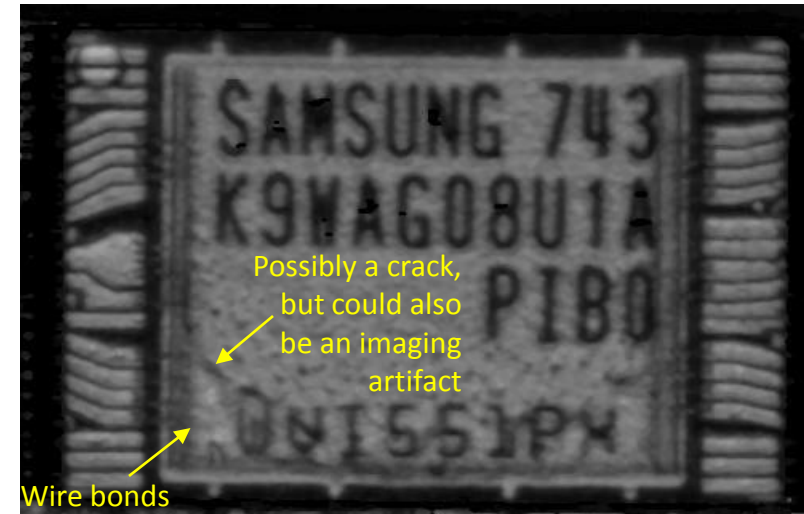
Module U1 C-SAMs

The anomaly may be a crack in the die, or an imaging artifact – overall, the top two chips appear to be intact (and very likely, the underlying ones as well)

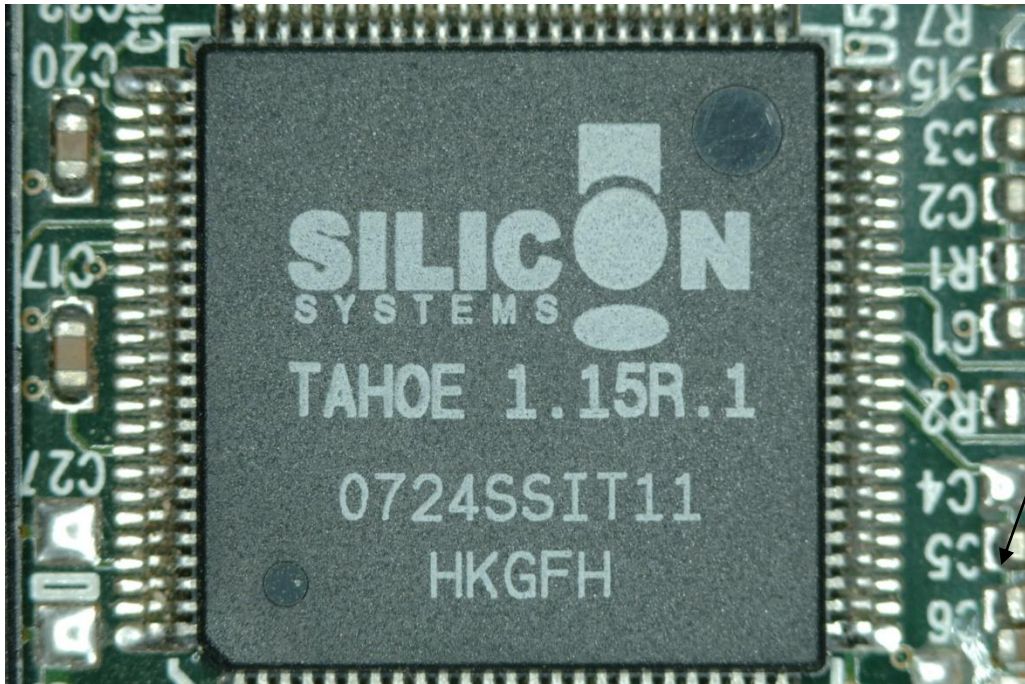
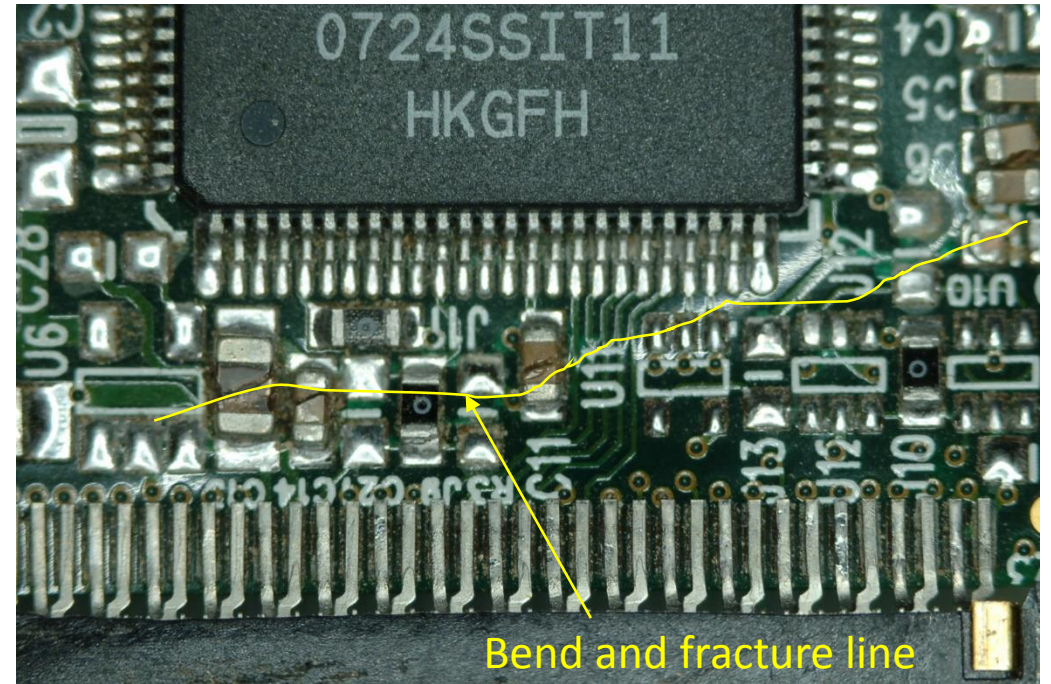
Micrographs of U5

No cracks in U5

Bend appears to miss module U5

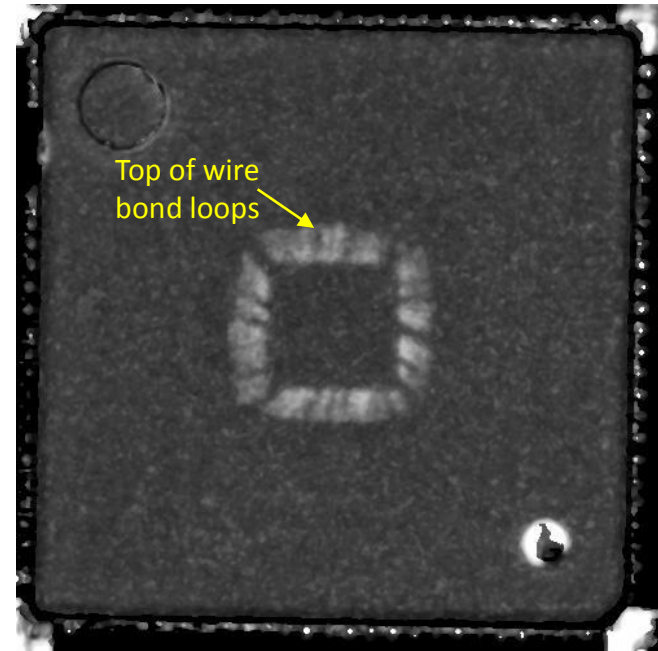
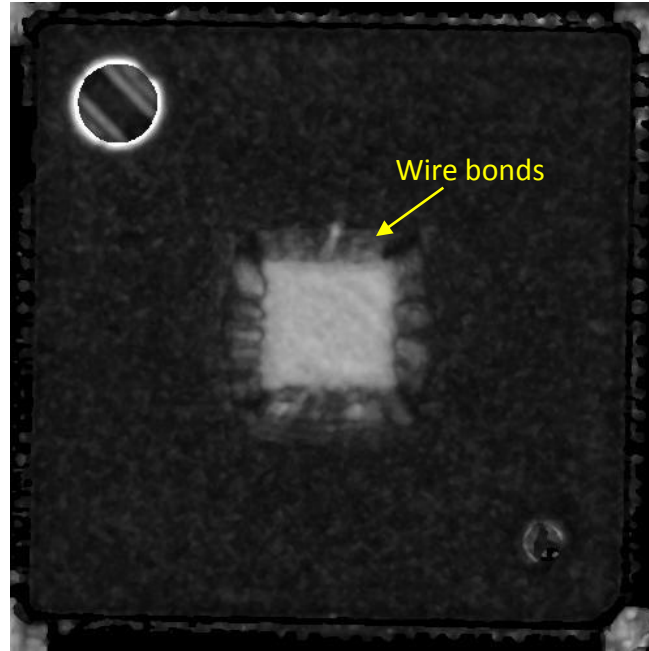
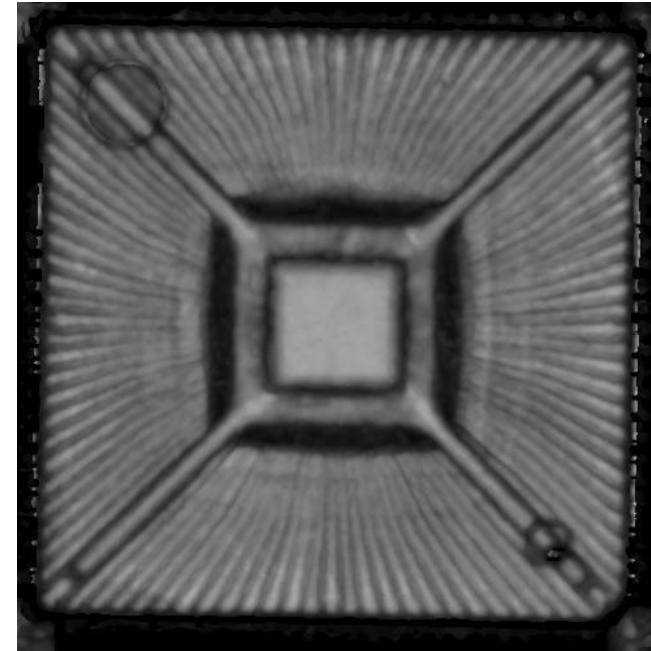
Module U5 C-SAMs

No evidence of cracking or delamination

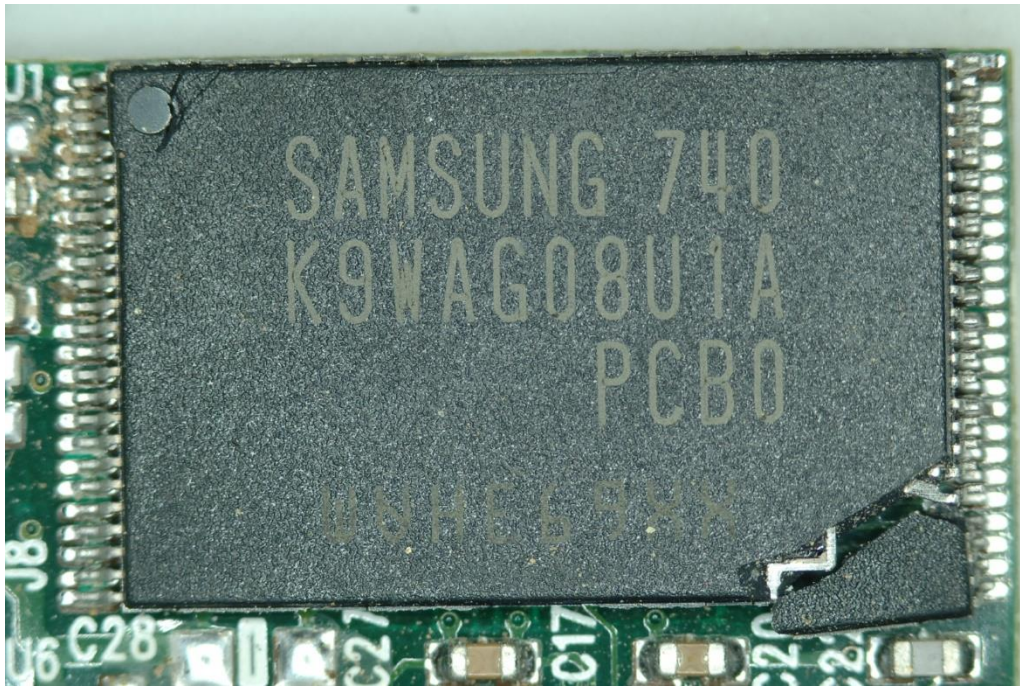
Micrographs of U1 and U3

Crack in U1 exposing internal features

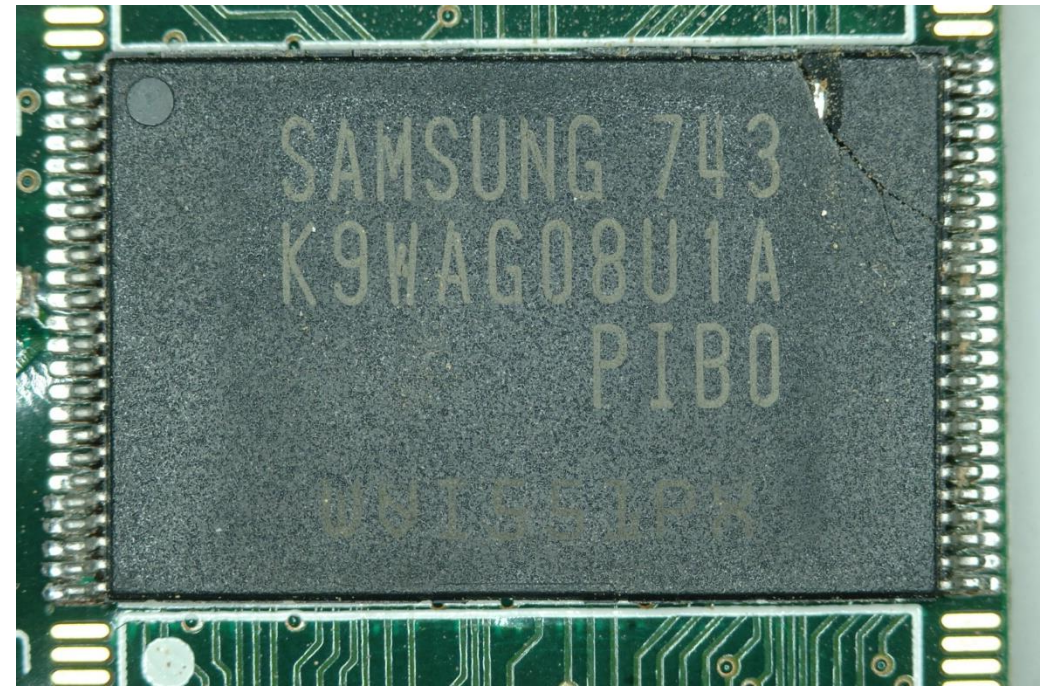
Crack in U3 exposing internal features

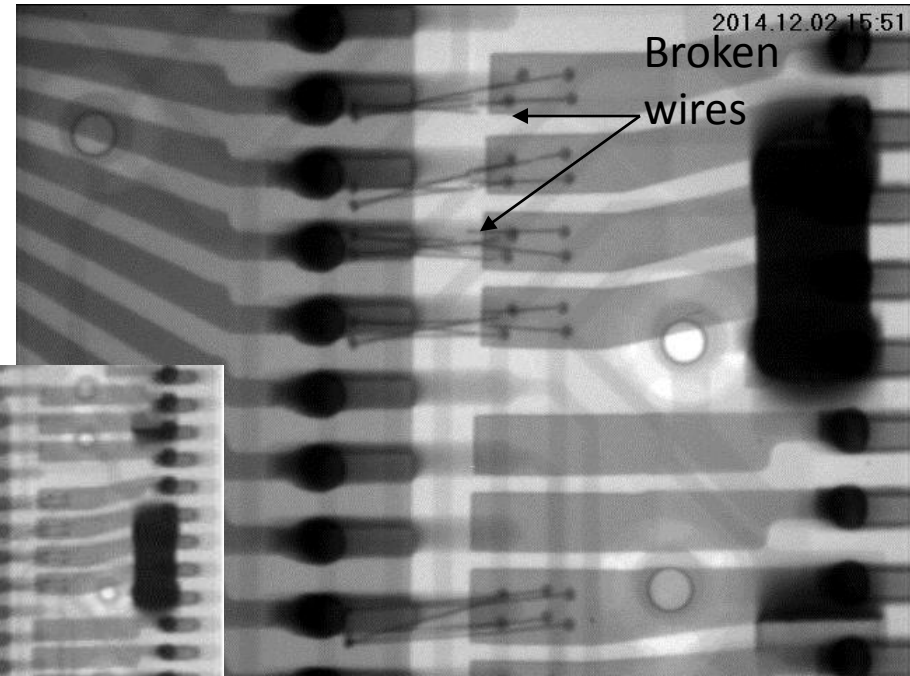
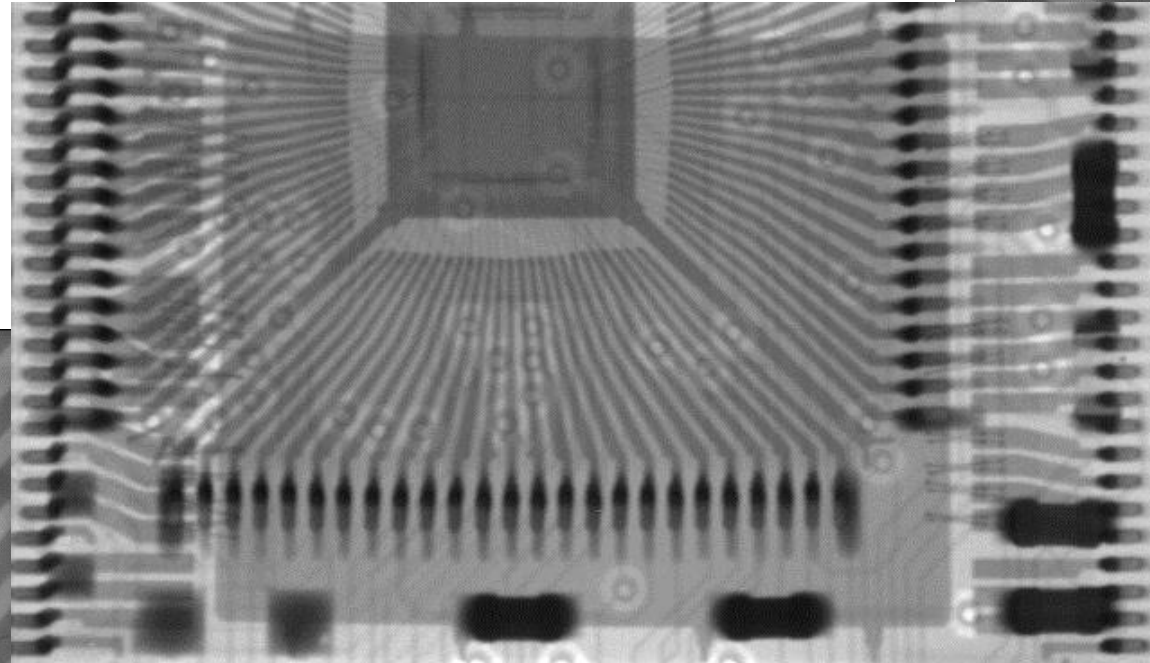
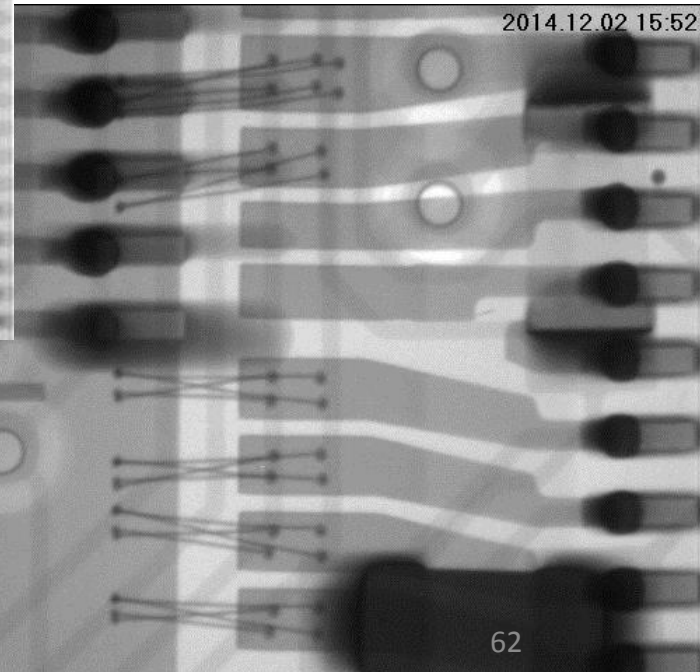
X-rays of U3

Broken wires were found in U3

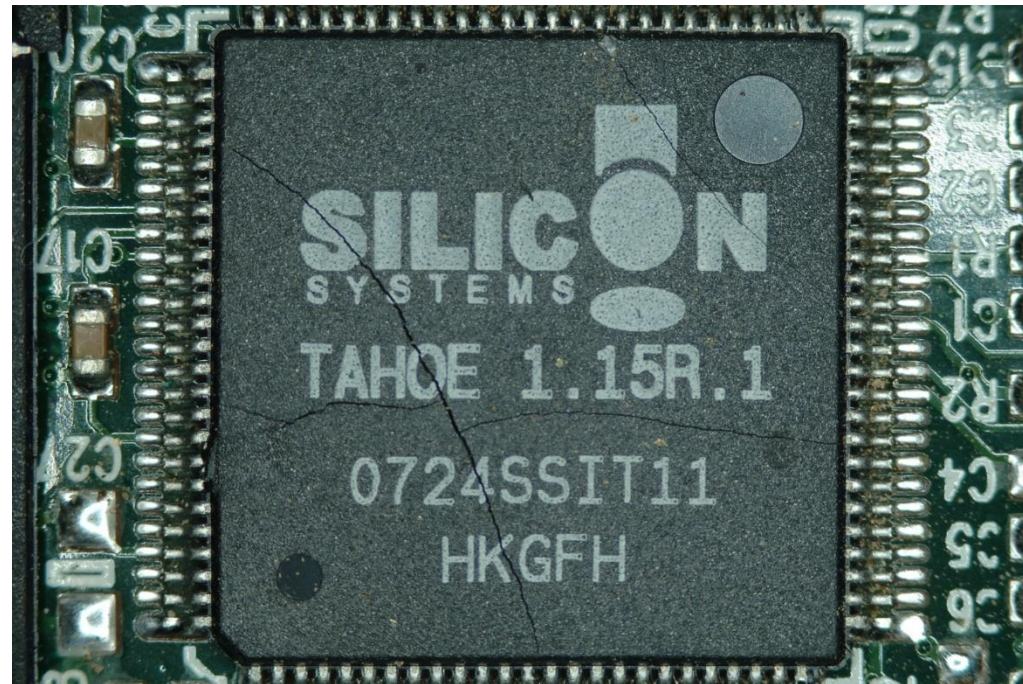
Micrograph of U5

Obvious cracks in U5

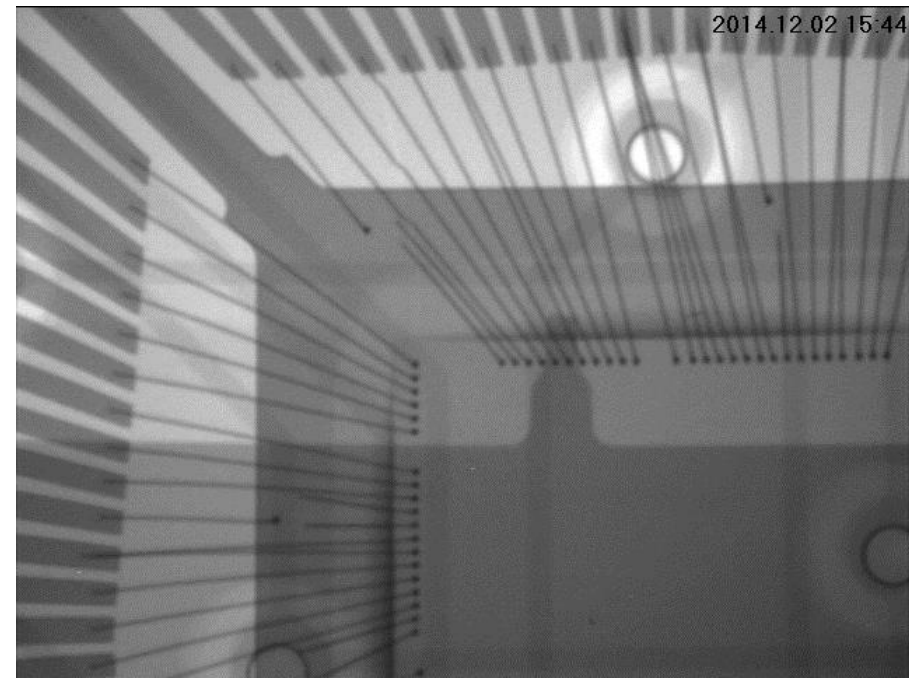
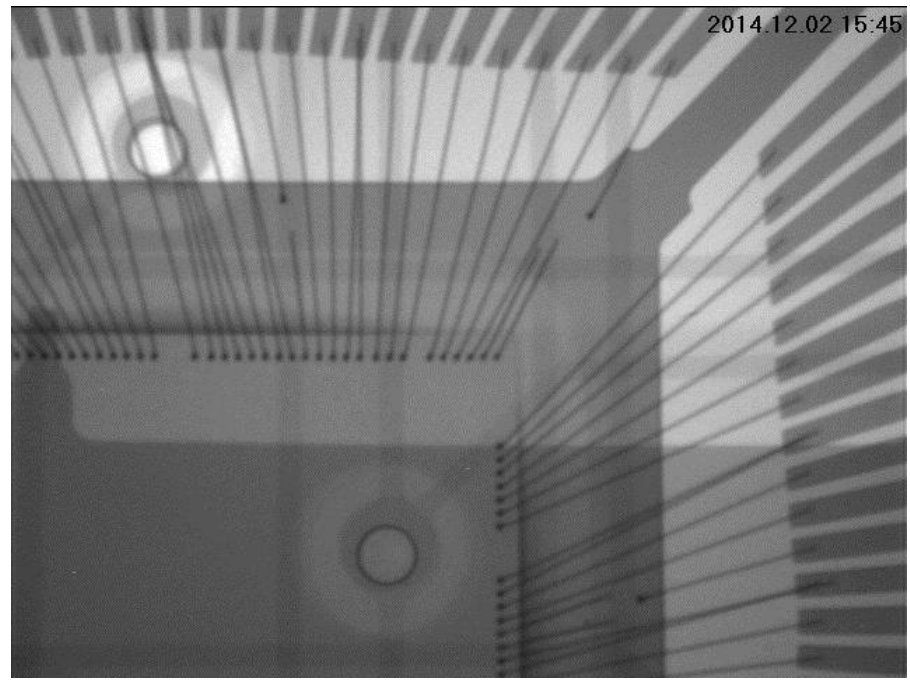
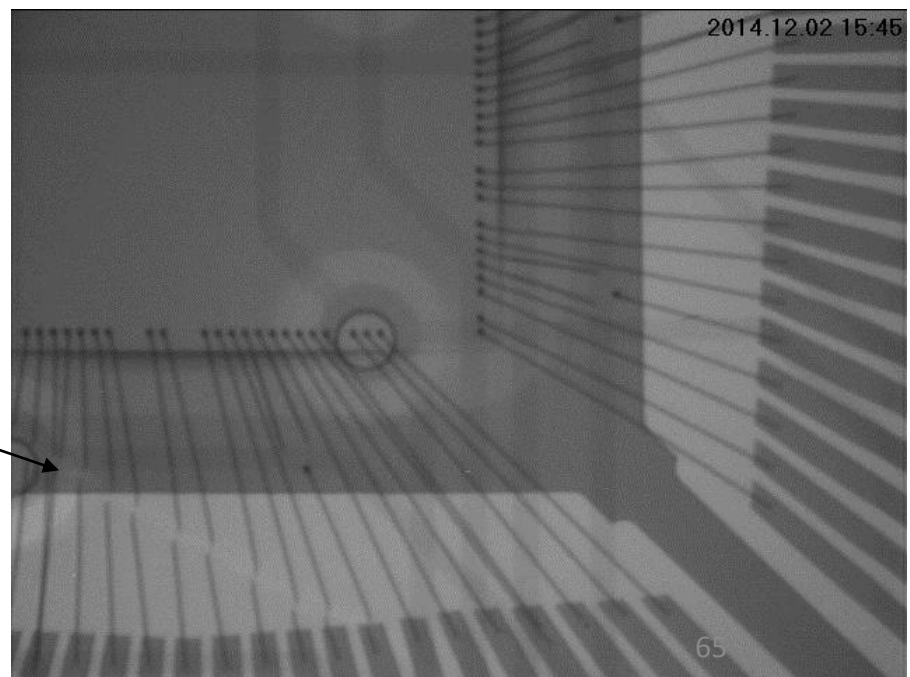
X-rays of U5

Broken wires found

Broken wires
