**NATIONAL TRANSPORTATION SAFETY BOARD
Office of Research and Engineering
Vehicle Recorder Division
Washington, DC 20594**

**GROUP CHAIRMAN'S FACTUAL REPORT OF INVESTIGATION
Electronic Recording Devices and Flight Data Factual Report
DCA15MA019**

Location: Koehn Dry Lake, California
Date: October 31, 2014
Vehicle: Model 339 SpaceShipTwo
Registration: N339SS
Operator: Scaled Composites
NTSB Number: DCA15MA019

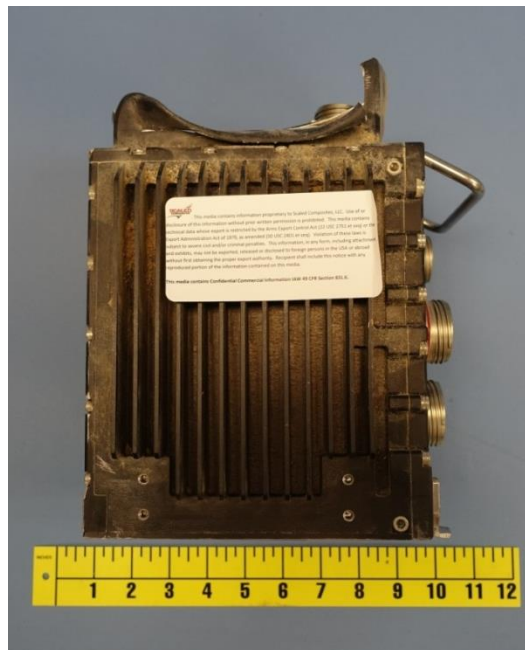
Figure 1. The RMC as recovered from wreckage site # 2¹.

The device was removed from the wreckage in one piece. The device exhibited heavy crush damage to the externally attached PCB⁶ board area on the top end of the device. Upon arrival at the laboratory, the area of crush damage was removed and the

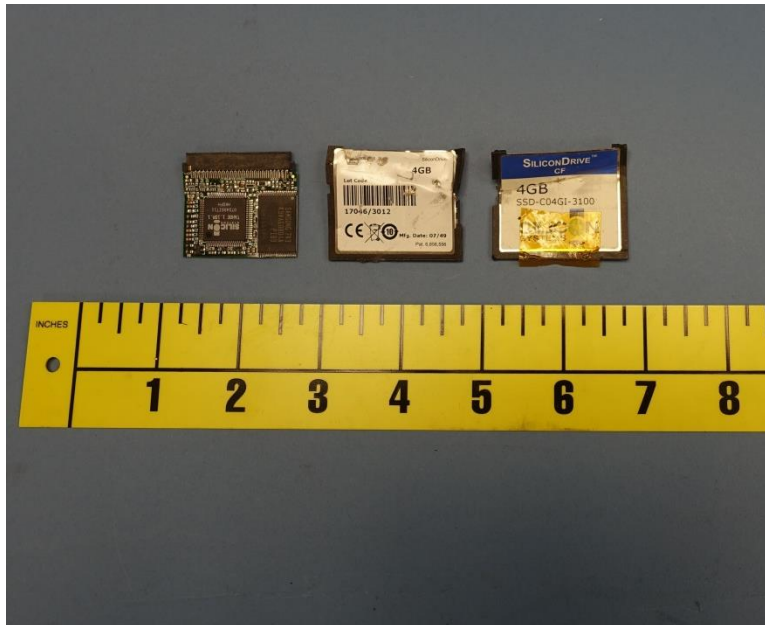
Figure 3. A Silicon Drive CF card located near the pilot's seat at wreckage site 4.

These items were sent to the Integrated Electronics Center (IEEC) at State University of New York (SUNY) - Binghamton for evaluation and possible recovery. According to the report, card 1 had a fine crack along the surface of the U3 chip but overall, the device had a "fair to good" likelihood of data retrieval. A readout in the NTSB lab using a forensic write blocker was unable to access the card's internal memory. No further readout attempts were made.

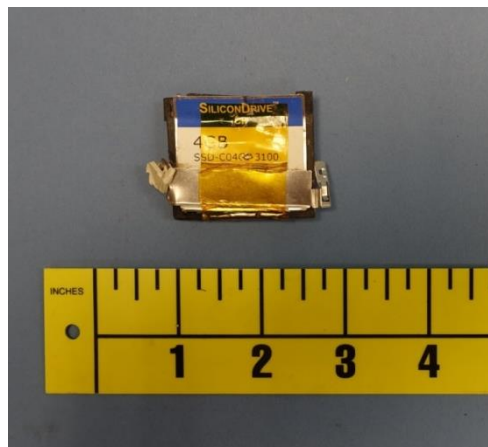
Figure 4. A Silicon Drive compact flash card found near wreckage site 4.

Evaluation of Compact Flash card 2 revealed that all three internal chips were cracked and broken wire bonds were found using C-SAM¹¹ and X-Ray microscopy. The report listed the likelihood of data retrieval as "poor". No further attempts were made to read the card at the NTSB laboratory.

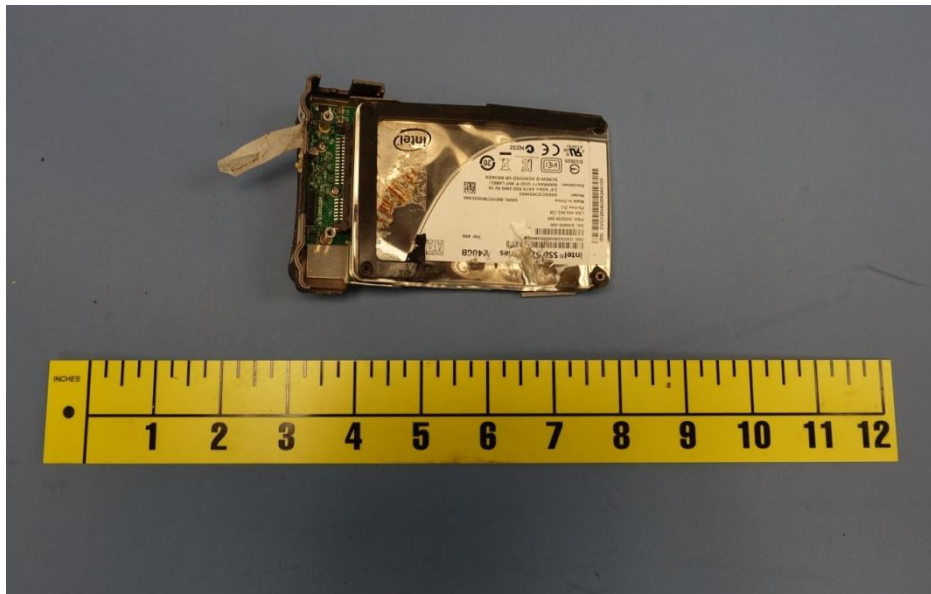
Figure 5. The "SS AFT CAM" Hard Drive as Recovered from the SS2 Wreckage.

Evaluation of the solid state hard drive "SS Aft Cam" revealed that the majority of the device's internal memory chips that comprise the solid state hard drive were cracked, in some cases through the respective chip's silicon die. The report listed an overwhelming majority of the internal chips as having a "poor" likelihood of recovery. No further recovery work at the NTSB laboratory was performed.

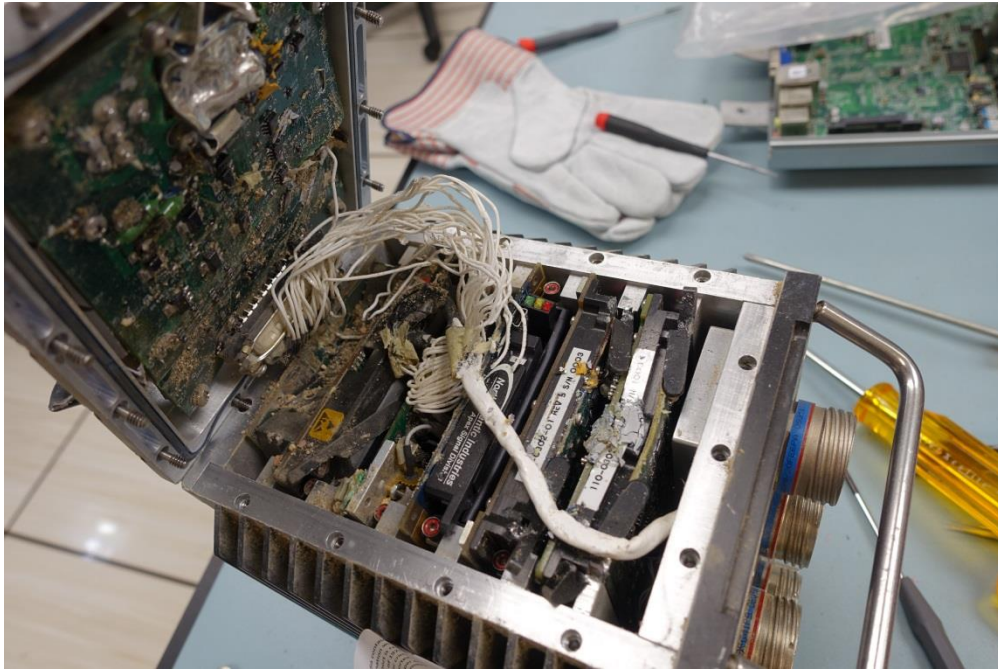
top panel was opened. An internal inspection revealed that minor crush damage was evident to each of the five internal component cards on the PCB side of the device (Figure 8). Working with Scaled Composites and the manufacturer of the internal cards, Aitech Defense Systems, the component card of interest (CP901) was identified and removed from the device (Figure 9). An inspection of the CP901 card revealed the crush damage had displaced numerous pins on the side of the board opposite the slot connector and that a screw and resistor had been displaced (Figure 10).

Figure 8. Crush damage exhibited to the five internal data cards.

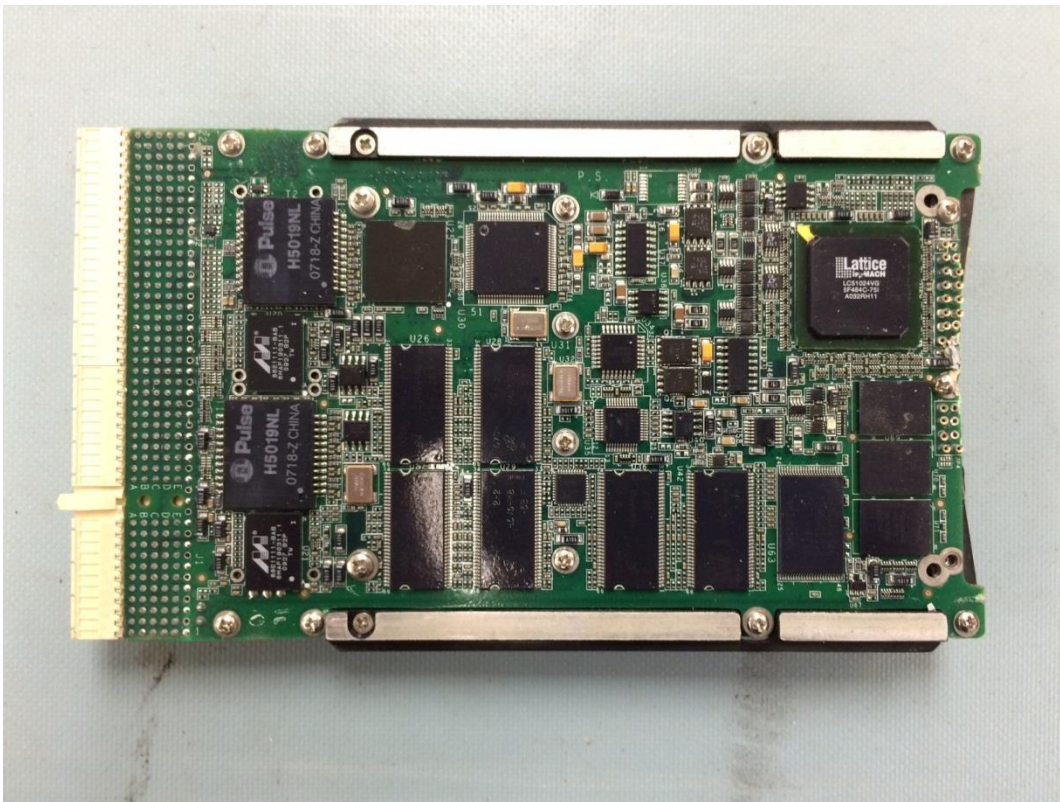
On December 18, 2014, the card was brought by an NTSB specialist to Aitech Defense Systems in Chatsworth, California for further inspection and read out. Upon arrival at Aitech Defense Systems, the card was inspected for damage by a production specialist. It was confirmed that the board contained damaged pins in the JP3 and JP4 region of the card and the subsequent displaced resistor was identified. A rework order was created and the damage was repaired by an Aitech laboratory specialist. The card was then put through an impedance test to verify that the card could safely be powered on a test board. The card passed the impedance test with only slight deficiencies noted and it was determined to be a low risk of data loss to apply power to the card in a test board. Power was applied to the card on a test board (Figure 11) and the card was unable to boot. It could not be ascertained why the card would not function properly in the test board.

The memory chip containing critical data was identified on the card as U66 and was removed from the board by an Aitech laboratory specialist. The chip was then placed on a CP901 test card. The CP901 test card was then placed in a laboratory chassis and was read out normally.

Figure 9. The CP901 card removed from the device.

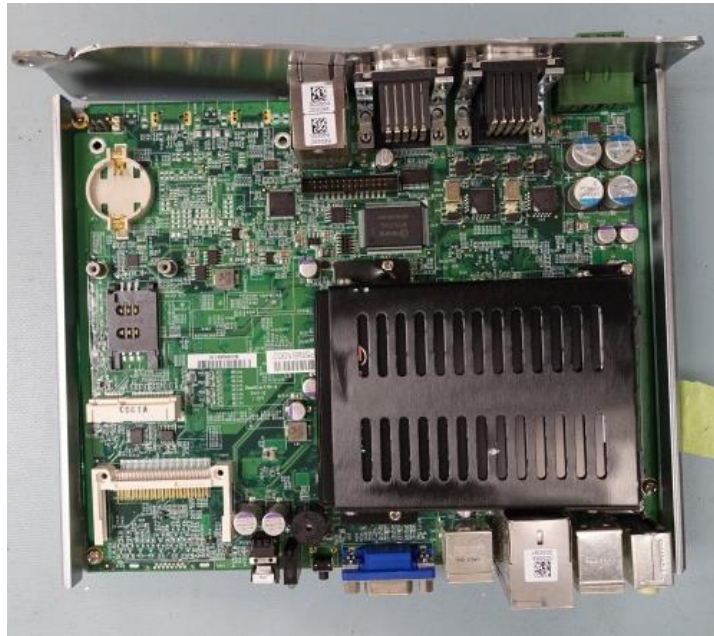
The device arrived with minor damage and structural deformation to the outer metal casing. The device's metal casing was removed for an inspection of its internal components. Minor structural deformation of the device's external connectors in relation to its main board was noted (Figure 12). Some minor structural deformation of the device's hard drive casing area was noted. The hard drive was removed from the device (Figure 13). The hard drive's plastic casing was removed for an internal inspection of the hard drive's components. The internal inspection revealed that four of the hard drive's SATA⁸ pins were lifted from their respective solder pads (Figure 14). The four lifted pins were repaired under a microscope with a soldering iron, and the hard drive was read out normally using a SATA forensic write blocker⁹. The readout revealed a PSC data log in a .SQLite¹⁰ format.

Figure 12. The PSC data logger with the external casing removed.

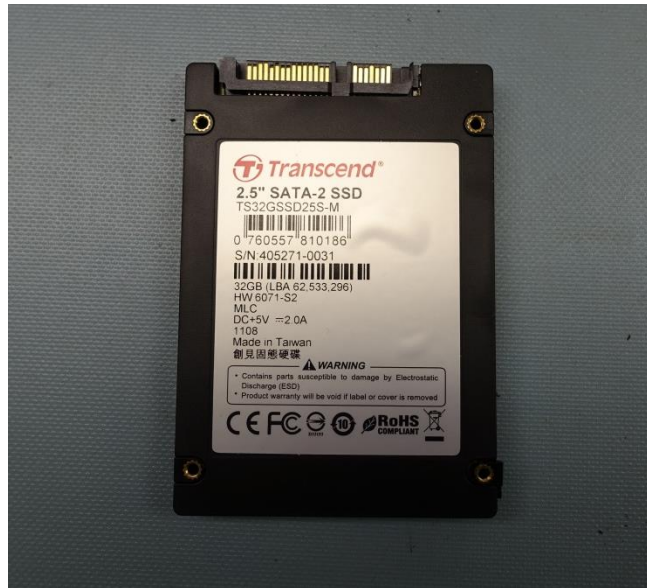
Figure 13. The PSC data logger's solid state drive in the condition it was extracted from the device.

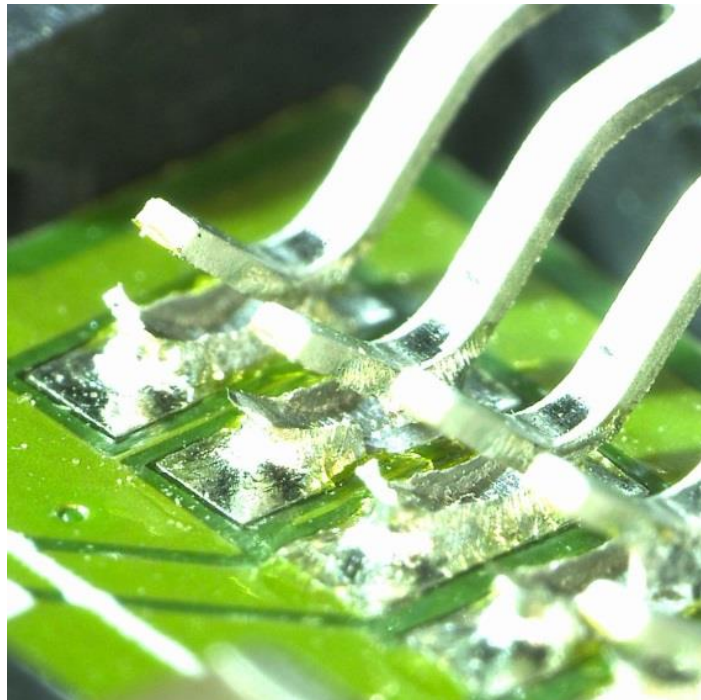
Figure 14. A stereoscopic image of the 4 lifted SATA pins on the solid state hard drive prior to repair at the NTSB laboratory.
