1 **NTSB Investigation of Tesla Model X collision with private home and post-crash fire**
2 **HWY17FH013**

22
23 **1. Emergency Response**

1.2. Orange County Fire Authority

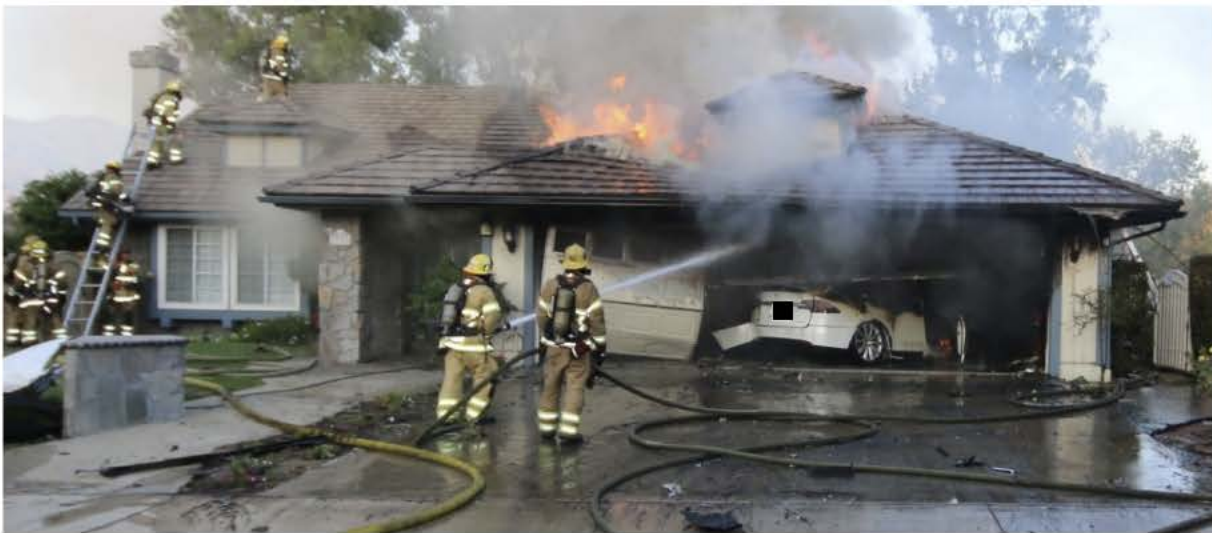
It was noted at 6:55 p.m. that the garage fire continued to grow. After the structural fire progress was stopped, the fire under the Tesla continued to re-ignite on and off until cooling measures were temporarily successful. It was reported by HR6 that the Tesla battery pack compromise was the primary source of fire. Figure 16 shows the house with the Tesla in the garage from a photo taken by the OCFA with a time stamp of 6:56 p.m. The fire in the upper portion of the garage appeared to be separate from the vehicle, but flames can still be seen at the bottom front end of the Tesla. Note that the photograph has been cropped from their original form.

Figure 1: Residence and Tesla at approximately 6:56 p.m. (source: OCFA)

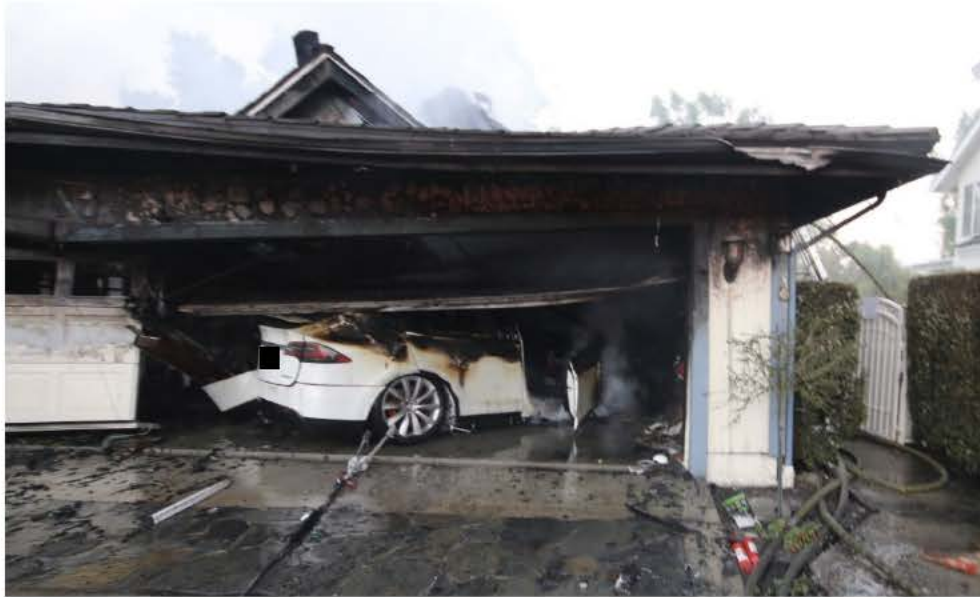
Notification of building officials and utility company occurred from 7:03 p.m to 7:10 p.m. HR6 placed two spot shores under the sagging garage headers to stabilize the wall of the garage. B7 responded with All Clear on the garage and residence at 7:17:52 p.m. Once the building was stabilized, focus turned to the removal of the Tesla. Figure 17 shows a view of the garage and Tesla with a winch cable connected to the right rear wheel of the Tesla, and the photograph was taken by the OCFA with a timestamp of 7:26 p.m.

Figure 2: Garage and Tesla at approximately 7:26 p.m. (source: OCFA)

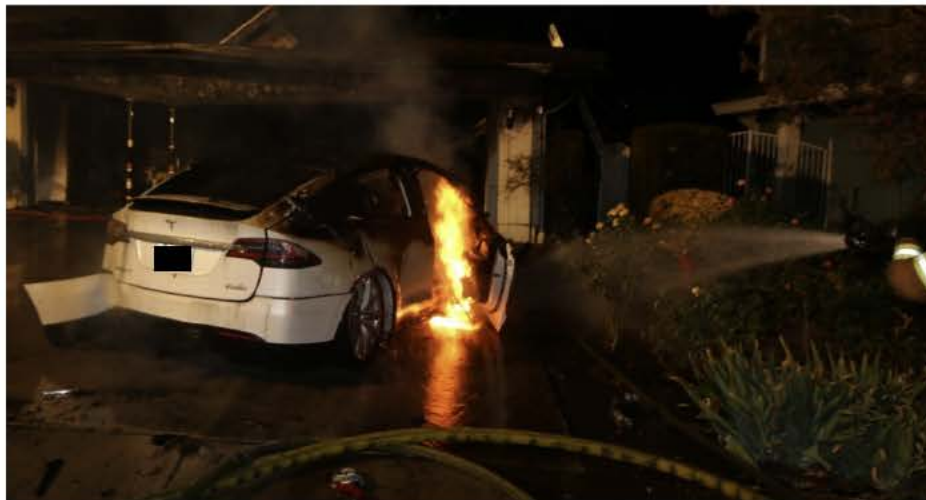
At 8:04 p.m. the Tesla had been removed from the garage with the winch on HR6, and the Tesla battery was noted as still on fire. The structure was still deemed unsafe to enter by the Incident Commander. Figure 18 shows the Tesla as photographed by the OCFA at approximately 8:05 p.m. The vehicle was now on the driveway and has fire emanating from the bottom of the car.

Figure 3: Tesla at approximately 8:05 p.m. (source: OCFA)

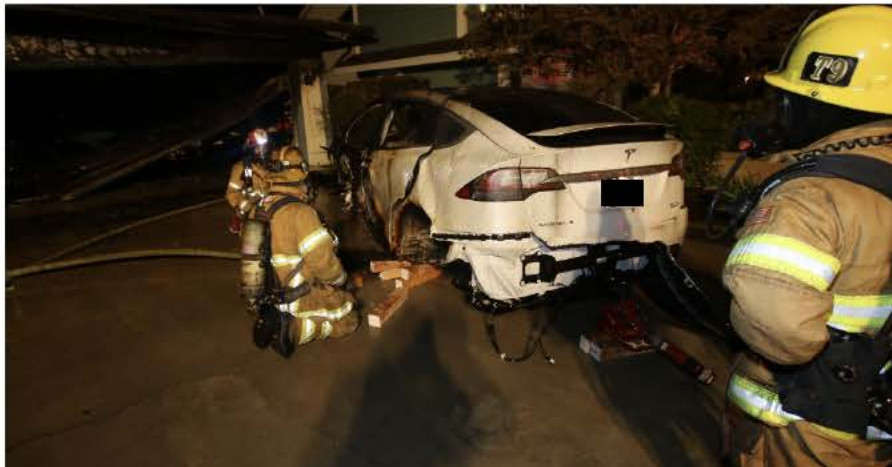
When it was extinguished, a skid steer was requested at 9:02 p.m. for use in accessing the underside of the car, however the estimated arrival time for this equipment was 1.5 to 2 hours. Instead, Fire Fighter (FF) propped up the car with cribbing blocks and a floor jack. The skid steer did arrive later and was used to reposition the Tesla as well as the other car that was in the garage during the collision. Figure 19 shows the Tesla being cribbed up in a photograph taken by the OCFA at approximately 9:13 p.m.

Figure 4: Tesla at approximately 9:13 p.m. (source: OCFA)

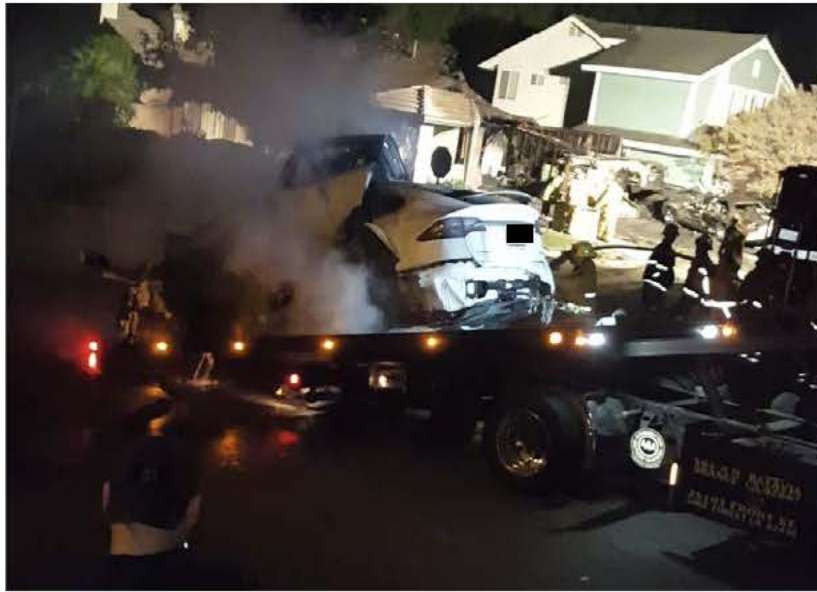
The Southside Towing dispatch log (shown in section 3.2 of this report) indicated that they received the call to tow the Tesla at 10:40 p.m., and the tow truck arrived at 11:09 p.m. The IC noted that the Tesla began to smoke again, as the vehicle was being loaded onto the tow truck. Figure 120 shows a still image frame of a cell phone video taken by a Southside Towing worker, which shows a view of the Tesla on fire while partially loaded onto the tow truck. This still image shows the vehicle mostly on the flatbed, with the bed near the ground.

151 Figure 5: Tesla reignited on the flatbed towtruck. (source: OCFA)

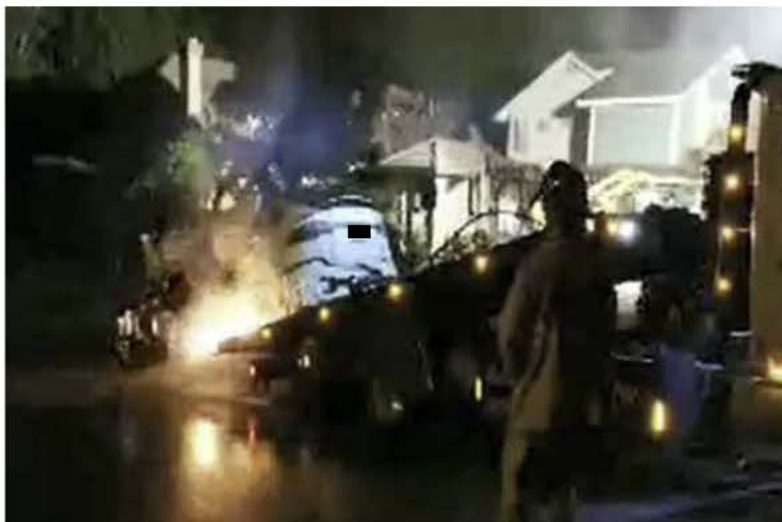
152 As described by the tow truck driver, the Tesla was raised in elevation and the Tesla
153 unloaded further off the flatbed in order to open up space underneath the car for better application
154 of water. Figure 21 shows a still image from a video taken by an OCSD officer of the same event.
155 This image is later in time, and shows the Tesla further off the truck with the flatbed raised.

158 Figure 6: Tesla reignited on the flatbed tow truck. (source: OCSD)
