SERVICE BULLETIN

FLIGHT CONTROLS – INSTALLATION OF AN ALERTING PLACARD ABOUT MAXIMUM SPEED TO PITCH-TRIM AFTER TAKEOFF

FLIGHT CONTROLS - MODIFICATION OF THE ELEVATOR FORWARD CONTROL SYSTEM TO COMPLY WITH 18-DEGREE FLAP IMPLEMENTATION

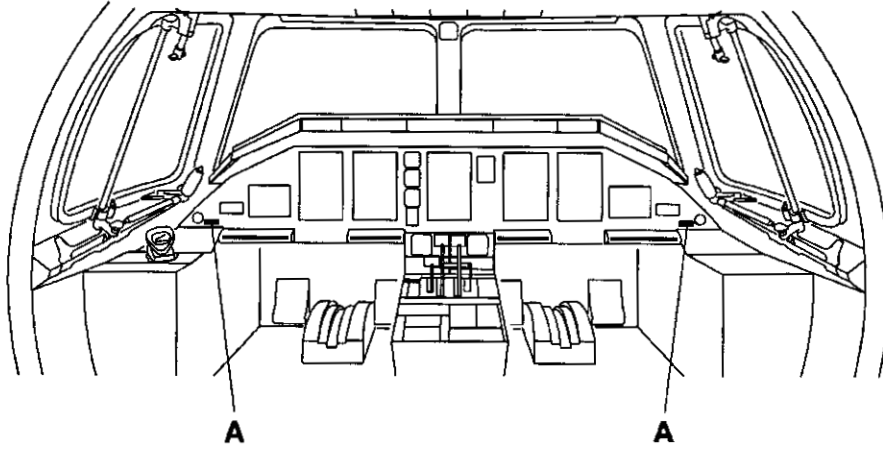
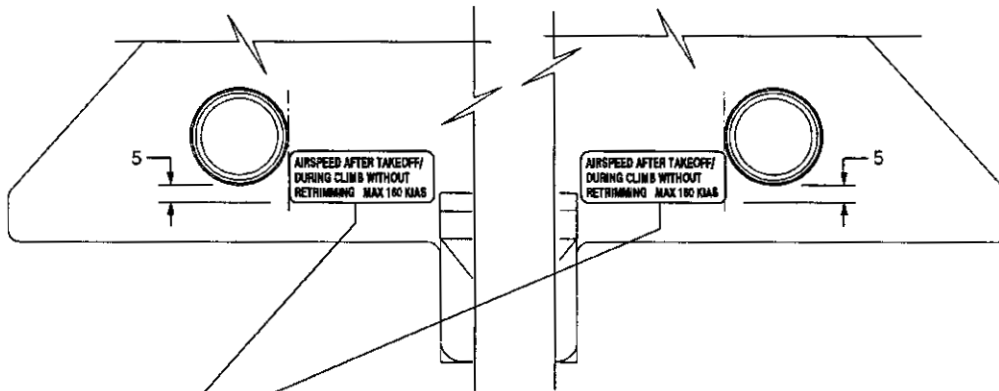
**FIGURE 1: INSTALLATION OF THE PLACARDS
(SHEET 01 OF 01)**

Instances have been reported concerning the occurrence of temporary loss of pitch trim command after takeoff / during climb phase.

**AIRSPPEED AFTER TAKEOFF/
DURING CLIMB WITHOUT
RETRIMMING MAX 160 KIAS**

1. Make sure that the aircraft is safe for maintenance.
2. Install placards P/N 145-46718-001 (2 positions) on the main instrument panel by using adhesive tape P/N YR-9625. Refer to figure 1 or figure 2, according to the aircraft panel configuration, as well as to instructions in the applicable "Aircraft Maintenance Manual" – Chapter – 20-12-01 – Standard Practices – Airframe.
3. Restore the aircraft to normal.
4. Enter the accomplishment of this bulletin in the applicable document.

PLACARD
P/N 145-46718-001
(INSTALL)

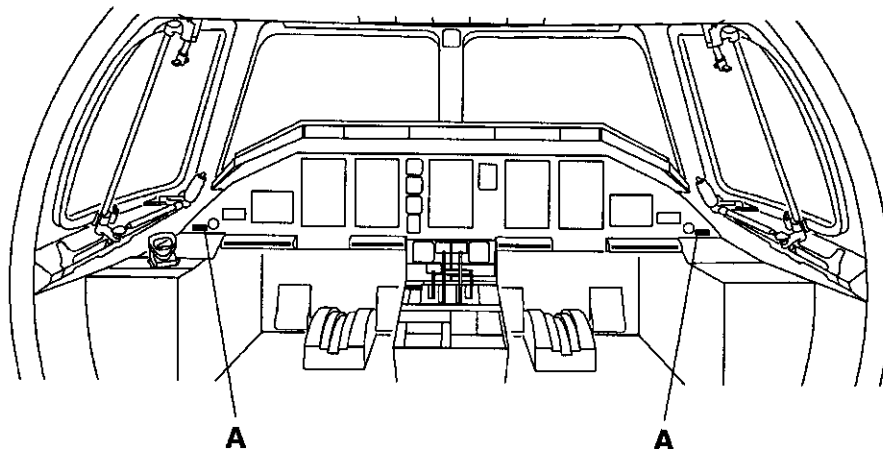
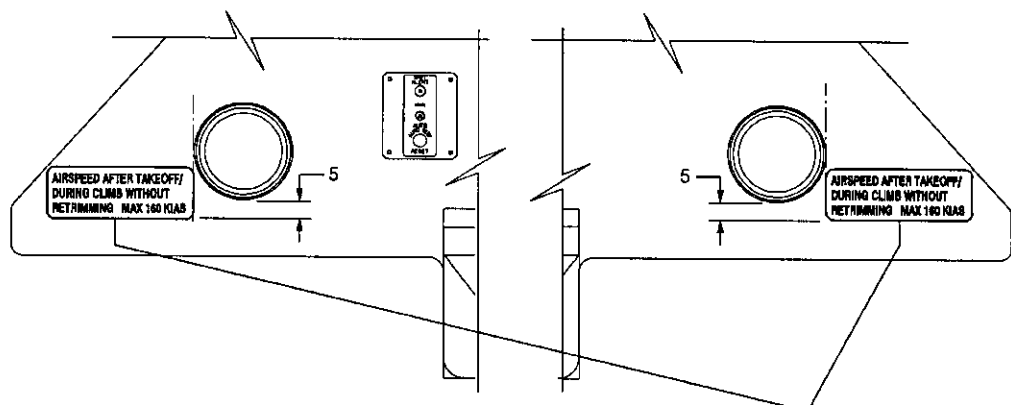
FIGURE 2: INSTALLATION OF THE PLACARDS
(SHEET 01 OF 01)

**AIRSPEED AFTER TAKEOFF/
DURING CLIMB WITHOUT
RETRIMMING MAX 160 KIAS**

PLACARD
P/N 145-46718-001
(INSTALL)

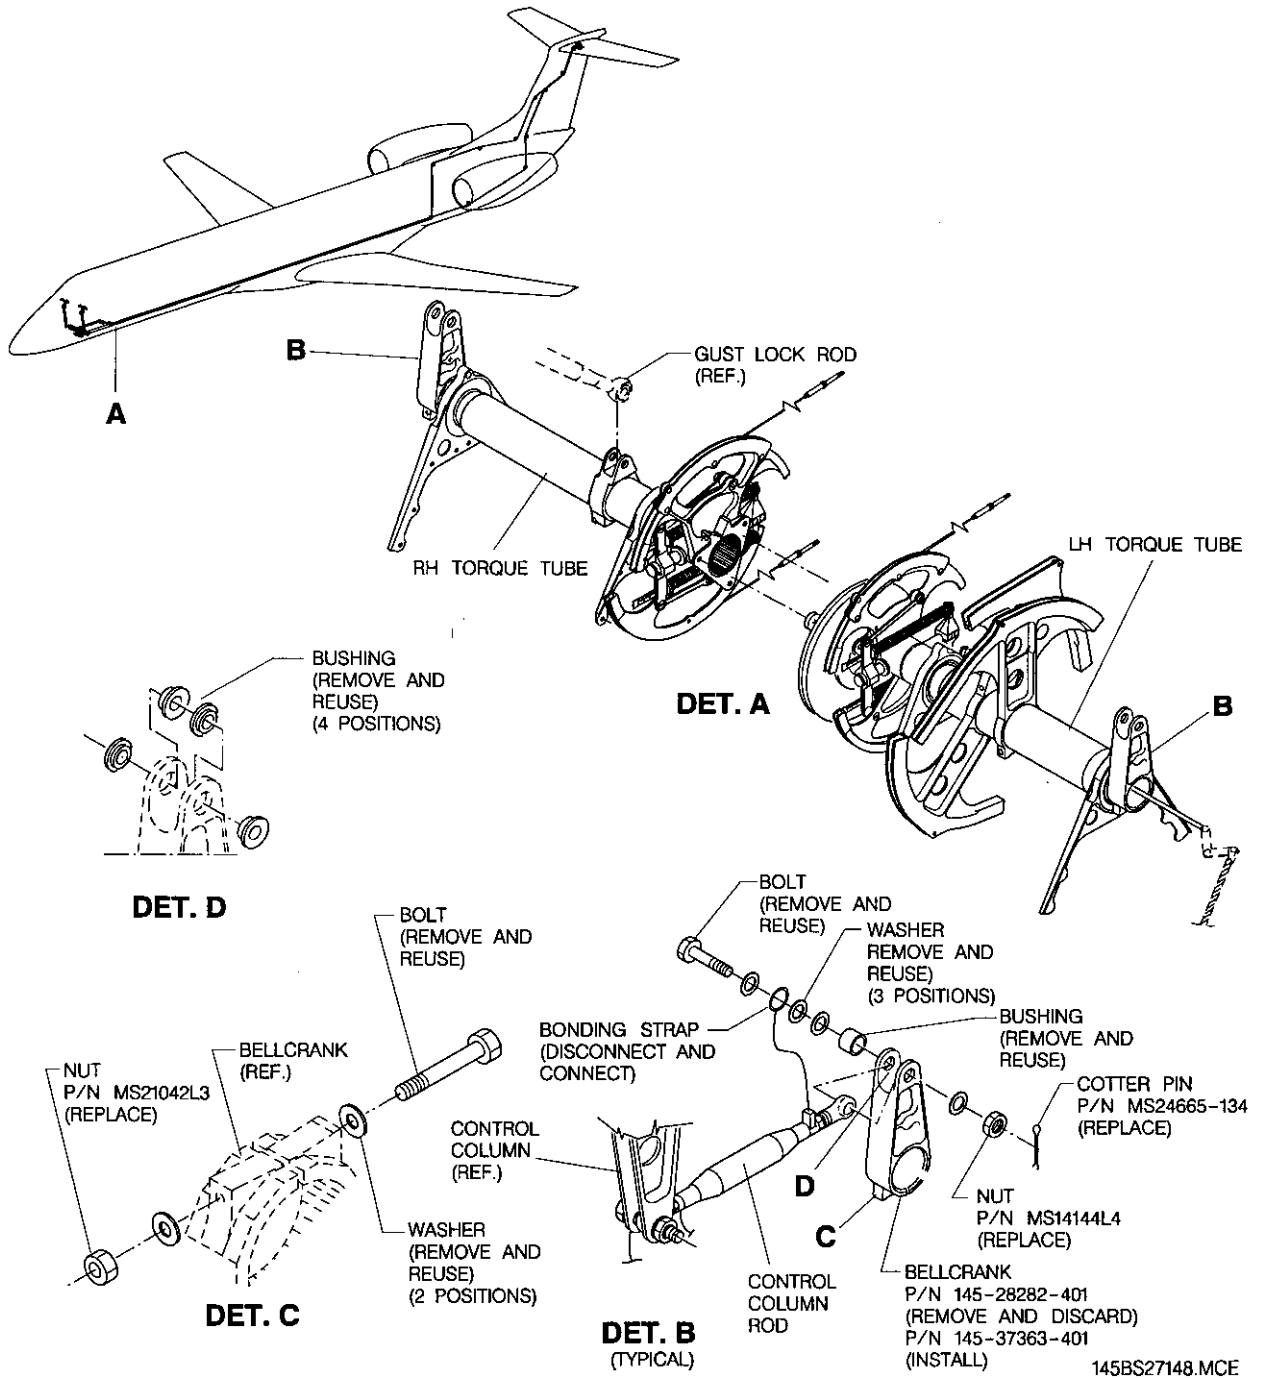
**FIGURE 4: REPLACEMENT OF THE BELLCRANKS
(SHEET 1 OF 1)**

During the 18-degree Flap development for takeoff, it was observed that this flap configuration requires a greater effort for the pilot to level the aircraft.

So, in order to reduce this effort, the elevator forward torque tube is being modified.

- K. Disconnect the end of the control column rods from the bellcrank at the LH and RH forward torque tube quadrants, by removing the cotter pin, nut, washers, bushing, bonding strap and bolt according to FIGURE 4.

- L. Replace bellcrank P/N 145-28282-401 from LH and RH forward torque tubes with bellcrank P/N 145-37363-401, according to FIGURE 4.
- M. Install rig pins on the LH and RH forward elevator torque tubes.
