**EMBRAER S.A. SUBMISSION Re- 505-0089
[C-GJOL] / RUDDER GUST LOCK ACTUATOR FAILURE at
PALM SPRINGS AIRPORT NOVEMBER 23, 2014**

This document presents a description of the EMB-505 Gust Lock System, and a technical analysis of the event with aircraft 505-0089 in Palm Springs, on November 23, 2014. This document also presents the actions taken by Embraer to reduce the possibility of similar events.

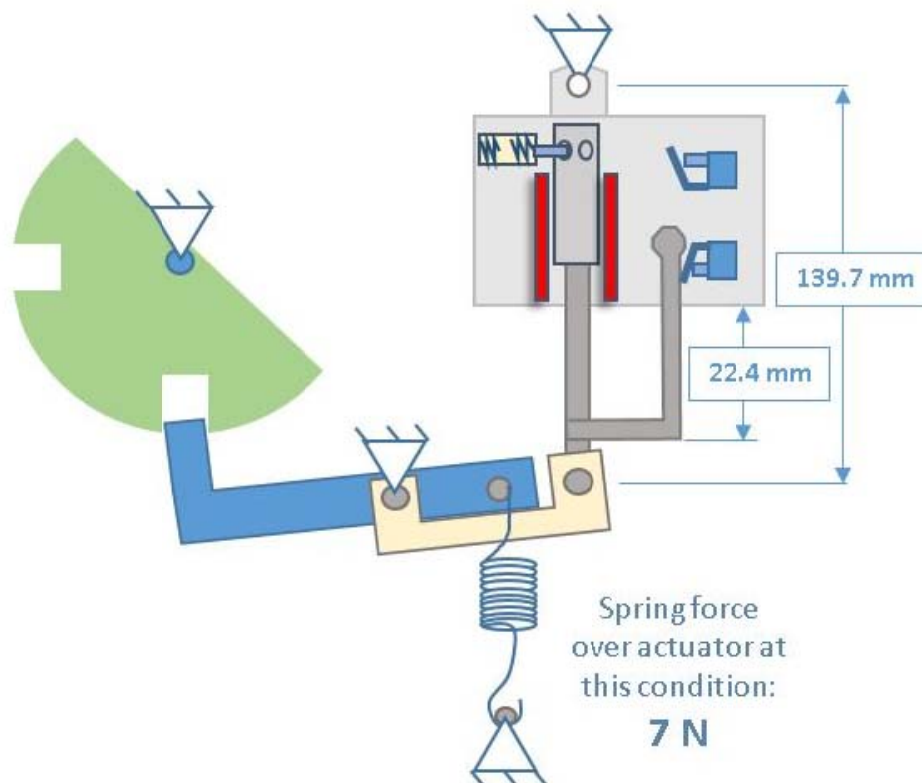
Figure 11: Probable mechanism condition during taxi and flight

1. The gust lock actuator had failed in a position that would lock the rudder surface with a deflection of approximately 12 degrees.

This statement is in accordance with gust lock actuator removed from aircraft 505-00089 after the incident, as it was found almost fully extended.

Gust lock mechanism condition was most likely as illustrated in **Erro! Fonte de referência não encontrada..** The actuator had probably failed in one of the two conditions:

- during actuator extension, when the gust lock was activated after the previous flight; or
- during actuator retraction, when the locking pin was removed before the flight where the incident occurred.

As the actuator was found in an intermediate position, there are two possibilities:

2. The actuator failed during extension or retraction, stopping at the found position. This scenario requires a single solenoid failure. The solenoid is energized while the actuator is moving; if it fails, the plunger will be released and lock the ball nut.

A solenoid failure during actuator movement seems a more plausible scenario: if during actuator retraction (or extension) the solenoid fails to hold the plunger, it will stop actuator movement. In this scenario, the motor would continue to be energized and trying to move actuator, but with an unexpected high load, causing the motor to overheat. In addition, it is more likely to have a solenoid failure while it is energized, which happens when the actuator is commanded to retract/extend.

As the plunger was found engaged exactly in a ballnut hole, it is more likely that it engaged during actuator movement than while the motor was stopped.

Embraer opted to replace the EMB-505 gust lock actuators through a retrofit campaign. Embraer Service Bulletin 505-27-0017/00 was issued on January 30th, 2014. By September 2016, 95% of EMB-505 fleet had incorporated the new gust lock actuator, which has the same Part Number as the actuator used on the ERJ-145 family and which has a successful operational history and simplified architecture – irreversible jack screw actuation with- out a solenoid/plunger.

After the incident in Palm Springs, Embraer developed a caution CAS message "RUD GUST LOCKED" to increase the crew situational awareness by indicating that the gust lock is engaged. In normal operation, this CAS message will be displayed whenever the gust lock pin is inserted. When gust lock pin is removed and the gust lock is actually disengaged, the CAS message will go away.

If the gust lock actuator fails in an extended position, the CAS message will remain active. Per the revised MEL the aircraft cannot be dispatched with the CAS message active.
