**NATIONAL TRANSPORTATION SAFETY BOARD**  
**Office of Aviation Safety**  
**Washington, D.C. 20594**

**EMERGENCY FLOTATION SYSTEM GROUP FACTUAL REPORT**

**NTSB No: ERA18MA099**

Operator: Liberty Helicopters, Inc.  
Aircraft: Airbus Helicopters AS350 B2, Registration N350LH  
Location: New York, New York  
Date: March 11, 2018  
Time: 1908 eastern daylight time

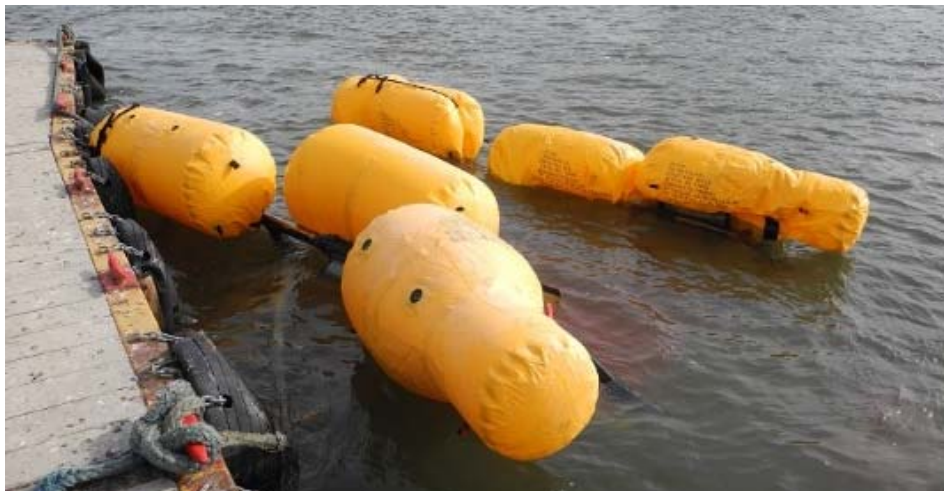
**Figure 3. The six visible floats while the helicopter remained inverted in the East River.**

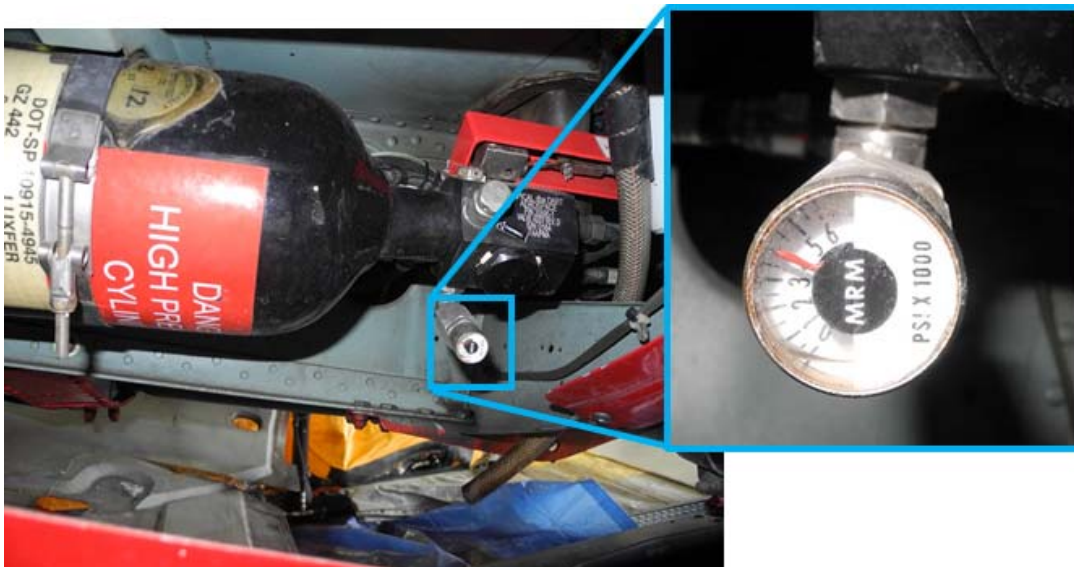
The right reservoir assembly was found in its normally installed location. The forward loop clamp was about 6 inches from the neck of the right cylinder. The right reservoir assembly gauge was visible and indicated about 4,000 psi (**Figure 4**). A sticker on the right reservoir showed the following information: right valve S/N 0101; and right cylinder S/N GZ442.<sup>3</sup>

**Figure 4. The right reservoir assembly showing the pressure gauge indicating about 4,000 psi.**

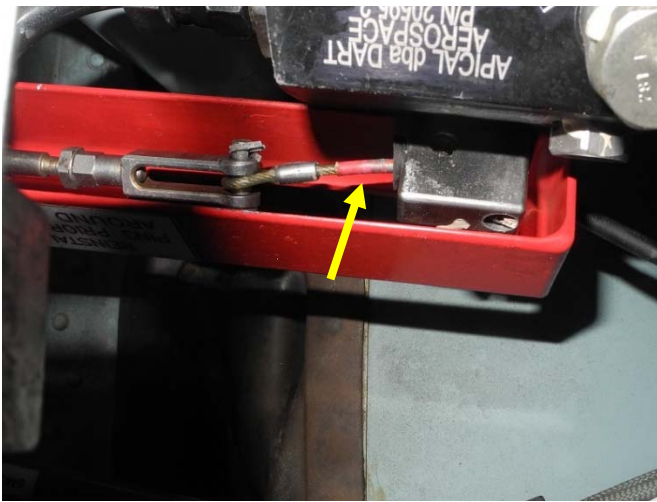
The left valve and shroud remained installed on the cylinder. About 3/4 inch of the left valve cable, red in color, was visible (**Figure 5**); this measurement was taken from the silver-colored valve body to the aft end steel sleeve on the cable. The left valve cable remained connected to the clevis of the aft-upper pull cable from the junction box. The right valve and shroud remained installed on the reservoir. About 5/16 inch of the right valve cable was visible (**Figure 6**); this measurement was taken from the silver-colored valve body to the aft end of the steel sleeve on the cable. The right valve cable remained connected to the clevis of the aft-lower pull cable from the junction box.

**Figure 5. The left valve assembly. The yellow arrow points to the valve cable.**

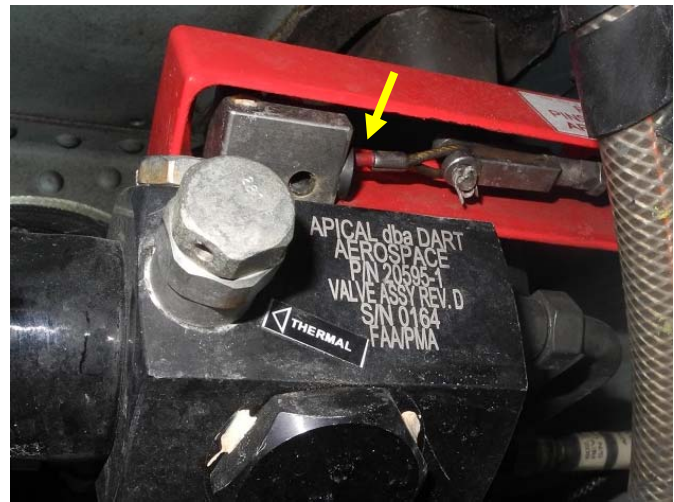
**Figure 6. The right valve assembly. The yellow arrow points to the valve cable.**

A safety pin was inserted into the right valve assembly by the investigation group in order to prevent inadvertent activation of the valve during the wreckage documentation.

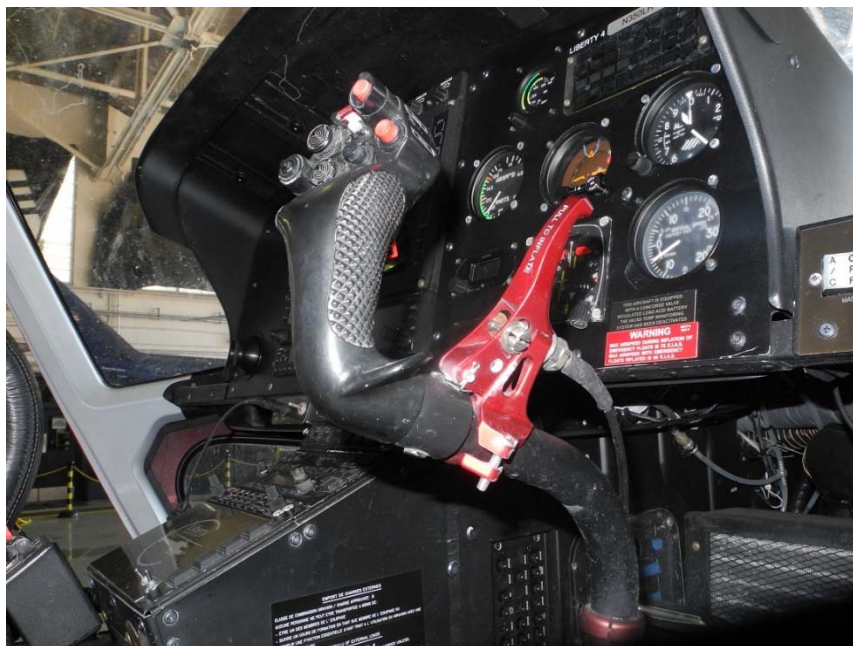
The activation handle remained installed on the pilot cyclic stick (**Figure 7**). The activation handle shear pin was not present. The pull cable routing was continuous from the activation handle to the junction box. The junction box remained attached to the outboard side of the left frame rail and its cover remained attached with safety wiring between cover screws. The aft-upper and aft-lower cables were seen exiting the junction box and their routing were continuous to the left and right valves, respectively. The exterior cover (sheathing) of the pull cables did not exhibit evidence of anomalous damage.

**Figure 7. The activation handle installed on the cyclic control.**

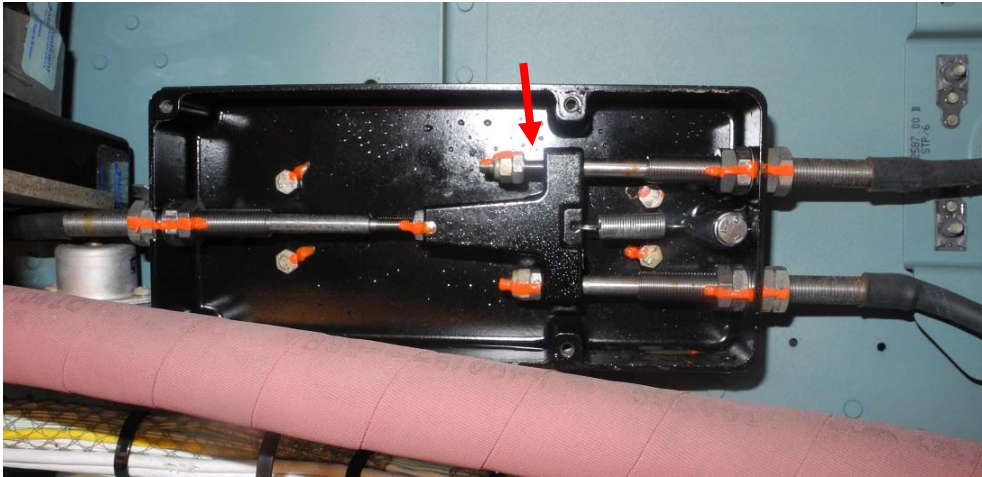
The junction box cover screws and cover were removed, revealing the dual cable block and its pull cable connections (**Figure 8**). The forward pull cable, leading to the float activation handle, the aft-upper cable, aft-lower cable, and spring remained attached to the dual cable block. For the aft-upper cable, there was a gap of about 0.25 inches between the nut and the block surface. For the aft-lower cable, there was no apparent gap between the nut and the block surface to which the nut contacts. Orange-colored torque striping was present on all nuts within the junction box.

**Figure 8. The junction box after removal of its cover. The red arrow points to the gap observed between the aft-upper cable nut, leading to the left reservoir assembly, and the dual cable block.**

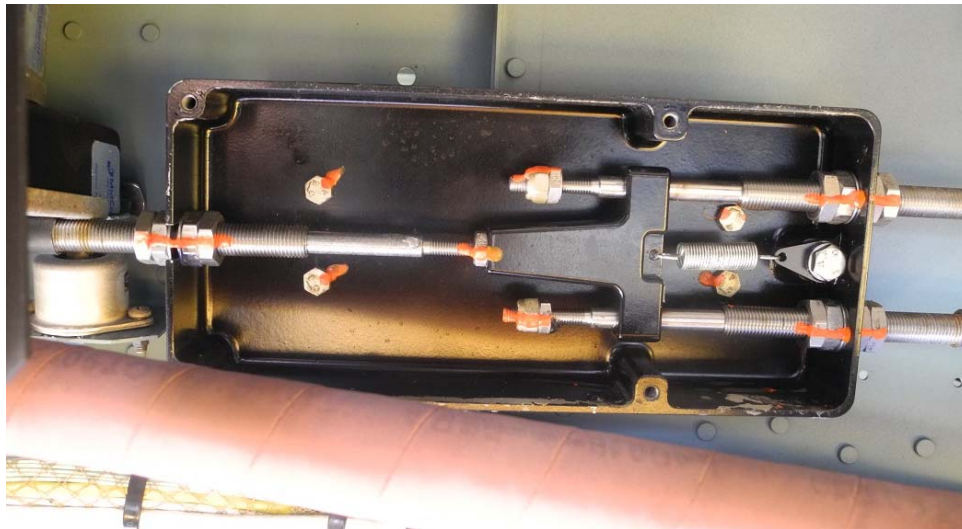
The aft-lower pull cable to the right valve was disconnected (by the group) from the right valve cable clevis connection by removing the pin. When attempting to remove the clevis pin securing the clevis connection between the aft-upper pull cable and the left valve cable, the latter came out of its shroud, consistent with prior activation of the left valve. After both pull cables were disconnected from the left and right valves, a continuity check of the pull cables was performed by pulling the float activation handle and simultaneously observing the dual cable block and the aft-upper and aft-lower pull cable clevis connections. Continuity of the pull cable mechanism from the activation handle to both clevis connections was confirmed. Movement of the activation handle was smooth with no evidence of binding. When the activation handle was released, the handle returned to its starting position; the dual cable block also returned to its starting position due to the spring between it and the junction box. A gap of about 0.75 inches was observed between aft-upper cable nut and the block surface. An identical gap of about 0.75 inches was observed between the aft-lower cable nut and the block surface (**Figure 9**).

**Figure 9. A view of the junction box showing the gap of about 0.75 inches between the cable nuts and the dual cable block after a continuity check was performed by pulling the activation handle. Prior to the continuity check, the pull cables were disconnected at the left and right valves.**

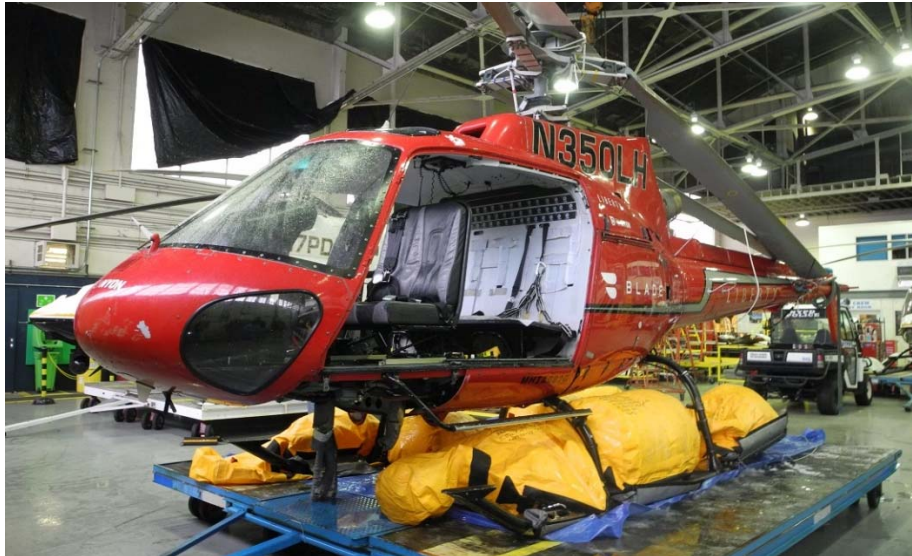
**Figure 10. The three floats installed on the left skid.**

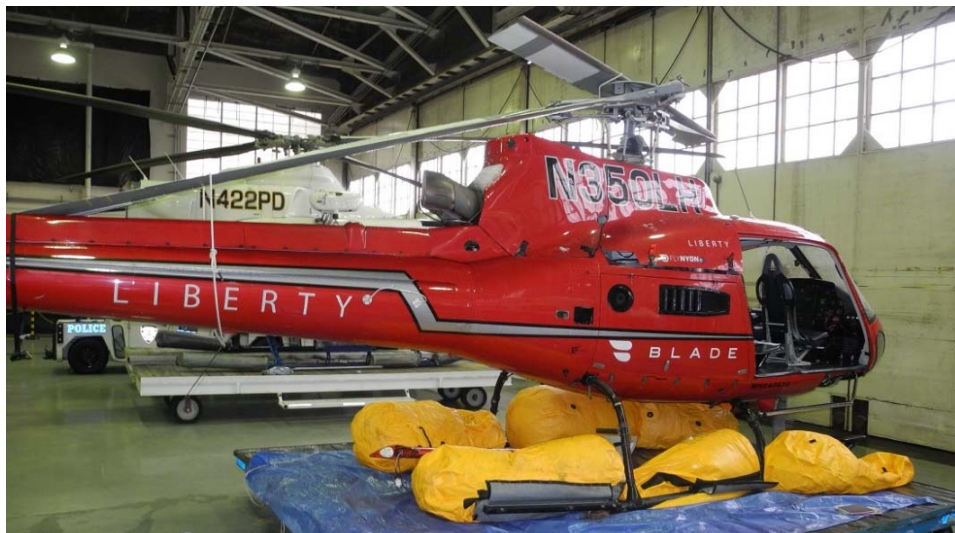
**Figure 11. The three floats installed on the right skid.**

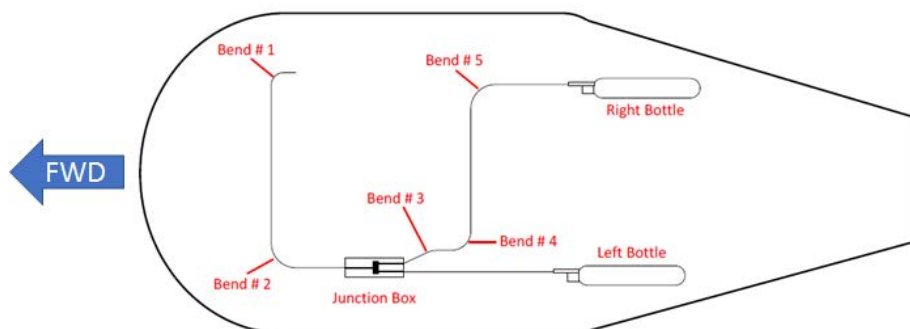
The pull cable bend radius was measured at 5 locations where the pull cable routing made directional turns. Each bend radius measurement was performed by tracing the pull cable bend radius on a piece of paper and subsequently measuring the radius of the curvature. **Figure 12** shows the location of each measurement. The radius measured at bend No. 1 was about 2.5 inches and the pull cable routing was curved about 90 degrees. The radius measured at bend No. 2 was about 2 inches and the pull cable routing was curved about 90 degrees. The No. 3 bend was not a curved bend but rather an angular bend, thus a radius was not measured; the cable was bent downward about 30 degrees (**Figure 13**). The radius measured at bend No. 4 was about 4.25 inches and the pull cable routing was curved about 90 degrees. The radius at bend No. 5 was about 3.25 inches and the pull cable routing was curved about 90 degrees.

**Figure 12. Location of each bend radius measurement for the pull cable installation on N350LH.**

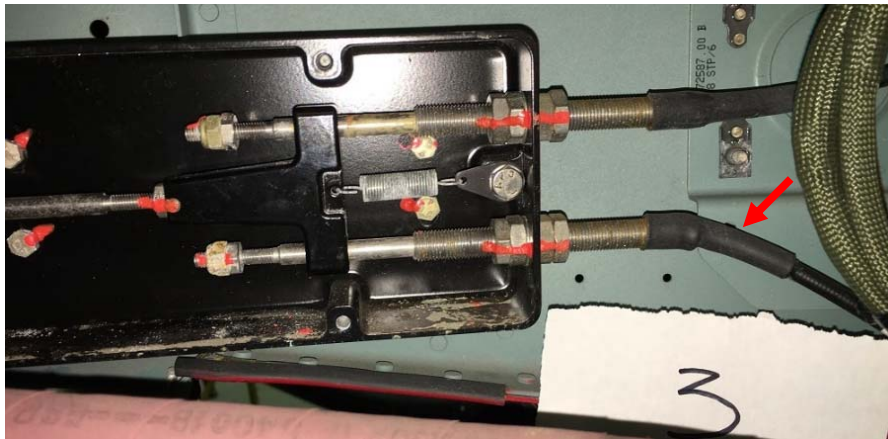
**Figure 13. The downward bend (red arrow) observed on the aft-lower pull cable leading to the right reservoir assembly. (Note: Photograph was taken after the activation handle pull force test described in Section 3.3 of this report.)**

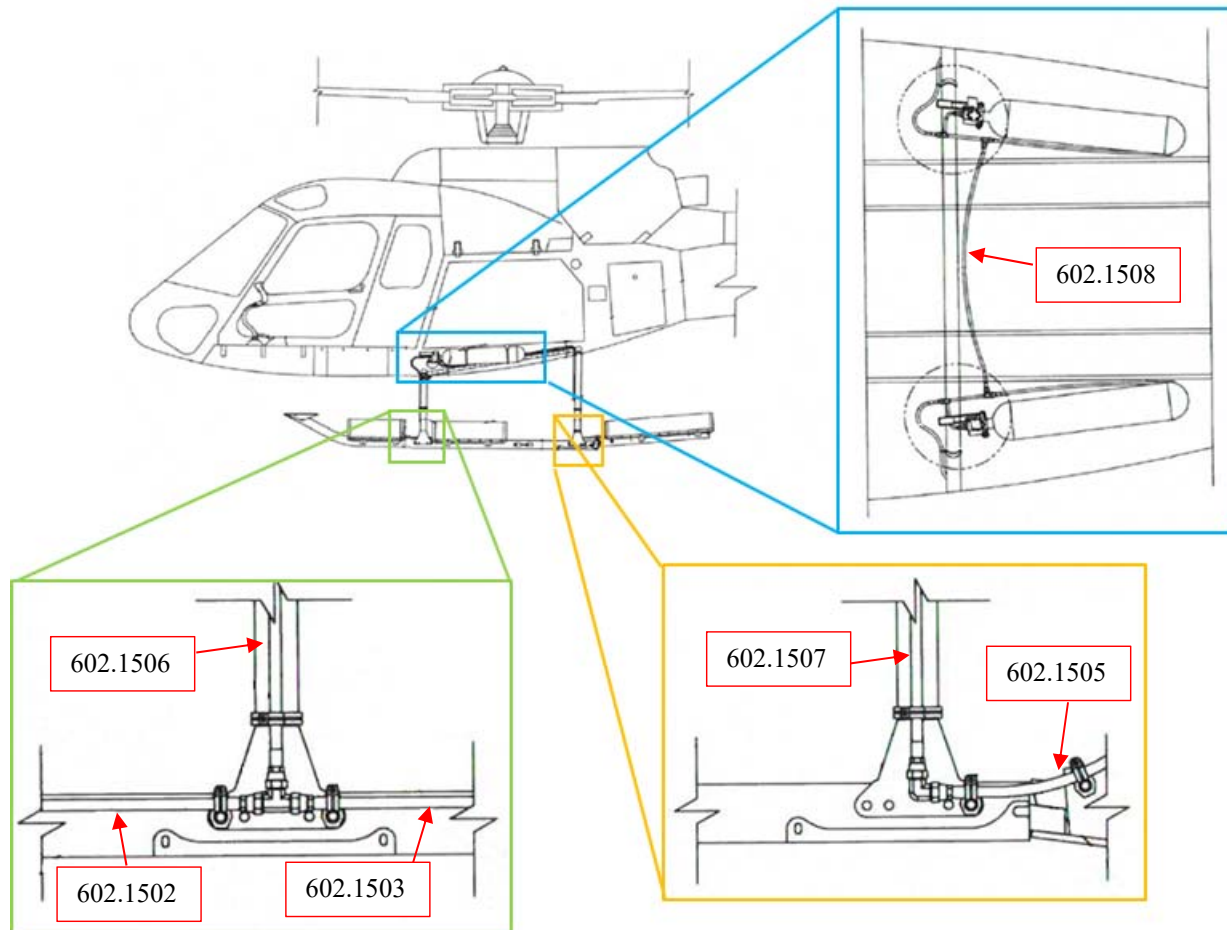
The hose assemblies were removed from the helicopter for examination. **Figure 15** shows the hose installation. The cross-feed hose, P/N 602.1508, exhibited no anomalous damage.

The hoses primarily supplied by the left reservoir assembly, and mounted on the left skid, were examined for condition. Hose part number (P/N) 602.1505 exhibited a kink at mid-length. A portion of hose P/N 602.1507 was observed to be collapsed but still allowed the passage of gas. Hose P/N 602.1506 exhibited bubbles on the black sheathing. Hose P/N 602.1503 exhibited no anomalous damage. Hose P/N 602.1502 exhibited two kinks.

The hoses primarily supplied by the right reservoir assembly, and mounted on the right skid, were examined for condition. Hose P/Ns 602.1505, 602.1502, and 602.1503 exhibited a kink. Hose P/N 602.1507 exhibited no anomalous damage. The sheathing on hose P/N 602.1506 had been chaffed through, exposing the underlying steel braided hose.

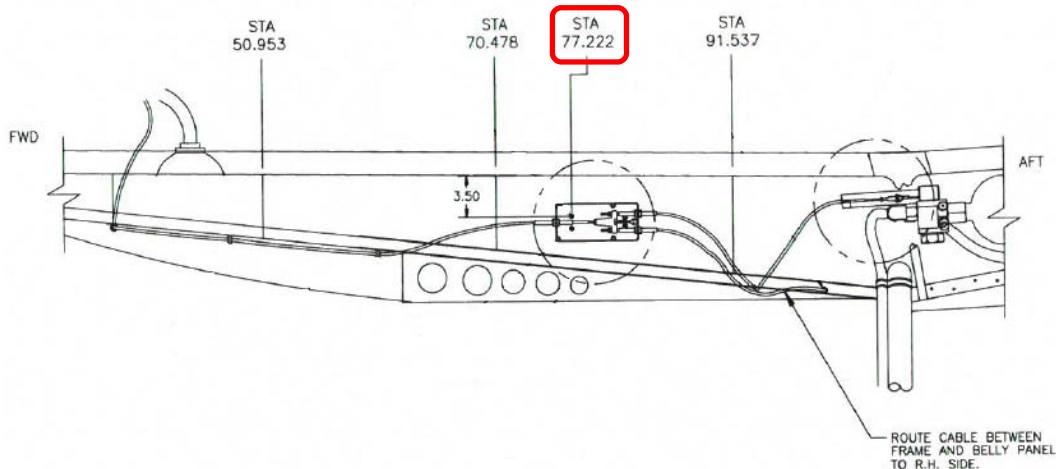
During the examination of the emergency flotation system at Anglin Aircraft Recovery, the pull cable routing was examined and found to conform with the requirements of Installation Instruction No. II350-600 with the exception of the junction box location. According to Installation Instruction No. II350-600, the forward screws to mount the junction box to the

airframe structure were required to be located on the left frame rail at frame station (STA) 77.222 and about 3.50 inches below the underside of the cabin floor ([Figure 16](#)).<sup>5</sup> The junction box of the accident helicopter was found at about STA 78.8 and about 3.25 inches from the underside of the cabin floor. The KG-102A directional gyro was observed to be mounted to the left and forward of the junction box.

**Figure 16. The junction box location (red box) prescribed by Installation Instruction No. II350-600. (Image courtesy of Dart Aerospace)**

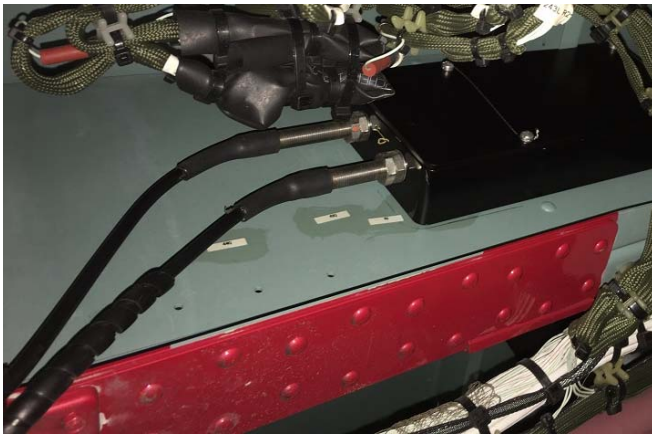
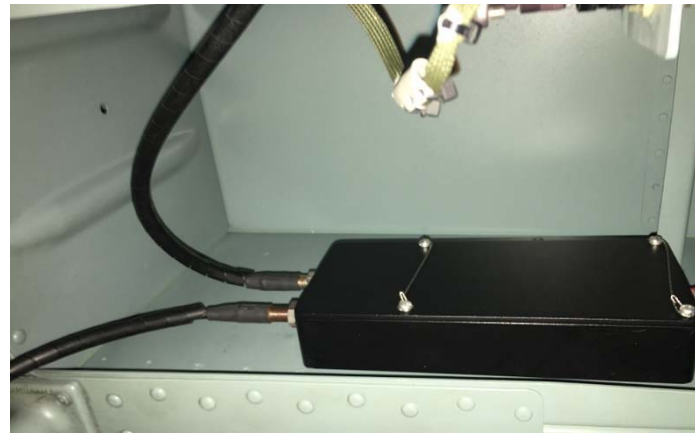
On April 17, 2018, an NTSB investigator examined the activation pull cable and junction box installation on two exemplar helicopters, N351LH and N353JS, equipped with STC No. SR00470LA, at Liberty Helicopters’ facility in Kearny, NJ. The junction box for both helicopters were installed on the inboard side of the left frame rail. The junction box for N351LH was located at about STA 78.228. The junction box for N353JS was located at about STA 79.978. The cabling exiting the junction box on both helicopters exhibited a similar downward turn as that observed on N350LH ([Figures 17 and 18](#)).

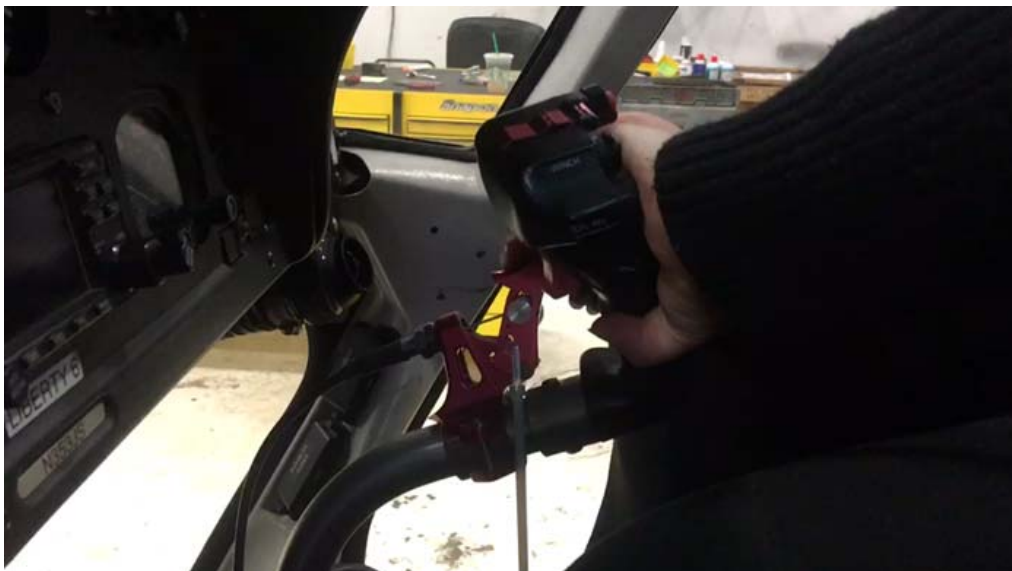
**Figure 19. A screen-capture from the video for the emergency float system deployment as part of the 36-month inspection on N353JS. The image shows the cyclic grip was braced with the left hand while the right hand pulled aft on the emergency float system activation handle. (Video courtesy of Liberty Helicopters)**

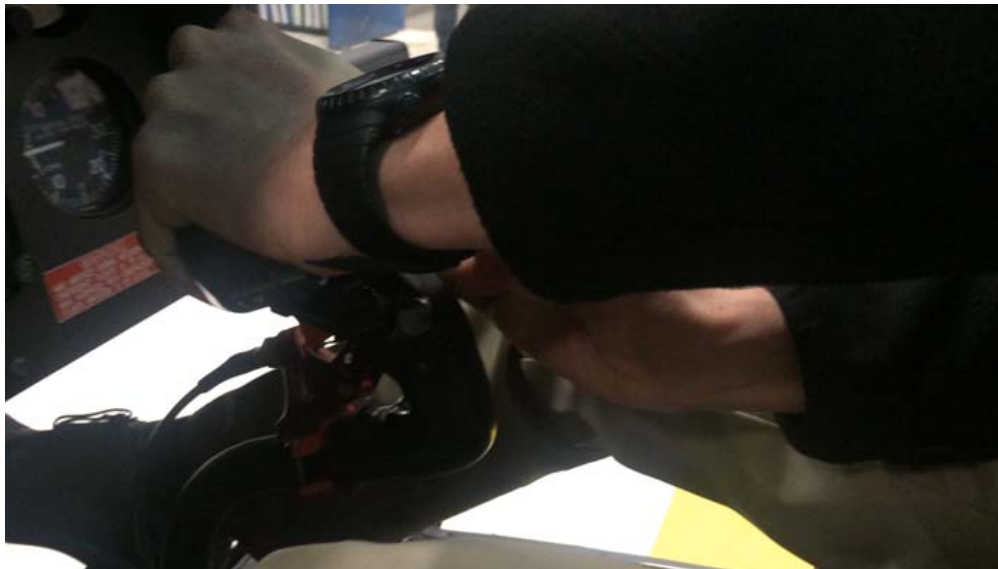
**Figure 20. A screen-capture from the video for the emergency float system deployment as part of a 36-month inspection performed on March 1, 2017. The image shows the cyclic grip was braced with the left hand while the right hand pulled aft on the emergency float system activation handle. (Video courtesy of Liberty Helicopters)**

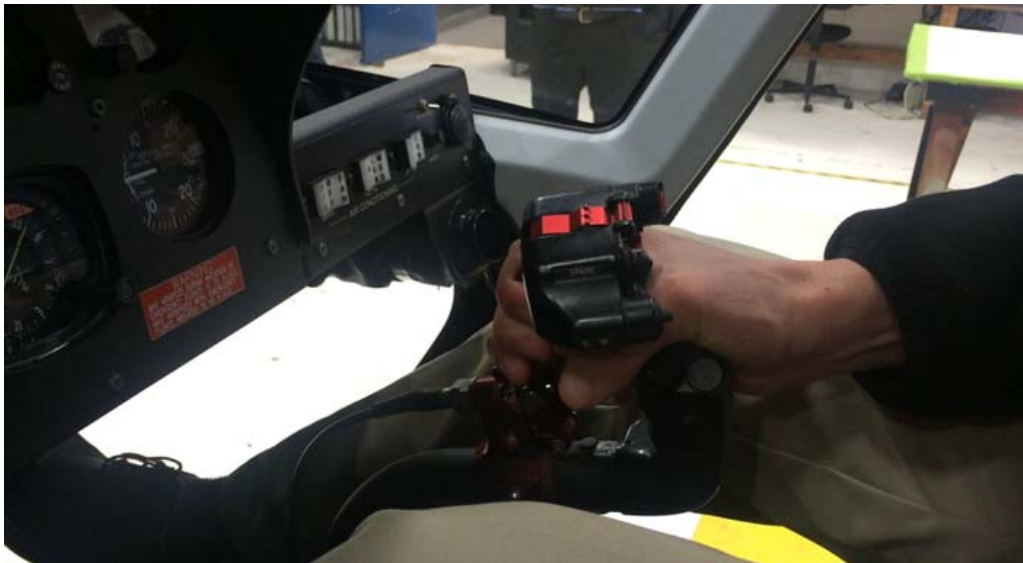
**Figure 21. A screen-capture from a second video on March 1, 2017. The image shows the activation handle was in-line with the cyclic grip, resulting in contact with the cyclic head when the activation handle was pulled aft. (Video courtesy of Liberty Helicopters)**

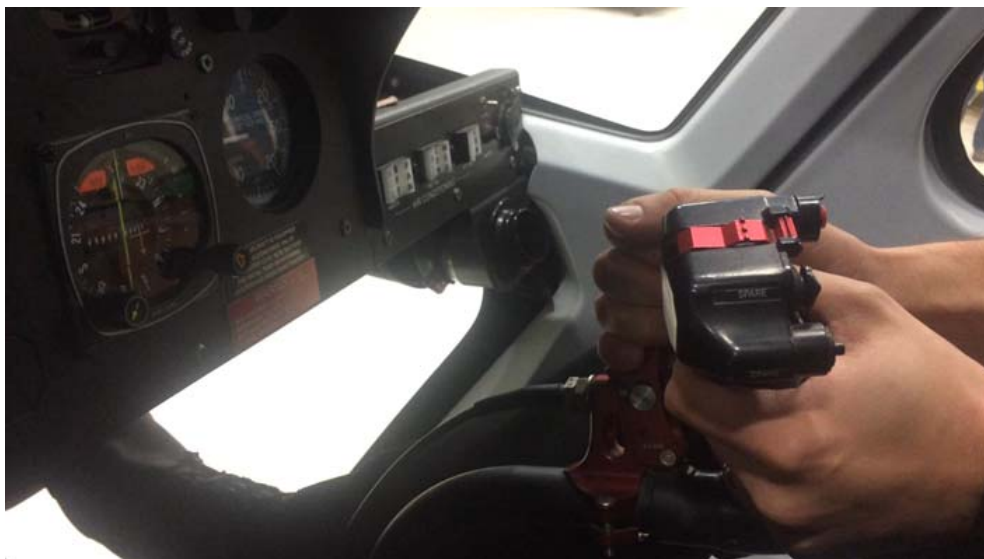
In the video of the inflation test on December 14, 2016, the vantage point was similar to that of the previously discussed cockpit videos. The video was likely of the inflation test for the emergency flotation system installed on N350LH, given the maintenance record showed the 36-month inspection was performed on the same day. The right-seated person had their left hand bracing the cyclic grip and their right hand on the activation handle (**Figure 22**). A countdown starting at “three” was heard, and at the end of the countdown the activation handle was pulled aft while the cyclic stick did not appear to have been displaced noticeably from its starting position. A muted “bang” was heard, followed by hissing sounds. The front-right person continued to hold the activation handle aft until the end of the video.

**Figure 22. A screen-capture from the video for the emergency float system deployment as part of a 36-month inspection performed on December 14, 2016. The image shows the cyclic grip was braced with the left hand with the right hand on the emergency float system activation handle. (Video courtesy of Liberty Helicopters)**

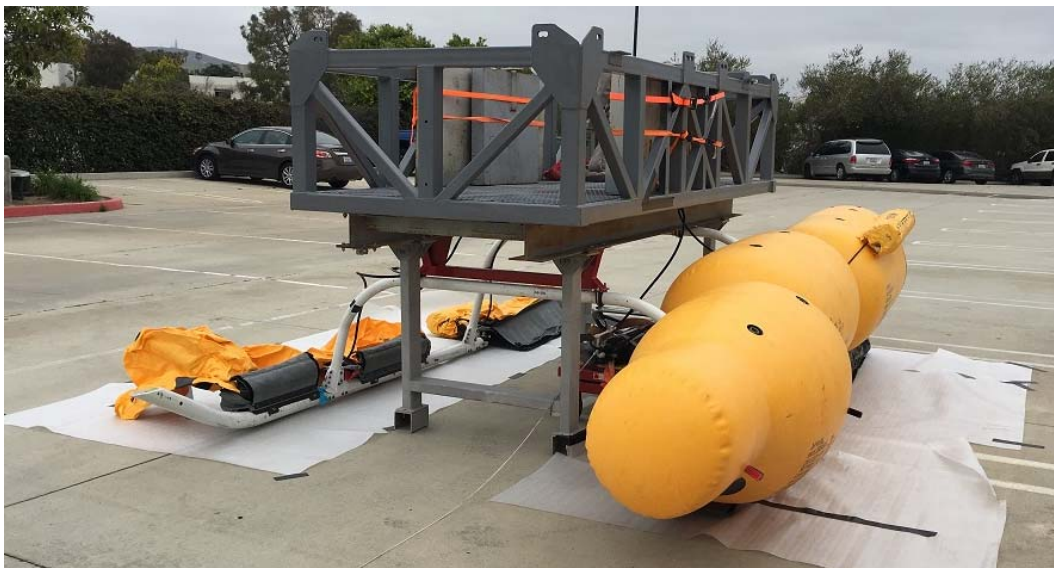
For the second inflation test, the floats on the left side appeared fully inflated and felt rigid to the touch (**Figure 24**); the floats on the right side did not inflate. **Table 3** contains the measured inflation of each float chamber for the second inflation test.

**Figure 24. The inflated floats at the conclusion of the second inflation test.**
