Federal Aviation Administration

Memorandum

Subject: Teardown investigation of an Ameri-King AK-450-[] series Emergency Locator Transmitter (ELT) sent from the National Transportation Safety Board (NTSB). (Refer to NTSB ERA14FA464)

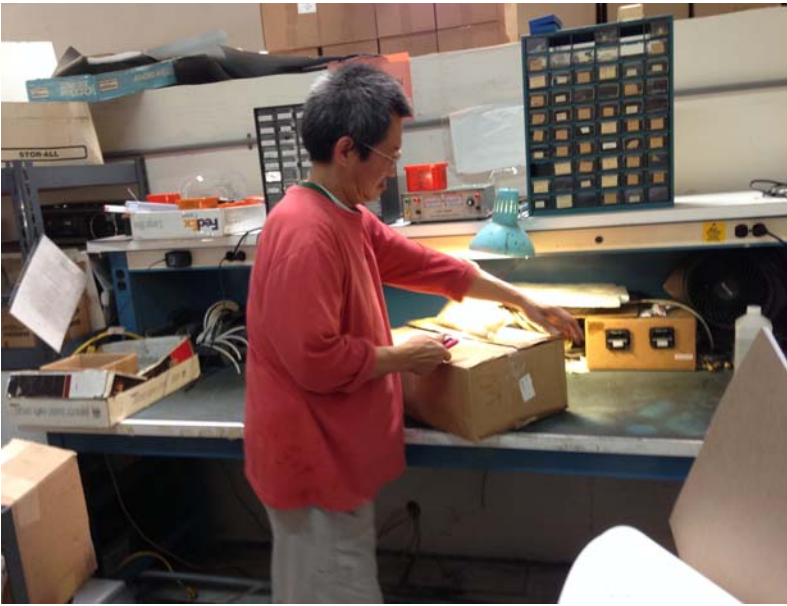
Figure 1 Opening of NTSB shipping container

At 1:36 PM PDT the sealed ELT Main Unit was removed from the box by Mr. Michael Ta, Assembler at Ameri-King (Refer to Figure 1.). The ELT Main Unit was sealed in a tamper proof sealed bag (Refer to Figure 2.). The ELT Main Unit switch was in the OFF position. Upon removal from the tamper proof bag the part number and serial number were recorded. All participants agreed that the Main Unit part number was AK-450. The serial number appeared to be 436187; however some of the participants thought the serial number could be 456187 (Refer to Figure 3.).

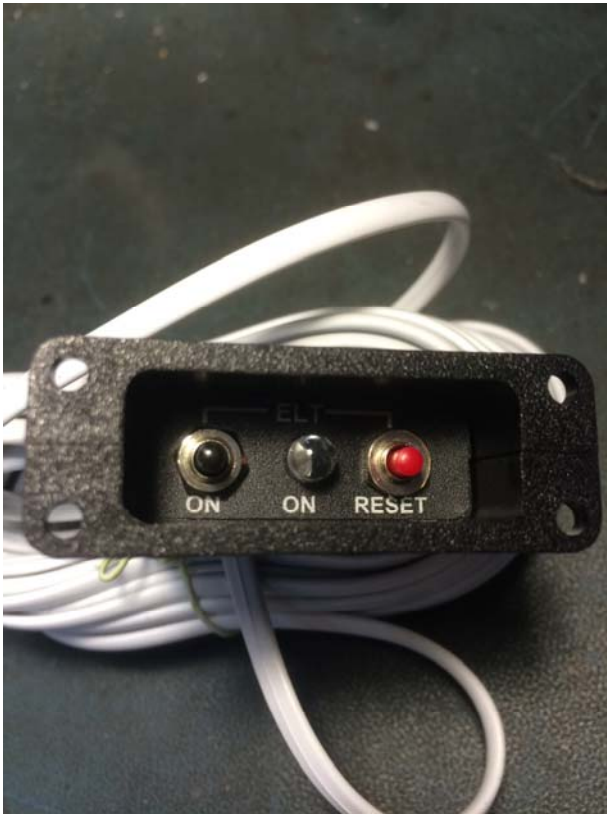
Figure 5 Cockpit Remote Switch

2. Cockpit Remote Switch connected to ELT Main Unit via cable interface.	Cockpit Remote Switch connected to ELT Main Unit via cable interface	Cockpit Remote Switch connected to ELT Main Unit via cable interface	Refer to Figure 5.

3. Cockpit Remote Switch connected to ELT Main Unit via cable interface.	Cockpit Remote Switch connected to ELT Main Unit via cable interface	Cockpit Remote Switch connected to ELT Main Unit via cable interface	Refer to Figure 5.

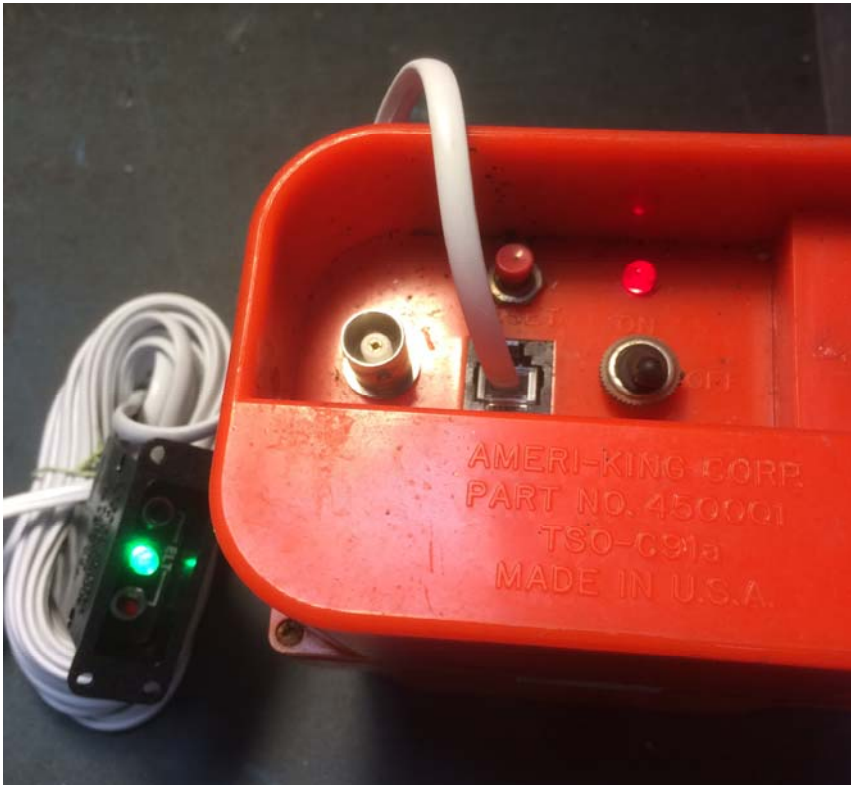
Figure 6 Lights Illuminated on Cockpit Remote Switch and Main Unit

4. The ON button on the Cockpit Remote Switch depressed to ON.	The green light on the Cockpit Remote Switch illuminates, the ELT Main Unit light illuminates and a swept tone is broadcast on the Receiver.	The green light on the Cockpit Remote Switch illuminated, the ELT Main Unit light illuminated and a weak swept tone was heard on the AM/FM Receiver.	Swept tone heard on the AM/FM Receiver was very weak. Refer to Figure 6 and Figure 7.

cable interface.	cable interface	cable interface	
3. The ON button on the Cockpit Remote Switch depressed to ON.	The green light on the Cockpit Remote Switch illuminates, the ELT Main Unit light illuminates and a swept tone is broadcast on the Receiver.	The green light on the Cockpit Remote Switch illuminated, the ELT Main Unit light illuminated and a weak swept tone was heard on the AM/FM Receiver.	Swept tone heard on the AM/FM Receiver was initially loud and then faded. Refer to Figure 6 and Figure 7.

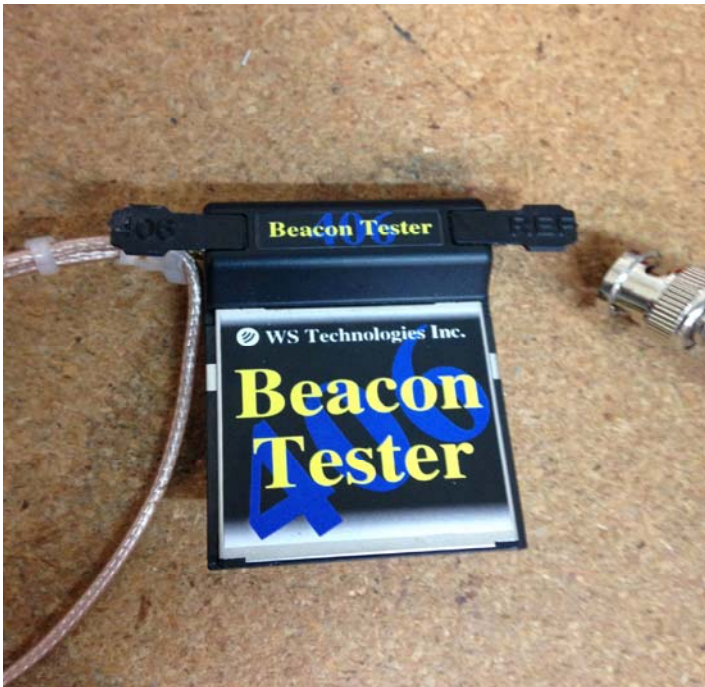
Figure 8 WS Technologies Beacon Tester

Instead of continuing to run the Periodic Maintenance Test- IM-450 Rev A, para 3.4; Mr. Van had Roger Ha run the Beacon Test. Due to the weak sweep tone heard during the Transmitter Functional Test; Mr. Van directed Mr. Ha to perform the Beacon Test in order to measure the signal power. The signal power level measured via the Beacon Test was 21.3 dBm. Per Mr. Ha the minimum acceptable level is 17.0 dBm.

Mr. Van had Roger Ha run the Beacon Test using an automated test run via a Dell Axim X-50 Personal Digital Assistant (PDA). The tester was a WS Technologies Inc., model BT100AV Series ELT Tester. (Refer to Figure 8 and Figure 9.). It should be noted that Mr. Ha entered the Serial Number of the ELT Main Unit as 436187 for these two runs. The ATP was completed at 4:11 PM PDT.

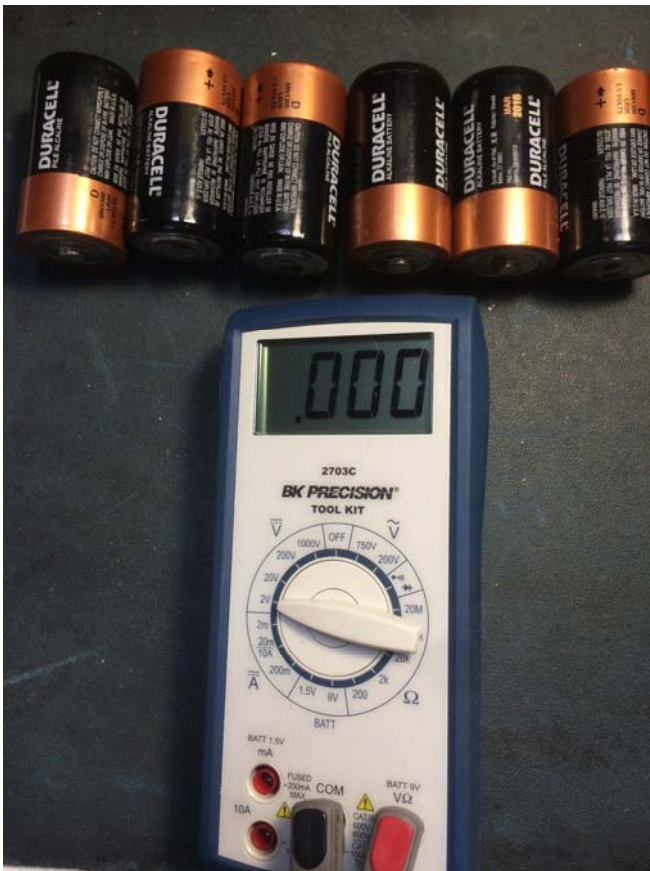
Figure 10 Multi-meter and Batteries

The voltage of each battery was measured using a BK Precision Model 2703C Digital Multi-meter and is included in the table below (Refer to Figure 10 and Figure 11):

Battery	Voltage (V)
1	1.574
2	1.565
3	1.569
4	1.565
5	1.574
6	1.568
AVG	1.569

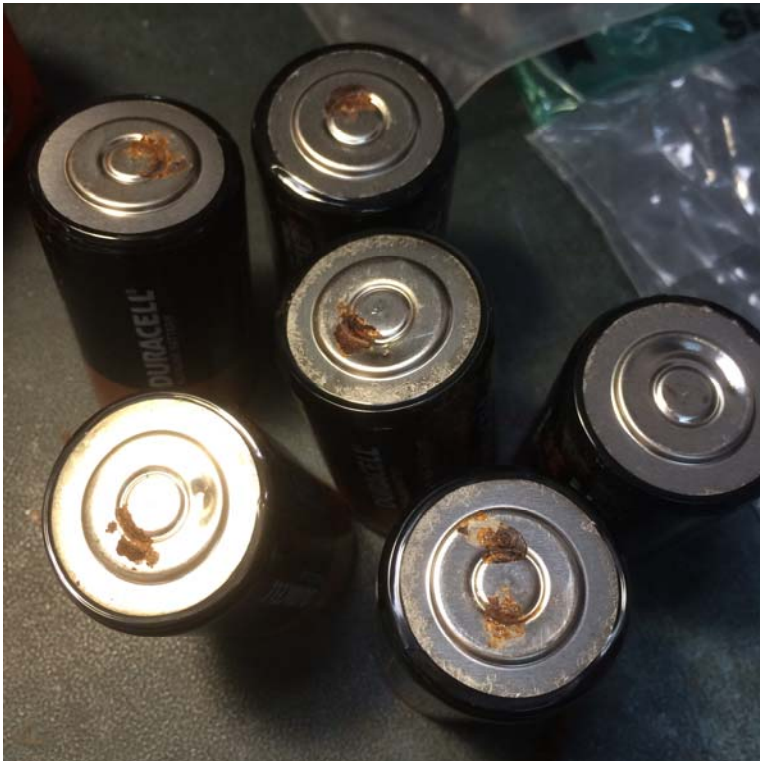
Figure 11 ELT Main Unit Batteries

- a) Slight corrosion present on bottom (negative terminal) and top (positive terminal) of the batteries.
- b) Batteries all had the same expiration date: Mar 2016.
- c) Five out of six of the batteries were corroded on the bottom (negative terminal).
- d) Four out of six of the batteries were corroded on the top (positive terminal).
- e) No evidence of battery leakage.
