NATIONAL TRANSPORTATION SAFETY BOARD

Emery Flight 017 Airplane Performance Study Addendum 2

Location: Rancho Cordova, California
Date: February 16, 2000
Time: 1951 Local Time
Aircraft: Douglas DC-8-71, N8079 U
Operator: Emery Worldwide Airlines, A CNF Company (FAR Part 121
Supplemental)
NTSB#: DCA-00-MA-026

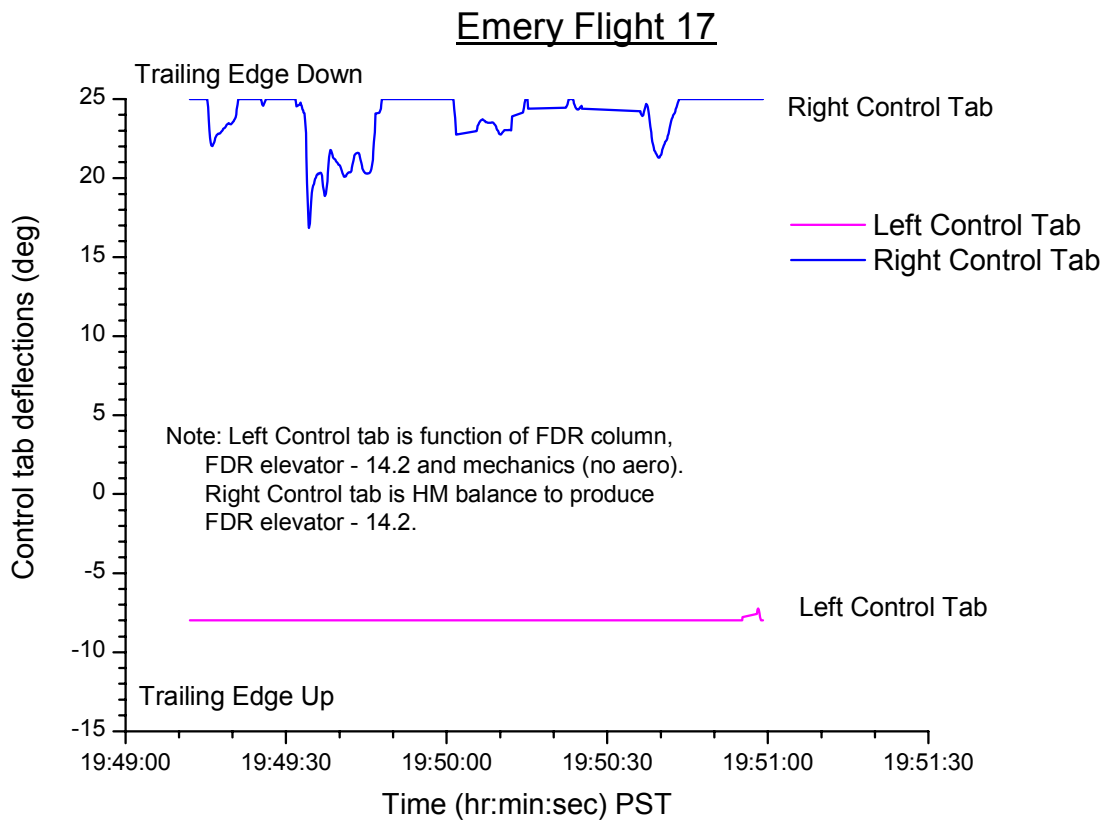
Figure 1: Derived control tabs for the accident flight

The original report used an elevator with the 11 degree elevator offset derived from the recorded elevator with the gust lock on applied to derive the control tabs for the accident flight. Kinsurf was run again for the accident flight using the 14.2 trailing edge up offset to the FDR data. The results are shown in figure 1.
