**EMERY WORLDWIDE AIRLINES**

**RESPONSE TO**

**EXHIBIT 17J**

Oct. 16<sup>th</sup> - Nov. 2<sup>nd</sup>, 2000

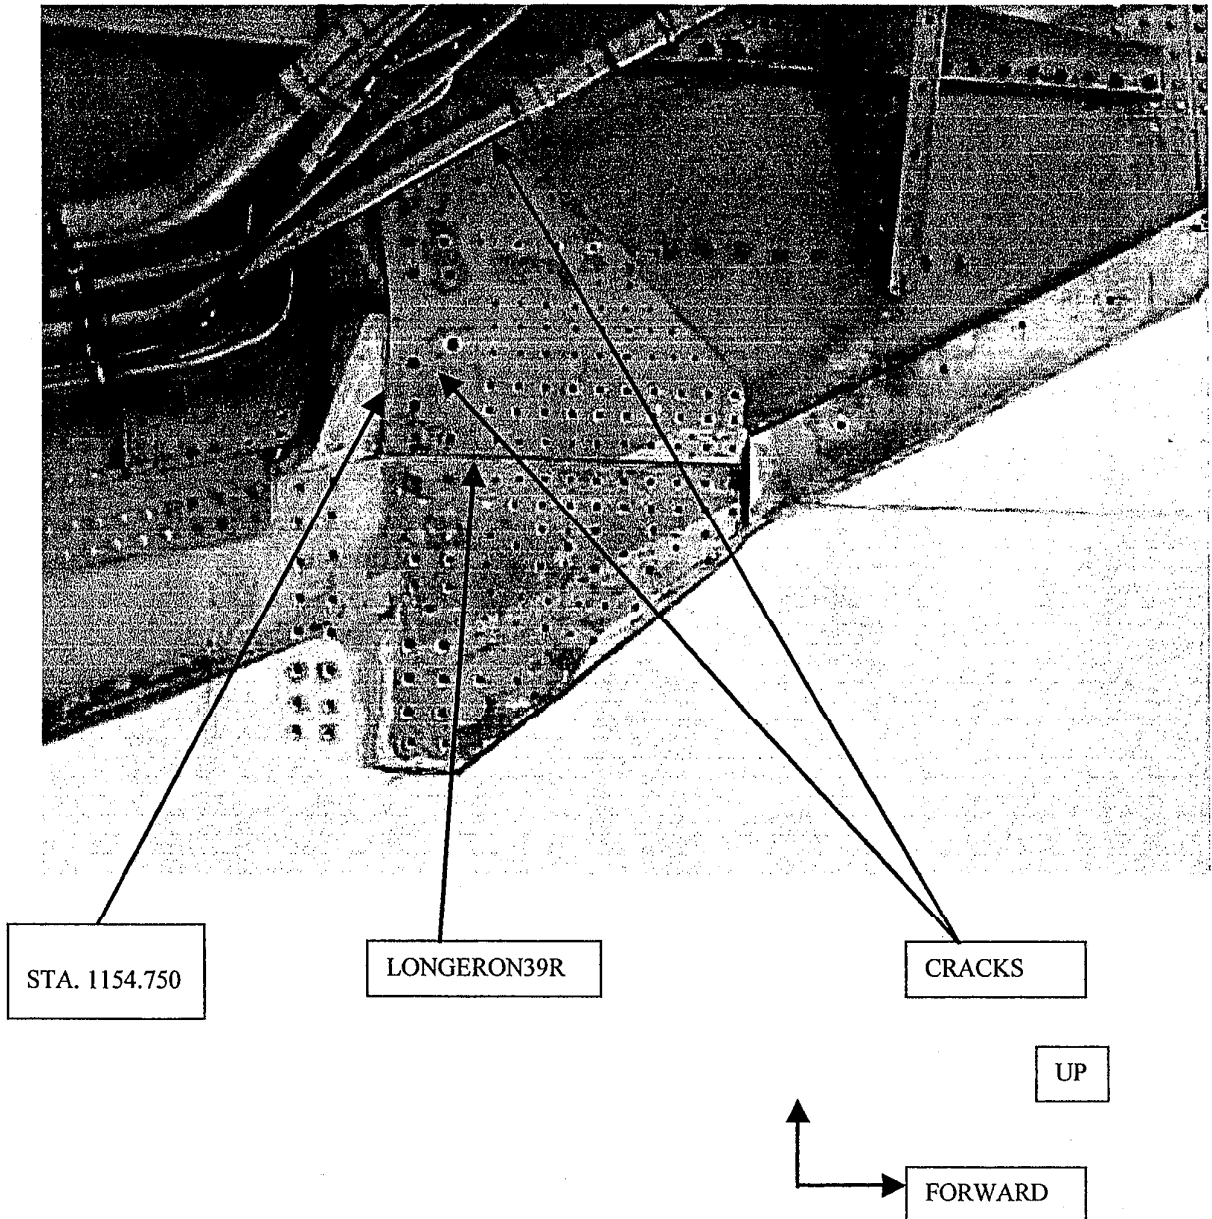
DAMAGE LOCATION  
FIGURE 1

DURING HEAVY CHECK AT MAE, THE CUSTOMER REQUESTED THAT REFERENCE (B) BE INCORPORATED. THIS REQUIRED REMOVAL OF REPAIR DOUBLER THAT WAS INSTALLED BY REFERENCE (C), UNDER WHICH WAS FOUND 2 CRACKS. ONE CRACK WAS 6.1-INCHES LONG AND THE OTHER WAS 0.8-INCHES LONG BEGINNING AT AND EXTENDING FORWARD OF A FASTENER HOLE AND THE SAME CRACK WAS 0.65-INCHES LONG BEGINNING AT AND EXTENDING AFT OF SAME FASTENER HOLE. THE SKIN MATERIAL IS MADE FROM 0.090-INCH THICK CLAD 7075-T6 PER REFERENCE (A). SEE FIGURE 1 FOR DAMAGE LOCATION.

RIGHT HAND FUSELAGE SKIN NEA6013-19 HAS A 6.1 INCH CRACK WHICH IS PROPAGATING FROM Y STATIONS 1154 TO 1160 WHICH EXCEEDS REF /C/ GENERAL NOTE 9.2 LIMIT OF 5 INCHES ALLOWED. IN ADDITION, THERE IS ANOTHER CRACK COMMON TO THE RIGHT HAND FUSELAGE SKIN NEA6013-19 WHICH IS 0.8 INCH LONG. MAE DOES NOT WANT TO EXTEND THE REF /D/ -34 MOD DOUBLER THREE ROWS OF FASTENERS IN THE UPWARD DIRECTION WHICH WOULD BE COMMON TO FUSELAGE STRINGER 37R AND THE ADA0154 FITTING.  
MAE REQUESTS BOEING APPROVED REPAIR CONCEPT TO RESTORE THE CRACKED AREAS AS DESCRIBED BY REF /A/.

REPAIR IN ACCORDANCE WITH THE FOLLOWING STEPS. THIS REPAIR IS CONSIDERED MAJOR AND IS BOEING APPROVED PER REFERENCES (E) AND (F).

1. TRIM OUT ALL CRACKS MAINTAINING A MINIMUM OF 0.5-INCH TRIM RADIUS. BREAK ALL SHARP EDGES CREATED BY TRIM OUT.
2. PERFORM NDT EDDY CURRENT INSPECTION TO ENSURE COMPLETE CRACK REMOVAL AT TRIMMED OUT AREAS.
3. FABRICATE PER REFERENCE (D) THE SR10530073-34 DOUBLER TO PICK UP EXTRA ROWS OF FASTENERS AS SHOWN ON FIGURE 2. THE THICKNESS AND TAPER OF THE ADDED SECTIONS IS TO BE THE SAME AS WHAT THE -34 DOUBLER IS AT THE LOCAL AREA, WHERE MATERIAL WILL BE ADDED. ALSO MODIFY THE DOUBLER TO HAVE A LINEAR TAPER WHICH WILL INCREASE THICKNESS OVER TRIMMED OUT AREAS.

4. FABRICATE FILLERS FROM 7075-T6 THICKNESS AS REQUIRED. SHIM AS REQUIRED.
5. MAINTAIN A MINIMUM OF 2D EDGE DISTANCE FROM THE UPPER EDGE OF REPAIR DOUBLER AND THE ADA0154 FITTING. MAINTAIN A MINIMUM OF 2D FASTENER SPACING COMMON TO THE 2 FASTENER ROWS ABOVE THE UPPER CRACK.
6. COMPLETE REPAIR PER REFERENCE (B) AND REFERENCE (D).
7. SEE NOTES ON PAGE 4 FOR REPETITIVE INSPECTION REQUIREMENTS.
