**EMERY WORLDWIDE AIRLINES
CORROSION PREVENTION AND CONTROL PROGRAM
CORROSION SUMMARY REPORT**

C & D CHECK INSPECTIONS

**CORROSION
SUMMARY
REPORT**

July 28, 1999

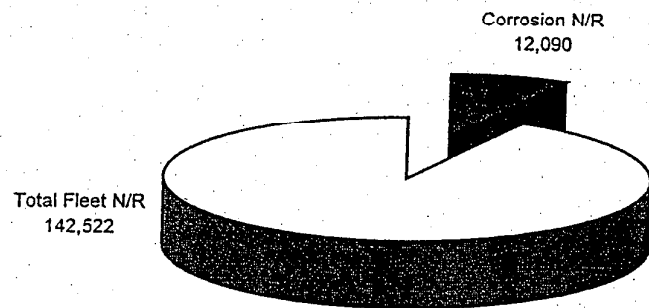
"C" Check Non-Routines VS Corrosion Non-Routines

The 12,090 cumulative corrosion findings reported on the forty-three (43) aircraft exhibited in Section I of this report represent 8.4% of all inspection findings reported during the C-Check inspections. 12,090 Cumulative corrosion findings recorded on the DC-8 fleet averaged one hundred eleven (111) per C-Check. Work Area 5, which includes structure comprising the main fuselage cabin, main landing gear, wheel wells, and lower cargo compartments accounted for the majority of all corrosion findings.

Fleet N/R's VS Corrosion N/R's - 8.4%

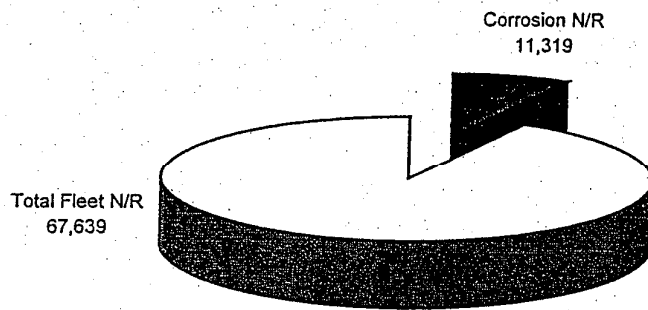
"D" Check Non-Routines VS Corrosion Non-Routines

The 11,319 cumulative corrosion findings reported on the twenty-two (22) aircraft exhibited in Section II of this report represent 16.7% of all reported inspection findings reported during the D-Check inspections. Corrosion findings from the exhibited aircraft averaged five hundred fourteen (514) per D-Check. Work Area 5, which includes structure comprising the main fuselage cabin, main landing gear, wheel wells, and lower cargo compartments accounted for the majority of all corrosion findings.

Fleet N/R's VS Corrosion N/R's - 16.7%

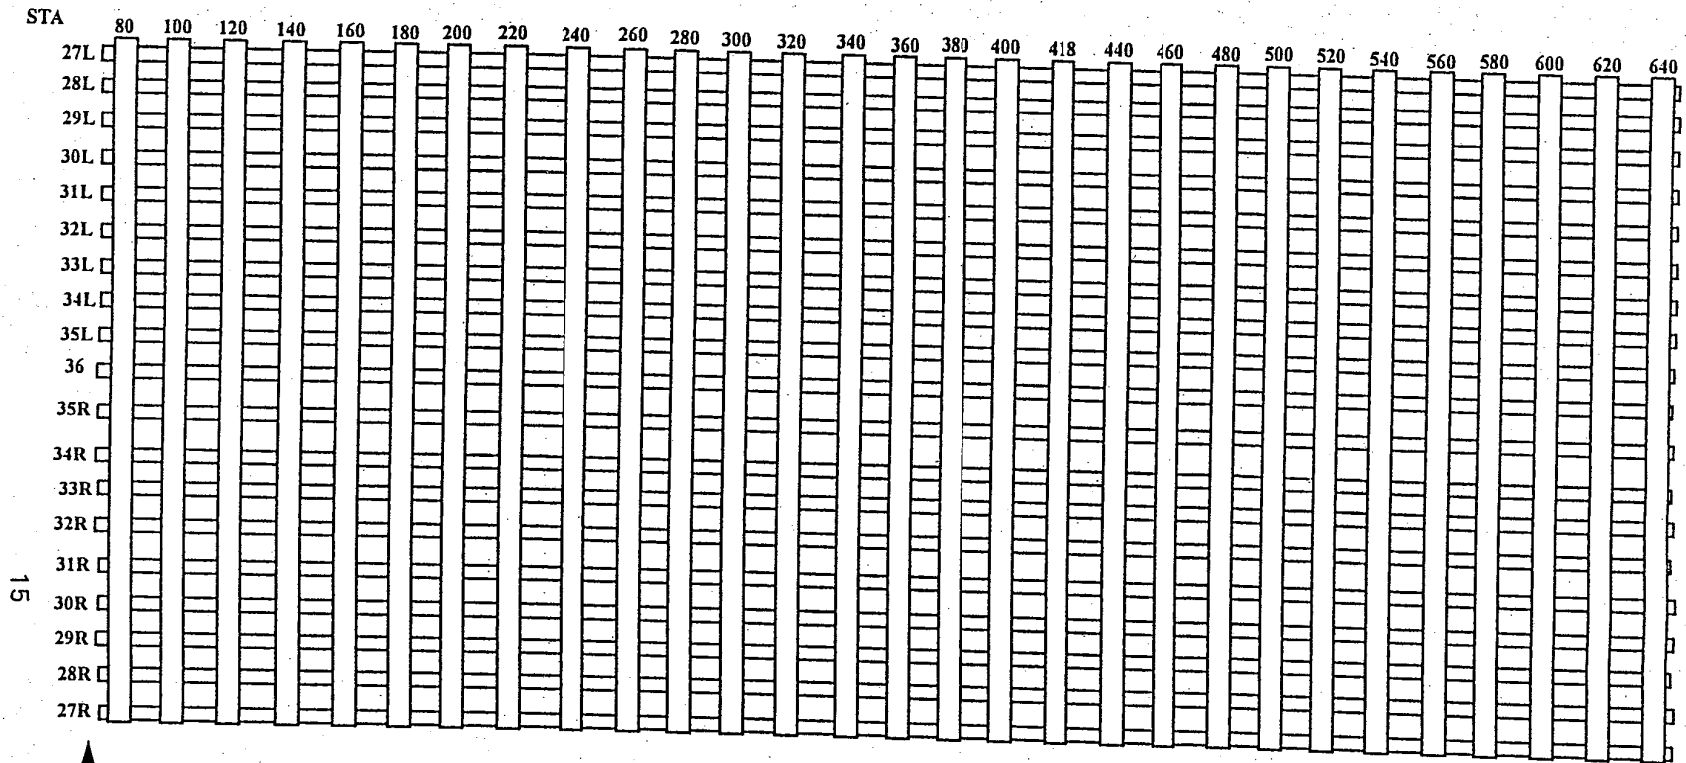
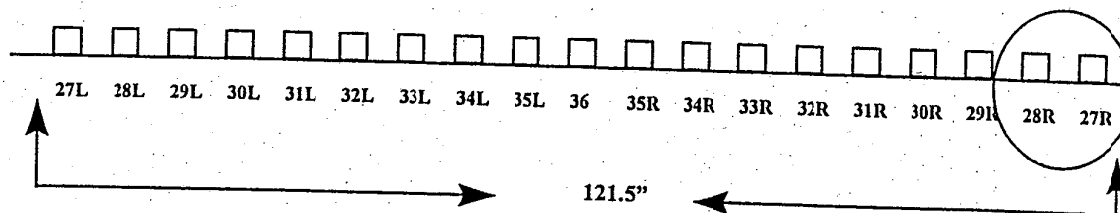
TASK 55700551

- CPCP Task Numbers 55700551 and 55900551, fuselage center section, represented the highest number of Level 2 repeat inspection findings in EWA's fleet, approximately 60% of the fleet. Analysis has proven that these number of Level 2 repeats effecting the specific aircraft listed, are minor in the consideration of the dimensional area of this inspection zone, and that the write-ups indicate the corrosion is limited to small or local areas, that are repaired and/or replaced with a new part (see attachment #4). It was determined by physical inspection of these aircraft, by Quality Control, and the type of repair required, that in any of these findings a potential urgent airworthiness concern did not exist. The next page represents the actual number of write-ups per aircraft for these tasks.

Top View (Length) X Side View (Width)
= 3,948.75 square inches or 329.06 square feet.

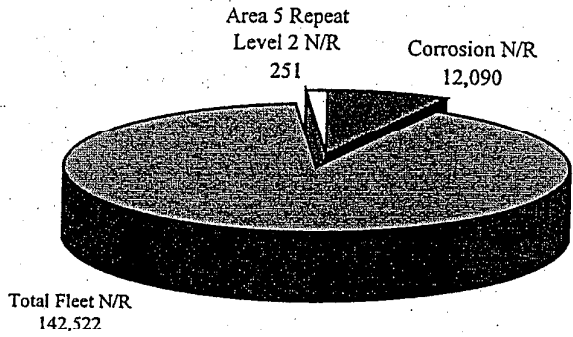
**"C" CHECK NON-ROUTINES VS CORROSION NON-ROUTINES
VS AREA 5 REPEAT LEVEL 2**

Fleet N/R's VS Corrosion N/R's - 8.4%

Corrosion N/R VS Area 5 Repeat N/R's - 2%
