ENERGETIC TANK INC.
80, Broad Street, Monrovia, Liberia

Re: ALNIC MC Collision with USS JOHN S MCCAIN
Singapore Strait, August 21, 2017

A. Proposed Findings

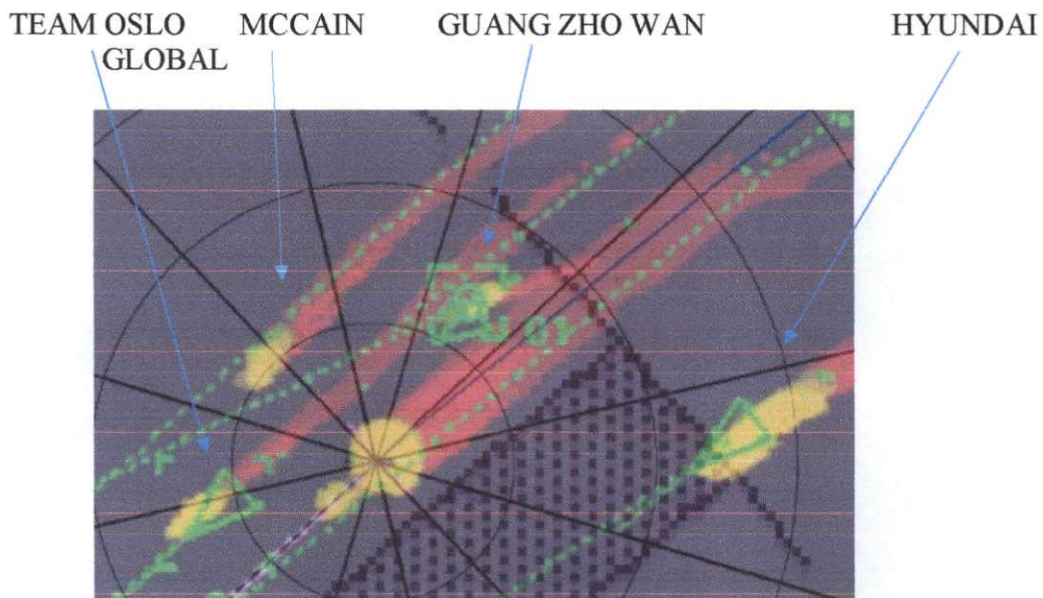
16. At no time prior to the collision did the McCain make any bridge-to-bridge call on the VHF to warn nearby vessels, nor did it make any danger signal with its ship's whistle. At no time did the McCain give orders to fully stop her engines.
17. In the time shortly before the collision, the Alnic had just been passed by the Team Oslo and had the Guang Sho Wan overtaking to starboard and the Hyundai Global overtaking to port.
18. Following are screen shots from Alnic's VDR replay reflecting their radar view in the moments leading up to the collision. (Alnic's radar completed one sweep about every 14 or 15 seconds, with the image refreshing at 05:22:20, :34, :49, 23:06, :21, :35 and :50.):
 - a. ALNIC radar view at 05:22:20, just at the moment the McCain's port engine was slowed:

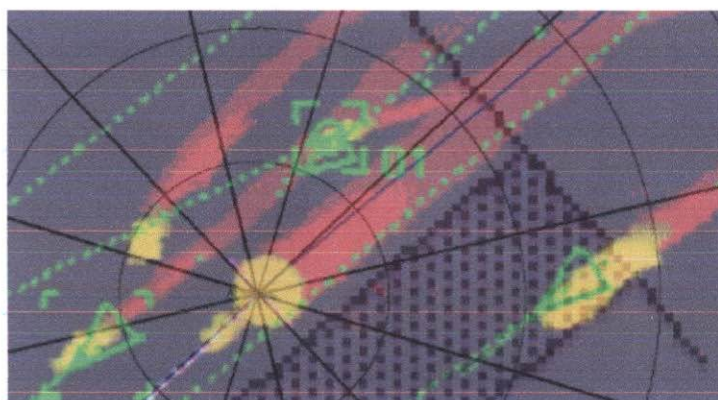
c. ALNIC Radar view at 05:22:49

19. As can be seen from the radar screen shots above, until 05:22:49 the McCain and Alnic were on roughly parallel courses. At that time, the McCain's turn to port became noticeable, and at 05:23:05, the Master can be heard on the bridge recording commenting that he thought the McCain intended to pass between Alnic and Team Oslo. At 05:23:12, the Master remarked "Think he is OK." A few seconds later, at 05:23:16, he further remarked "Doing wrong maneuver."
