03/10/2020 Examination Big Lake, AK

N7384D Piper Super Cub

PA-18-150 S/N: 18-5749

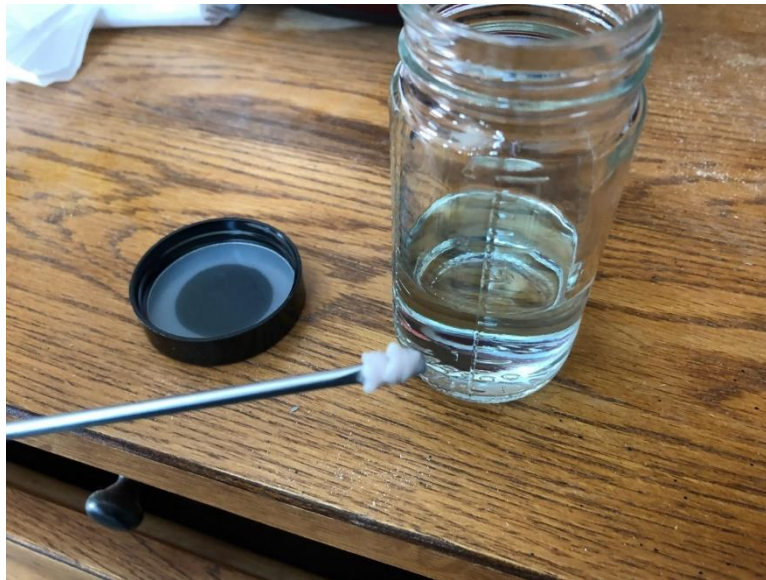
Gas was drained from both wing tanks and the firewall fuel drain and checked for water with water finding paste. No presence of water or contamination was noted. (see figure 1 for water paste test)

(Figure 1: Water paste test)

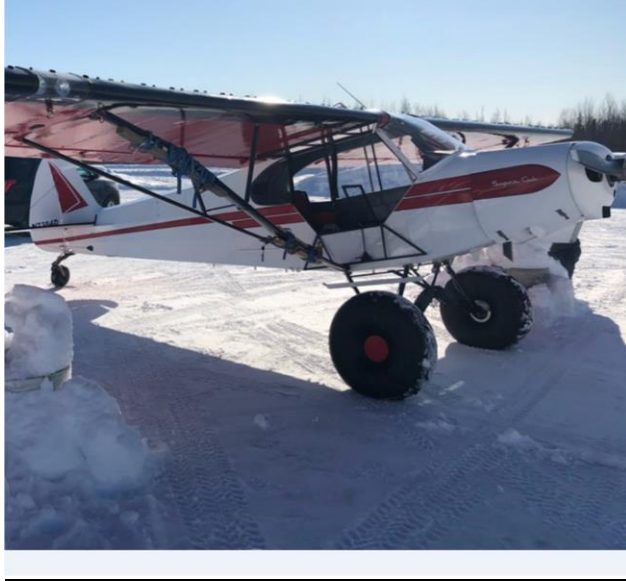
(Figure 2: Accident airplane)

The airplane was located in a heated hangar at the Big Lake Airport (BGQ), Big Lake, Alaska. The damaged airplane propeller was removed, and a substitute propeller was supplied by Alaska Claims LLC. When the NTSB arrived, the substitute propeller was already installed, and the engine had been rotated by hand with the lower spark plugs removed to assure no blockage in the cylinders. The engine showed no signs of damage.
