ENGINE EXAMINATION REPORT

ENGINE MODEL	IO-520-E
ENGINE SERIAL NUMBER	215503-R
AIRCRAFT MAKE & MODEL	Aero Commander 500A
AIRCRAFT SERIAL NUMBER	500A-914-22
AIRCRAFT REGISTRATION	N41AV
FILE NUMBER	14-308

EXAMINATION		ACCIDENT DATA	
DATE	04/14/2015	NTSB ACCIDENT #	CEN15FA056
FACILITY	Continental Motors Inc.	NTSB INVESTIGATOR	Jason Aguilera
ADDRESS	2039 S Broad St Mobile, AL 36615	FAA INVESTIGATOR	Brian Fricker
		ACCIDENT DATE	11/23/2014
		ACCIDENT LOCATION	McDade, Texas

Inspection of the engine revealed that the engine displayed oil starvation signatures. It was reported that the oil gage housing extension was not installed in the oil gage housing at the accident site. Inspection of the oil gage housing and housing extension revealed the rubber hose was not properly installed when compared to SIL14-6.

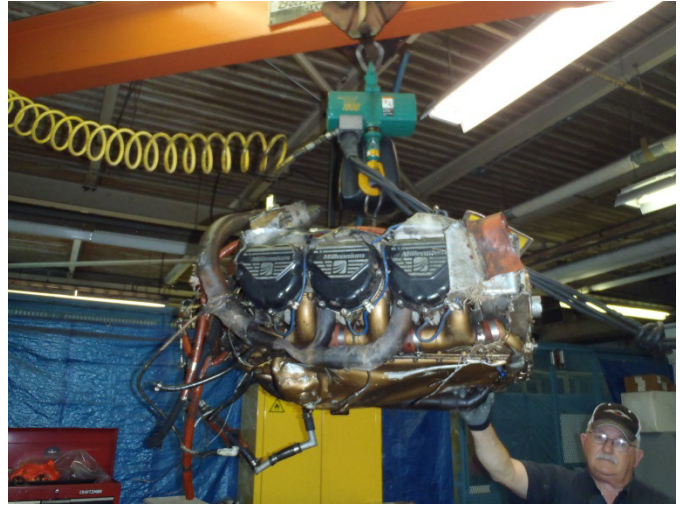
EXHAUST SYSTEM

Condition: The exhaust system displayed damage consistent with impact damage; the damage was more prevalent to the right side exhaust system. There were no anomalies noted with the exhaust system.

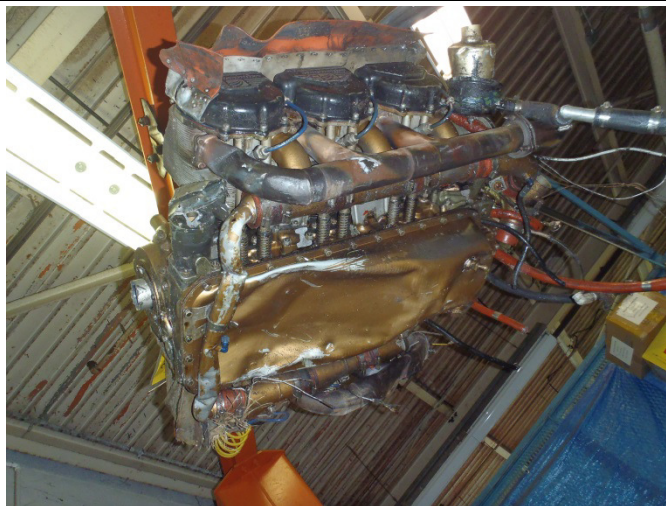
INDUCTION SYSTEM

Condition: The induction system displayed damage consistent with impact damage. The balance tube was partially crushed and one of the intake tubes going to the throttle body had broken free from the intake system. There were no signatures of intake leaks noted.

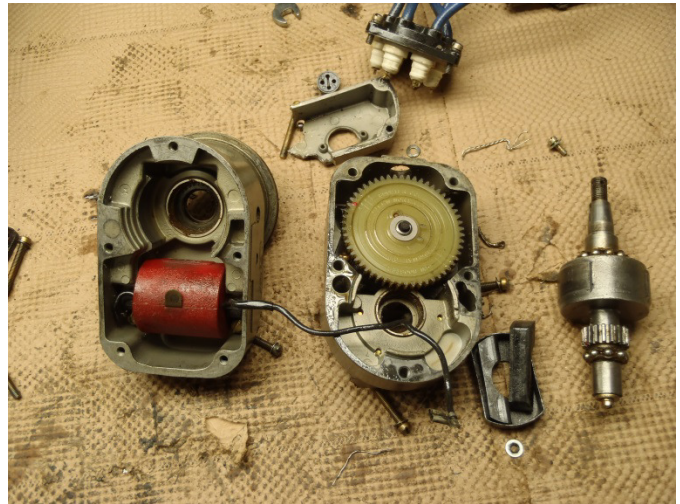
MAGNETO-TO-ENGINE TIMING	Specification: 22° BTDC	L/H: Unable to determine	R/H: Unable to determined
LEFT MAGNETO	Manufacturer: CMI	P/N: 10-600606-1	S/N: 716055
Condition:	The left magneto remained attached to its respective mounting pad and displayed damage consistent with impact and mechanical damage; the top magneto cap was broken. Due to the impact damage the magneto could not be tested on a test bench. The magneto was disassembled and there were no anomalies noted with the internal components.

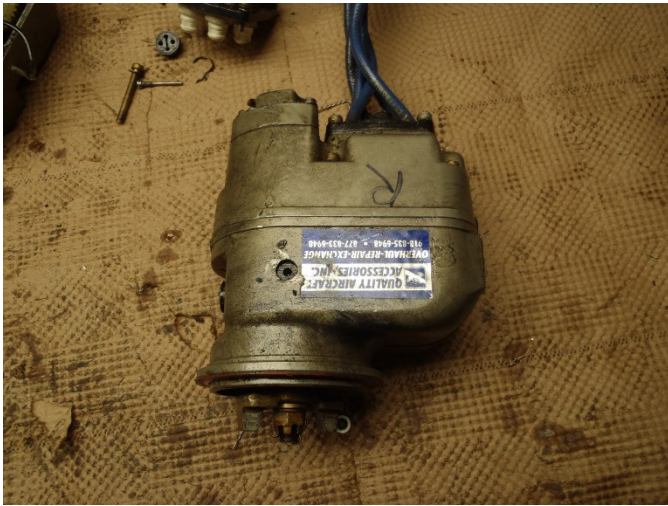
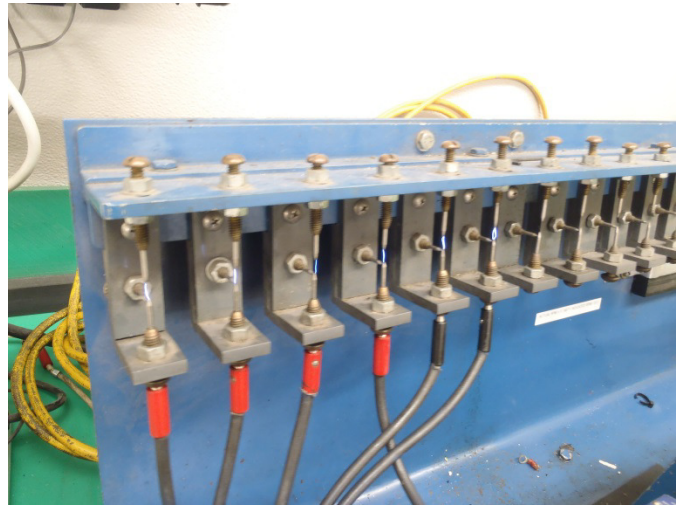
RIGHT MAGNETO	Manufacturer: CMI	P/N: 10-600656-1	S/N: 1023292
Condition:	The right magneto remained attached to its respective mounting pad and displayed minor damage consistent with impact damage. The magneto was mounting on a test bench and it was noted that the magneto was capable of producing a spark across a 7mm gap at all tested RPM settings. There were no anomalies noted with the magneto.

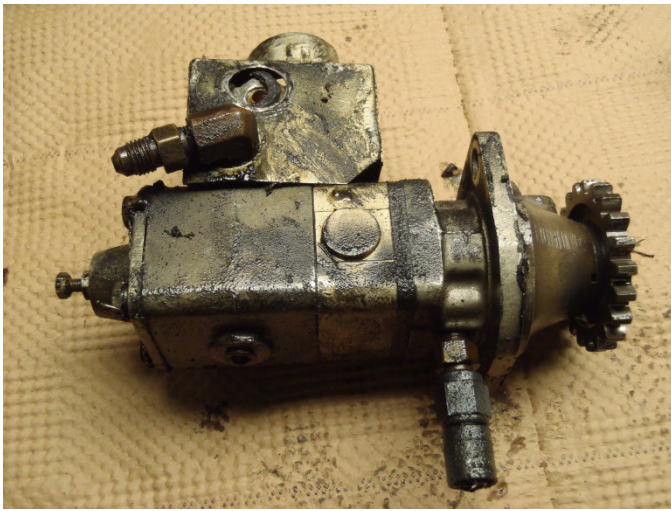
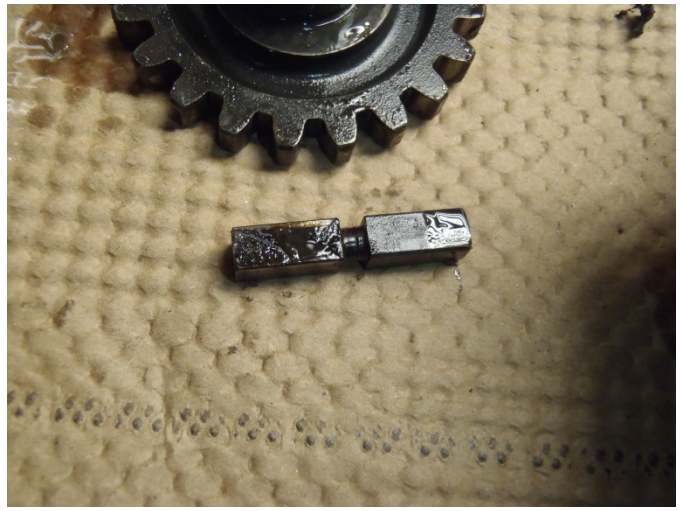
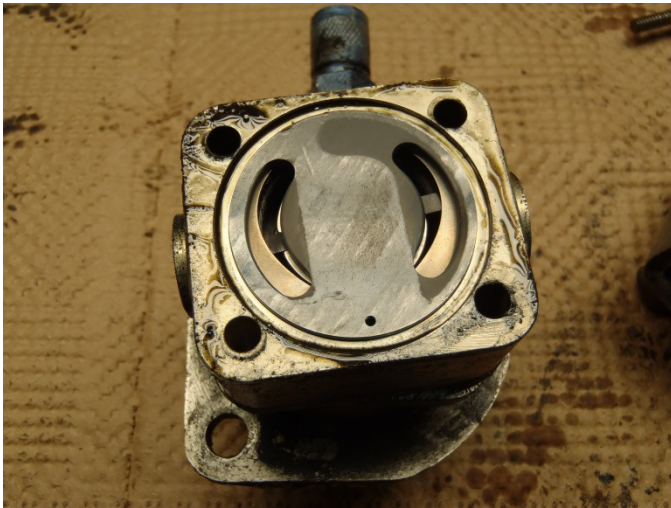
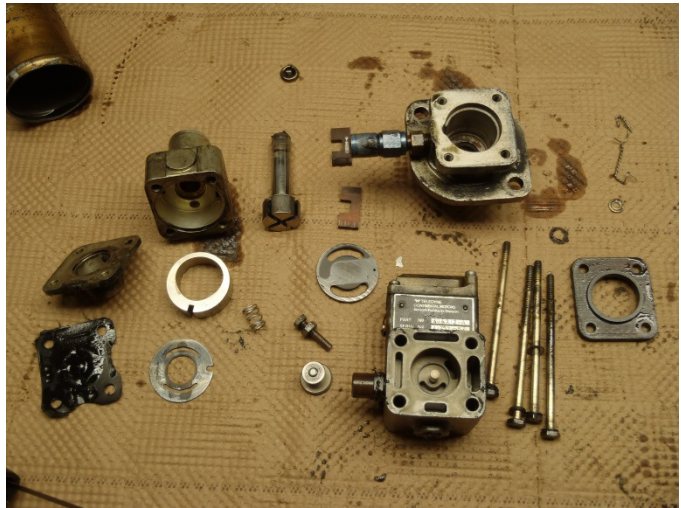
FUEL PUMP

The fuel pump remained attached to its respective installation point and displayed damage consistent with impact damage; two of the fuel AN elbows had broken free from the fuel pump. The fuel pump was removed and disassembled; it was noted that the fuel pump drive shaft was intact. The internal components displayed normal operating signatures. There were no anomalies noted with the fuel pump.

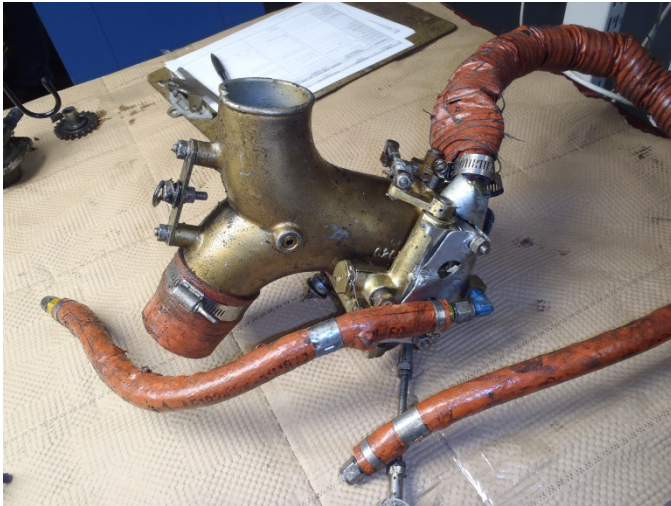
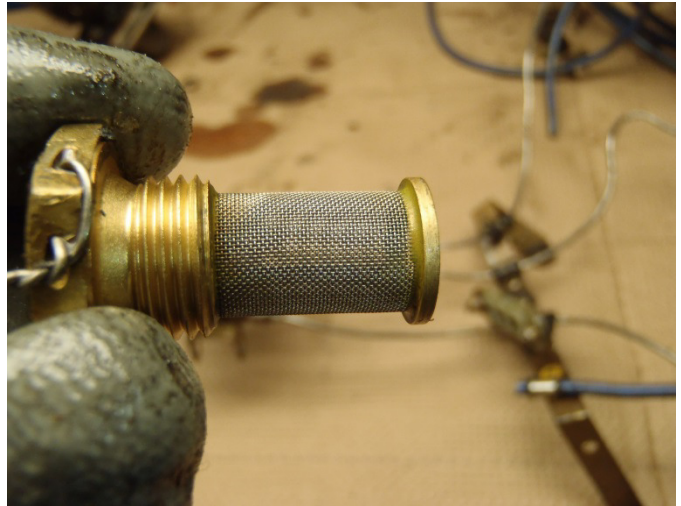
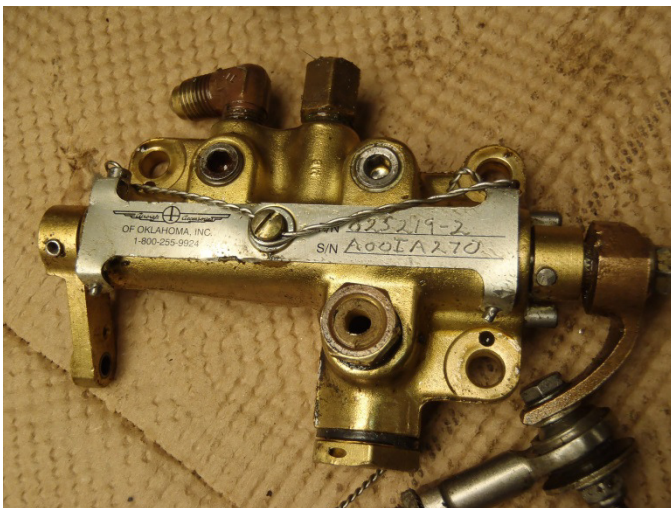
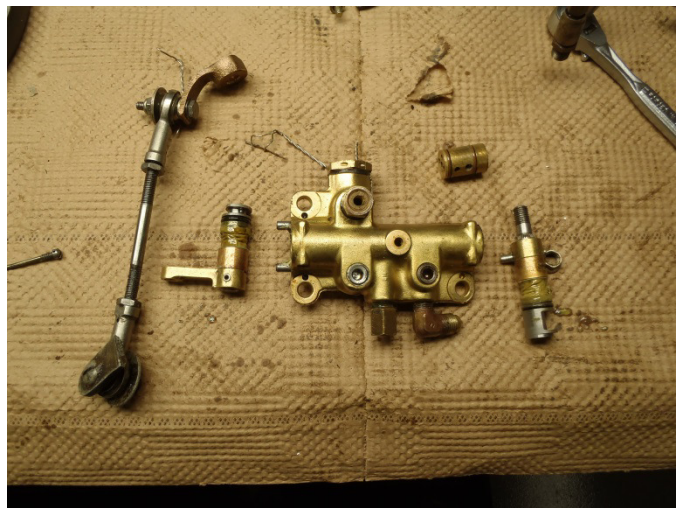
THROTTLE BODY METERING UNIT

Condition: The throttle and fuel metering assembly sustained damage consistent with impact damage and had partially broken free from the engine. The throttle and fuel metering assembly was removed and the fuel metering unit was disassembled. The internal components displayed normal operating signatures and the fuel screen was clear of any contaminants.

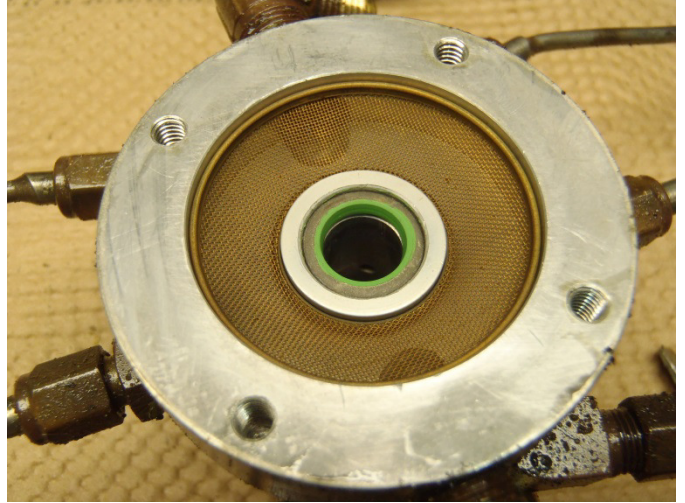
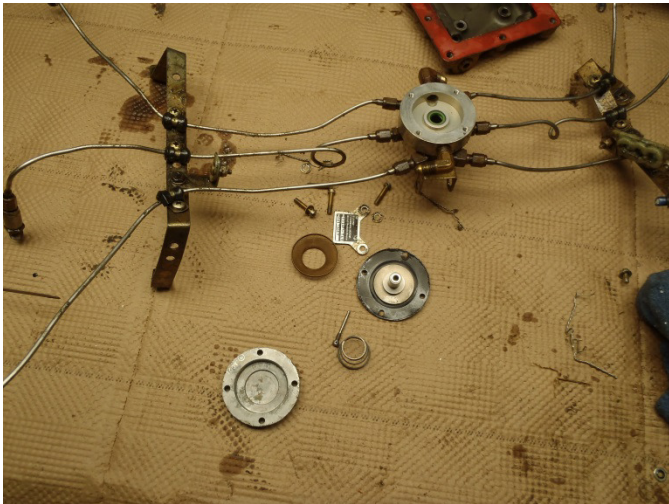
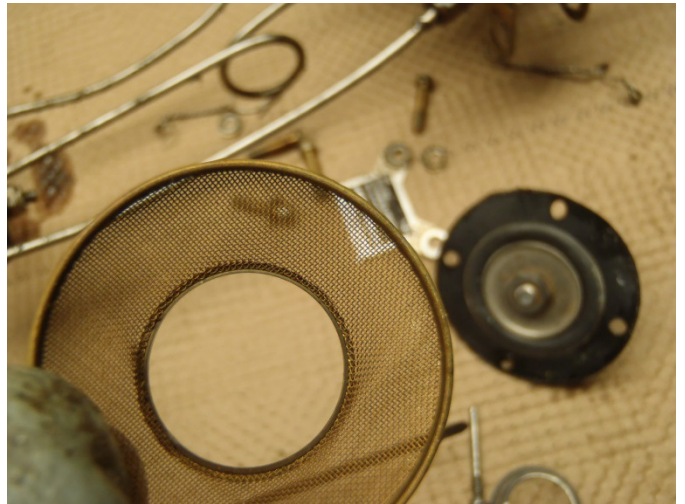
Condition:	The fuel manifold valve remained attached to its respective installation point and was undamaged. The manifold valve was disassembled and the internal components were inspected. There were no anomalies noted with the internal components and the screen was clear of contaminates.
-------------------	--

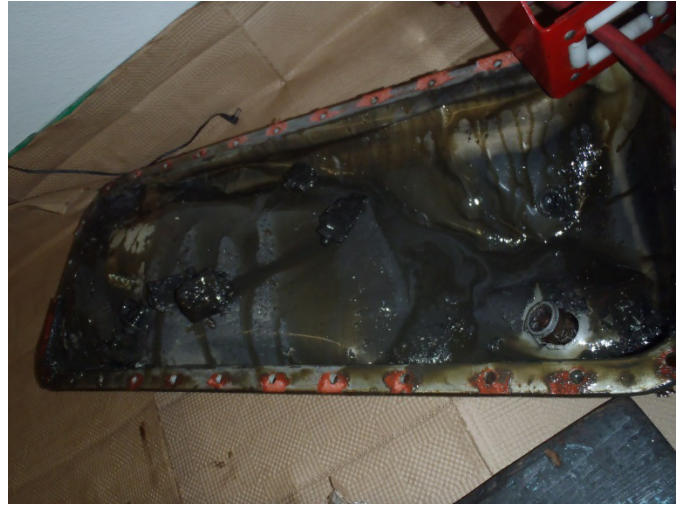
OIL SUMP

Condition: The oil sump sustained damage consistent with impact damage. The oil sump was removed and it was noted only residual oil remained within the oil sump. The oil sump also contained a significant amount of metallic material consistent with connecting rods, bearings, crankcase material, and other unidentifiable metallic debris.

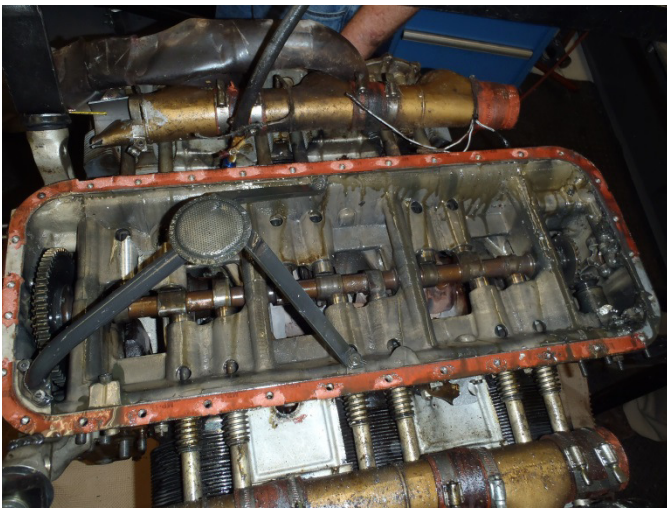
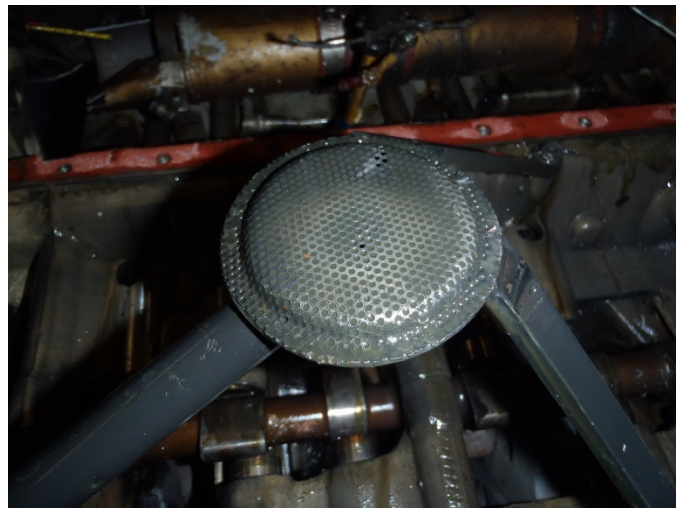
OIL PICK-UP TUBE & SCREEN

Condition: The oil pickup tube and screen was undamaged and displayed normal operating signatures. The oil pickup screen contained a small amount of metallic material; however, the screen was not blocked.

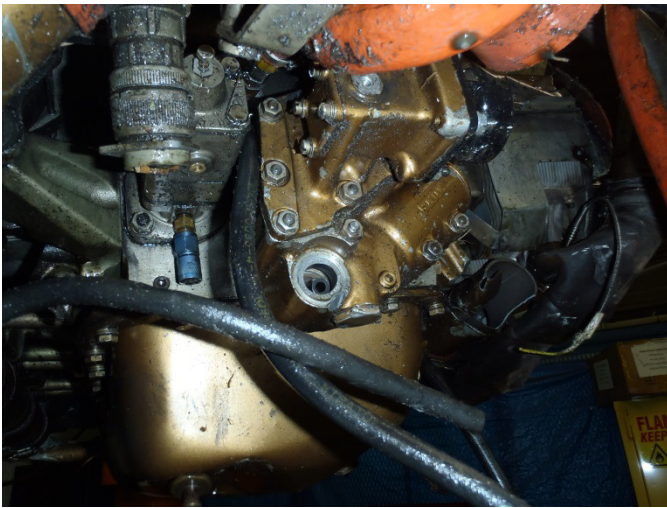
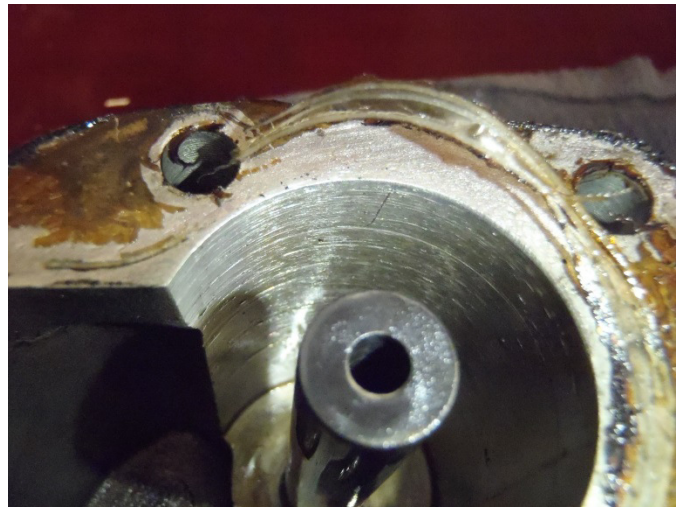
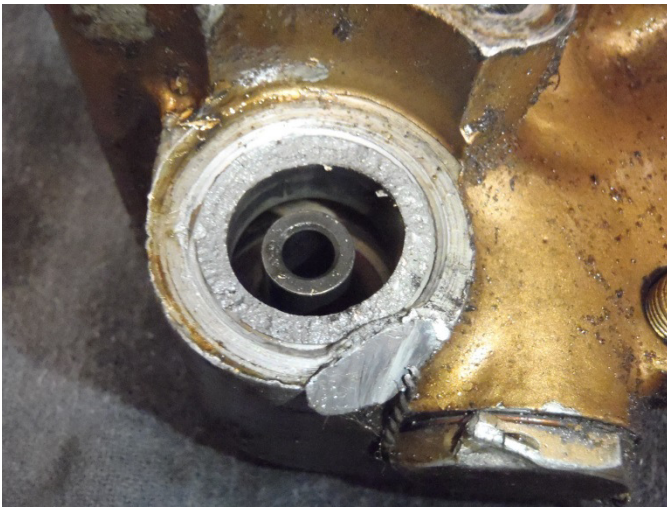
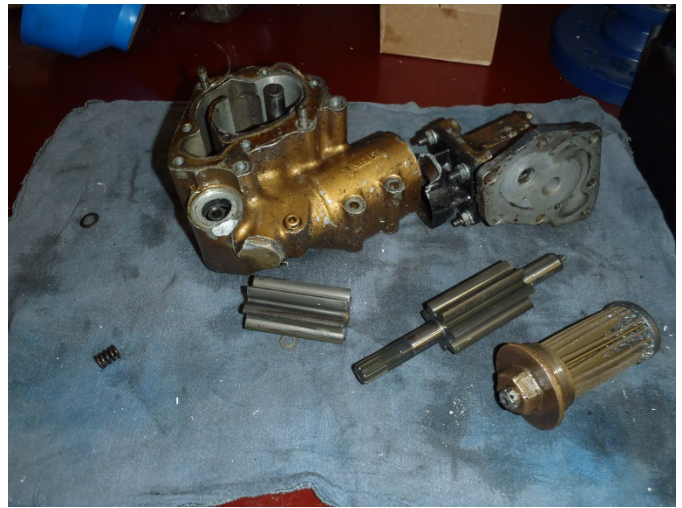
OIL PUMP

The oil pump sustained damage consistent with impact damage; the oil pressure relief valve housing had broken free from the rest of the oil pump. The oil pump was disassembled and visually inspected. The oil pump housing displayed scoring consistent with hard particle passage and there was metallic material present on the oil pump gears. The oil pressure relief valve could not be removed due to the impact damage.

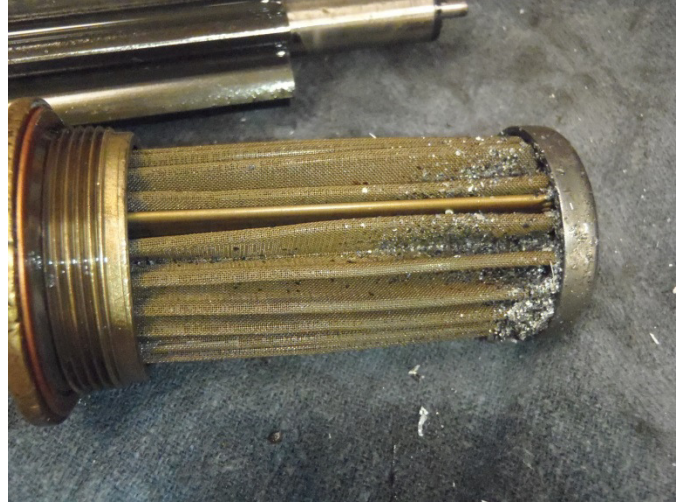
OIL SCREEN

Condition: The oil screen remained secure in its respective installation point and was undamaged. The screen was removed and it was noted there was a significant amount of metallic material present in the oil screen.

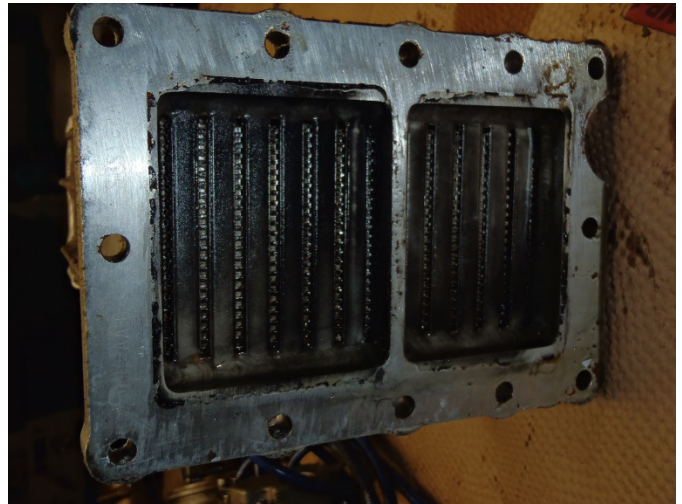
OIL COOLER

Condition: The oil cooler remained attached to the oil cooler adapters and displayed minor impact damage signatures and normal operating signatures. There were no anomalies noted with the oil cooler

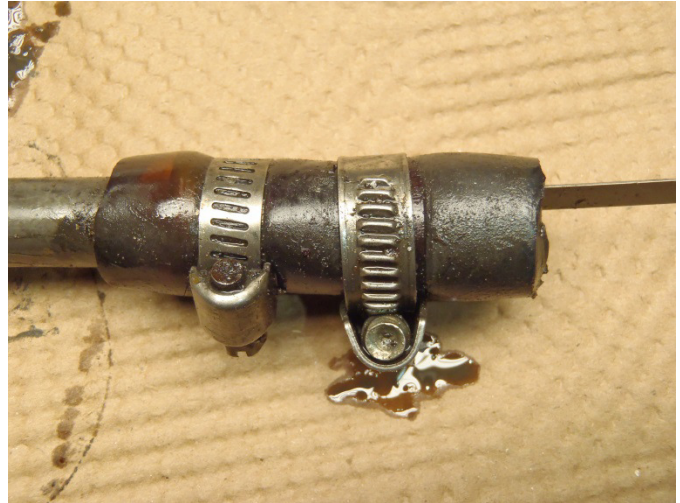
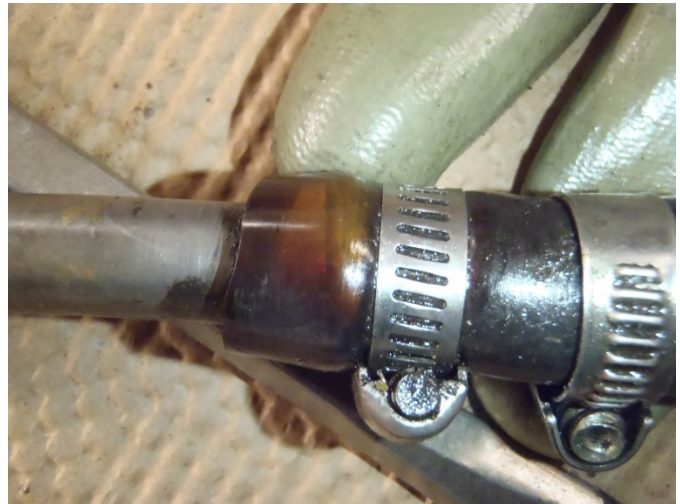
OIL GAGE

Condition: According to the on scene investigator the oil gage housing extension was found detached from its oil gage housing in the engine crankcase. The oil gage housing extension was inspected and there were no signs of impact damage. The oil gage hose was not positioned in such a way to place the oil gage housing extension joint in the middle of the hose; according to SIL14-6 the hose should be centered over the connection joint. It was also noted that the top hose clamp was placed below the oil gage housing extension bead; the bead on the oil gage housing extension is designed to fit securely against the oil gage housing. The hose material was not as specified in CMI parts manual.

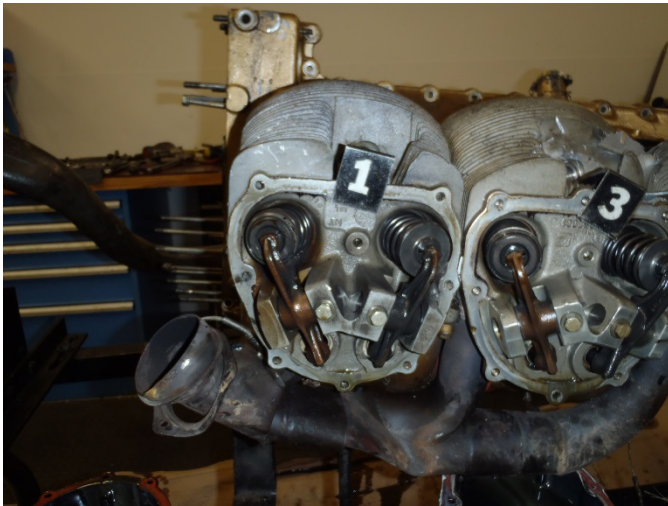
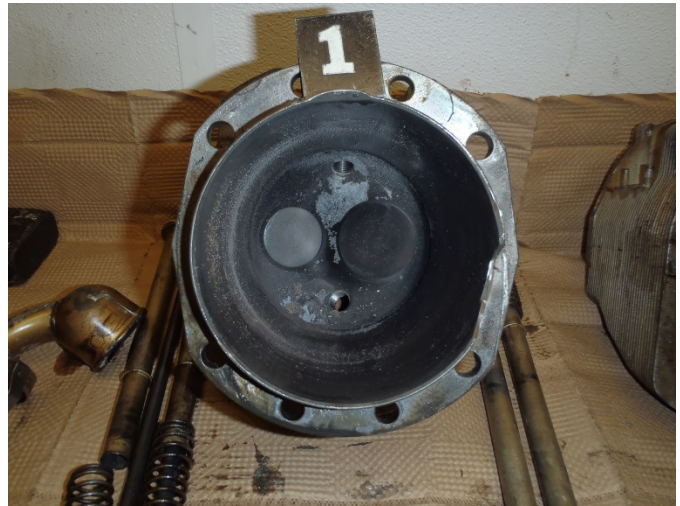
CYLINDER #1	P/N: Illegible	S/N: ECC712ST	
Condition:	The cylinder remained attached to its respective cylinder bay and displayed damage consistent with impact damage. The cylinder was removed and it was noted that the valve heads, cylinder bore, and combustion chamber displayed normal operating and combustion signatures. The cylinder skirt displayed damage consistent with mechanical damage. The overhead components displayed normal operating signatures.

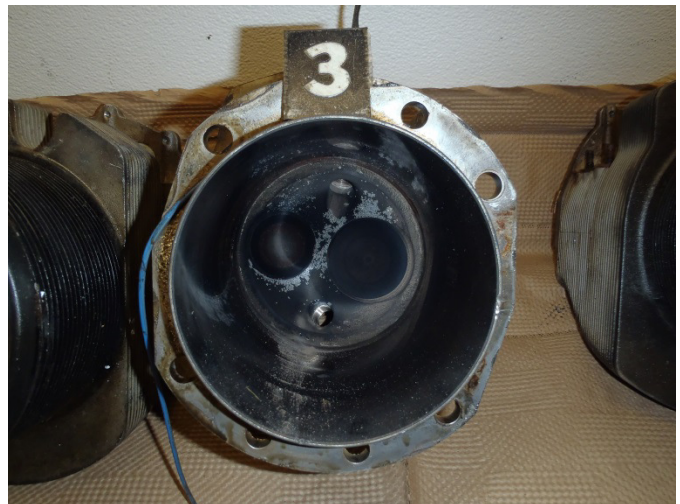
CYLINDER #3	P/N: SA52006-A1	S/N: 526-113-12630	
Condition:	The cylinder remained attached to its respective cylinder bay and displayed damage consistent with impact damage. The cylinder was removed and it was noted that the valve heads, cylinder bore, and combustion chamber displayed normal operating and combustion signatures. The cylinder skirt displayed damage consistent with mechanical damage. The overhead components displayed normal operating signatures.

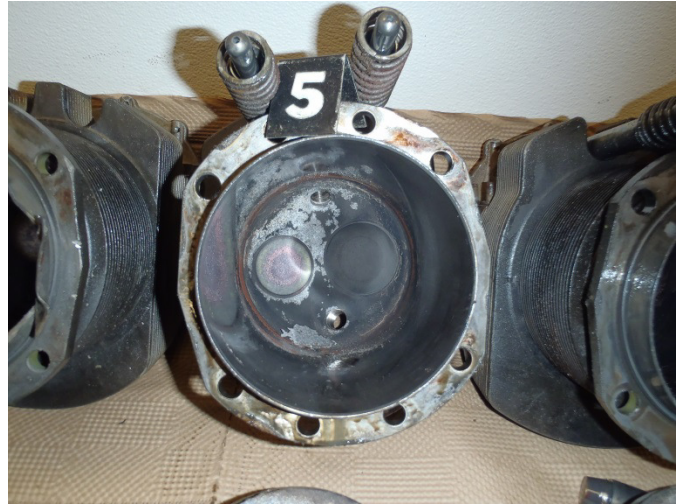
CYLINDER #5 P/N: Illegible S/N: Illegible

Condition: The cylinder remained attached to its respective cylinder bay and displayed damage consistent with impact damage. The cylinder was removed and it was noted that the valve heads, cylinder bore, and combustion chamber displayed some corrosion and normal operating and combustion signatures. The cylinder skirt was undamaged. The overhead components displayed normal operating signatures.

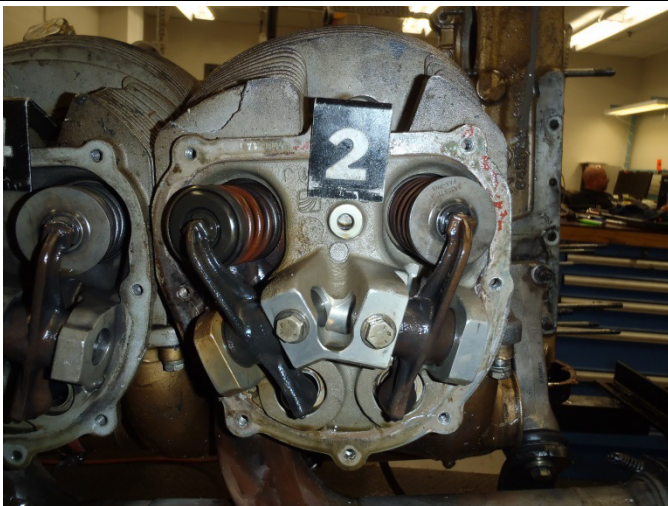
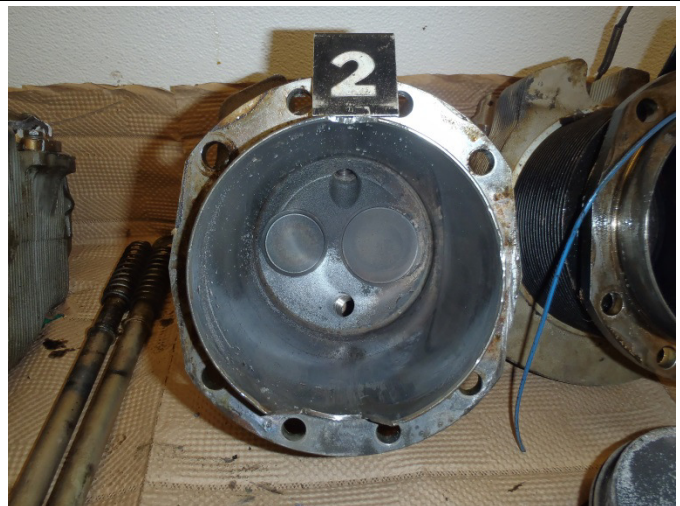
CYLINDER #2 P/N: SA52006A16 S/N: 528-G11-9300

Condition: The cylinder remained attached to its respective cylinder bay and displayed damage consistent with impact damage. The cylinder was removed and it was noted that the valve heads, cylinder bore, and combustion chamber displayed normal operating and combustion signatures. The cylinder skirt displayed damage consistent with mechanical damage. The overhead components displayed normal operating signatures.

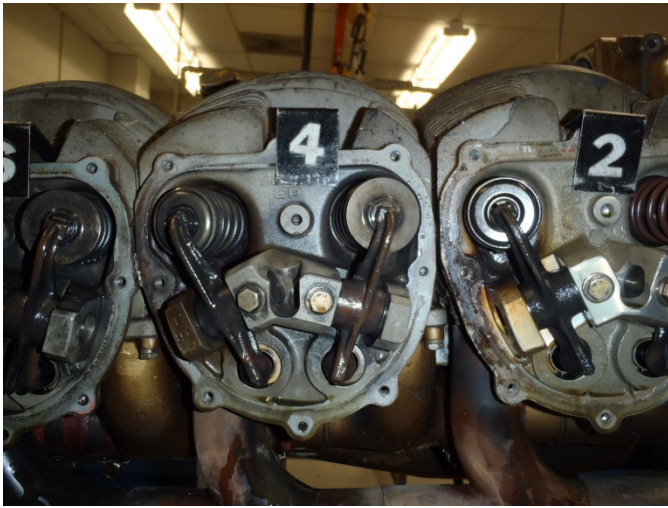
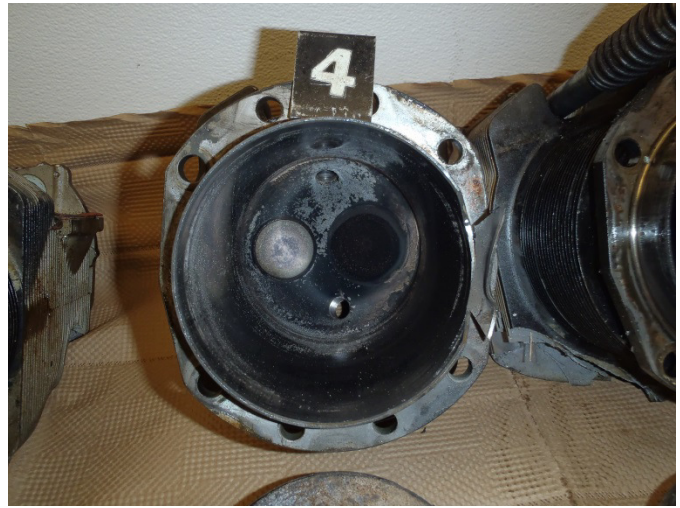
CYLINDER #4 P/N: Illegible S/N: Illegible

Condition: The cylinder remained attached to its respective cylinder bay and displayed damage consistent with impact damage. The cylinder was removed and it was noted that the valve heads, cylinder bore, and combustion chamber displayed normal operating and combustion signatures; the cylinder also displayed minor corrosion. The cylinder skirt displayed damage consistent with mechanical damage. The overhead components displayed normal operating signatures.

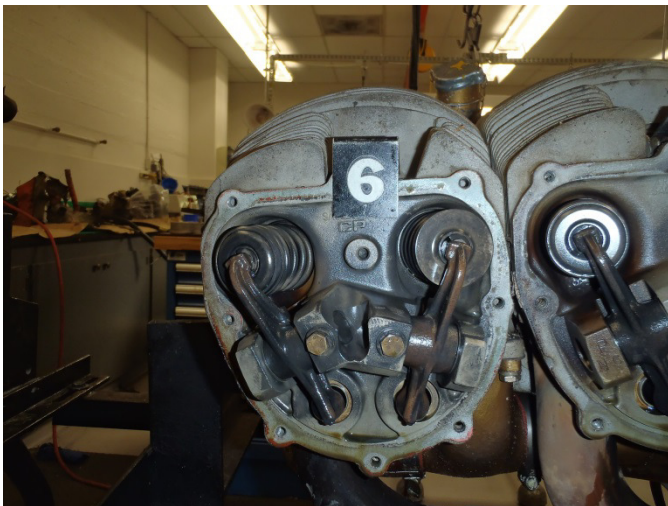
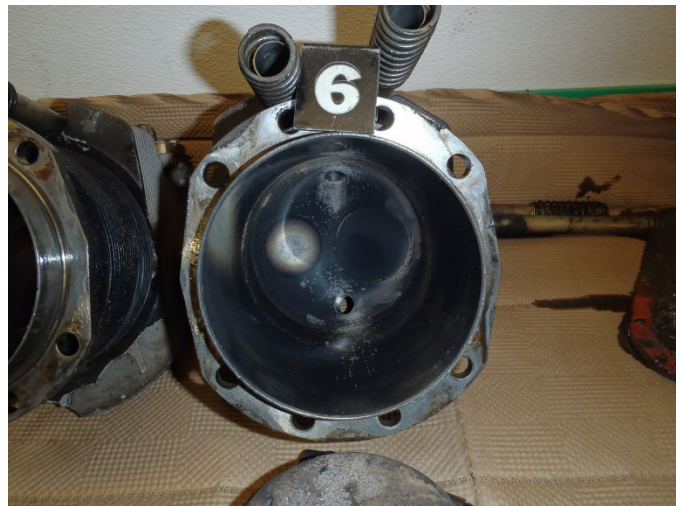
CYLINDER #6 P/N: SA52000-A1 S/N: 52-J02-25097

Condition: The cylinder remained attached to its respective cylinder bay and displayed damage consistent with impact damage. The cylinder was removed and it was noted that the valve heads, cylinder bore, and combustion chamber displayed normal operating and combustion signatures. The cylinder skirt was undamaged. The overhead components displayed normal operating signatures.

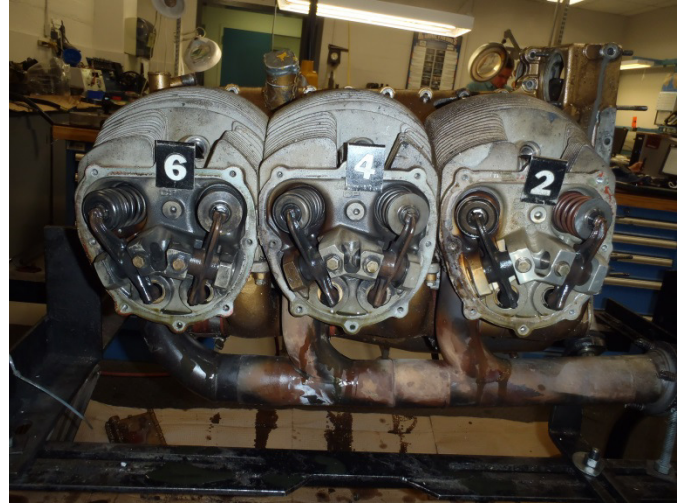
Condition: All of the valves and guides displayed normal operating signatures and normal combustion signatures. There were no anomalies noted with any of the valves.

Condition: All of the rocker arms displayed normal operating signatures. There were no anomalies noted with the rocker arms.

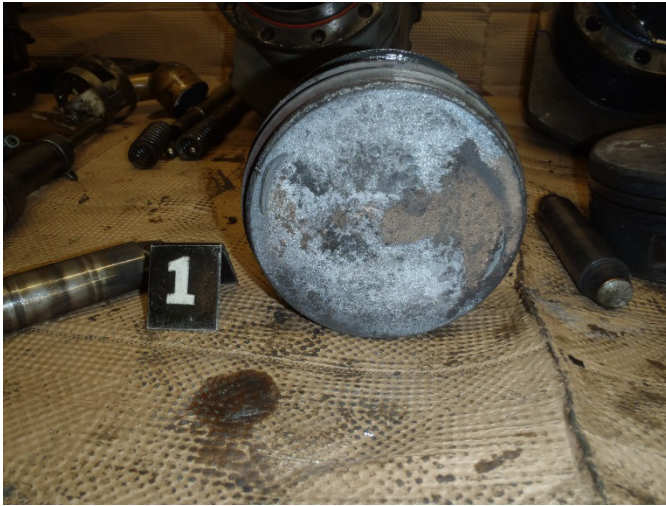
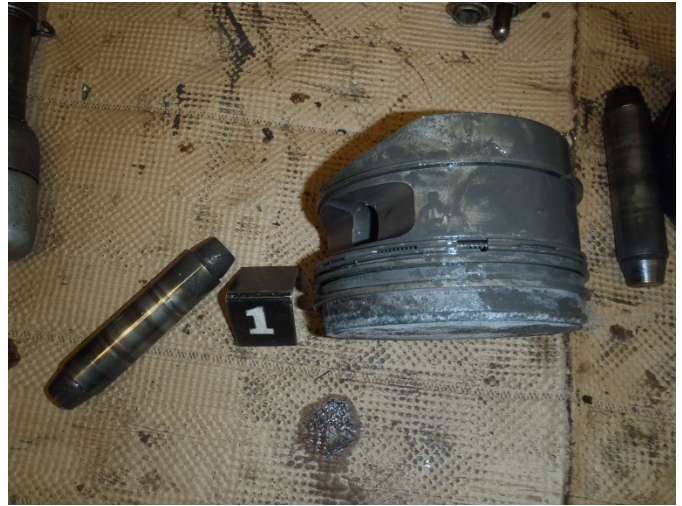
#1 PISTON, RINGS AND PIN

The piston head displayed normal combustion deposits and had two semicircular indentions consistent with valve strikes. The piston skirt displayed normal operating signatures and the back of the piston displayed damage consistent with mechanical damage. All of the piston rings were intact and free to move in their respective grooves.

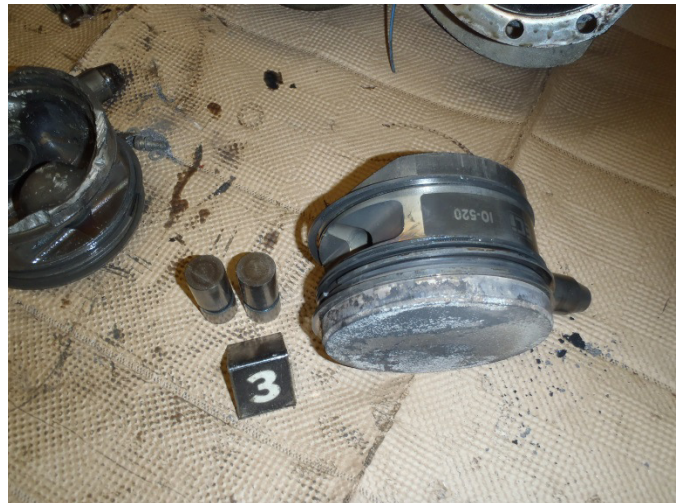
#3 PISTON, RINGS AND PIN

The piston head displayed normal combustion deposits. The piston skirt displayed normal operating signatures and the back of the piston displayed damage consistent with mechanical damage. All of the piston rings were intact and free to move in their respective grooves.

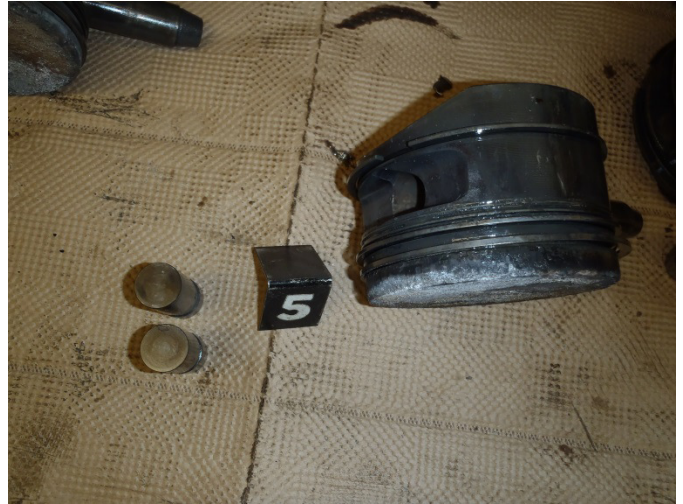
Condition: The piston head displayed normal combustion deposits. The piston skirt displayed normal operating signatures and the back of the piston displayed damage consistent with mechanical damage. All of the piston rings were intact and free to move in their respective grooves.

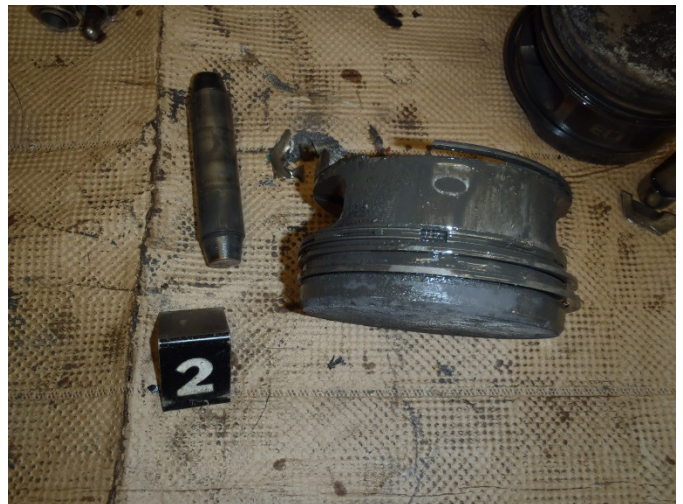
#2 PISTON, RINGS AND PIN	Piston P/N: 2654850
-------------------------------------	---------------------

Condition: The piston head displayed normal combustion deposits and had two semicircular indentions consistent with valve strikes. The piston skirt displayed normal operating signatures and the back of the piston displayed damage consistent with mechanical damage; a portion of the piston had broken free from the rest of the piston. The rear piston ring had broken which was consistent with the mechanical damage to the piston. The remaining piston rings were intact and free in their respective grooves.

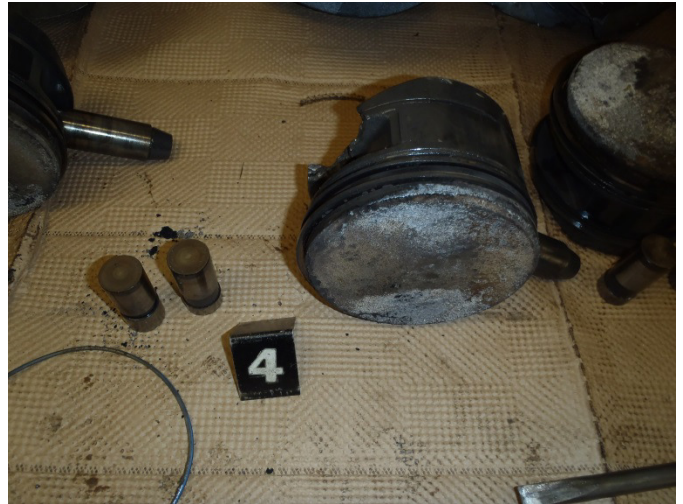
Condition: The piston head displayed normal combustion deposits. The piston skirt displayed normal operating signatures and the back of the piston displayed damage consistent with mechanical damage; a portion of the piston had broken free from the rest of the piston. The rear piston ring had broken which was consistent with the mechanical damage to the piston. The remaining piston rings were intact and free in their respective grooves.

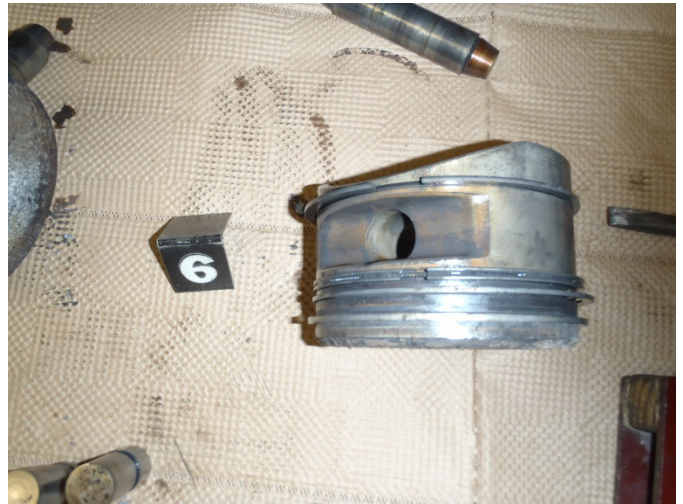
#6 PISTON, RINGS AND PIN	Piston P/N: SA648013
-------------------------------------	----------------------

Condition: The piston head displayed normal combustion deposits. The piston skirt displayed normal operating signatures and the back of the piston displayed damage consistent with mechanical damage. All of the piston rings were intact and free to move in their respective grooves.

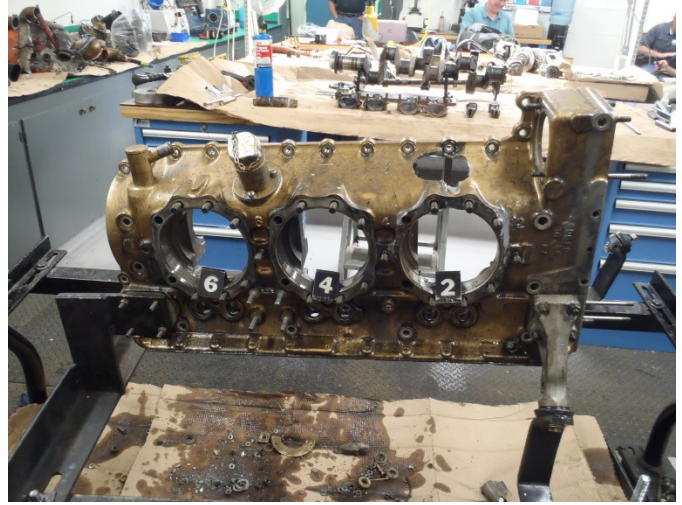
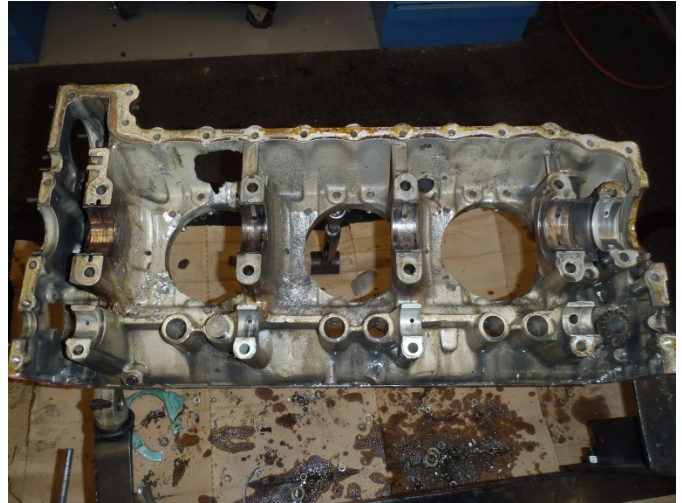
CRANKCASE	Casting Number:	1-3-5: 649043	2-4-6: 649042	S/N: A9 96 05 R
Condition:	The crankcase displayed damage in a form of a large hole at the #2 cylinder bay; the damage was consistent with mechanical damage from a released connecting rod. The internal portion of the crankcase displayed mechanical damage to the #1, #2, and the #4 cylinder bays. There were no signs of bearing movement or blockages of the oil galleys.

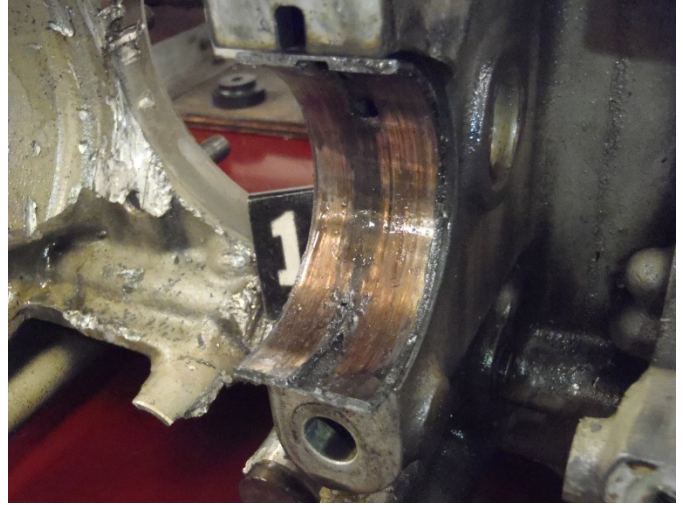
#1 MAIN BEARINGS	P/N: SA642720	Date Code: 2-07
Condition:	The bearing was in place in the bearing saddle and displayed damage consistent with lubrication distress. The bearing displayed scoring and thermal smearing of the surface babbit. The bearing displayed damage from being extruded.

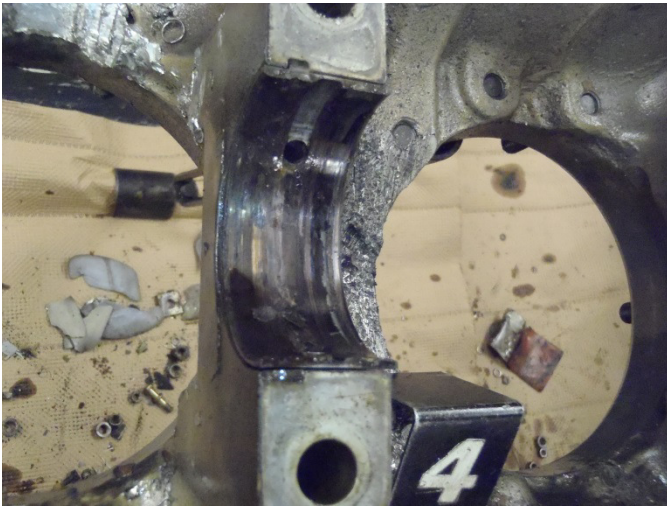
#2 MAIN BEARINGS	P/N: SA642720	Date Code: 2-07
Condition:	The bearing was in place in the bearing saddle and displayed damage consistent with lubrication distress. The bearing displayed scoring and thermal smearing of the surface babbit.

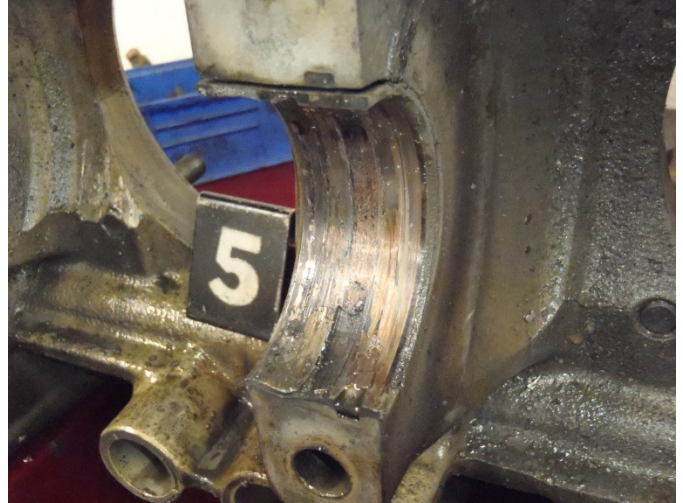
#3 MAIN BEARINGS	P/N: SA642720	Date Code: 2-07
Condition:	The bearing was in place in the bearing saddle and displayed damage consistent with lubrication distress. The bearing displayed scoring and thermal smearing of the surface babbit.

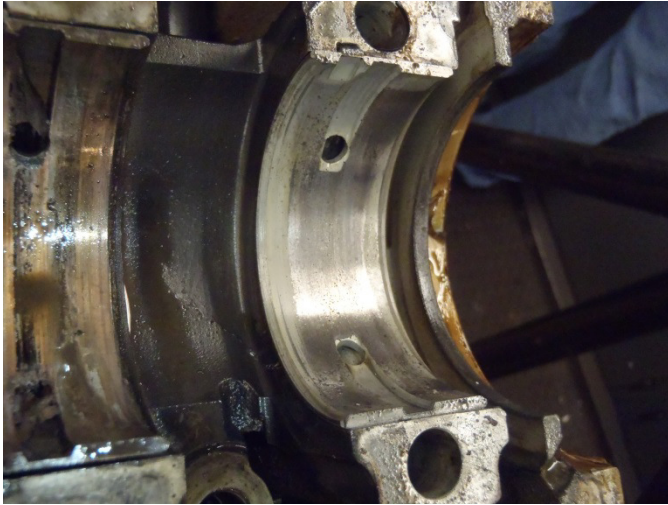
Condition: The bearing was in place in the bearing saddle and displayed normal operating signatures. There were no signs of bearing movement or distress with the bearing.

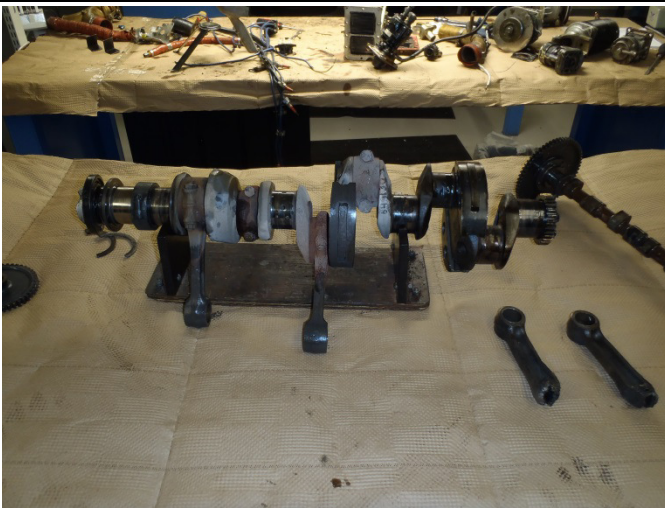
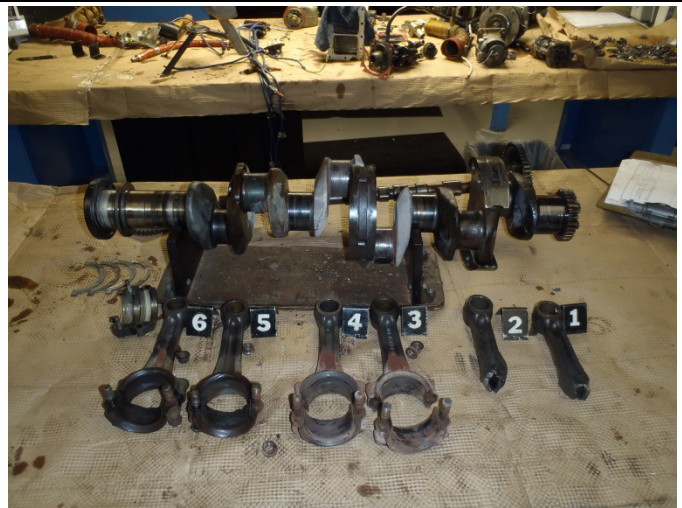
CRANKSHAFT	Forging Number: 649130	S/N: Propeller Flange Not returned	Heat code: HAO
Condition:	The propeller flange had broken free from the rest of the crankshaft and was not returned with the rest of the engine. The rest of the crankshaft was intact and the crankshaft gear was intact, secure, and the bolts were safety wired. The crankshaft main bearing displayed varying amount of lubrication distress; all of the connecting rod journal displayed lubrication distress signatures. The #1 and the #2 connecting rod bearings displayed the most thermal damage and also displayed some mechanical damage. The #1 and the #2 connecting rod journal oil galleys could not be inspected due to displaced journal material. The remaining oil galleys were intact and clear of any obstruction.

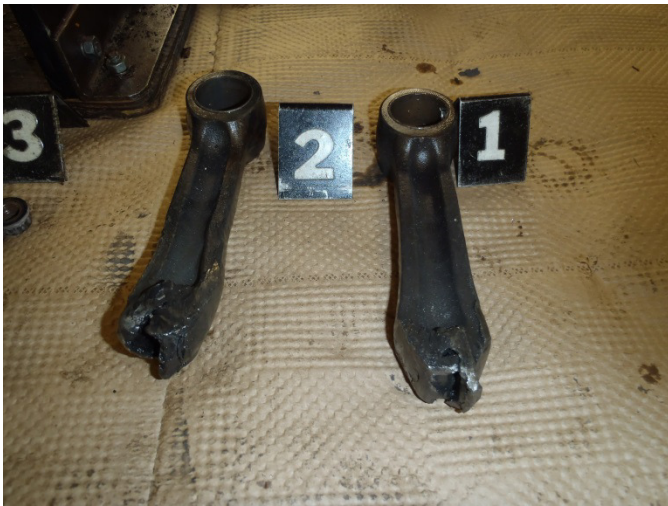
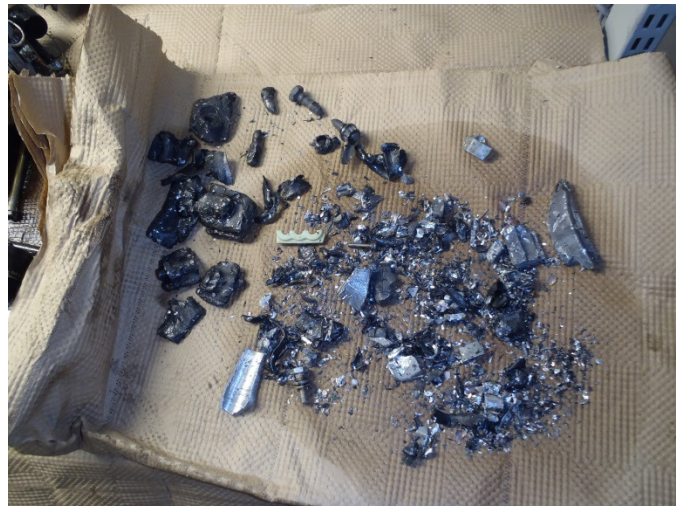
#1 CONNECTING ROD	P/N: Illegible	Forging: 632041
Condition:	The connecting rod had released from its respective journal and displayed damage consistent with thermal and mechanical damage. The connecting rod cap and the connecting rod bolts and nuts were located in the oil sump. The connecting rod cap displayed thermal and mechanical damage.

#1 CONNECTING ROD BEARING	P/N: Illegible	Date Code: Illegible
Condition:	Fragments of the connecting rod bearing were located in the oil sump. The bearing fragments displayed thermal damage consistent with lubrication distress as well as mechanical damage.

#2 CONNECTING ROD	P/N: Illegible	Forging: 632041
Condition:	The connecting rod had released from its respective journal and displayed damage consistent with thermal and mechanical damage. The connecting rod cap and the connecting rod bolts and nuts were located in the oil sump. The connecting rod cap displayed thermal and mechanical damage.

#2 CONNECTING ROD BEARING	P/N: Illegible	Date Code: Illegible
Condition:	Fragments of the connecting rod bearing were located in the oil sump. The bearing fragments displayed thermal damage consistent with lubrication distress as well as mechanical damage.
