ENGINE EXAMINATION REPORT

ENGINE MODEL	IO-520-E
ENGINE SERIAL NUMBER	215503-R
AIRCRAFT MAKE & MODEL	Aero Commander 500A
AIRCRAFT SERIAL NUMBER	500A-914-22
AIRCRAFT REGISTRATION	N41AV
FILE NUMBER	14-308

EXAMINATION		ACCIDENT DATA	
DATE	04/14/2015	NTSB ACCIDENT #	CEN15FA056
FACILITY	Continental Motors Inc.	NTSB INVESTIGATOR	Jason Aguilera
ADDRESS	2039 S Broad St Mobile, AL 36615	FAA INVESTIGATOR	Brian Fricker
		ACCIDENT DATE	11/23/2014
		ACCIDENT LOCATION	McDade, Texas

Inspection of the engine revealed that the engine displayed oil starvation signatures. It was reported that the oil gage housing extension was not installed in the oil gage housing at the accident site. Inspection of the oil gage housing and housing extension revealed the rubber hose was not properly installed when compared to SIL14-6.

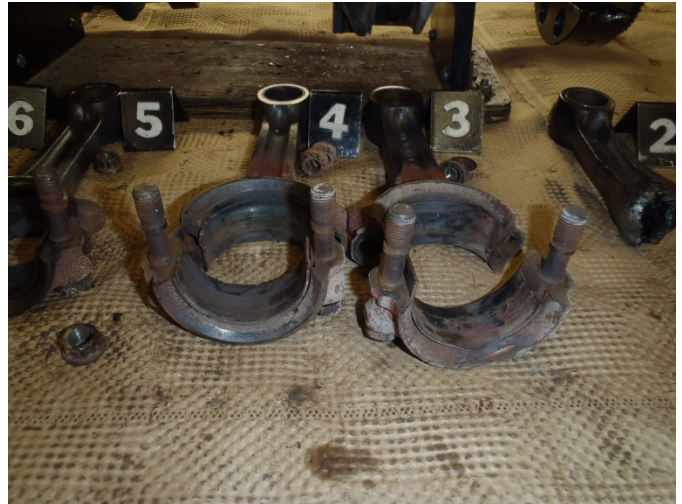
#3 CONNECTING ROD	P/N: Illegible	Forging: 632041
Condition:	The connecting rod assembly remained attached to its respective journal and displayed thermal discoloration consistent with lubrication distress of the rod bearing.

#3 CONNECTING ROD BEARING	P/N: SA630826	Date Code: 11-06
Condition:	The connecting rod bearing displayed lubrication distress and thermal damage of the surface babbitt; the copper layer of the bearing was partially exposed. The bearing had partially extruded from the bearing saddle.

#4 CONNECTING ROD	P/N: Illegible	Forging: 632041
Condition:	The connecting rod assembly remained attached to its respective journal and displayed thermal discoloration consistent with lubrication distress of the rod bearing.

#4 CONNECTING ROD BEARING	P/N: SA630826	Date Code: 11-06
Condition:	The connecting rod bearing displayed lubrication distress and thermal damage of the surface babbitt; the copper layer of the bearing was partially exposed.

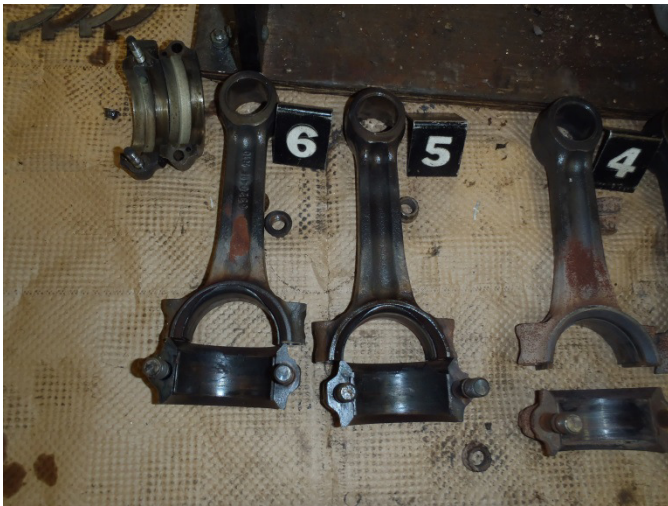
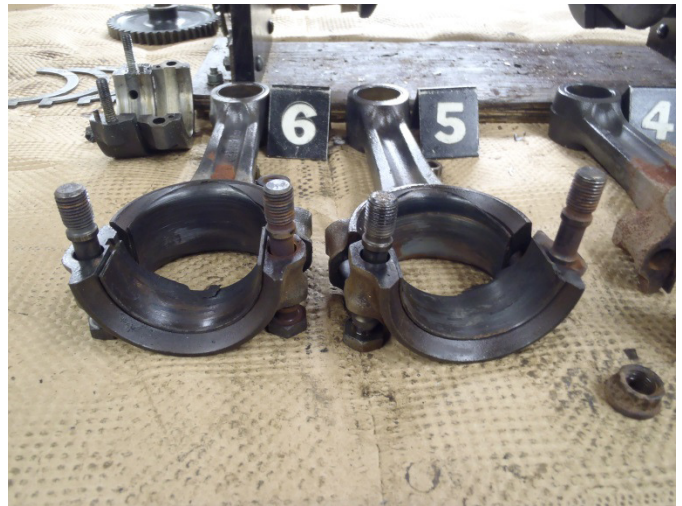
#5 CONNECTING ROD	P/N: Illegible	Forging: 632041
Condition:	The connecting rod assembly remained attached to its respective journal and displayed thermal discoloration consistent with lubrication distress of the rod bearing.

#5 CONNECTING ROD BEARING	P/N: SA630826	Date Code: 11-06
Condition:	The connecting rod bearing displayed lubrication distress and thermal damage of the surface babbitt; the copper layer of the bearing was partially exposed. The bearing had partially extruded from the bearing saddle.

#6 CONNECTING ROD	P/N: Illegible	Forging: 632041
Condition:	The connecting rod assembly remained attached to its respective journal and displayed thermal discoloration consistent with lubrication distress of the rod bearing.

#6 CONNECTING ROD BEARING	P/N: SA630826	Date Code: 11-06
Condition:	The connecting rod bearing displayed lubrication distress and thermal damage of the surface babbitt; the copper layer of the bearing was partially exposed. The bearing had partially extruded from the bearing saddle.

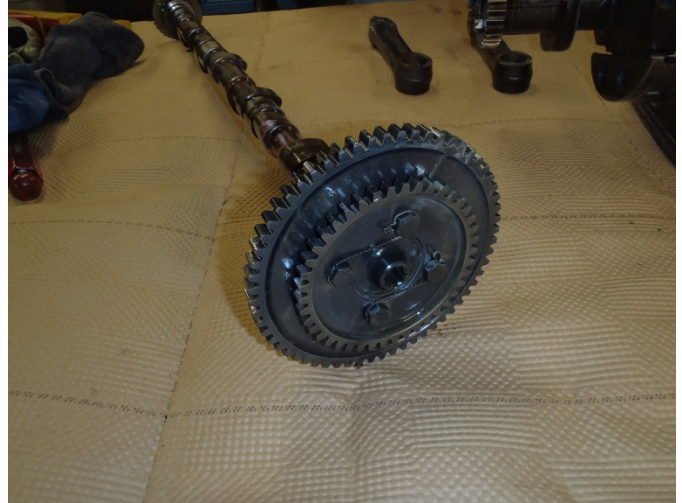
CAMSHAFT	P/N: 655384	S/N: N/A
Condition:	The camshaft remained intact and displayed normal operating signatures. The camshaft gear cluster remained secure and the bolts were safety wired. There were no anomalies noted with the camshaft.

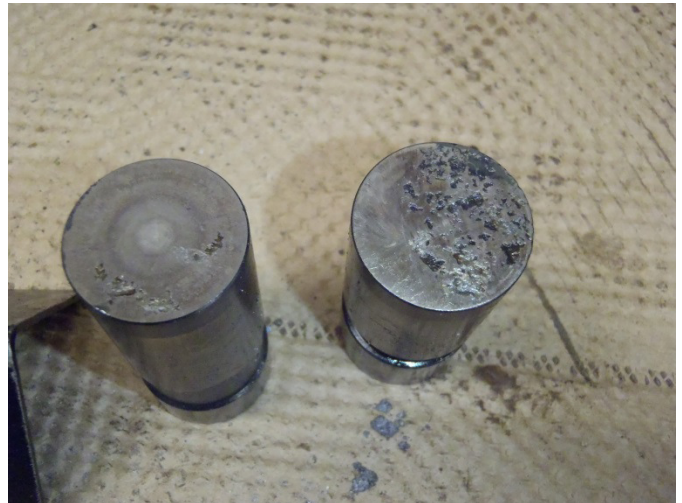
Condition:	The #2 and the #6 lifters displayed spalling of the lifter faces. The remaining lifters displayed normal operating signatures. There were no anomalies noted that would have prevented normal operation.
------------	--

#2 exhaust lifter displaying spalling

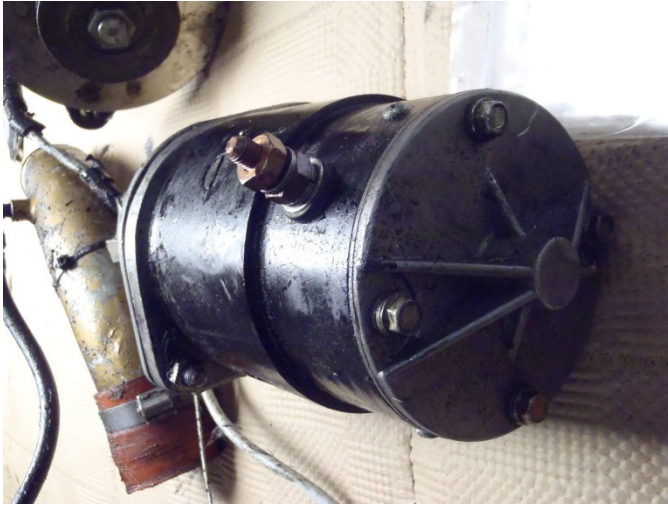
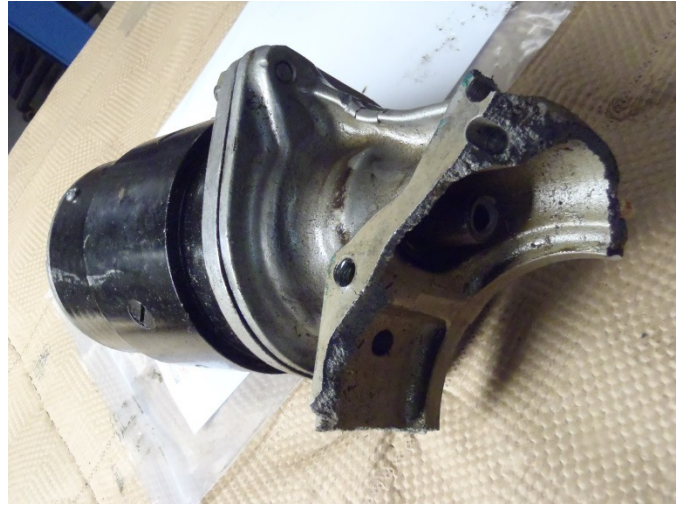
STARTER	Manufacturer: Dataplate Missing	P/N: Dataplate Missing	S/N: Dataplate Missing
Condition:	The starter remained attached to the starter adapter mounting pad; however, the mounting pad had broken free from the rest of the starter adapter. There were no anomalies noted with the starter.

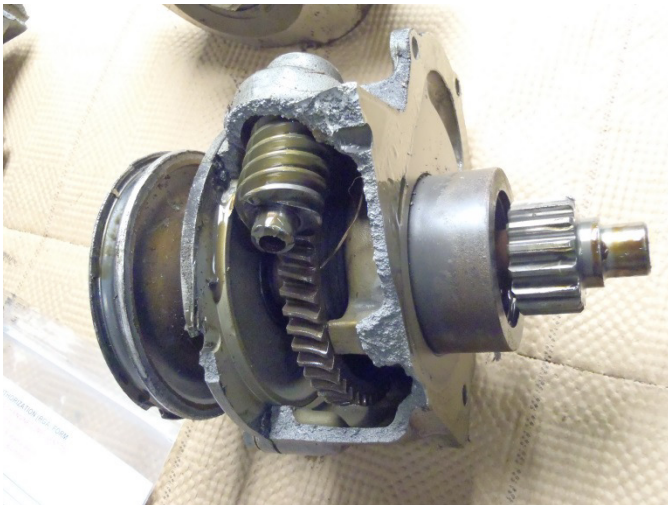
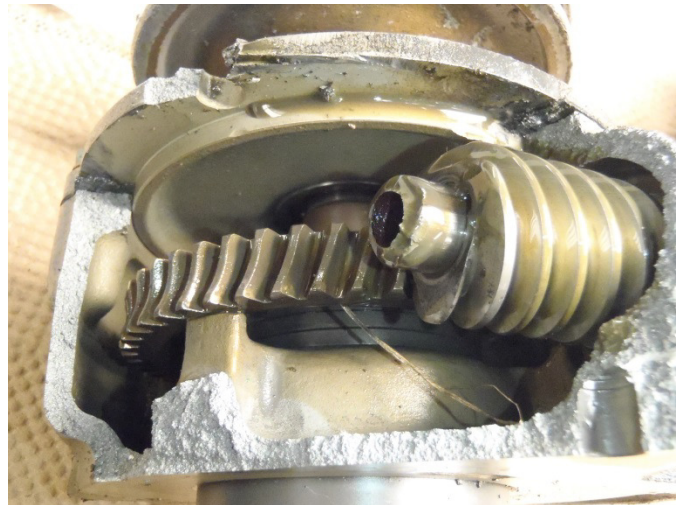
STARTER ADAPTER	P/N: Illegible
------------------------	----------------

Condition:	The starter adapter remained attached to the engine and sustained a significant amount of damage consistent with impact damage. The starter adapter housing was broken and portions of the internal components were exposed. There were no anomalies noted with the starter adapter.
------------	--

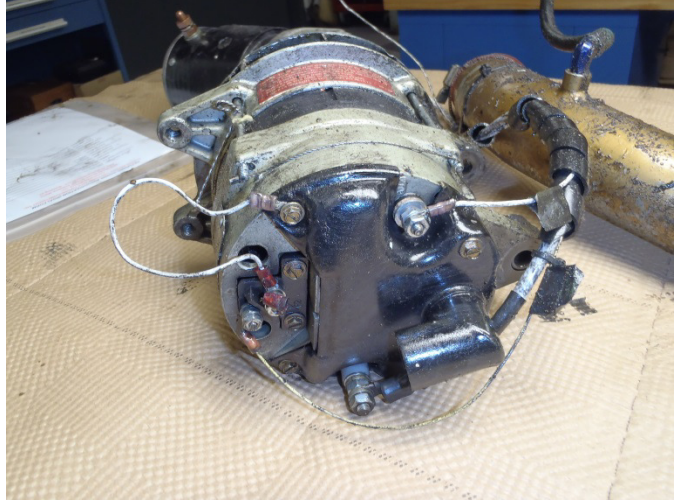
ALT/GEN #1	Manufacturer: Hartzell	P/N: ALU-8521R	S/N: H-N060094
Condition:	The alternator remained attached to its respective installation point and displayed minor damage consistent with impact damage. There were no anomalies noted with the alternator.

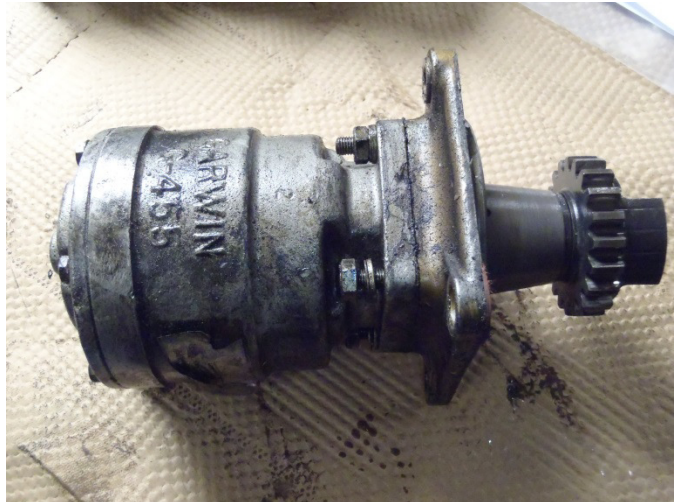
VACUUM PUMP	Manufacturer: Garwin	P/N: Illegible	S/N: Illegible
Condition:	The vacuum pump remained attached to its mounting pad and sustained damage consistent with impact damage. There were no anomalies noted with the vacuum pump.

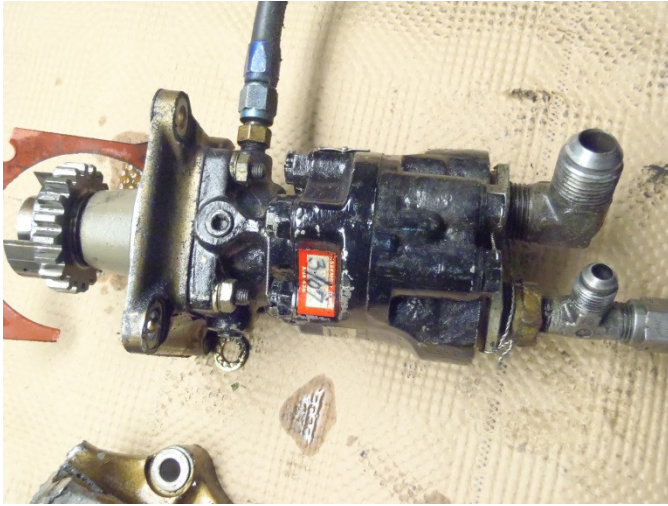
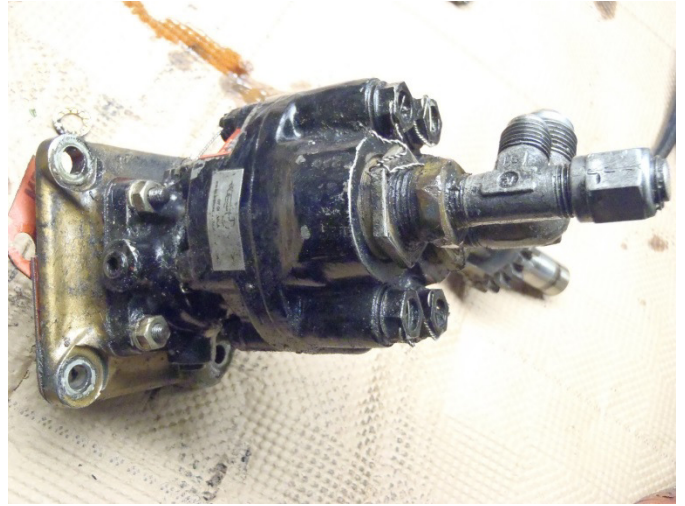
Condition: The hydraulic pump remained attached to its respective mounting pad and displayed minor impact damage signatures. There were no anomalies noted with the hydraulic pump.

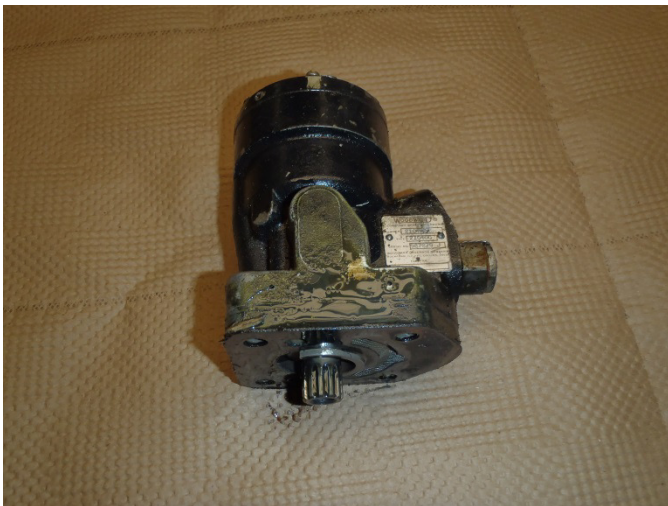
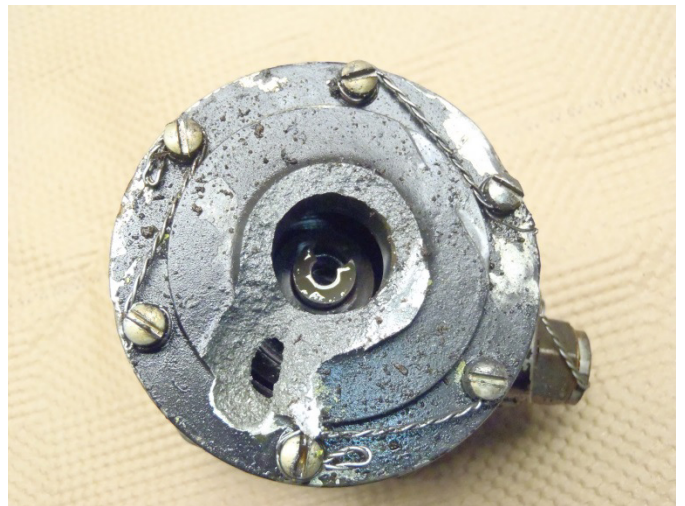
PROPELLER GOVERNOR	Manufacturer: Woodward	P/N: 210467	S/N: 987879 J
---------------------------	------------------------	-------------	---------------

Condition: The propeller governor remained attached to its respective mounting pad and displayed damage consistent with impact damage; a portion of the propeller governor control had broken free from the rest of the governor. There were no anomalies noted with the governor. The governor gasket screen had a small amount of metallic material present; however, the screen was not blocked.
