Engine Investigation

Rolls-Royce Corporation Model 250-C30 Engine CAE 900098

MD 369FF

Registration: N530RL

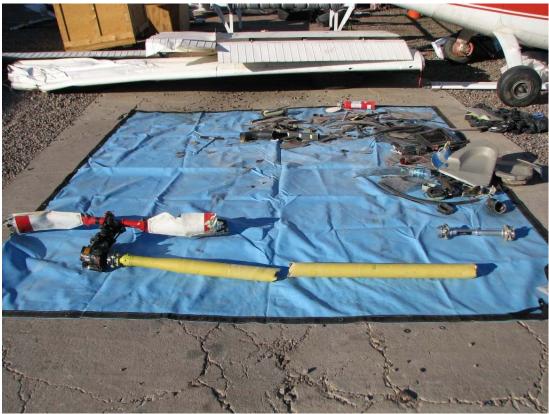
Tai rotor with gear box / tail rotor drive shaft

Tail rotor components (Return)

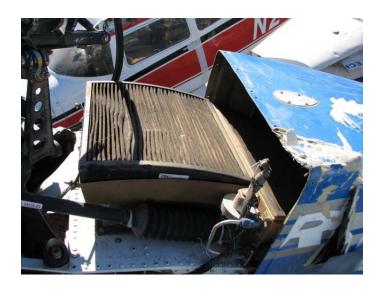
Inlet barrier filter (Return)

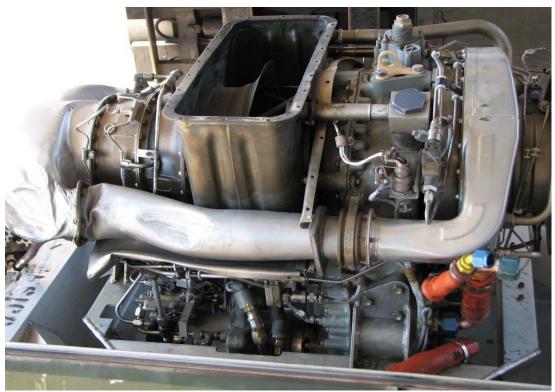
Exhaust collector support and accessory gear box (Return)

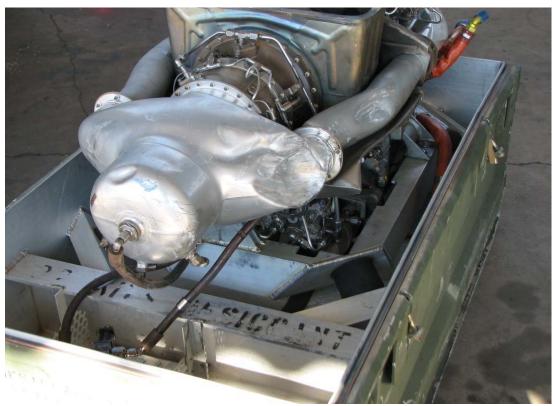
Outer combustion case / right side compressor air discharge tube

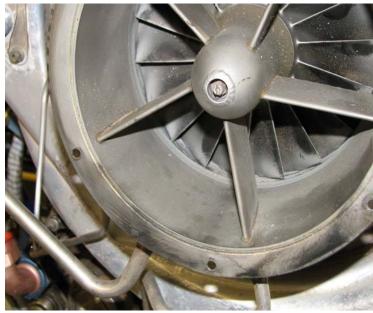
Compressor inlet

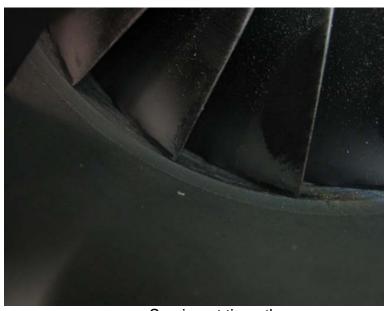
90 degree arc between 3 and 6 o'clock positions, aft looking forward. (Fig 12) Examination of the combustor liner revealed it to be serviceable with no unusual burn patterns or streaking. External examination of the fuel nozzle revealed it to be serviceable with no excessive carbon on outer air shroud. A visual examination into the N1 turbine section through the number 1 turbine nozzle revealed no damage or anomalies. (Fig 13) The engine was then examined thoroughly with no discrepancies noted which would preclude the engine run. The engine was then placed into the test cell where it was motored and with a positive indication of oil pressure the engine started within both time and temperature specifications. During engine warm up at ground idle, vibration scans revealed all components to be within specification. A five point power calibration check was then conducted during which the engine met or exceeded specification at each point. A governor droop check was then conducted where the power turbine governor responded normally and within specification. The engine was then shut down normally with no discrepancies noted.

Scoring at tip path
