Engine Investigation Report

**Allison Model 250-C20B
Engine CAE 831376**

**Bell 206B
Registration: N59518**

**Accident date: February 10, 2013
Investigation date: February 11 - 13, 2013
Engine disassembly date: August 13, 2013
Report date: 13 March, 2014**

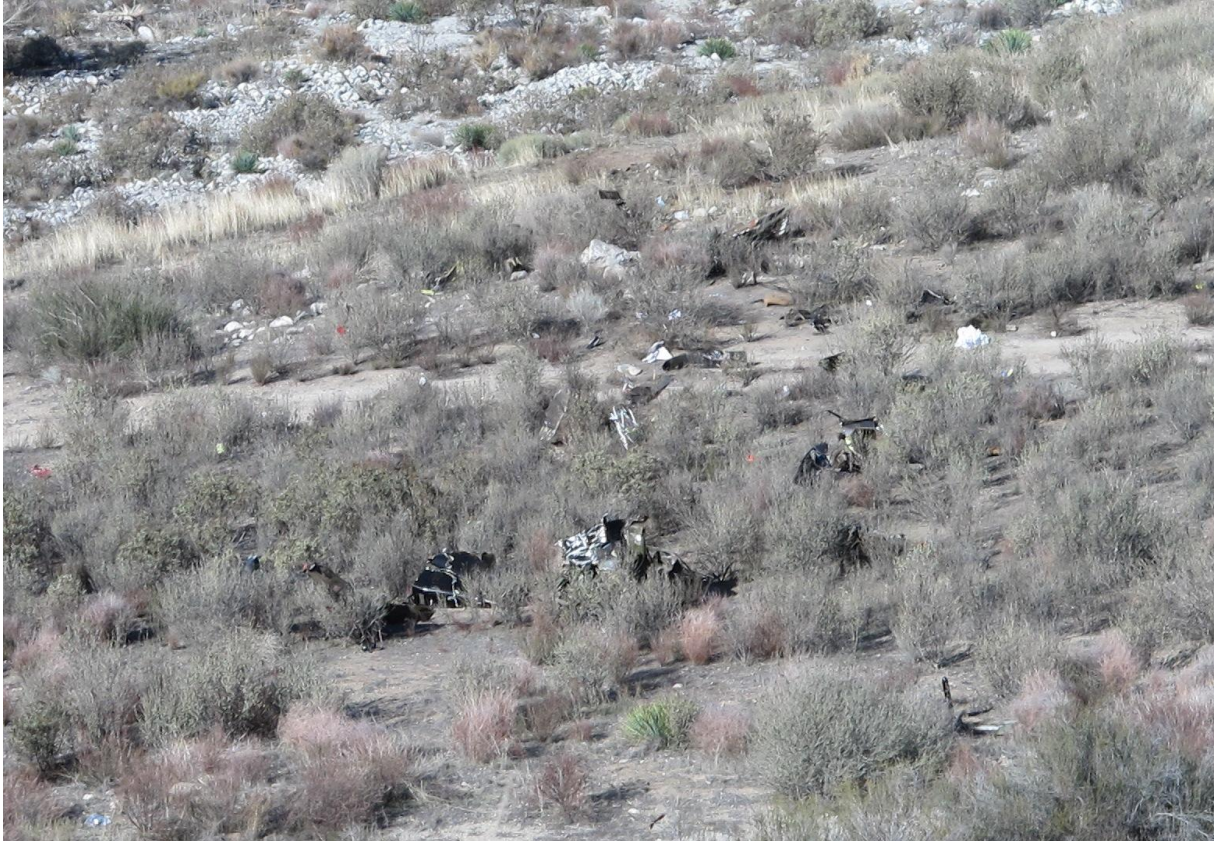
Fig: 1

Rolls-Royce was invited by the NTSB to participate in the on-site investigation of the accident on February 11, 2013. Also present were investigators from Bell Helicopters, the FAA, and NTSB. The accident site was located at the base of a valley wall with a portion of the left skid being the first identified point of impact. The helicopter's debris field scattered approximately 170 feet. The main wreckage, which consisted of a majority of the airframe fuselage, was located about 70 feet west of the edge of the plateau's ridgeline. All major structural components of the helicopter were located throughout the wreckage debris path. The engine was oriented exhaust down, located within the engine compartment along the debris path approximately 75 feet from the main wreckage. All engine mounts remained attached to the engine. However, they were separated from the airframe side of the engine bay. The majority of impact damage to the engine was on the left side with crushing and flattening of several components located on that side. One exhaust stack had separated from the exhaust collector with the other remaining in position, but crushed. The exhaust collector was crushed inward on both sides Fig 1. The aircraft wreckage was transported to a secured facility for further inspection.

Wreckage Debris Field

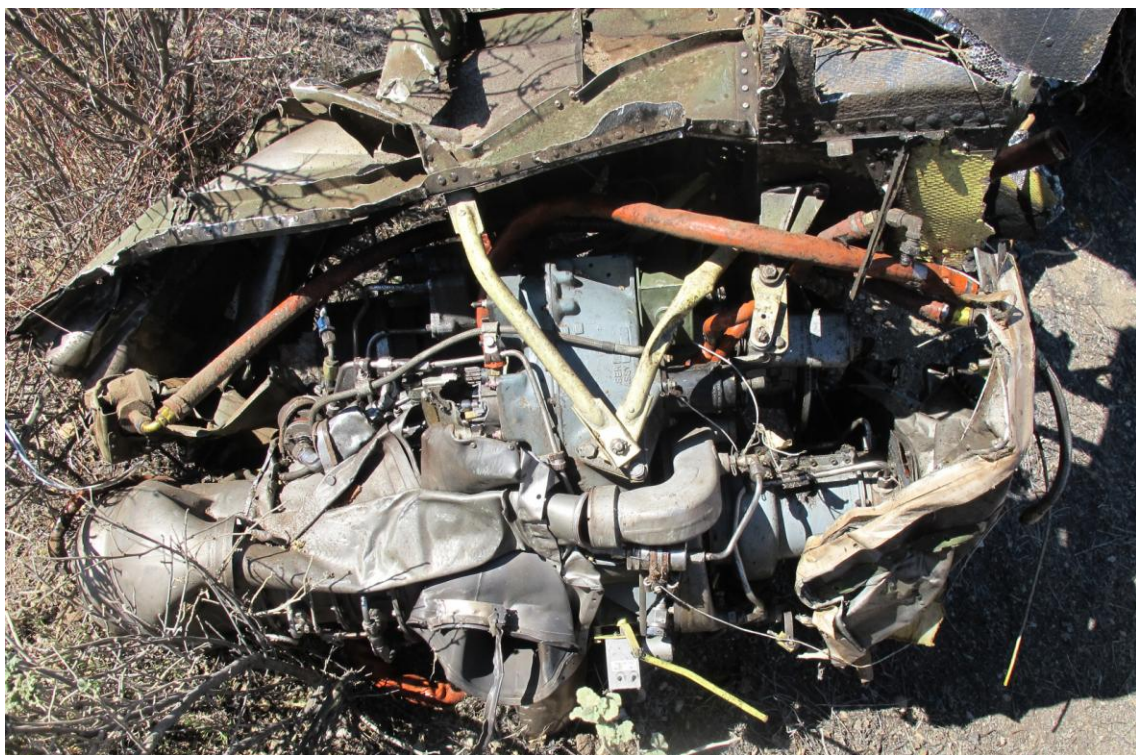
Engine On-Site

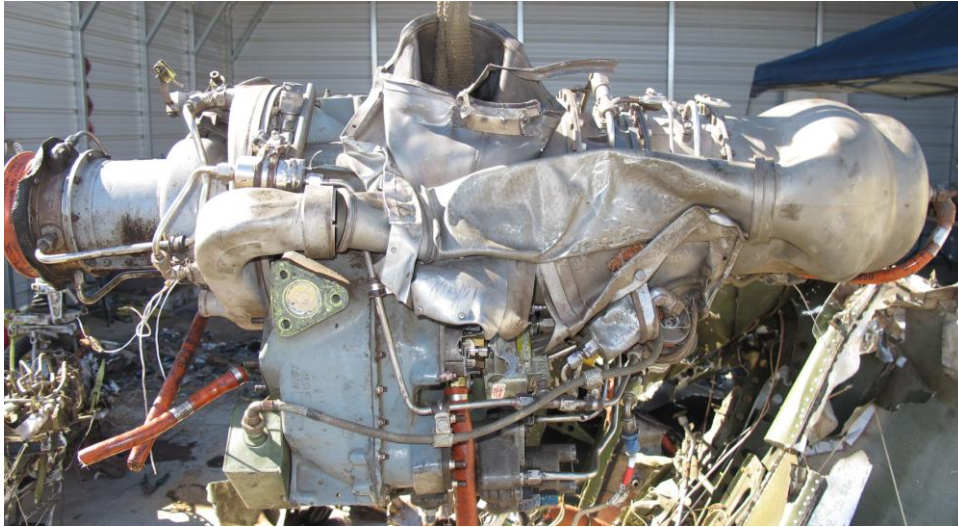
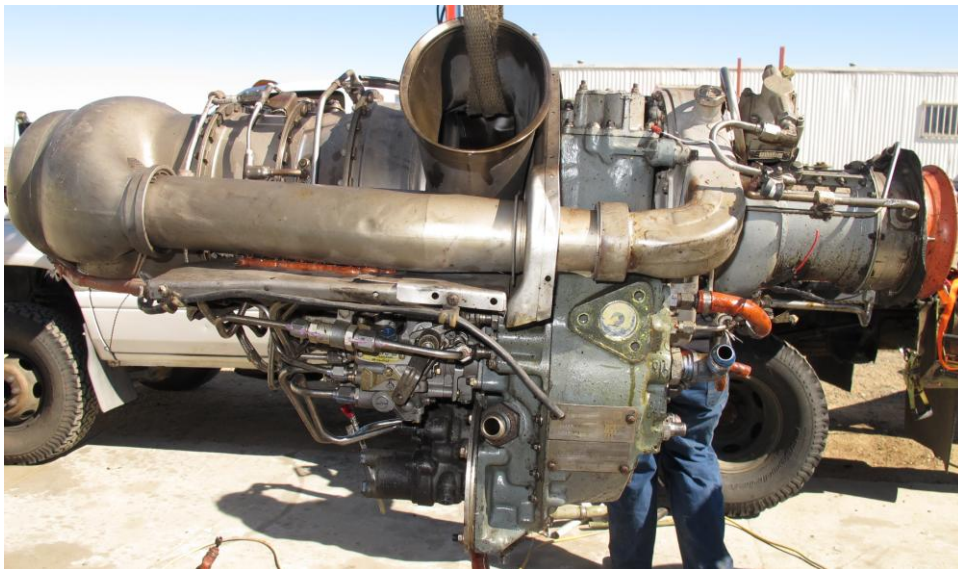
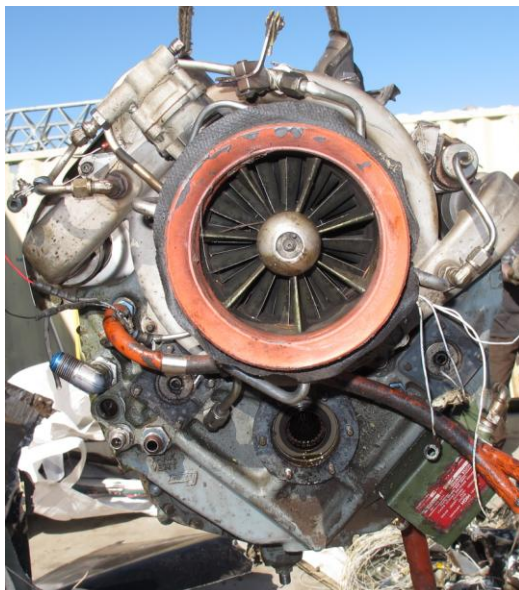
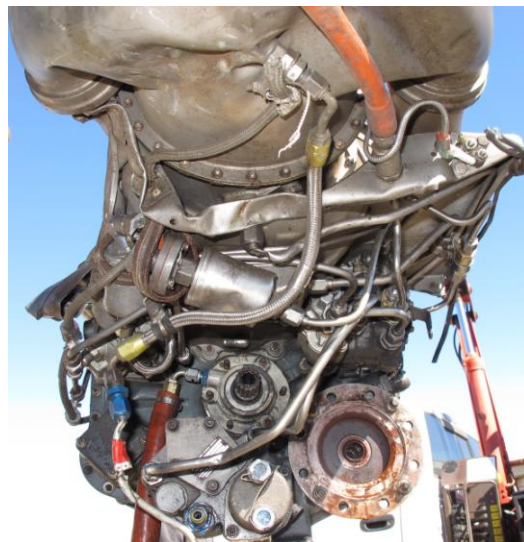
Fig: 2

The majority of external damage was isolated to the left side of the engine. The compressor assembly remained fully intact and did not exhibit signs of impact damage. There was a small amount of debris (small sticks/grass) in the compressor inlet. The first two stages of the axial compressor showed signs of minor foreign object damage Fig 3. The bleed air valve was in the

open position and could be manually actuated closed. The anti-ice valve was broke away from the scroll and held in place by the sensing lines. The left side air discharge tube was crushed/flattened and disconnected from the compressor scroll. It remained connected to the outer combustion case. The right side air discharge tube was not damaged and connected at both ends.

The outer combustion case was dented at the bottom due to impact, but otherwise unremarkable. The fuel nozzle was in place and normal in appearance. The engine fuel line between the check valve and fuel nozzle remained in position and attached at both ends. The line was removed from the fuel nozzle and a normal amount residual fuel drained out. The igniter was in place within the outer combustion case, but the ignition lead was separated from the igniter.

Engine At Recovery

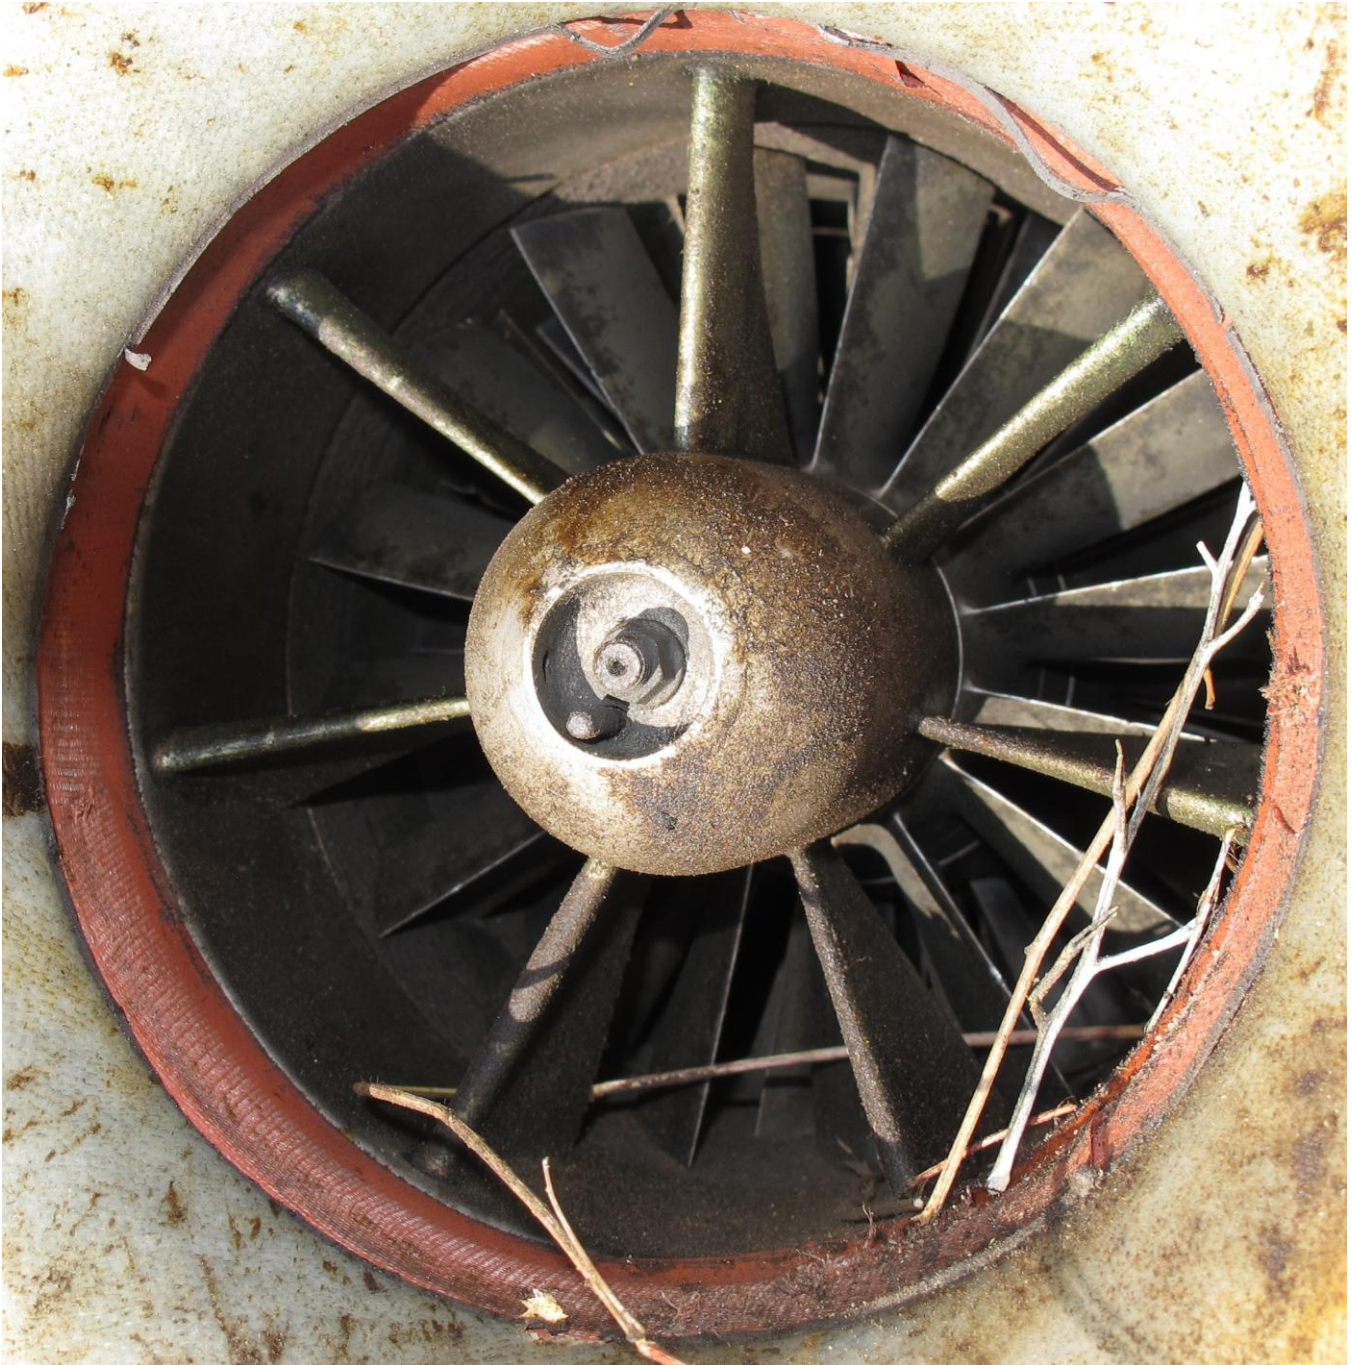
Fig: 3

Compressor

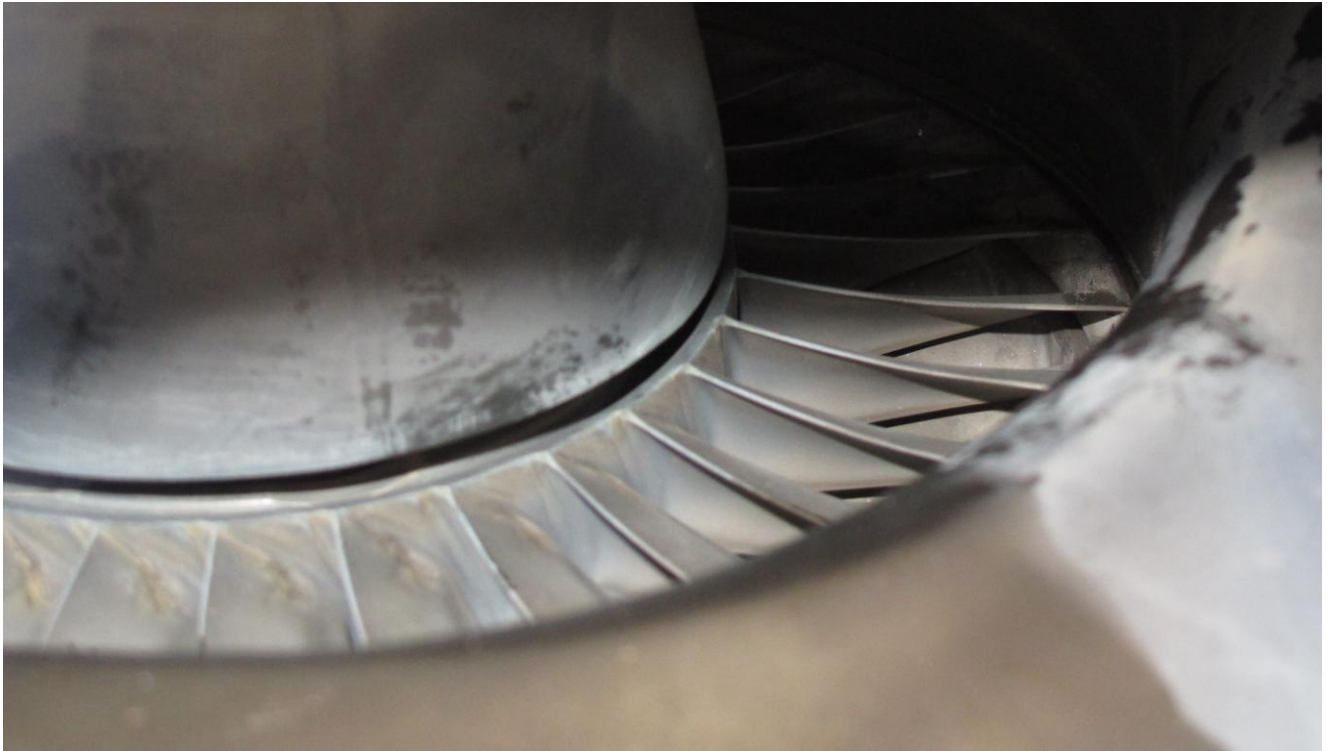
Fig: 4

Both the gas producer and power turbine supports were normal in appearance and displayed no impact damage. The fourth stage turbine wheel, as viewed through the exhaust collector, was normal in appearance Fig 4.

4th Stage Turbine Wheel

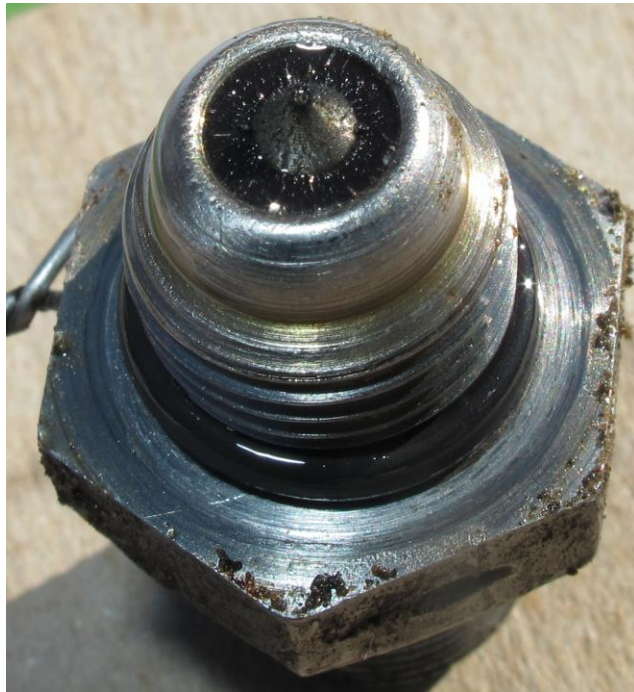
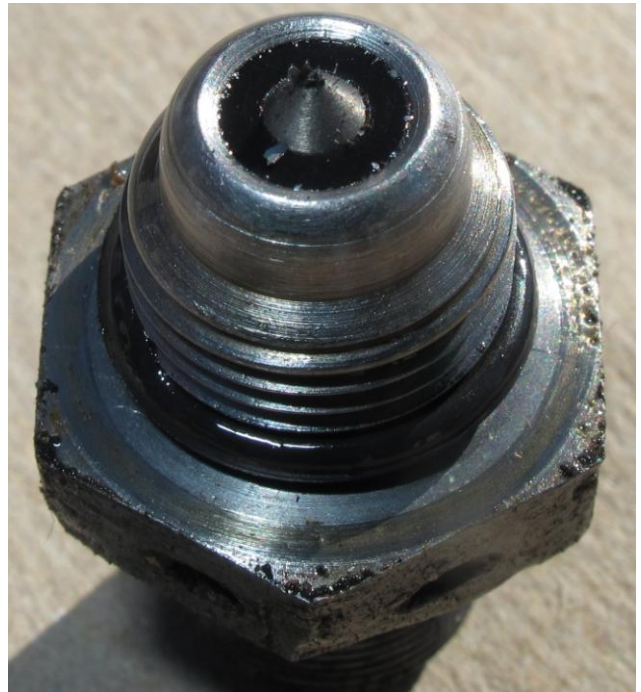
Fig: 5

The accessory gearbox was undamaged and normal in appearance. The upper and lower chip detectors were removed and visually examined. Both chip detectors contained a small amount of metallic debris, but were otherwise normal in appearance Fig 5. The fuel control unit was undamaged and normal in appearance. The throttle arm was free and smooth from stop to stop. Fig 6. The power turbine governor had a large section broken away exposing the internal flyweights. The missing portion included the governor arm Fig 7. The fuel pump was undamaged and normal in appearance. The fuel in line was fractured just aft of the "B" nut and residual fuel leaked out when the engine was shifted. All other external lines and associated fittings were secure when checked by hand with no cracks noted. The PG pneumatic line was loose at the first accumulator. A painted torque strip was present on the line, but was not aligned. The accumulator was damaged by impact. All other engine pneumatic lines were normal in appearance with "B" nut and connectors at least finger tight. Fig 8

Upper Chip Detector

Lower Chip Detector

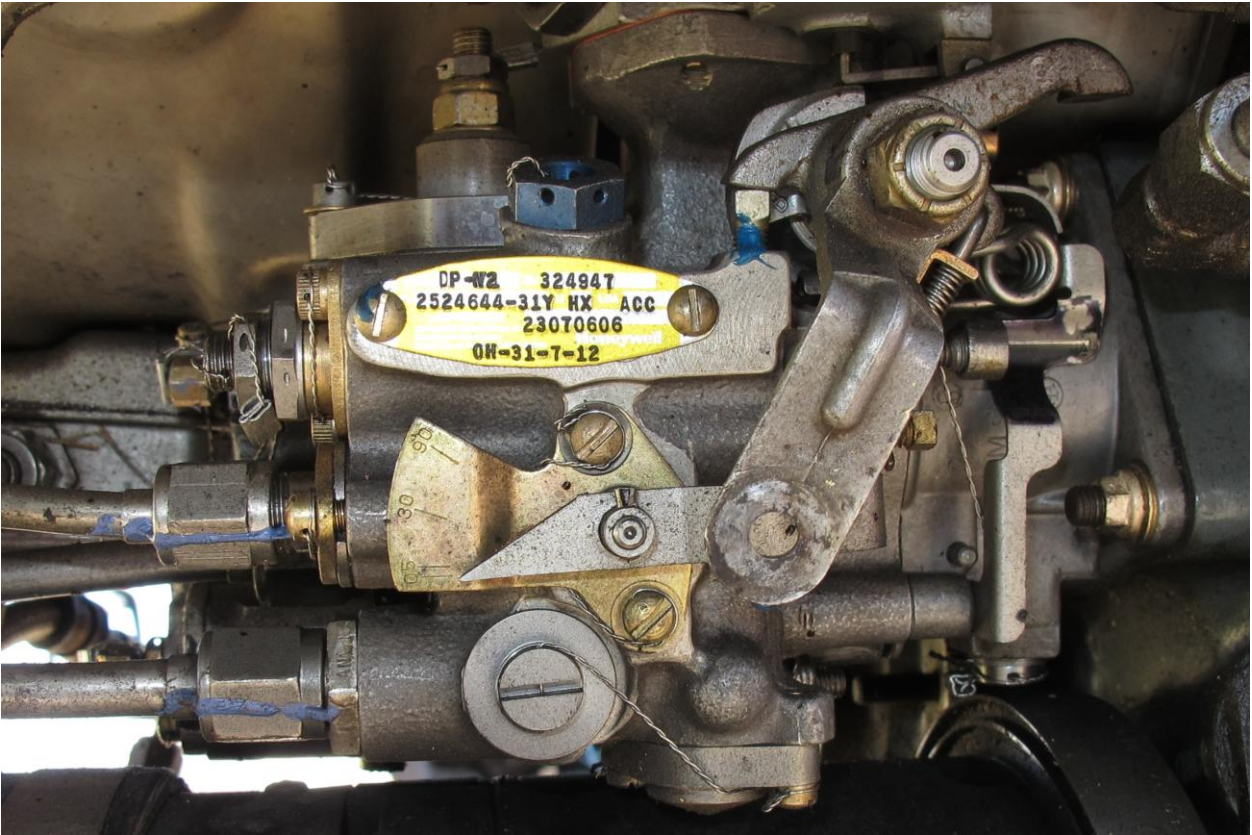
Fig: 6

Fuel Control Unit

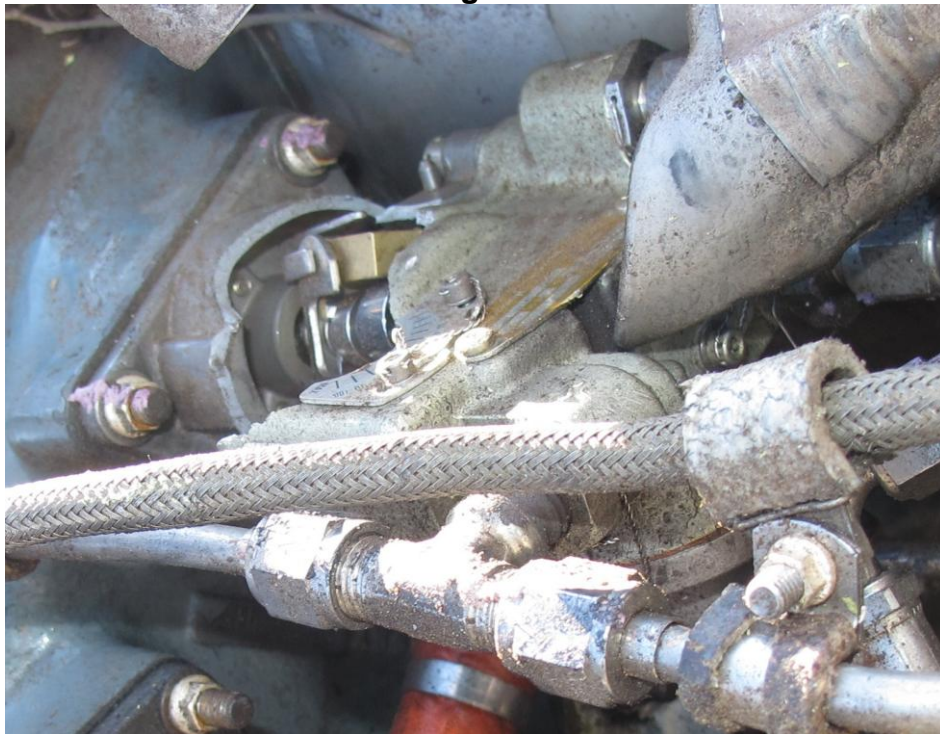
Fig: 7

Power Turbine Governor

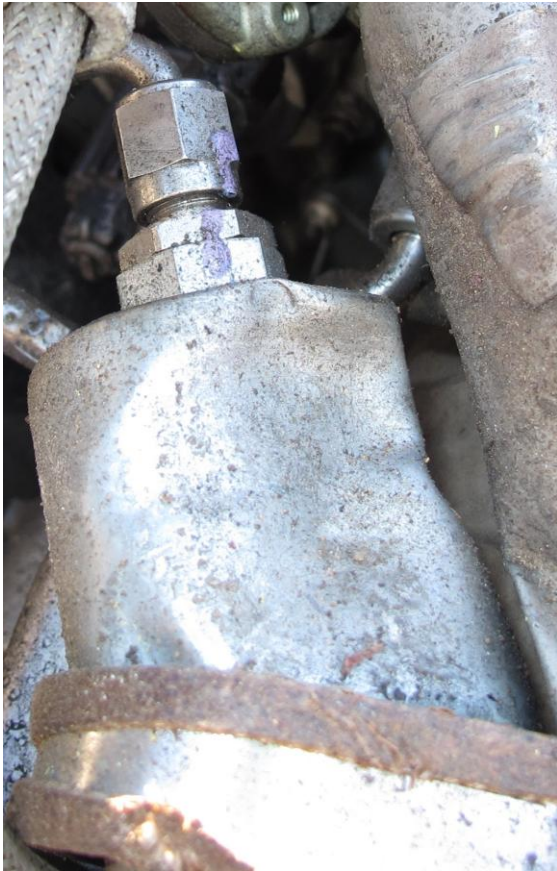
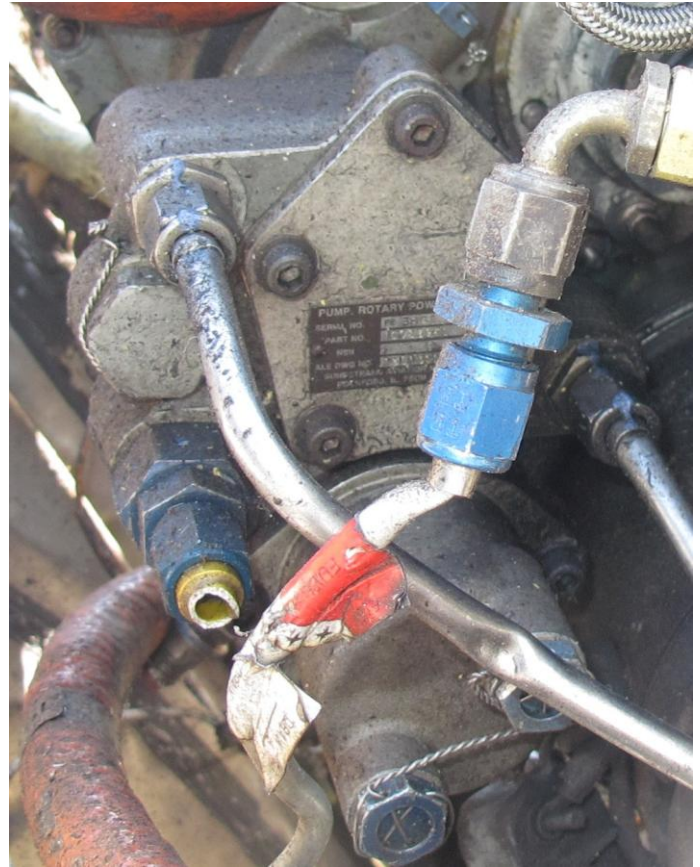
Fig: 8

PG Line and Accumulator

Fractured Fuel In Line

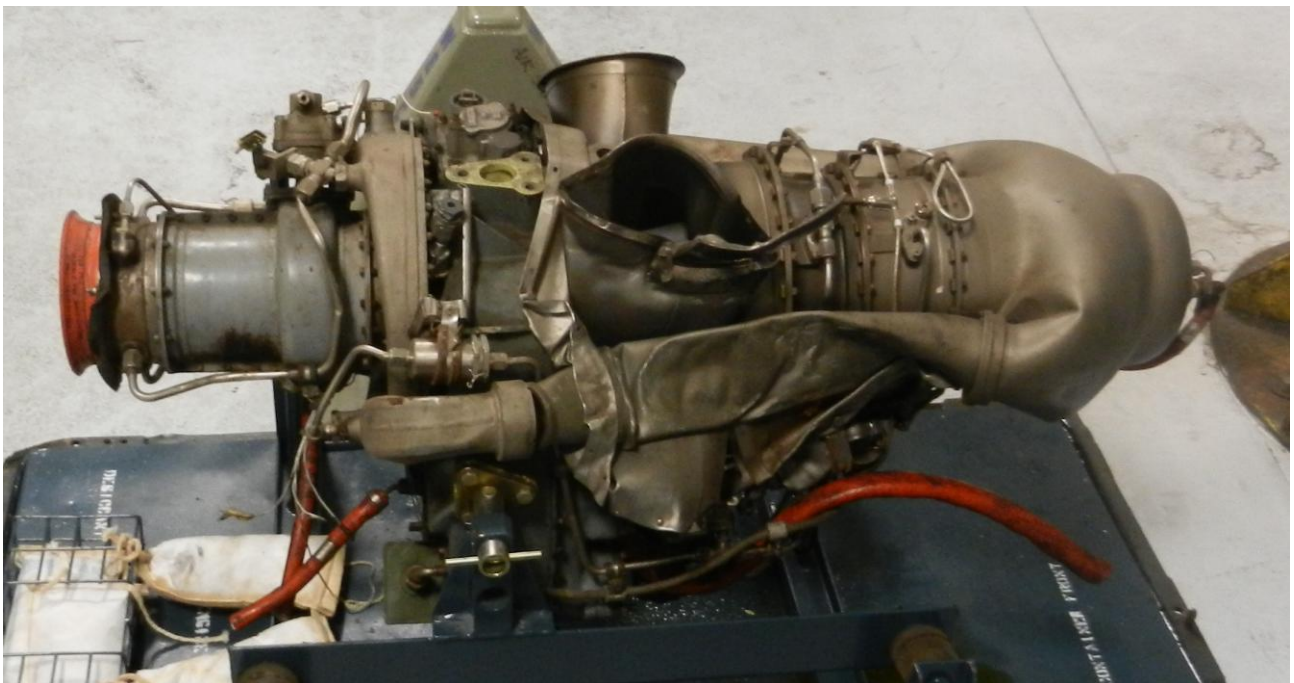
Fig: 9

The engine arrived at Rolls-Royce, Indianapolis in an engine shipping container and remained unopened until the NTSB commenced the examination. On 13 August 2013 the engine was removed for disassembly/examination. The NTSB IIC presided over the investigation and the following was noted: Fig 9

Engine As Received at Rolls-Royce

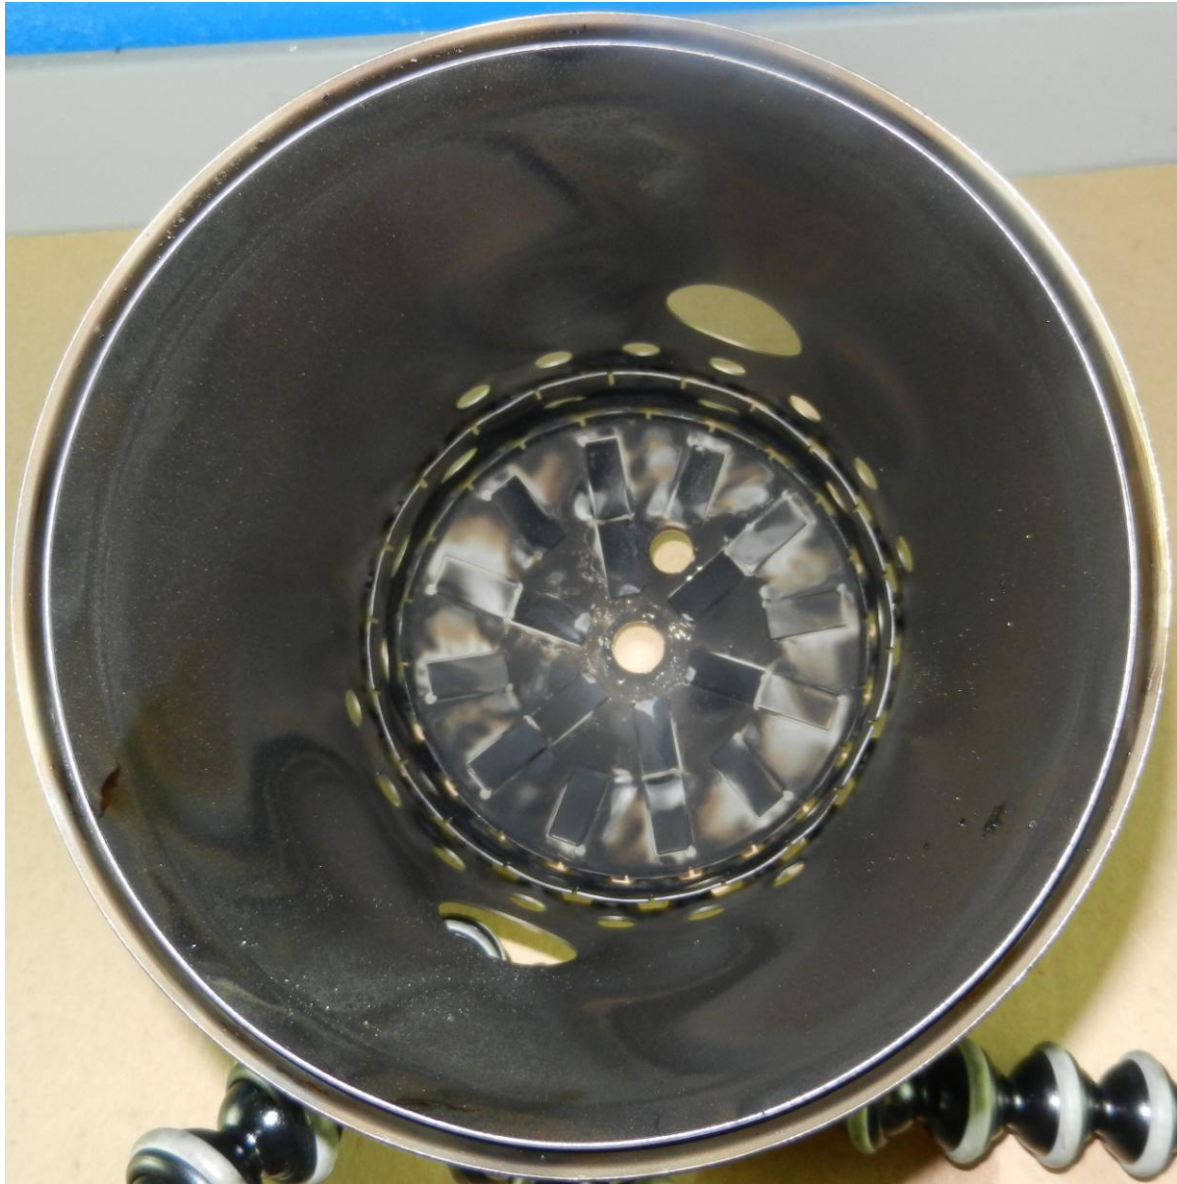
Fig: 10

The Turbine module was removed for examination. The outer combustion case and combustion liner were removed to facilitate further inspection. The combustion section displayed no signs of significant damage other than the previously noted impact damage to the outer combustion case. Inspection of the combustion liner revealed a small amount metallic spatter on the inside of the liner. The liner was otherwise normal in appearance with no unusual damage or streaking Fig 10. There was a small amount of carbon material on the face of the fuel nozzle, but it was otherwise normal in appearance. The fuel nozzle was disassembled with no damage noted. The screen was clean and unremarkable.

Combustion Liner

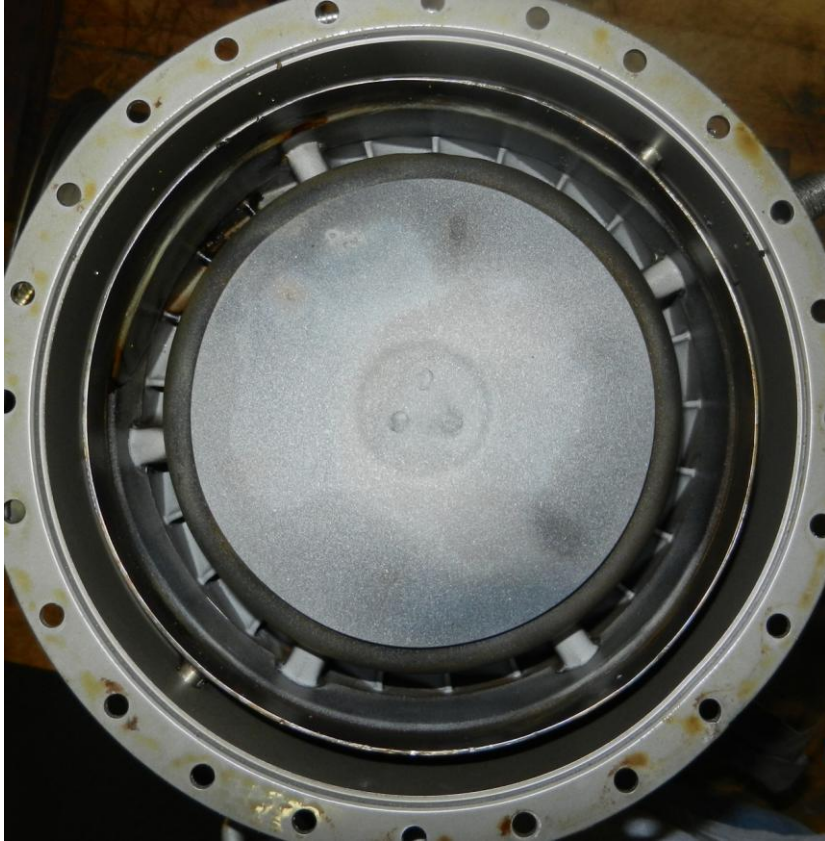
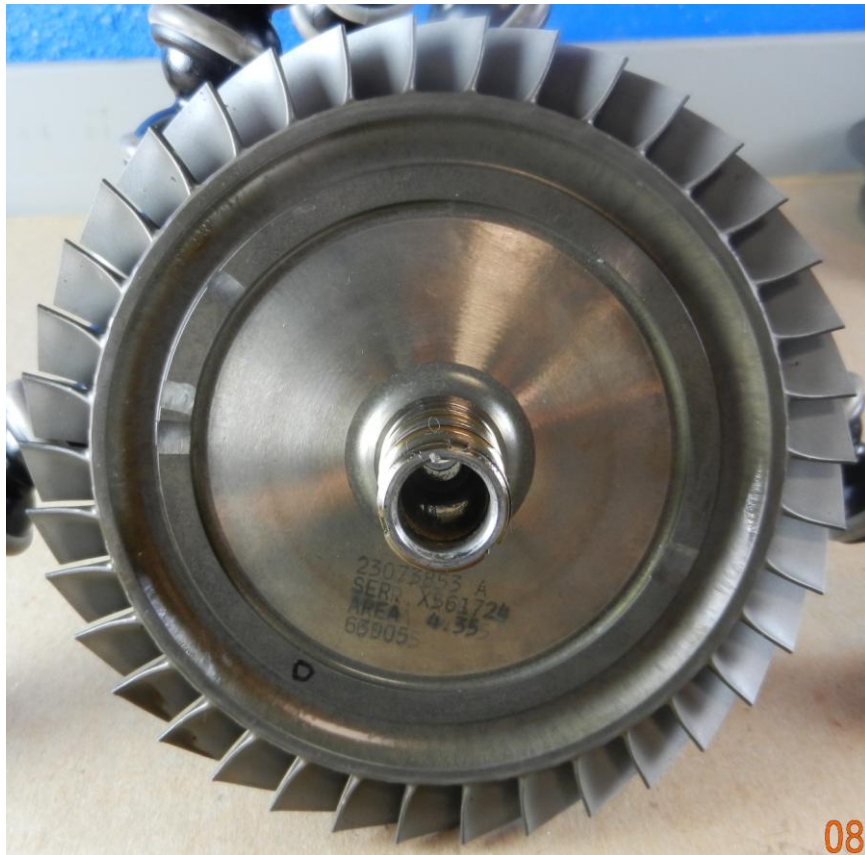
Fig: 11

The gas producer and power turbine were disassembled down to the rotors. The 1st stage turbine nozzle and nozzle shield revealed metallic spatter across the nozzle shield face and nozzle surfaces. The 1st stage nozzle was otherwise undamaged. Ingestion of small metallic debris was noted throughout the gas path. All four turbine wheels were otherwise undamaged. The 2st stage turbine nozzle, which contains the blade tracks for the 1st and 2nd stage turbine wheels, had indications of slight rub on the 2st stage blade track. The 3rd stage turbine nozzle was unremarkable. The 4th stage turbine nozzle, which contains the blade tracks for the 3rd and 4th stage turbine wheels, revealed signs of heavy rub on both the 3rd and 4th stage blade tracks. The 4th stage nozzle also had a crack and was sent to the Rolls-Royce Metallurgy lab for examination and documentation. Metallurgical evaluation of a 4th stage turbine nozzle indicates fatigue caused the initiation of cracking in the airfoil casting on the surface between two airfoils along the radial axial plane. Propagation of the crack through the casting and into the diaphragm appeared to be tensile overload. Small areas of fatigue features were observed at the end of the crack. Heavy oxidation on the surface of the fracture indicated that it was not related to or caused by the accident under investigation. The damage observed is not considered contributory to the event. Fig 11, Fig 12, Fig 13, Fig 14, Fig 15, Fig 16, and Fig 17

1st Stage Turbine Nozzle and Nozzle Shield

1st Stage Turbine Wheel

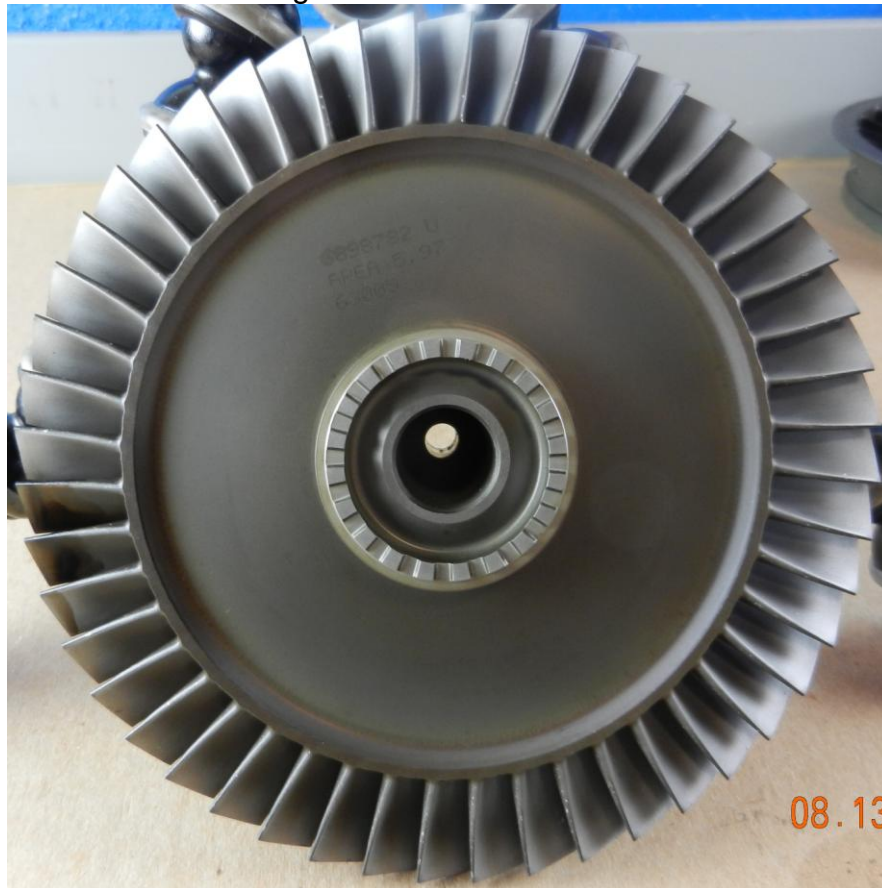
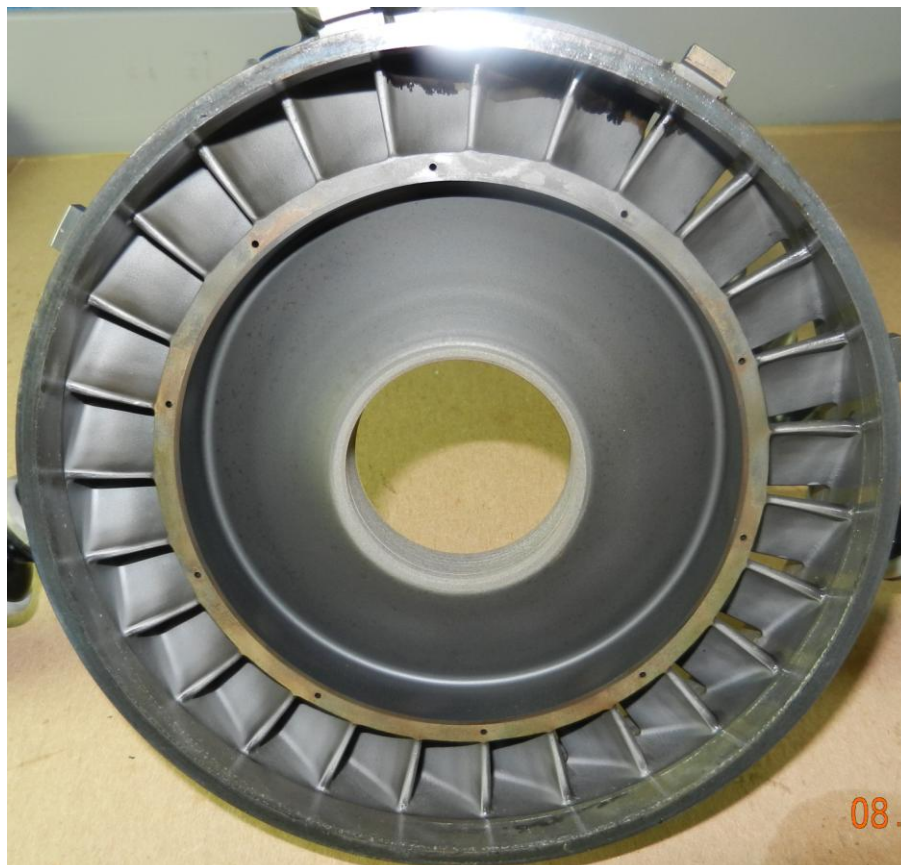
Fig: 12
2nd Stage Turbine Wheel and Nozzle

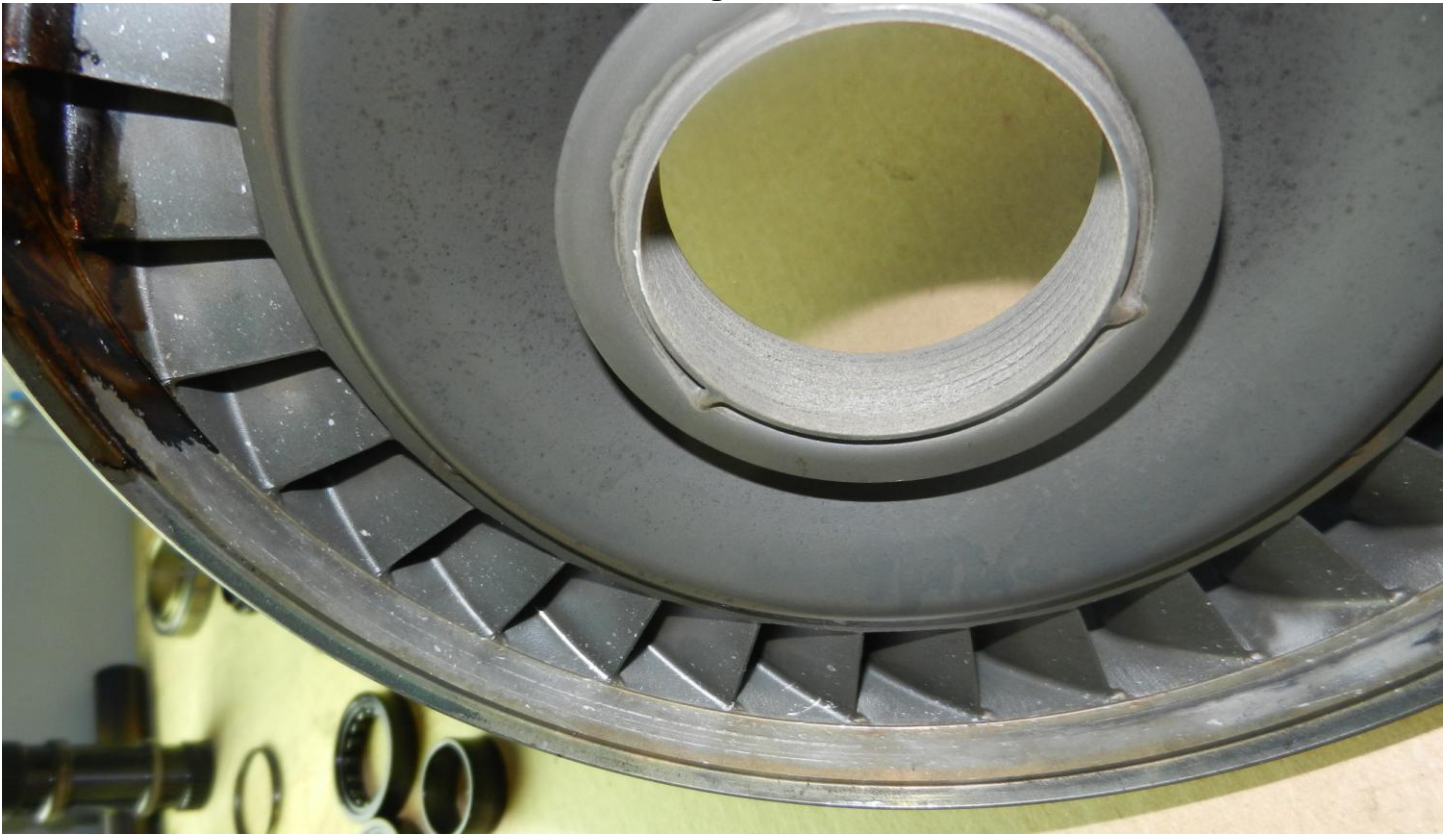
Fig: 13

2nd Stage Turbine Wheel Blade Tracks

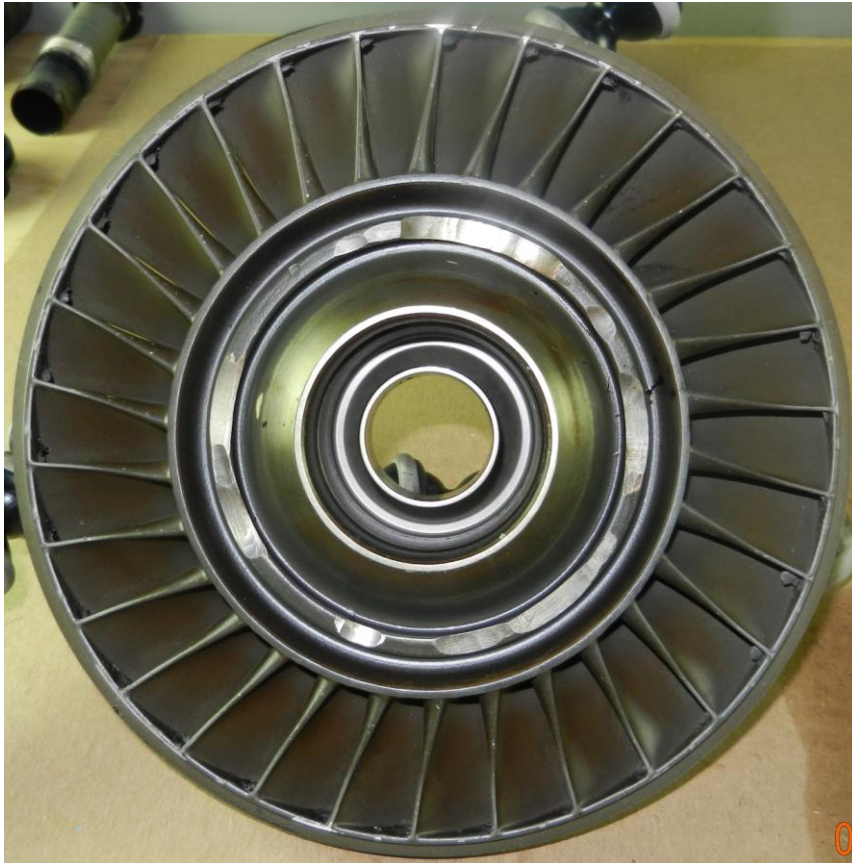
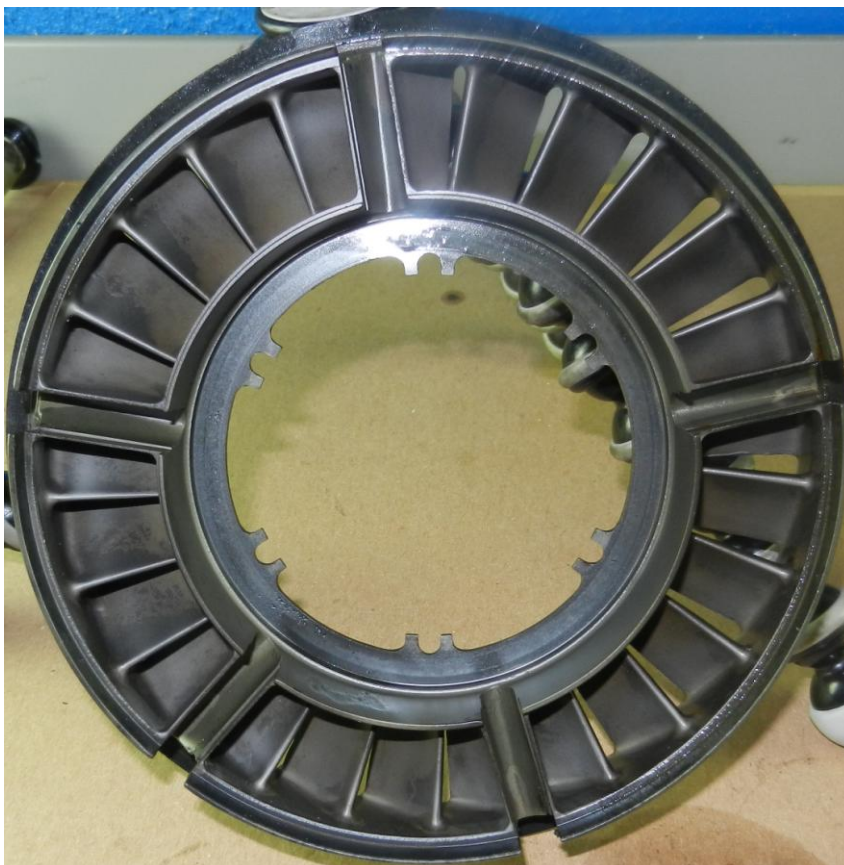
Fig: 14
3rd Stage Turbine Wheel and Nozzle

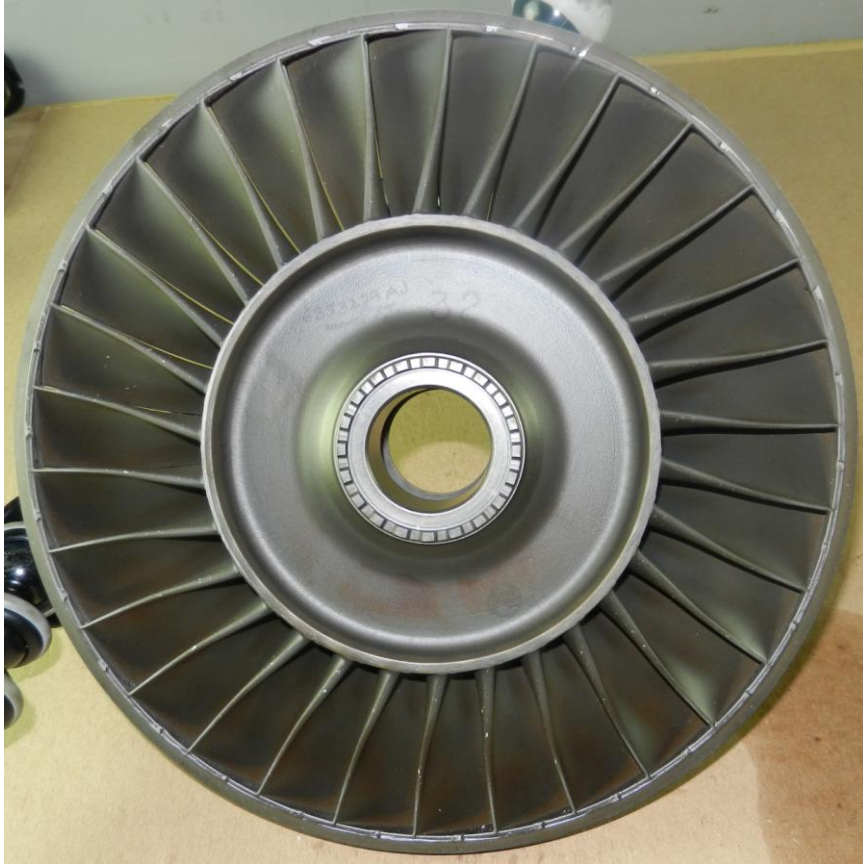
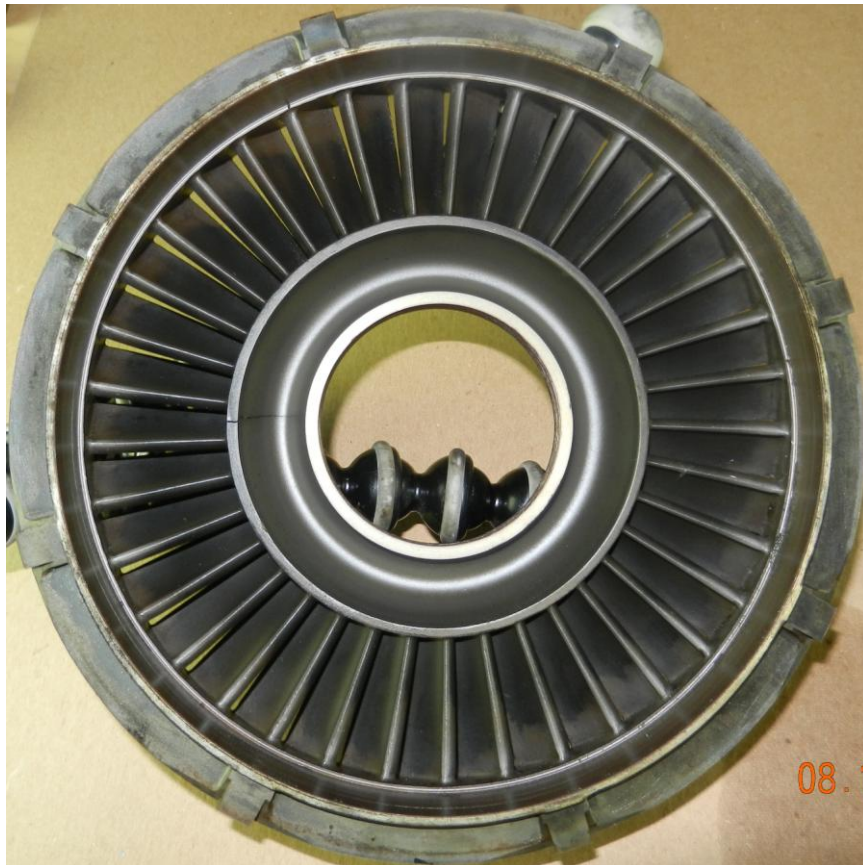
Fig: 15
4th Stage Turbine Wheel and Nozzle
