Engine Investigation Report

**Allison Model 250-C20B
Engine CAE 831376**

**Bell 206B
Registration: N59518**

**Accident date: February 10, 2013
Investigation date: February 11 - 13, 2013
Engine disassembly date: August 13, 2013
Report date: 13 March, 2014**

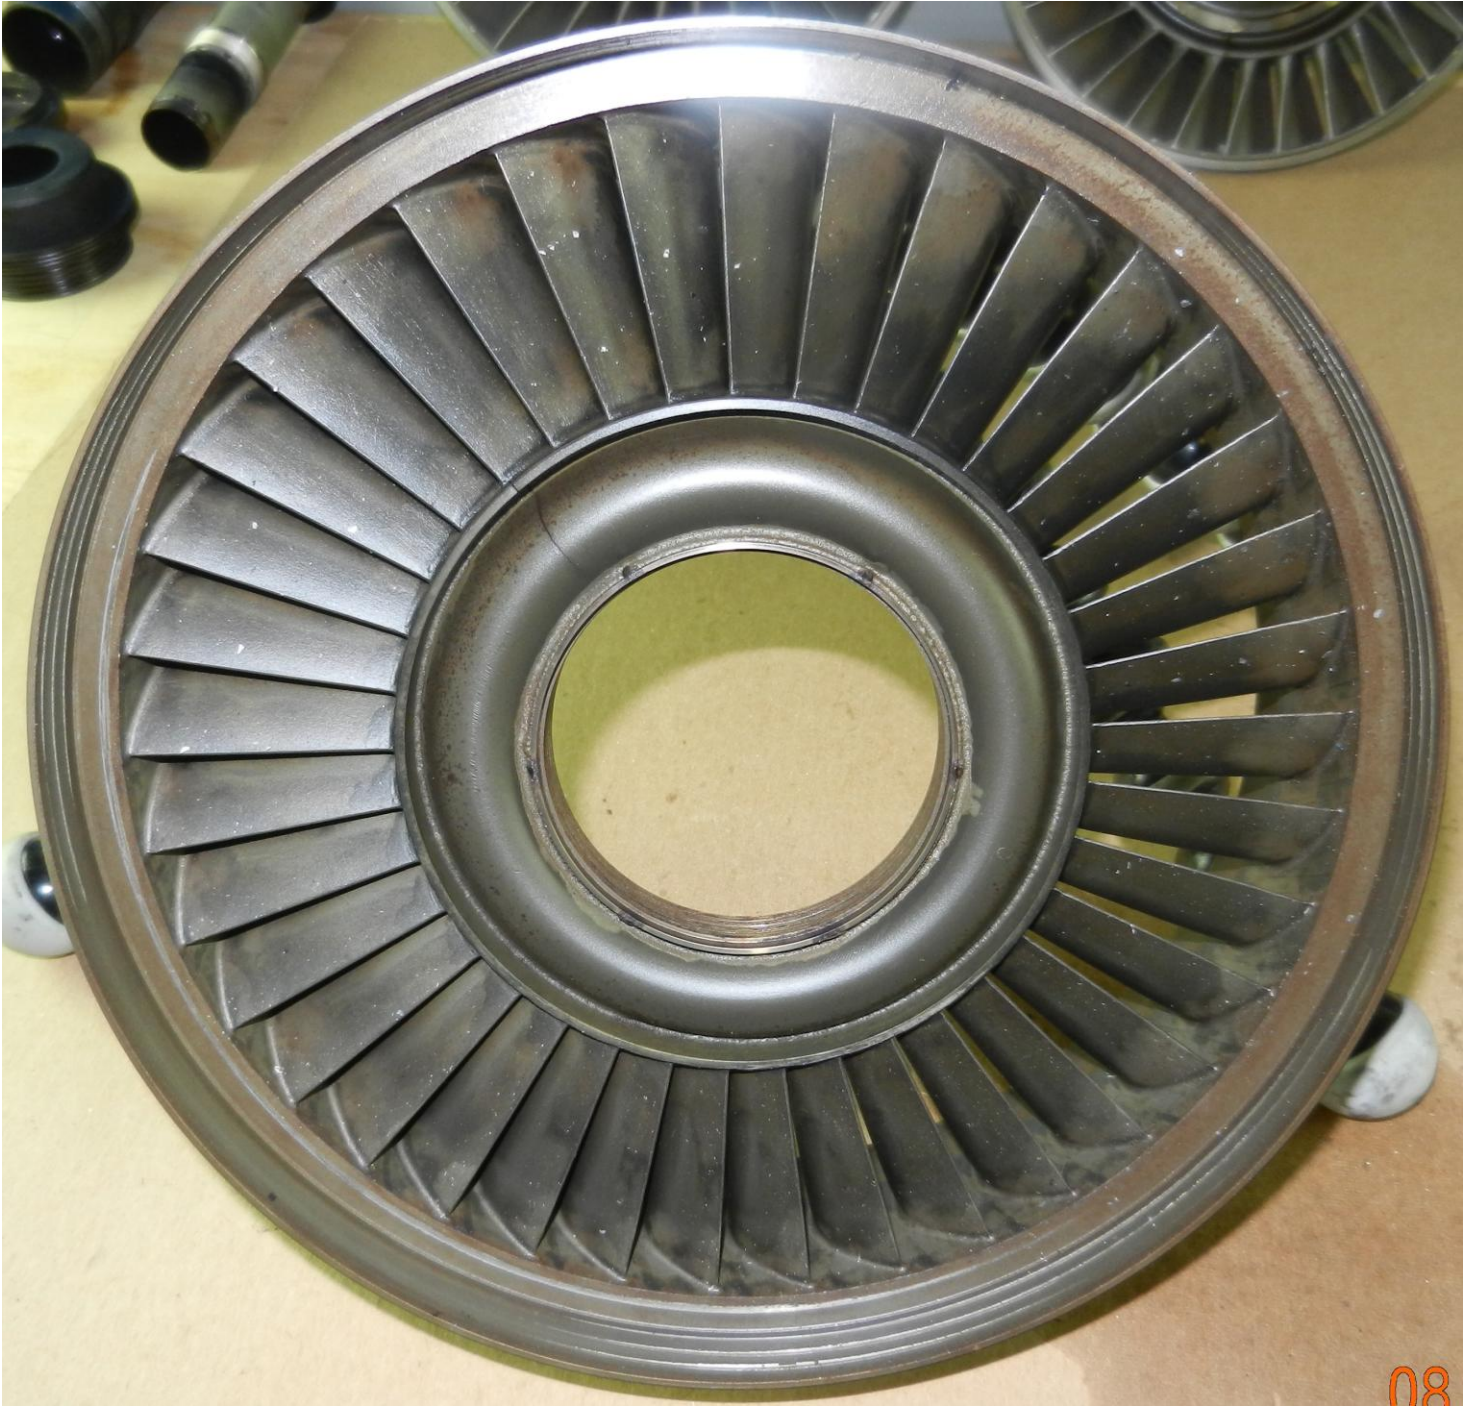
Fig: 16

The gas producer and power turbine were disassembled down to the rotors. The 1st stage turbine nozzle and nozzle shield revealed metallic spatter across the nozzle shield face and nozzle surfaces. The 1st stage nozzle was otherwise undamaged. Ingestion of small metallic debris was noted throughout the gas path. All four turbine wheels were otherwise undamaged. The 2st stage turbine nozzle, which contains the blade tracks for the 1st and 2nd stage turbine wheels, had indications of slight rub on the 2st stage blade track. The 3rd stage turbine nozzle was unremarkable. The 4th stage turbine nozzle, which contains the blade tracks for the 3rd and 4th stage turbine wheels, revealed signs of heavy rub on both the 3rd and 4th stage blade tracks. The 4th stage nozzle also had a crack and was sent to the Rolls-Royce Metallurgy lab for examination and documentation. Metallurgical evaluation of a 4th stage turbine nozzle indicates fatigue caused the initiation of cracking in the airfoil casting on the surface between two airfoils along the radial axial plane. Propagation of the crack through the casting and into the diaphragm appeared to be tensile overload. Small areas of fatigue features were observed at the end of the crack. Heavy oxidation on the surface of the fracture indicated that it was not related to or caused by the accident under investigation. The damage observed is not considered contributory to the event. Fig 11, Fig 12, Fig 13, Fig 14, Fig 15, Fig 16, and Fig 17

4th Stage Blade Track Rub

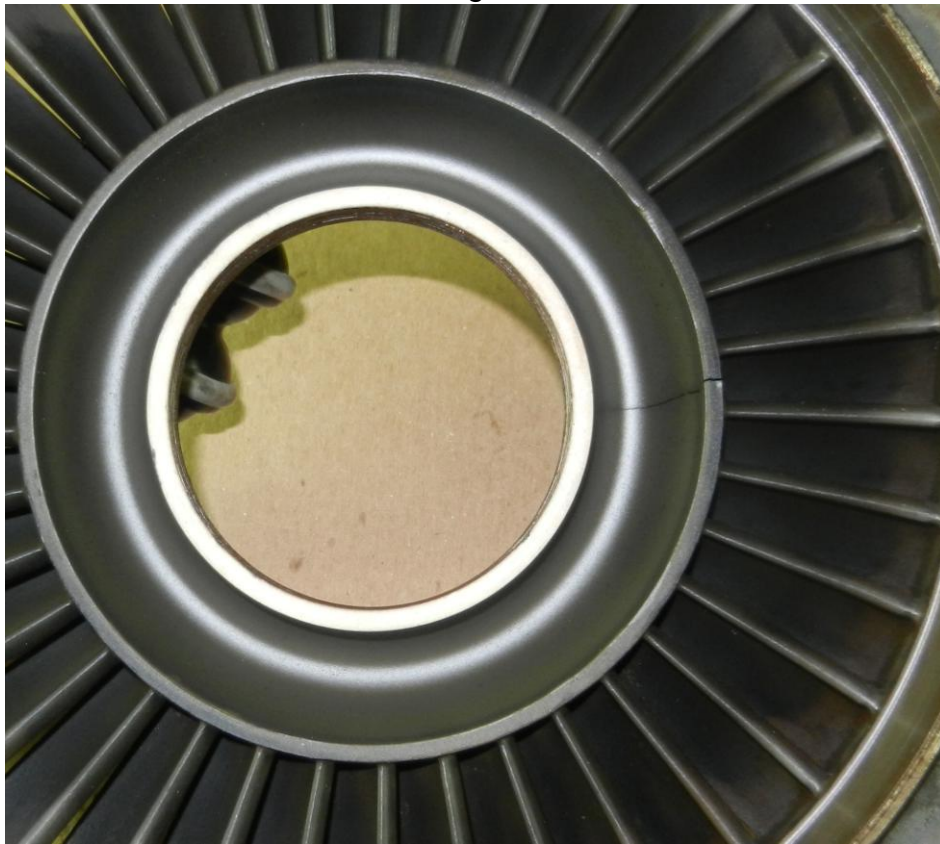
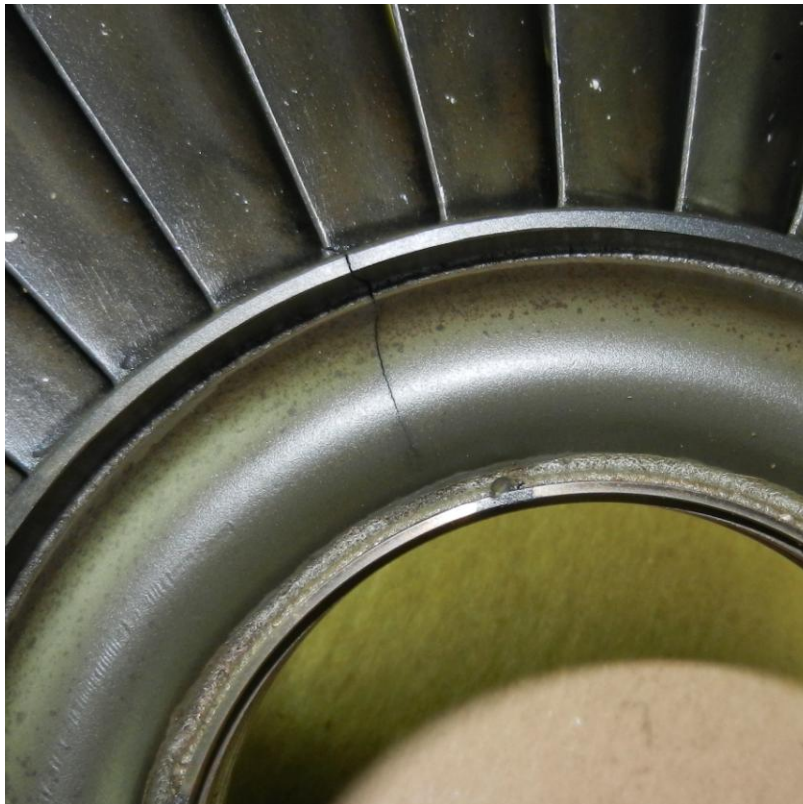
Fig: 17
Crack in 4th Stage Turbine Nozzle

Leading Edge Side

Trailing Edge Side

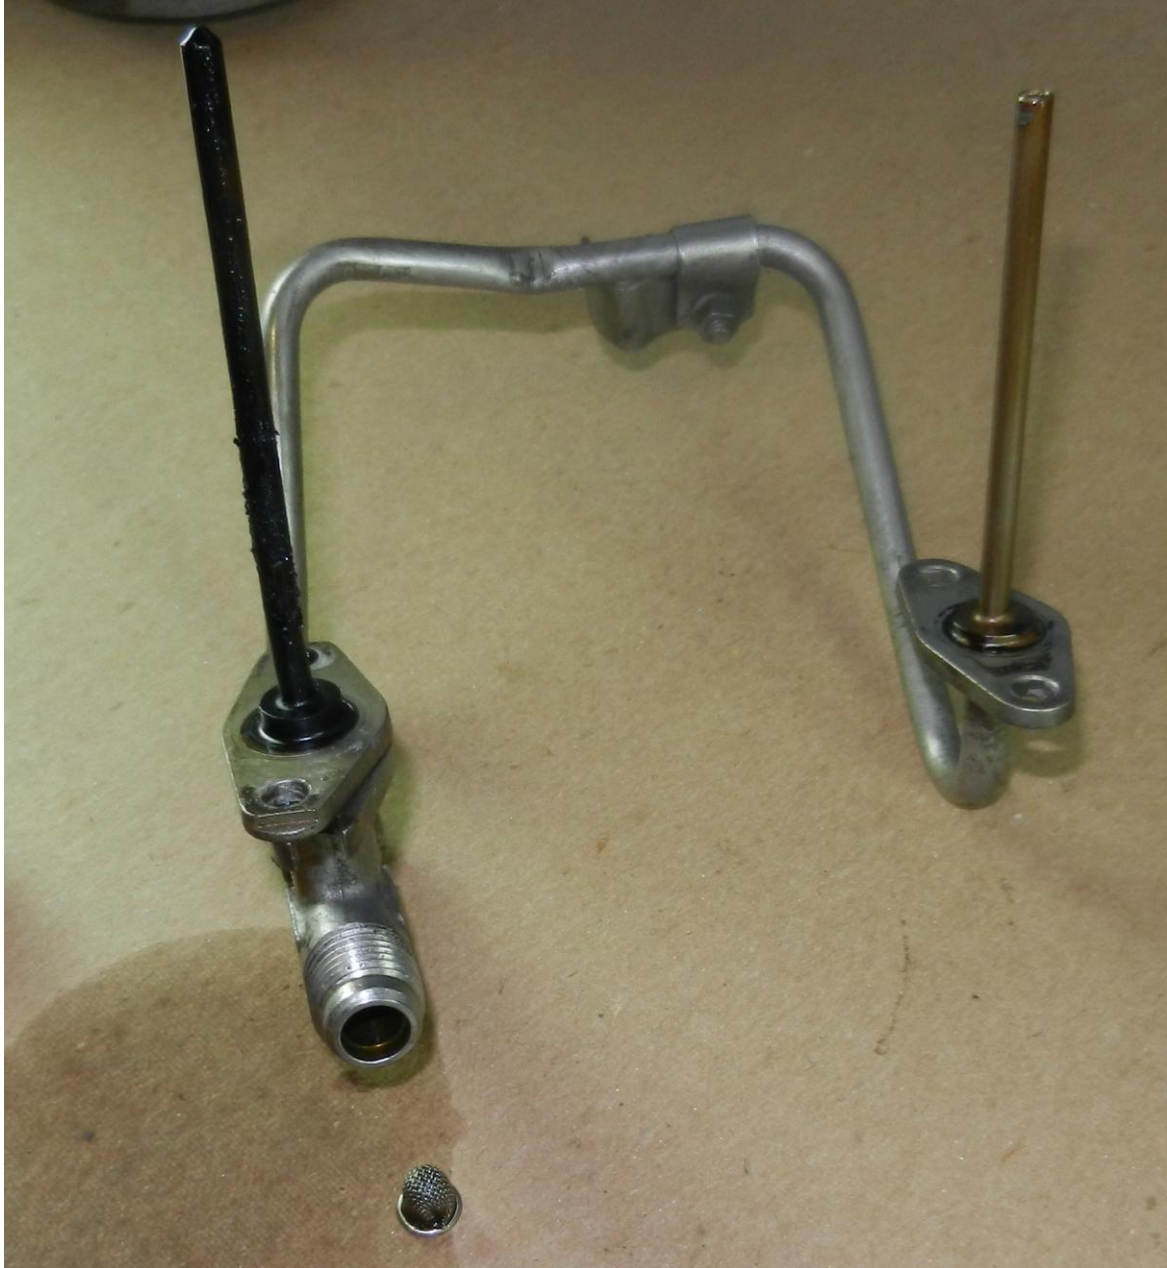
Fig: 18

Carbon buildup was noted on the No. 6 and 7 bearing oil pressure tube. The tube was otherwise normal in appearance. The No. 6 and 7 bearing oil pressure screen was clean and unremarkable. The No. 8 bearing oil pressure tube was unremarkable Fig 18. All Turbine main line bearings were oil wetted and intact with no damage noted Fig 19. No visible damage was noted to the four thermocouples or harness.

No. 6 and 7 Bearing Oil Pressure Tube, Oil Pressure Screen, and No. 8 Oil Pressure Tube

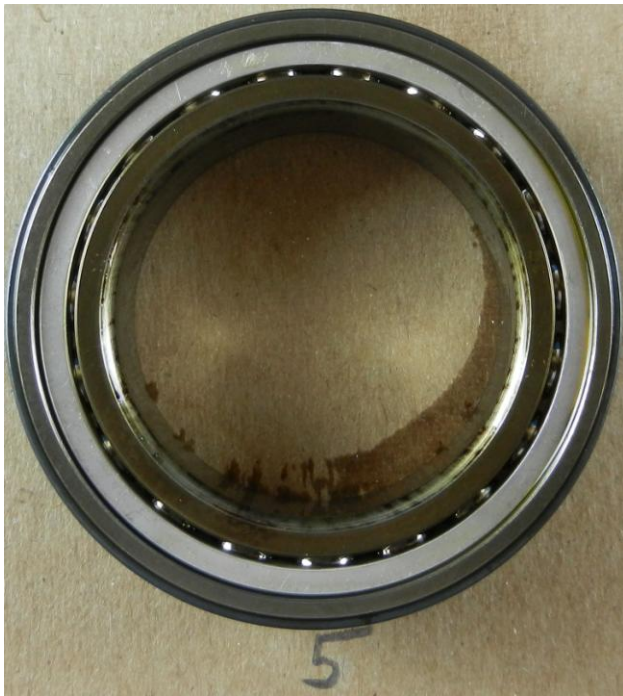
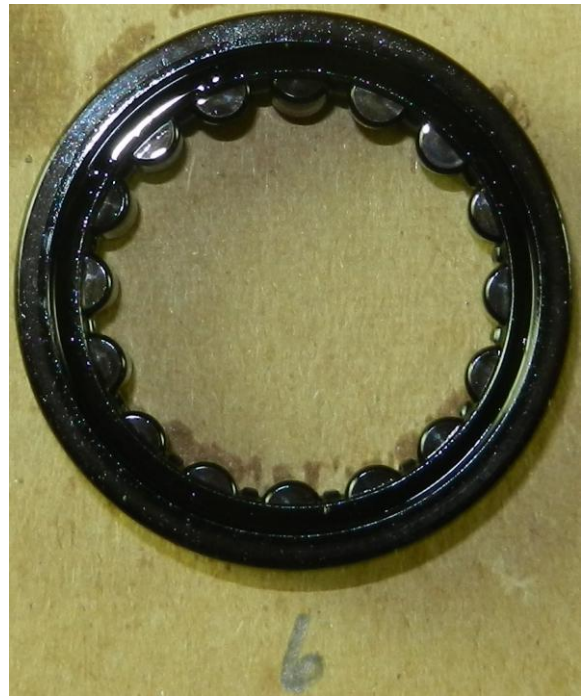
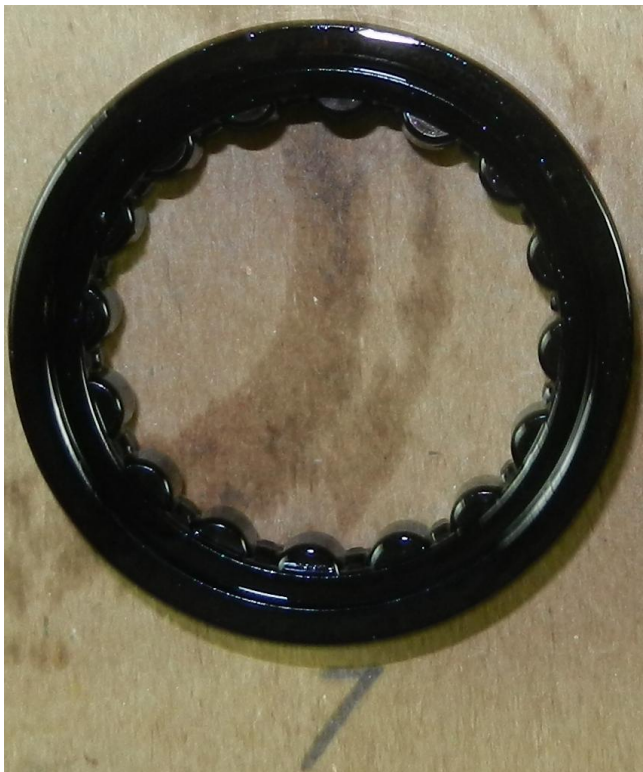
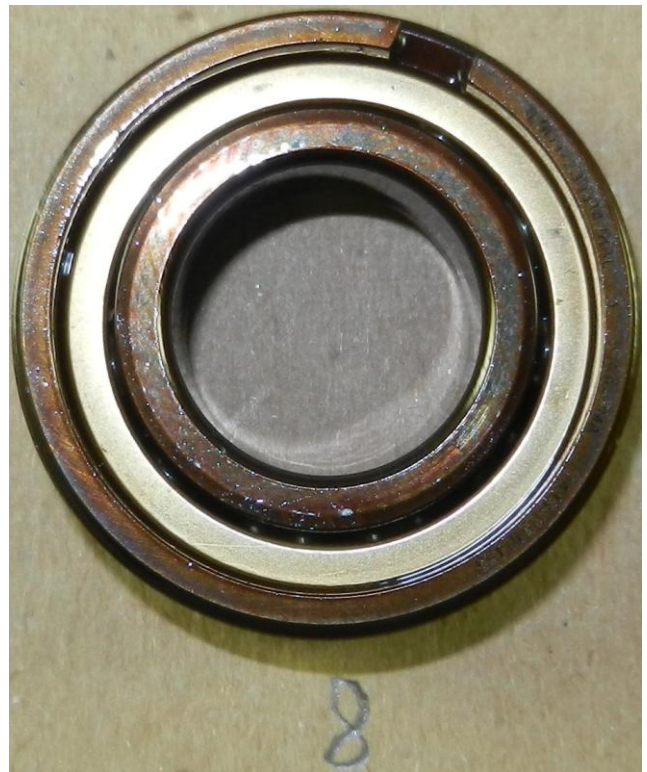
Fig: 19

No. 5, 6, 7, and 8 Bearings

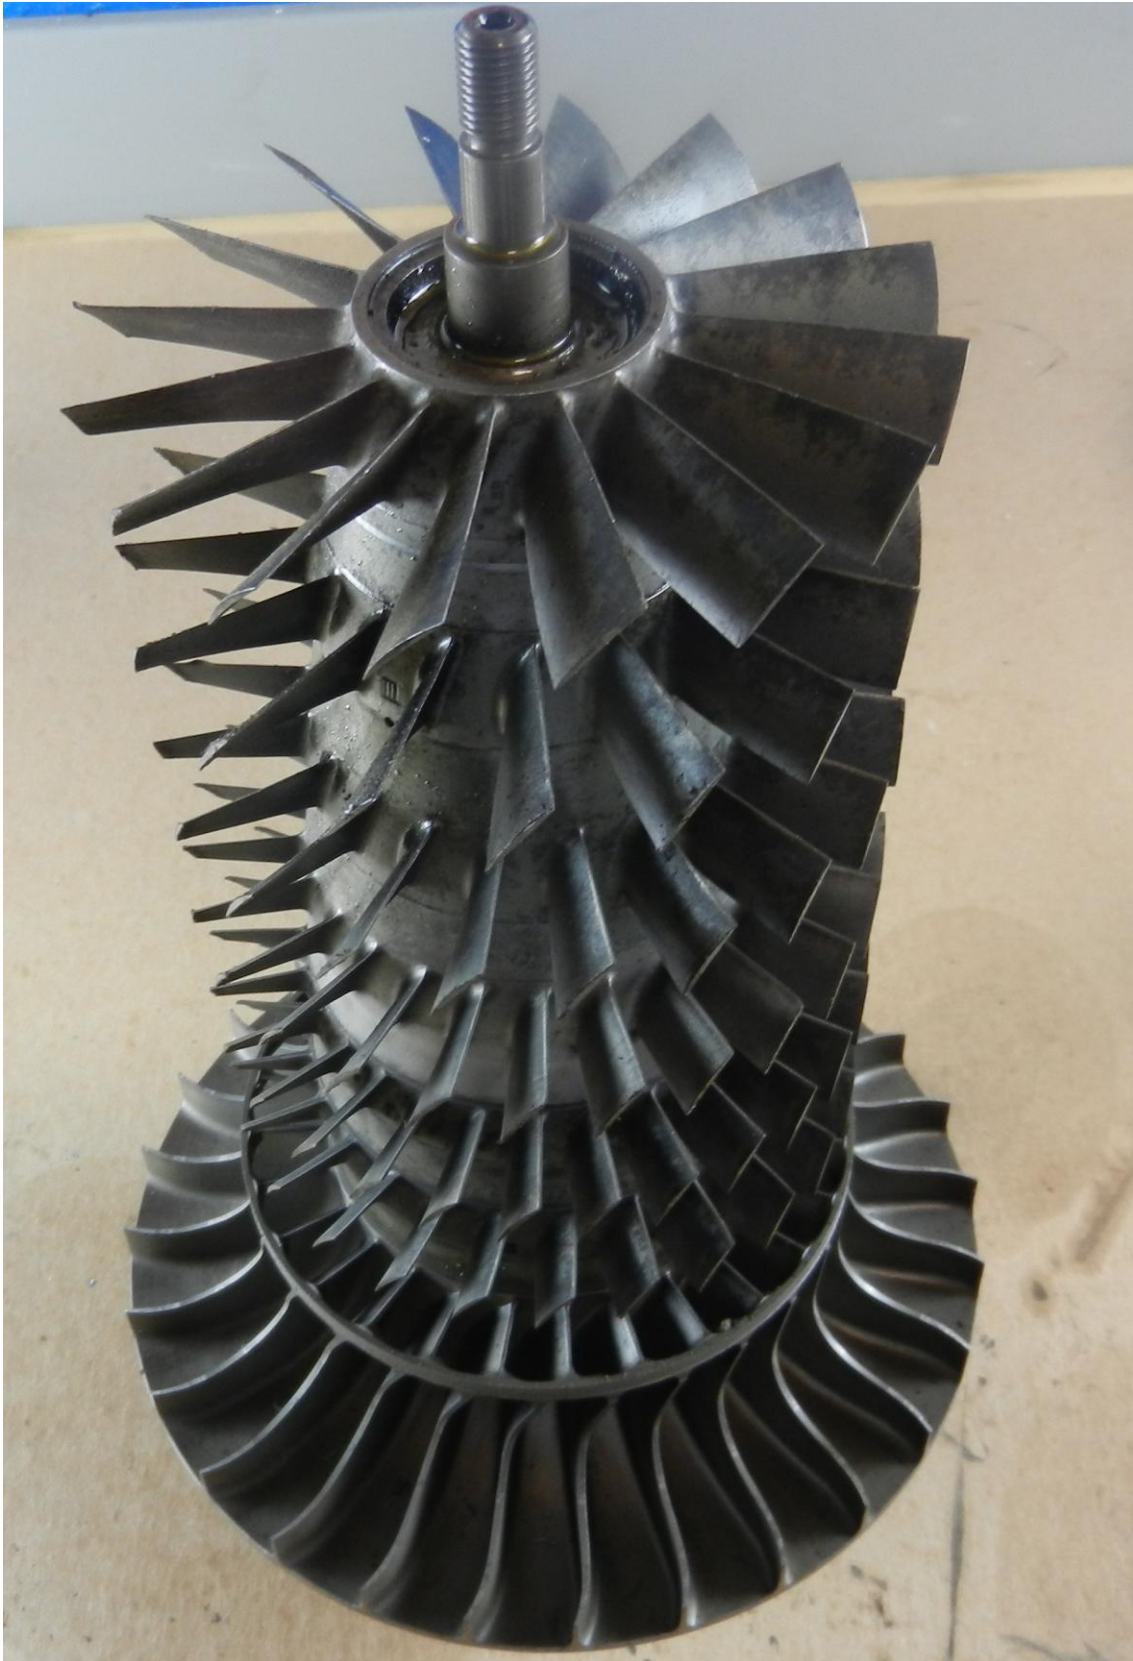
Fig: 20

The compressor was removed and disassembled for examination Fig 20. The axial compressor showed signs of foreign object damage with small nicks on the first three stages of blades and vanes. The plastic compressor case liner had several cracks and missing material, which was likely caused by impact. The centrifugal compressor impeller shroud showed signs of significant rub damage from the impeller with corresponding rub indications 360 degrees around the impeller blades Fig 21. The No. 1 and 2 bearings were both oil wetted and undamaged Fig 22.

Compressor Assembly

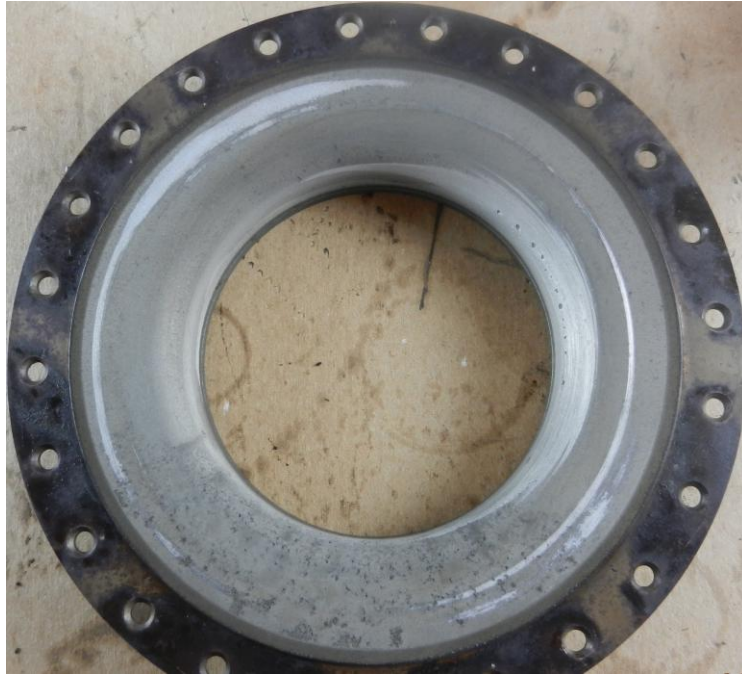
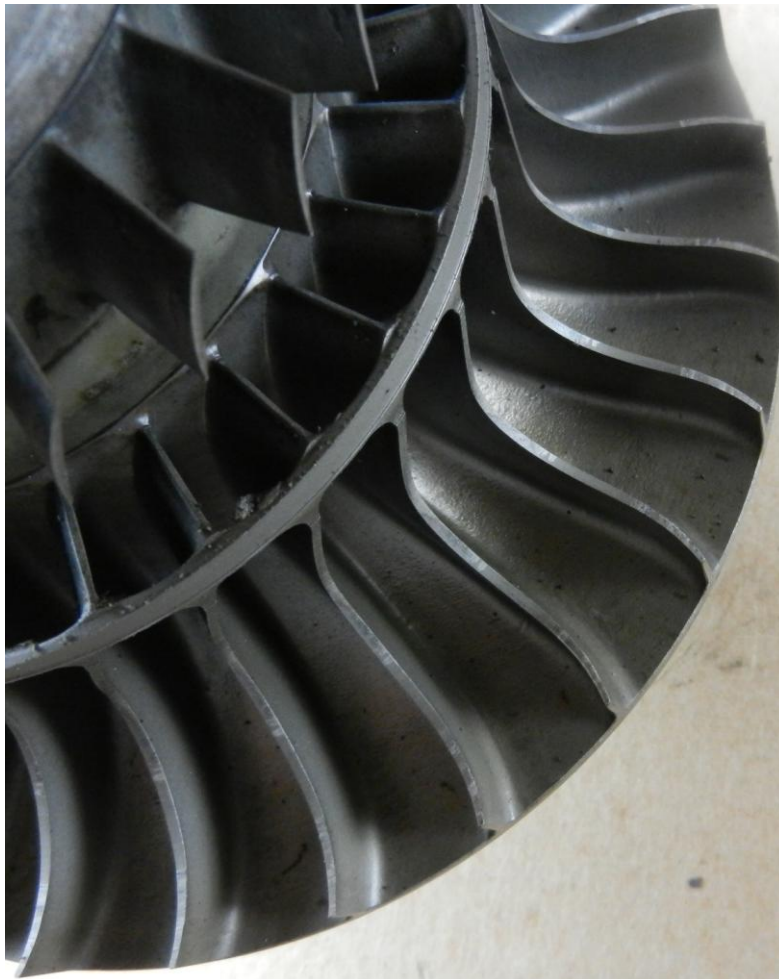
Fig: 21

Impeller Shroud

Impeller

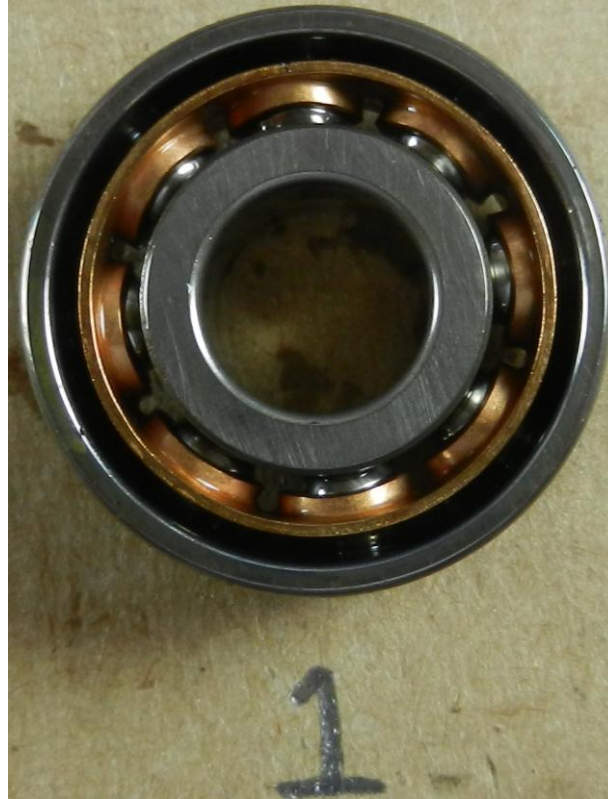
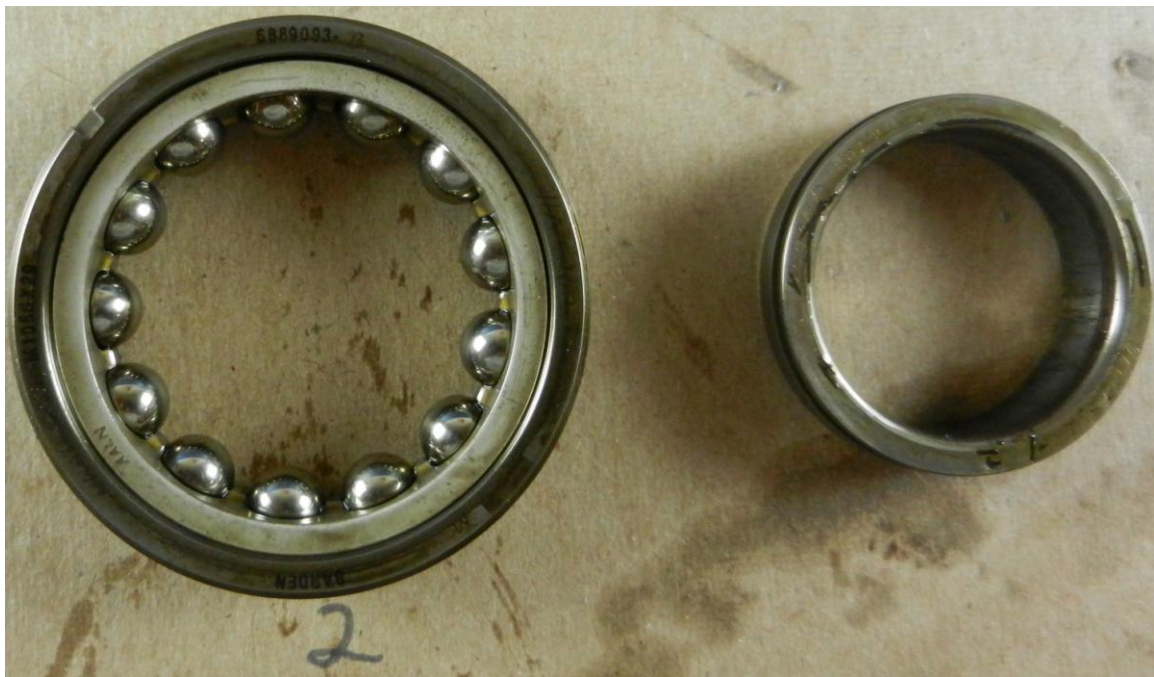
Fig: 22

No. 1 Bearing

No. 2 Bearing

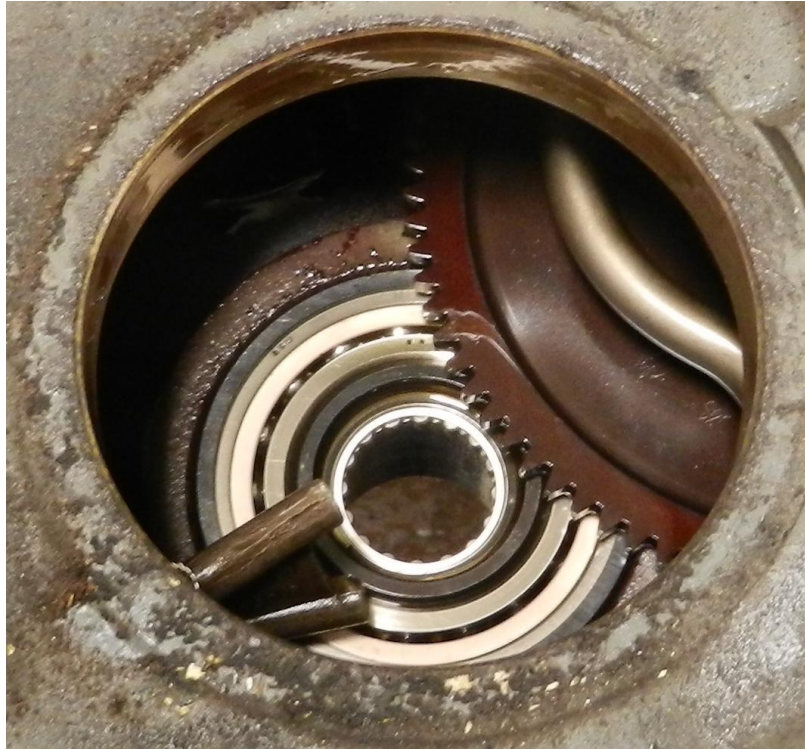
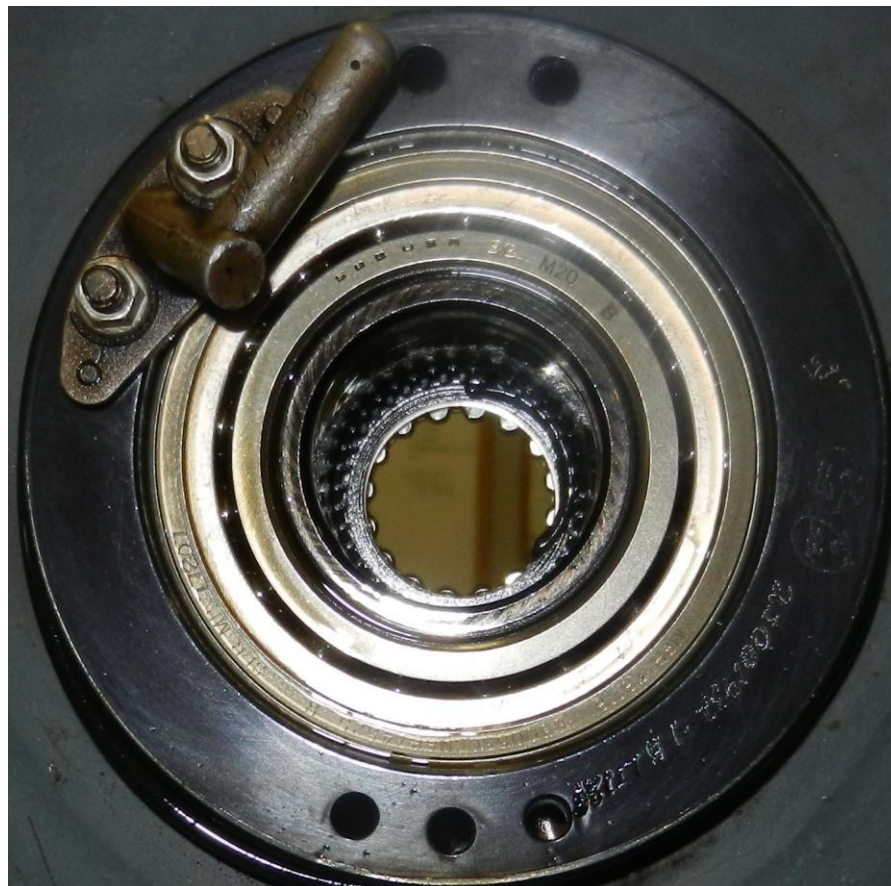
Fig: 23

The gearbox was not opened, but was turned by hand. There was no visible damage to the interior or exterior of the gearbox. Both the N1 and N2 drive systems rotated freely with no unusual noise. There was continuity to all accessory drive pads. The No. 2 ½, 3, and 4 bearings as viewed through the gearbox appeared to be oil wetted and undamaged Fig 23. The fuel filter bowl was removed and contained a small amount of fuel. The filter was clean and unremarkable. The fuel control unit was removed and no damage was noted. The drive shaft turned freely and the throttle arm had full, smooth travel from stop to stop. The power turbine governor was removed and displayed impact damage as noted previously. The governor drive shaft was sheared at the drive coupling Fig 24. The fuel control and governor were sent to Honeywell for further examination and testing.

No. 2 ½, 3, and 4 Bearing As Viewed Through the Gearbox

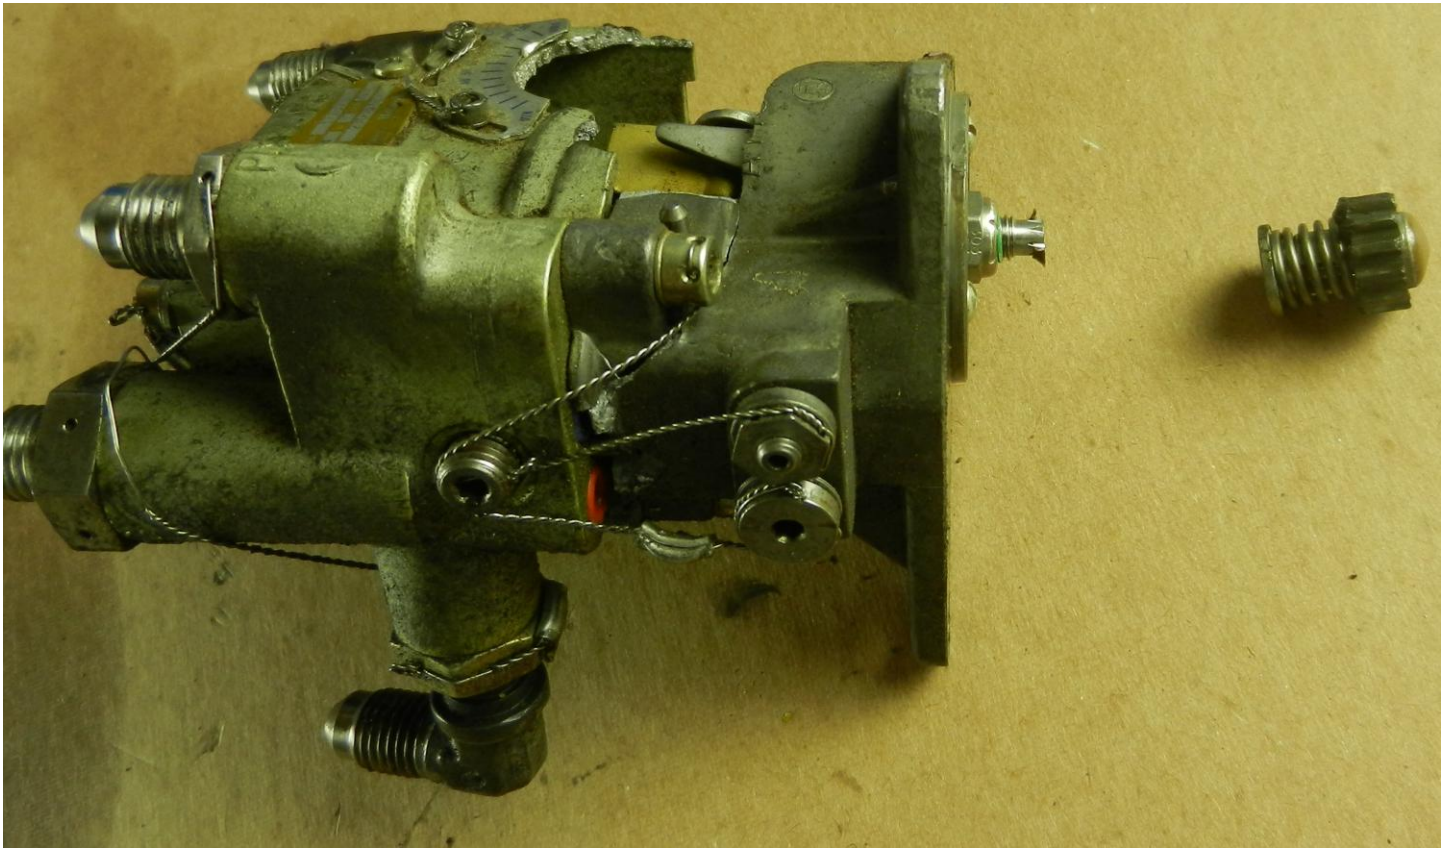
Fig: 24

Power Turbine Governor With Sheared Drive Shaft

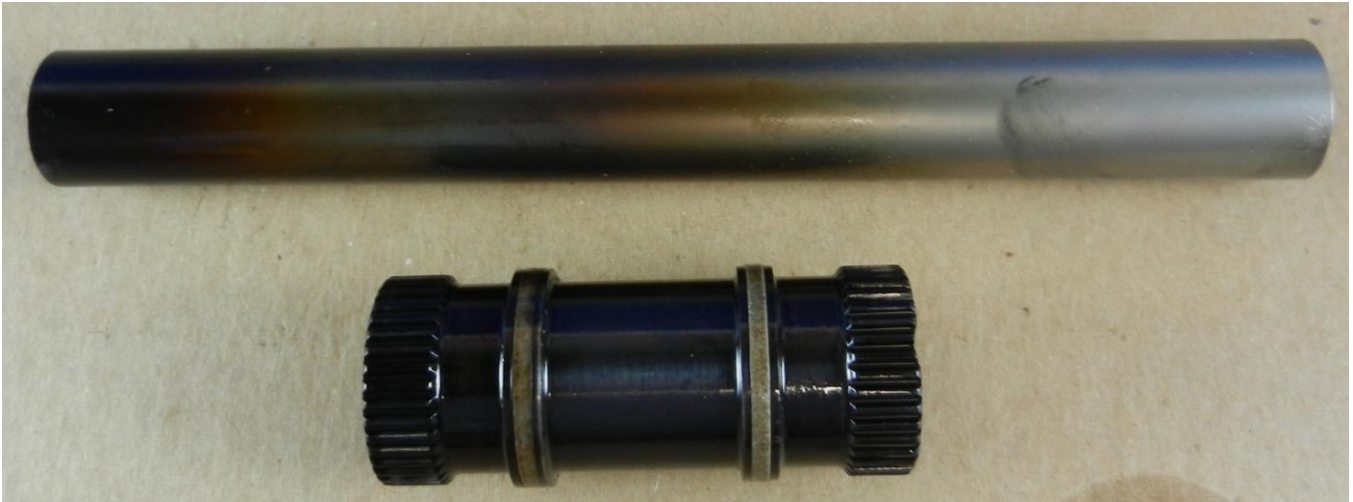
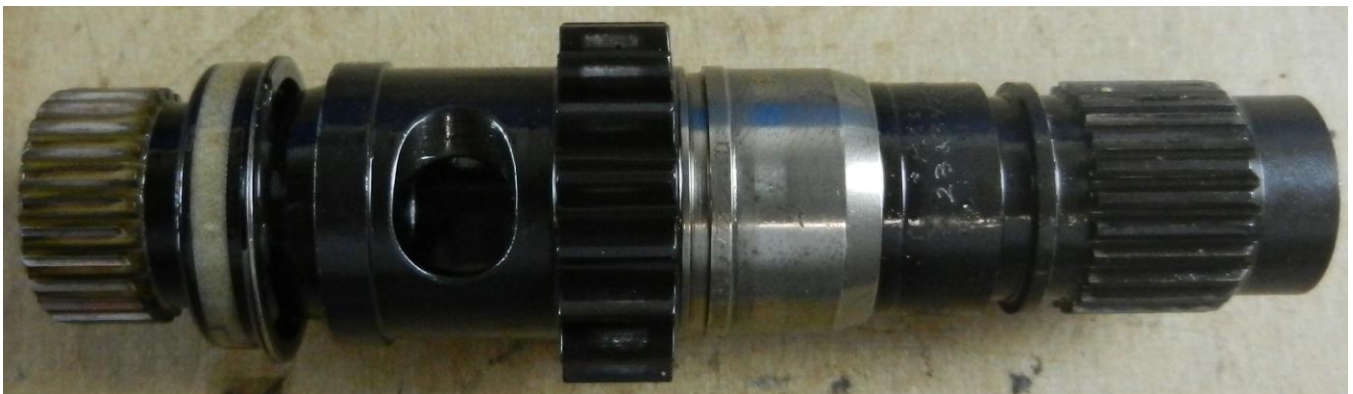
Fig: 25

Turbine-to-compressor coupling and power turbine-to-pinion gear coupling verified intact and properly engaged with no damage noted. The spur adapter gearshaft was intact with the retaining ring in place and secured. Fig 25

Turbine-To-Compressor Coupling and Power Turbine-To-Pinion Gear Coupling

Spur Adaptor Gearshaft
