NATIONAL TRANSPORTATION SAFETY BOARD

ENGINE EXAMINATION

WPR13FA289

Location: San Luis Obispo, California
Date: June 24, 2013
Aircraft: Cessna P337H, N337LJ
NTSB IIC: Elliott Simpson

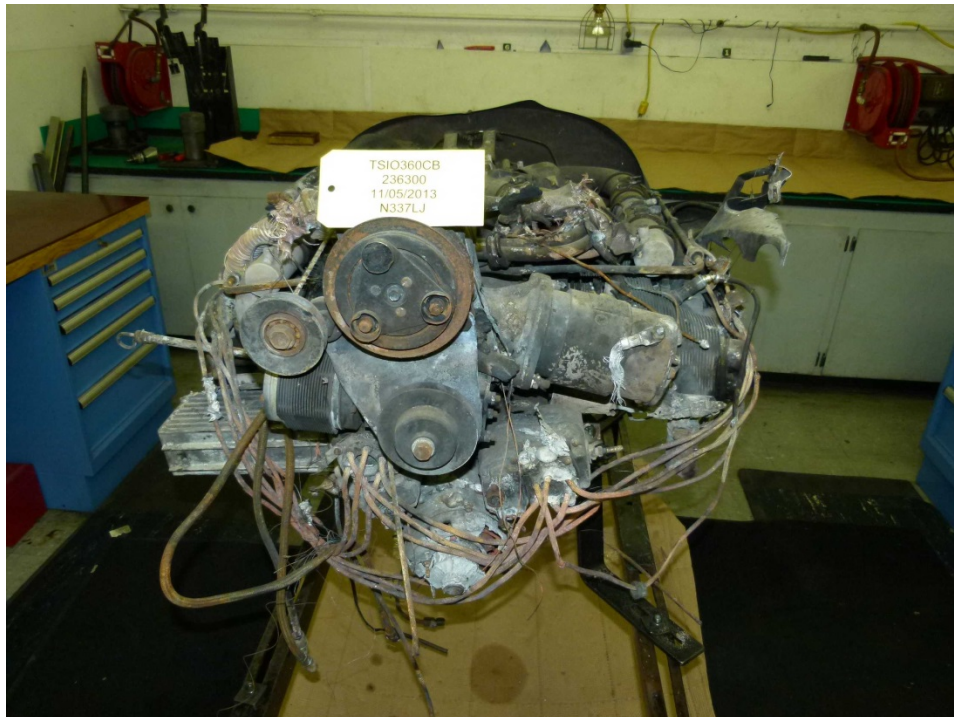
Photo 1 - Rear Engine on Examination Stand

The engine was removed from its shipping crate, and mounted on a rotating examination stand. The entire engine sustained thermal discoloration and sooting (Photo 1). The engine mounts had separated from the firewall, with the mounting stubs remaining bolted to the crankcase.

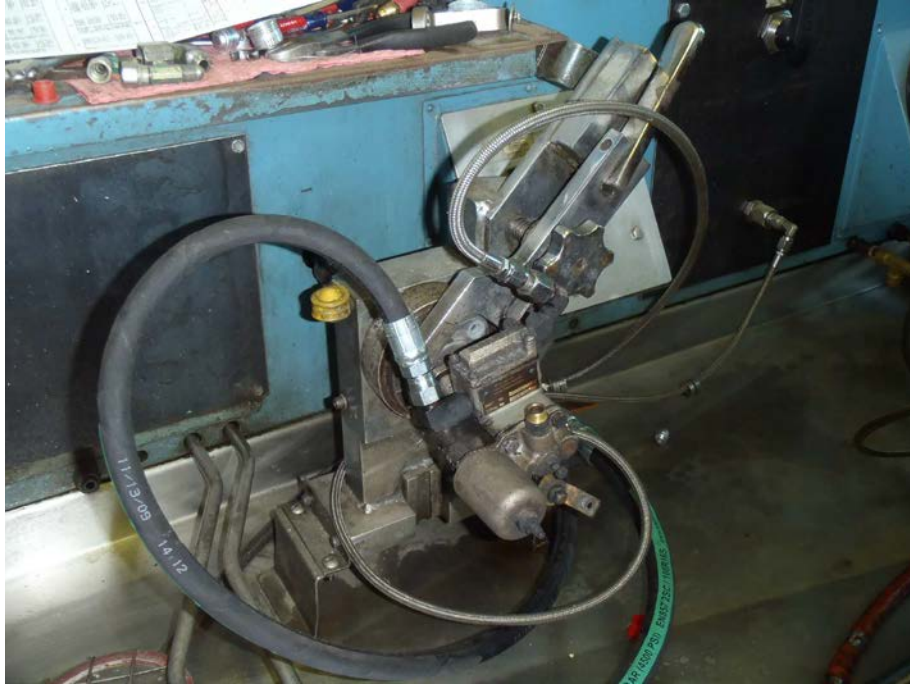
Photo 2 - Rear Engine Fuel Pump

The engine driven fuel pump sustained thermal damage and sooting and was removed for examination; the fuel lines were capped, and the unit was externally cleaned with solvent. The input shaft coupling remained attached and was undamaged, and the shaft could be rotated by hand with slight but smooth resistance felt. The unit was installed on a fuel injection test stand and tested in accordance with CMI fuel pump test procedures -20 (Photo 2). Fluid was observed to leak from the low-end adjustment seal when fluid was applied. The unit passed the flow/pressure test at 600 RPM, with a flow rate of 8.85 lbs/hr at a pressure of 7.2 psig (nominal 8-9 lbs/hr, 6.5 -7.0 psig).

At a speed of 2,800 RPM, the fuel pump was tested at a flow rate of 200.35 lbs/hr, and failed due to a resultant pressure indication of 10 psig. (Nominal: 15-17 psig at 200 lbs/hr). The unit was tested again at 600 RPM with the same result as the first 600 RPM test.

Turbo deck pressure of 39.39 in/hg was applied, and air was heard and felt to leak from the aneroid case O-ring seal. At 2,800 RPM the unit again failed, with 201.88 lbs/hr resulting in a pressure of 14.1 psig. (Nominal 36.0-36.5 psig at 199-201 lbs/hr with top deck pressure of 39 in/Hg).

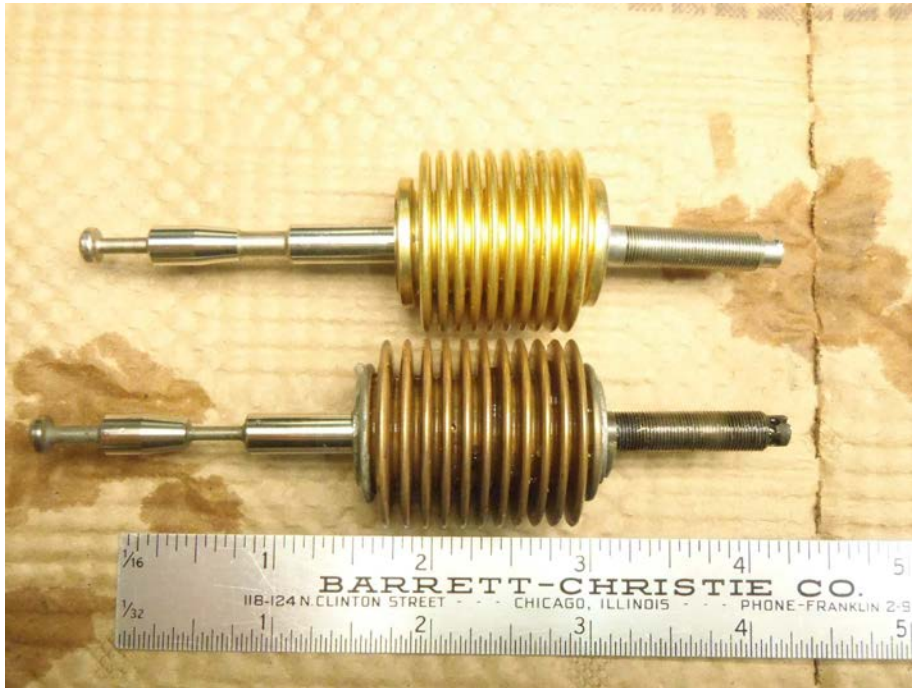
Photo 3 - Rears Engine Aneroid Bellows (Exemplar Above)

The unit was disassembled; the diaphragm seal was intact and stiff, sustaining thermal damage which resulted in globules coalescing on its outer surface. The mixture shaft cavity exhibited radial score marks to the inner surface. The rotor and vanes were intact. The aneroid was removed, and its solder joints appeared melted. The aneroid appeared to have expanded about 3/8 inch beyond its nominal size (Photo 3). The aneroid was dipped in water and appeared free of obvious leaks. When installed in a vacuum chamber, pressure was applied (56 PSI), and the unit was unable to maintain pressure.

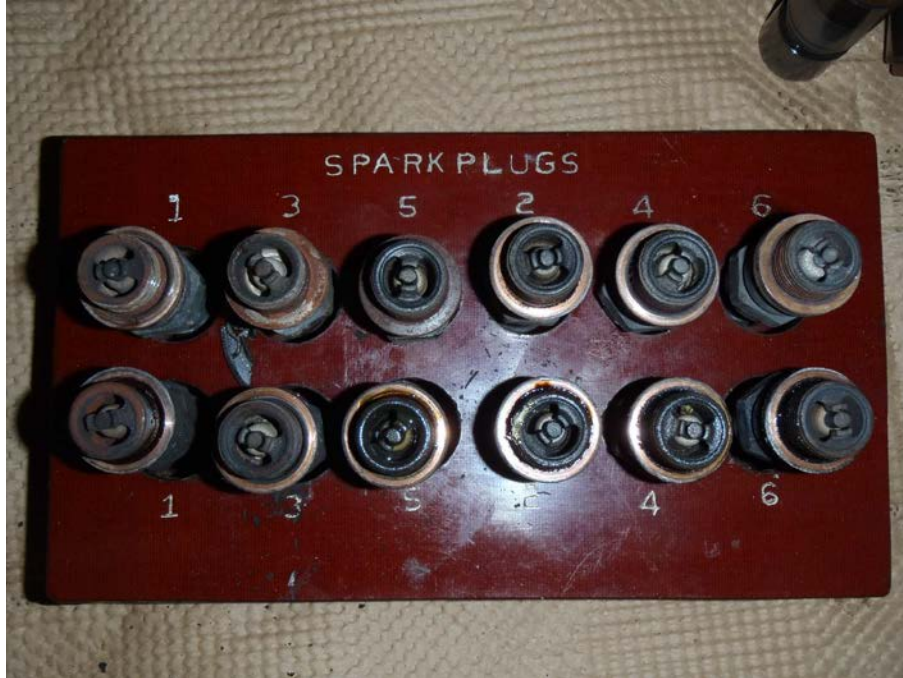
Photo 4 - Rear Engine Spark Plugs

All cylinders and pistons were removed for examination. The piston faces, intake valve heads, and the dome areas within each chamber were covered in light grey deposits, and coated in black soot. Each exhaust valve exhibited symmetrical coloration of the valve head. No mechanical damage was noted. All piston pins were free of scratches or indentations, and all piston rings moved freely within their skirts. The rocker areas were wet with oil, and free of distress. All pushrods were straight. The spark plug electrodes were free of mechanical damage, coated in black soot, and exhibited wear signatures to their electrodes consistent with "normal" operation when compared to the Champion AV-27 Check-A-Plug chart (Photo 4).

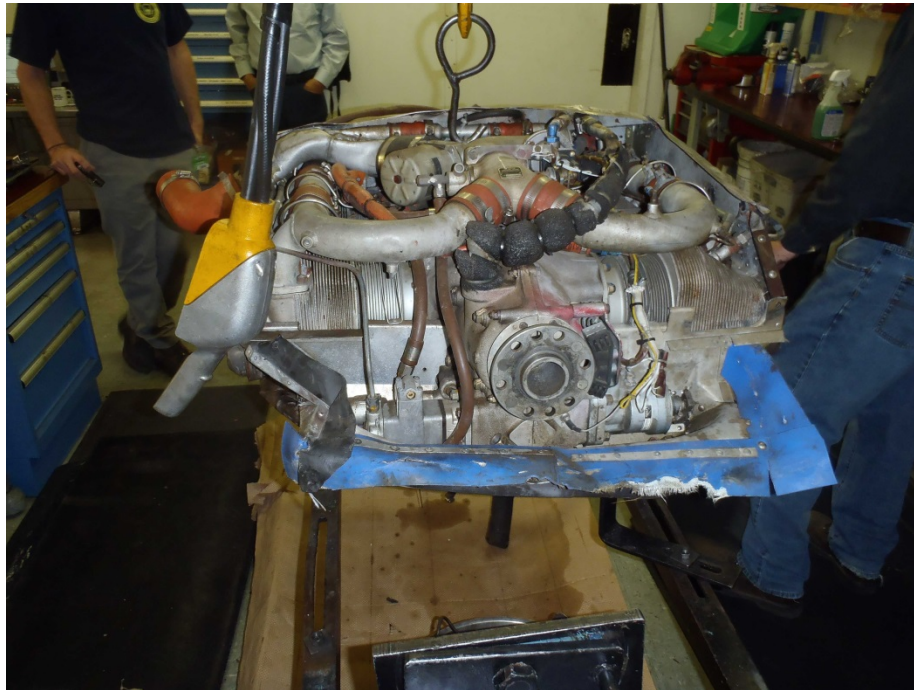
Photo 5 - Front Engine on Test Stand

The engine was removed from its shipping crate, and mounted on a rotating examination stand (Photo 5). The engine had separated from the firewall. The front left engine mount remained attached to the crankcase; the remaining three mounts had separated with their stubs still bolted to the crankcase. The oil sump sustained cracks to its lower right side, and no oil was present. The oil drain plug remained in place. The oil filter remained attached to its adapter, which was broken away from the crankcase pad.

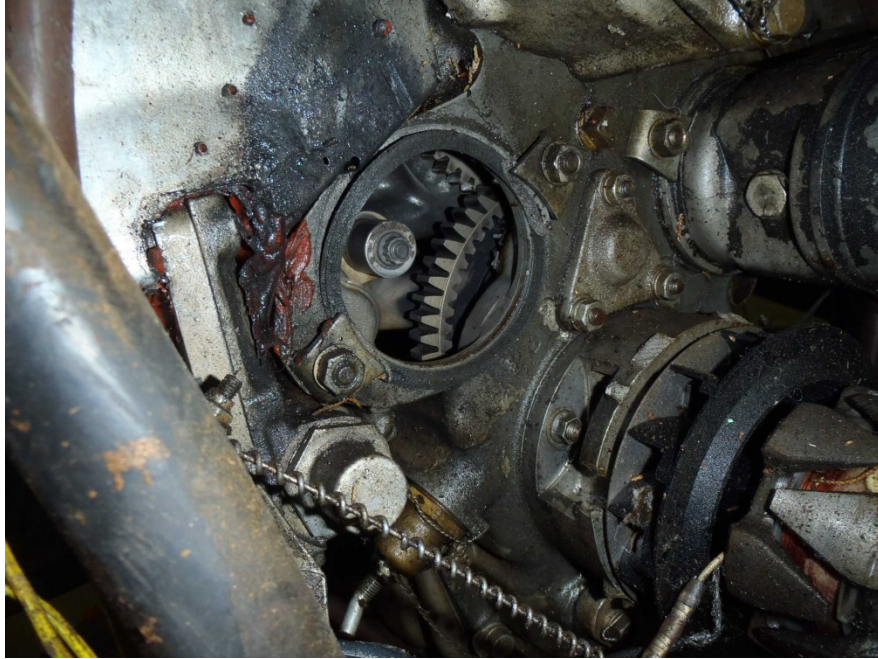
Photo 6 - Front Engine - Left Magneto Pad

The right magneto remained attached to the crankcase; the left magneto had broken away from its pad, with both mounting lugs still firmly attached to the crankcase (Photo 6). All spark plug leads, with the exception of the lower cylinder number 2, were continuous to the spark plugs.

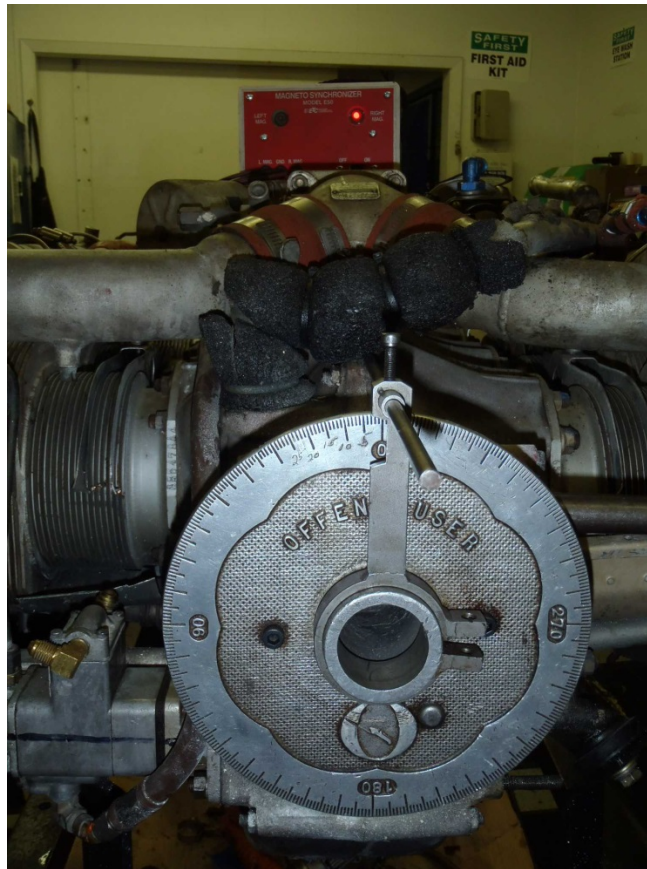
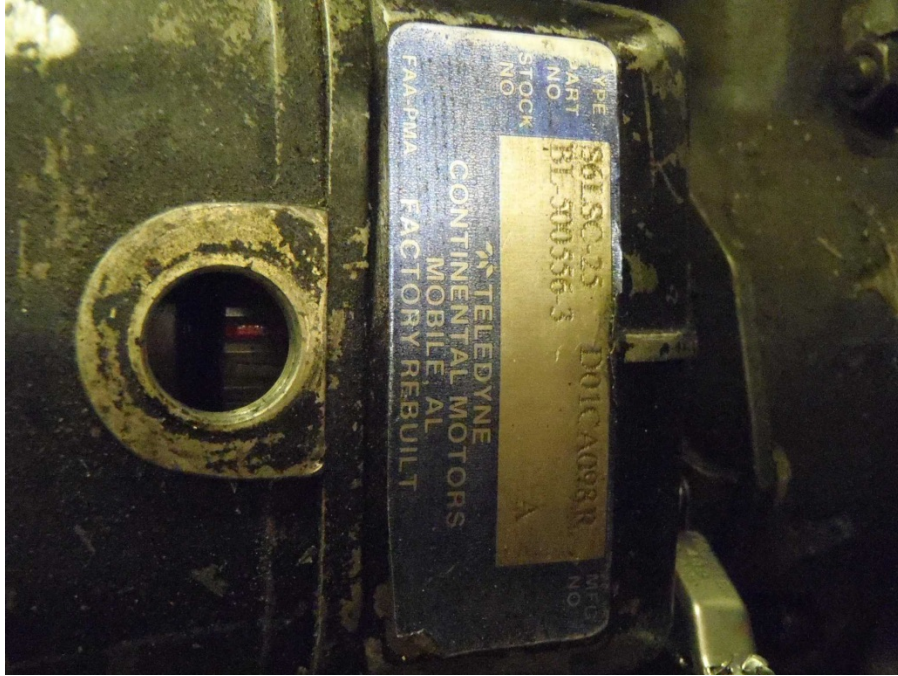
The ignition timing for the right magneto was tested in place on the engine utilizing a magneto synchronizer. The test revealed that the magneto points opened at 1 degree after top dead center (ATDC), instead of the nominal 20 degrees before top dead center (BTDC) (Photo 7, 8).

Photo 7 - Front Engine Right Magneto Timing

Photo 8 - Front Engine - Right Magneto Timing Inspection Hole

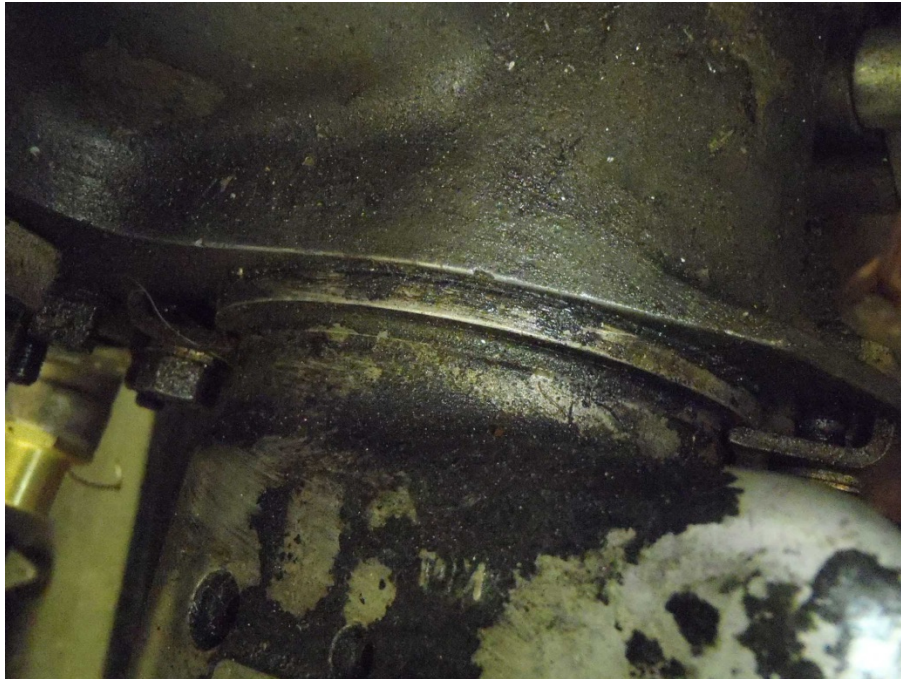
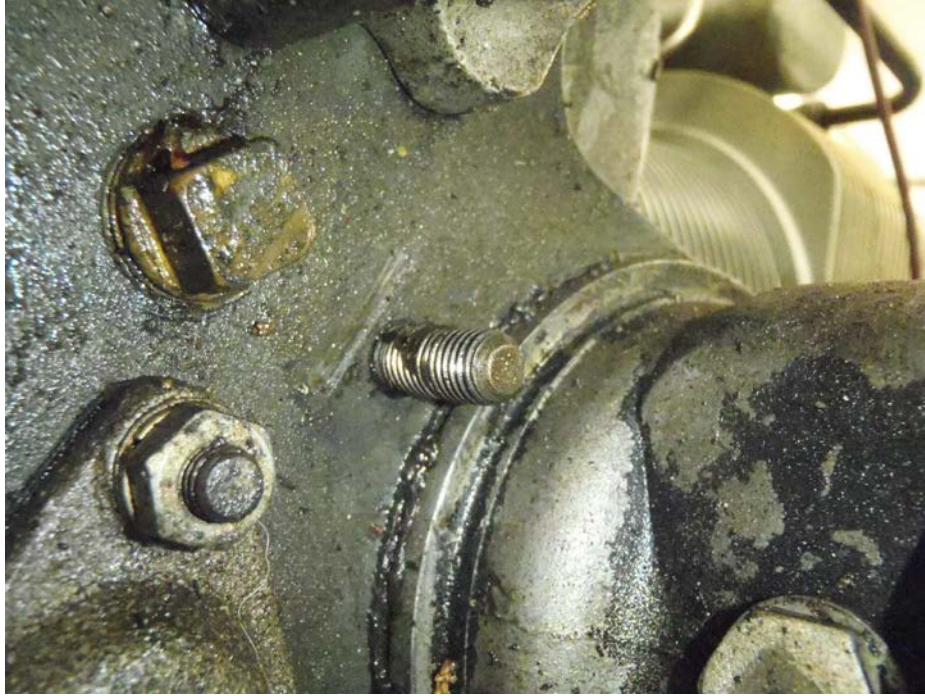
The left magneto was installed on a test stand and operated at speeds varying between 500 and 2,100 RPM. All leads produced a spark in firing order, and the impulse coupling triggered appropriately. The left mounting clip for the right magneto was temporarily removed, in an effort to determine if the magneto had moved during the accident sequence. The engine pad, magneto lug, and mounting clip were free of damage, and the magneto case was intact (Photo 9, 10).

Photo 9 - Front Engine - Right Magneto

Photo 10 - Front Engine - Right Magneto with Left Clip Removed

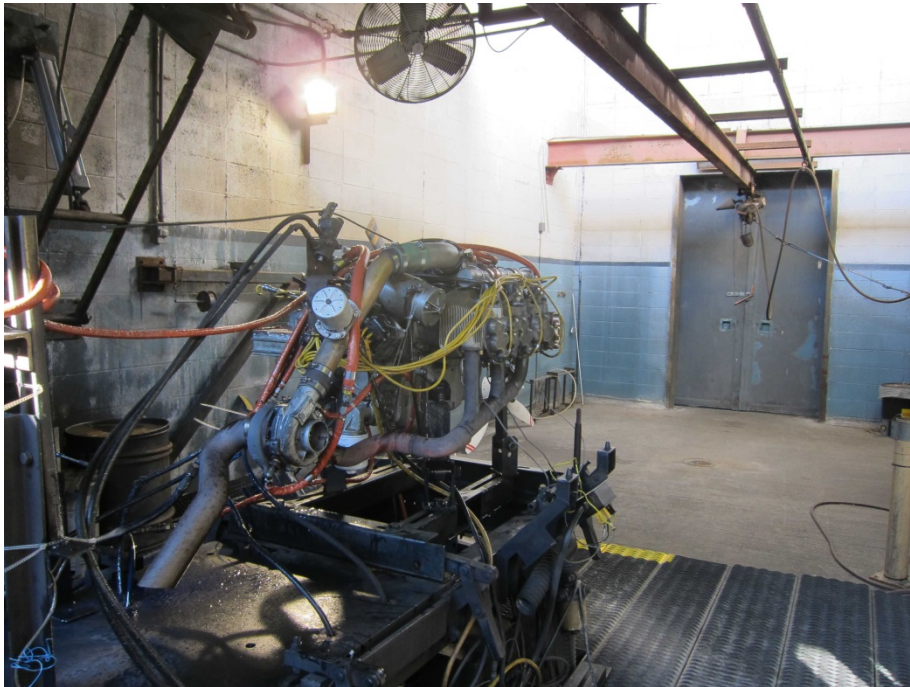
Photo 11 - Front Engine Operating In Test Cell

The engine was installed in a test cell, and an engine run was performed with the right magneto remaining in its as-found position of 1 degree ATDC. The left magneto was set to the same timing position. The engine started after two attempts, and was run at 1,000 RPM for five minutes to its operating temperature. The throttle was then advanced full open, and the engine speed accelerated to a maximum of 1,850 RPM with an indicated manifold pressure (MP) of 38.5 inHg. A magneto check was then performed, with a speed drop of 200 RPM observed for each magneto.

The left magneto was then set to the correct ignition timing of 20 degrees BTDC, and another engine run was performed. The engine started immediately and the throttle was advanced 2/3 of its travel, resulting in an engine speed of 1,860 RPM, with an indicated MP of 37.5 inHg. A magneto check was performed at 1,800 RPM a drop of 20 RPM was observed when the left magneto was selected, and a drop of 240 RPM with the selection of the right magneto. The test was then stopped in an effort to prevent an overboost condition.

A final series of four engine runs were performed with both magnetos set to 20 degrees BTDC. The propeller pitch was increased progressively during each run to prevent an overboost condition. For the last test, the engine reached a speed of 2,775 RPM at 36.5 inHg MP; during this test the engine speed was cycled through its entire range, and both accelerated and decelerated smoothly throughout.
