NATIONAL TRANSPORTATION SAFETY BOARD

ENGINE EXAMINATION

WPR16L019

Location: Folsom, California
Date: October 24, 2015
Aircraft: Eurocopter AS-350 B3, N911WL, Serial #: 4587
NTSB IIC: Elliott Simpson

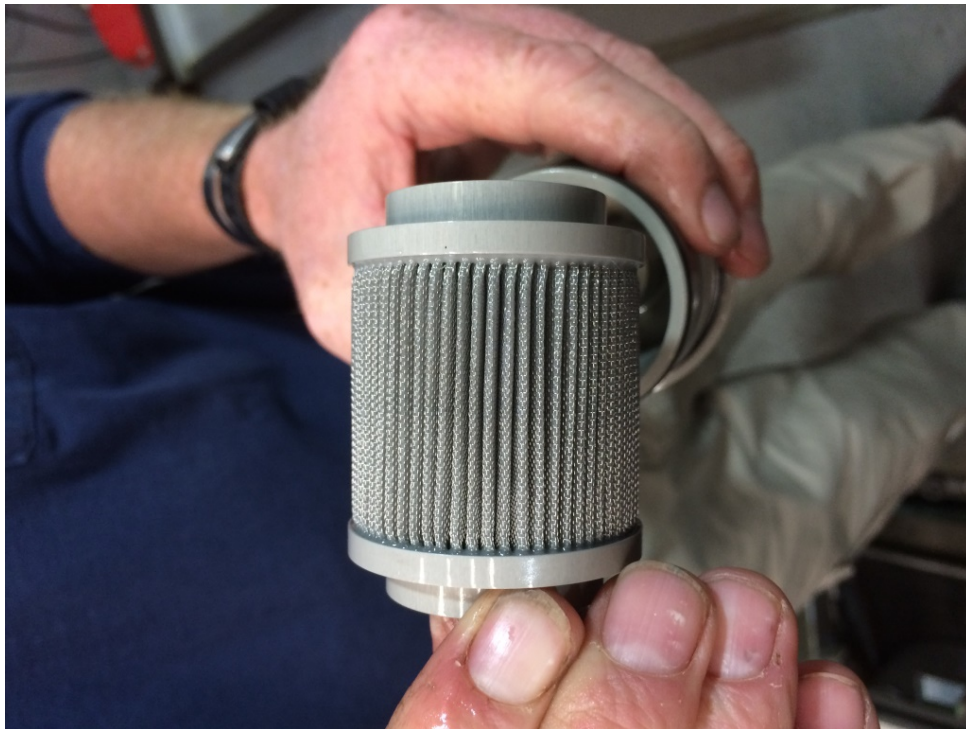
The engine was shut down and the fuel filter removed. No debris was observed.

Photo 1 - Engine Fuel Filter
