Continental Motors, Inc.

ENGINE FIELD INSPECTION REPORT

ENGINE MODEL: TSIO-520-R9B

REGISTRATION: N1631X

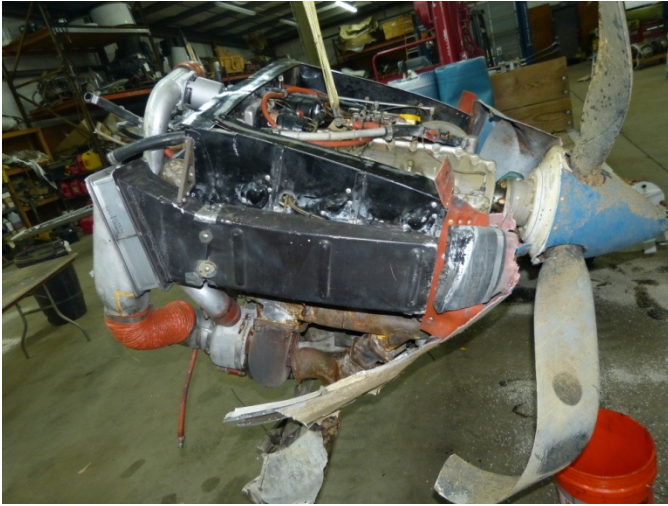
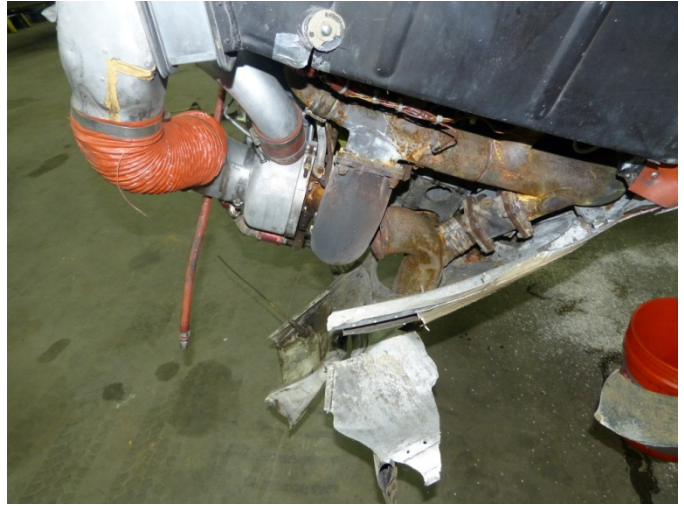
Intake and Exhaust: The only damage to the intake was where the manifold pressure line separated from the intake pipe. The exhaust pipe was impact damaged.

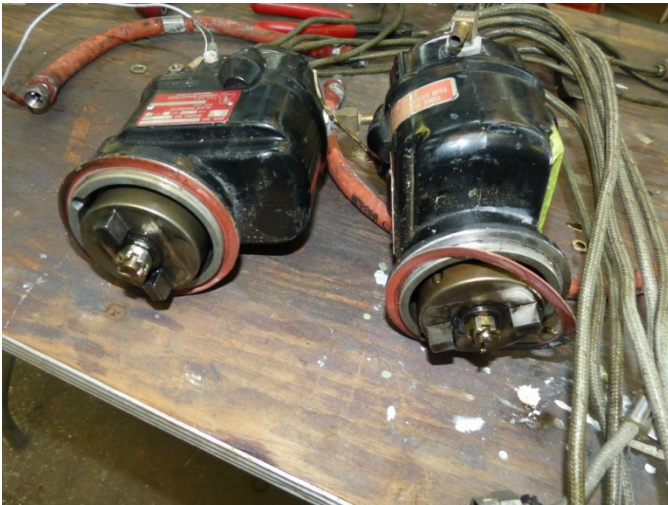
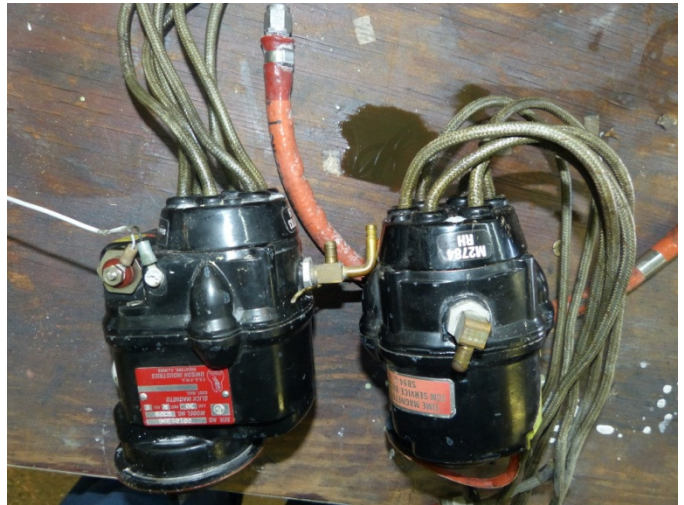
Both magnetos were in place and not damaged. They were both tested with an electric drill, and they both sparked at all ignition leads.

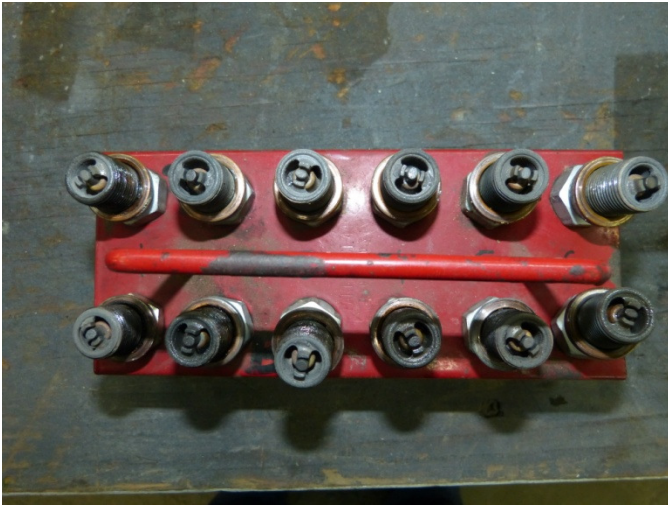
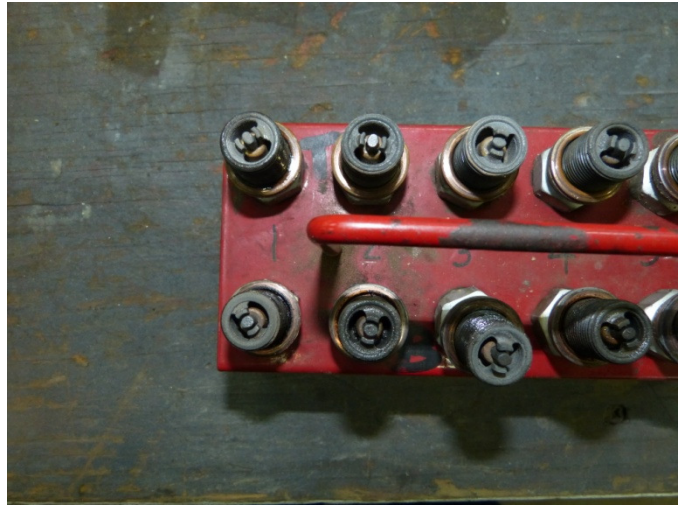
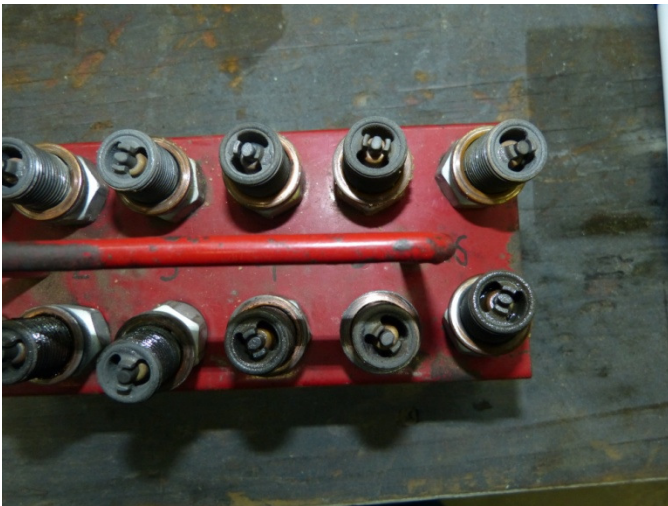
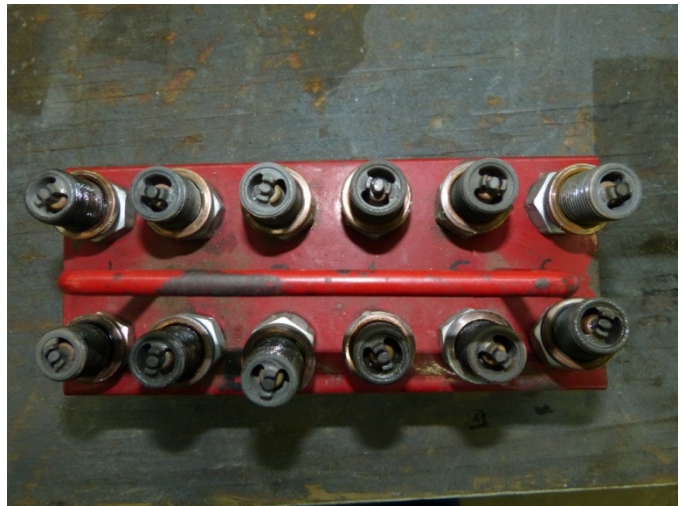
All of the spark plugs were removed and examined. The electrodes were worn out normal when compared to the Champion Check-A-Plug comparison card. They had light gray deposits in the electrode areas.

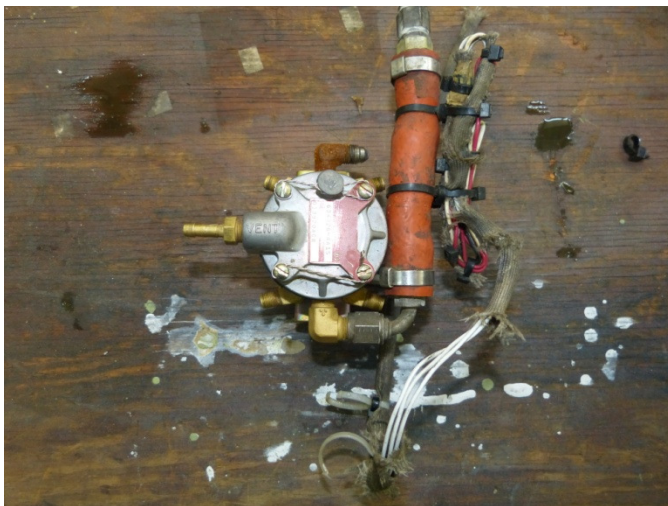
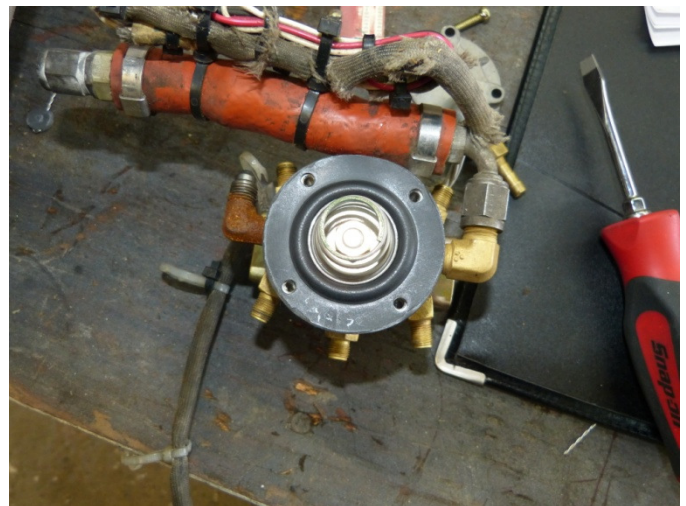
The safety wire and lead seal were in place. The unit was disassembled and the spring and diaphragm were not damaged. A small amount of debris was observed on the fuel screen. The screen was wet with fuel. The nut was tight on the plunger.

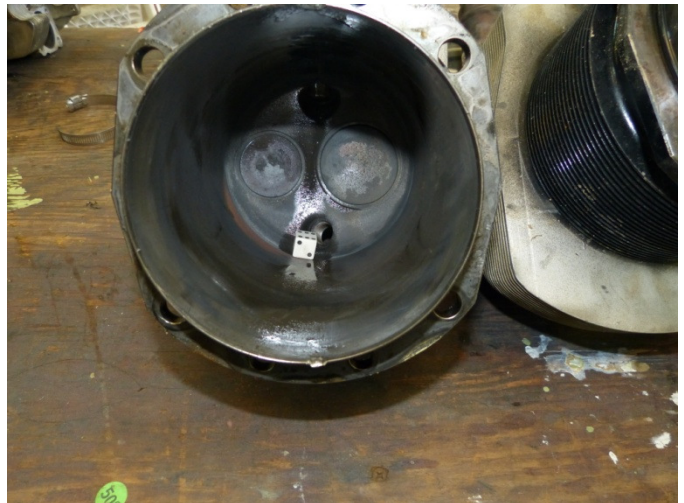
The number one piston could not be removed from the number one cylinder. The remainder of the cylinders were not damaged. They had light scoring in the barrels and light deposits in the domes. All of the valves were in place.

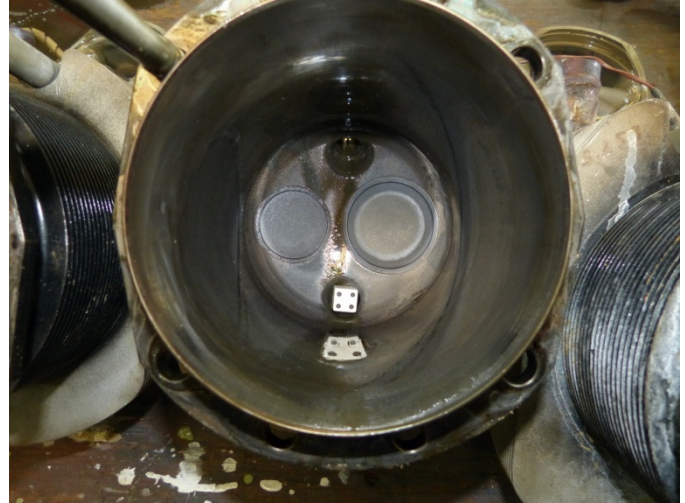
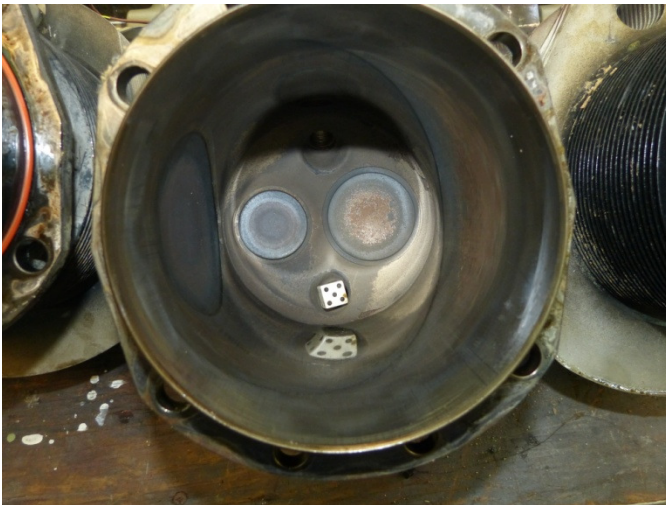
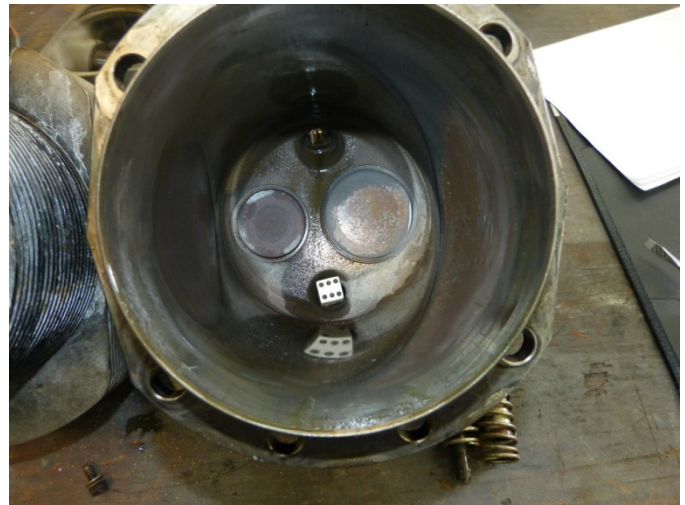
The pistons were not damaged. The number one piston could not be removed from the number one cylinder. All of the rings were in place and coated with oil. Light combustion deposits were observed on the piston faces.

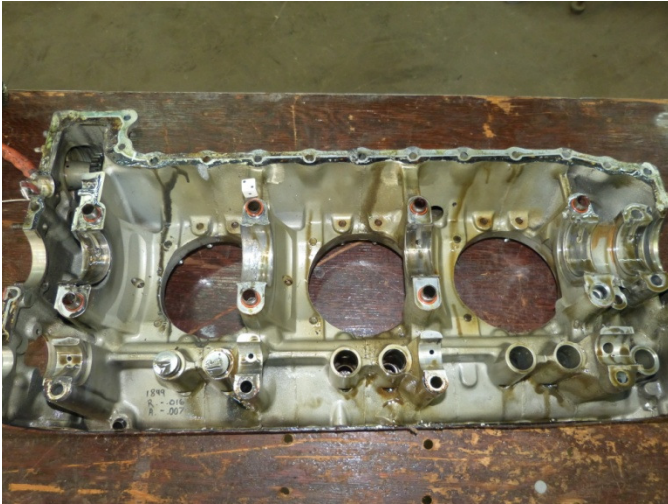
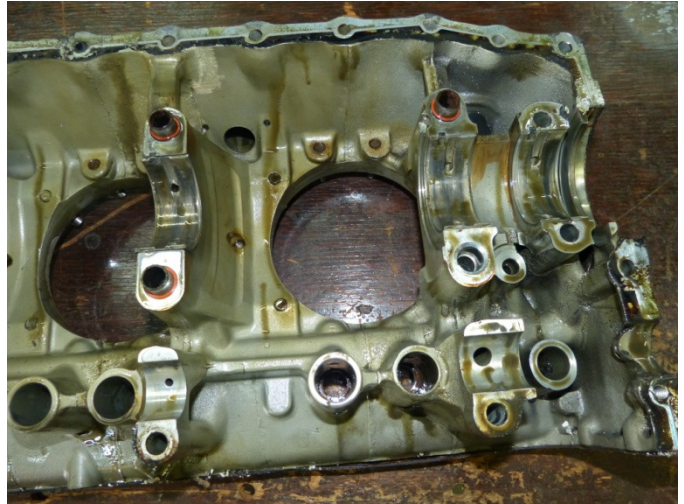
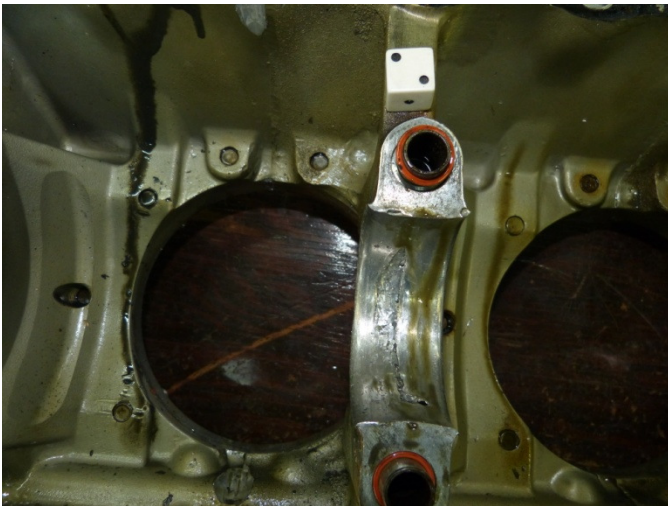
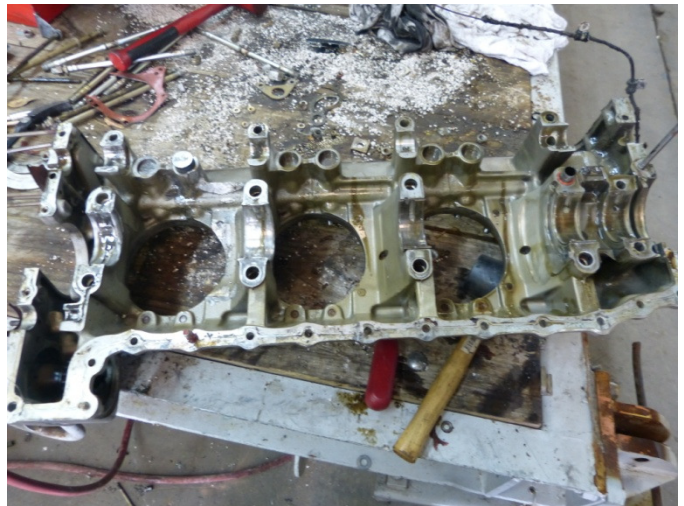
The crankcase halves had impact damage on their interiors, and the interiors were coated with oil. Heavy damage was observed on both crankcase halves on the number two main bearing saddles. The number two main bearing remained in the bearing saddle and had heavy impact damage and was extruded past the edge of the bearing saddle.

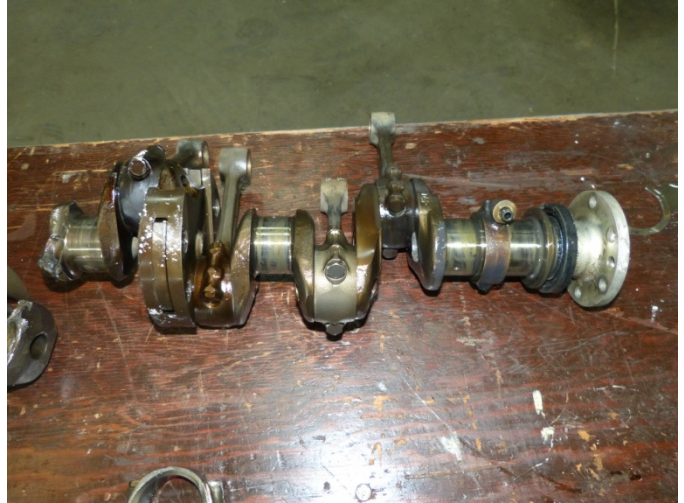
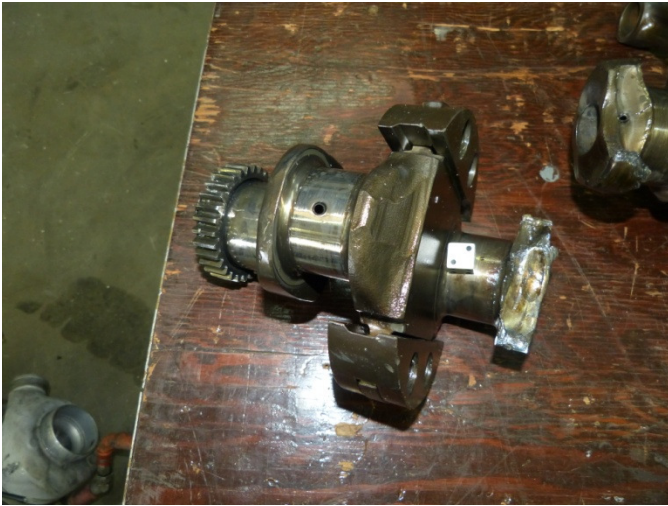
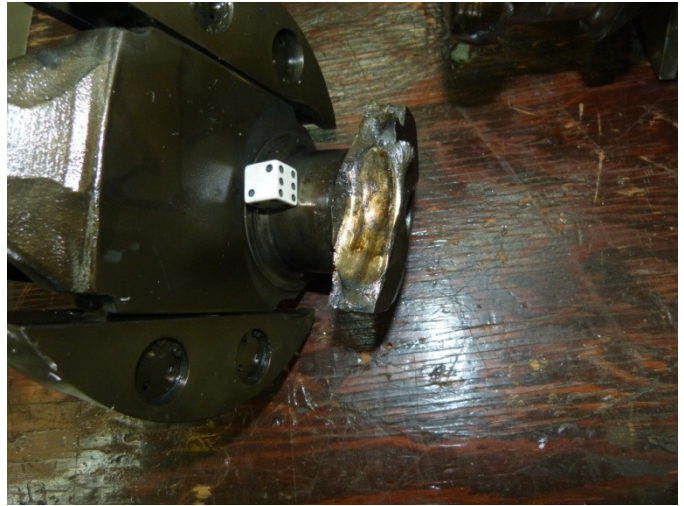
All of the main bearings were in place and coated with oil. The number two main bearing was in the bearing saddle and had heavy impact damage, but did not show any signs of heat discoloration. It was extruded over the edge of the crankcase bearing saddle.

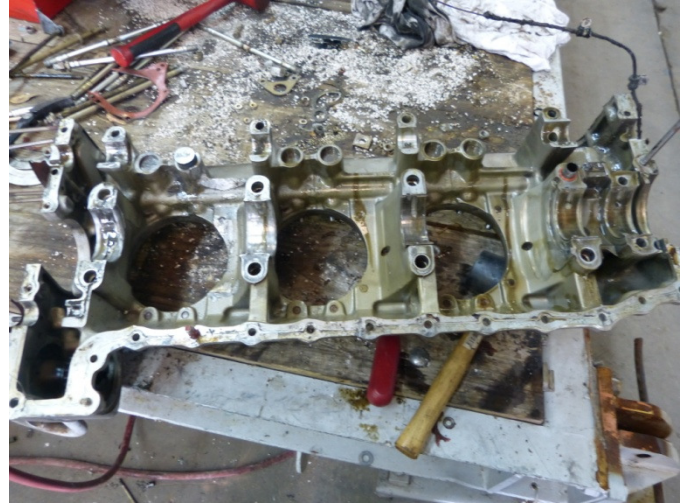
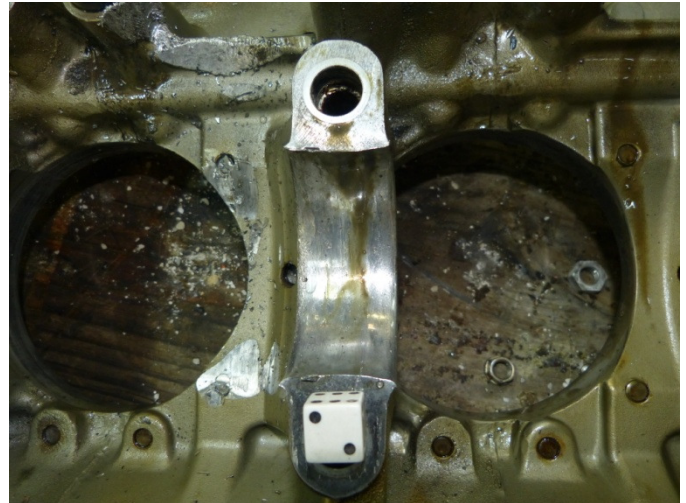
The connecting rods were not damaged. The number two connecting rod had one rod cap bolt separated.

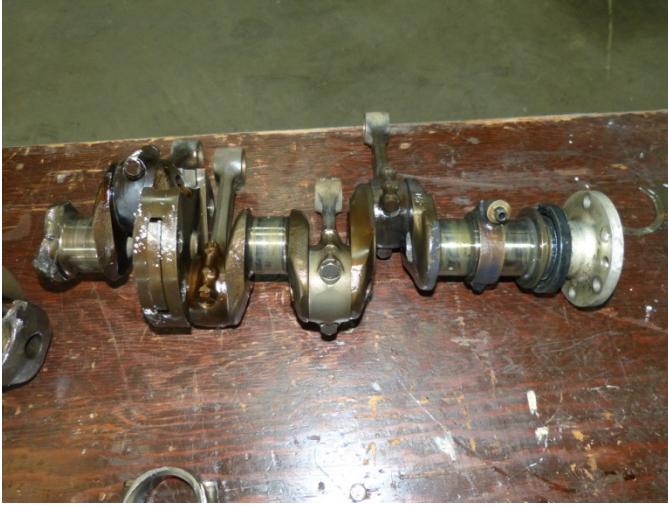
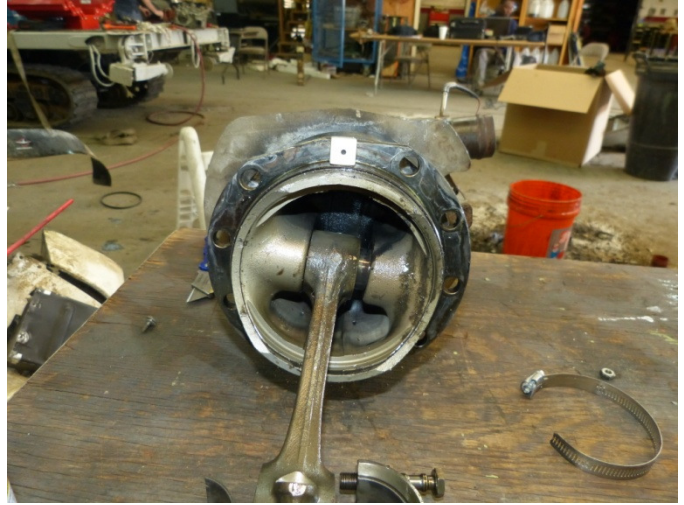
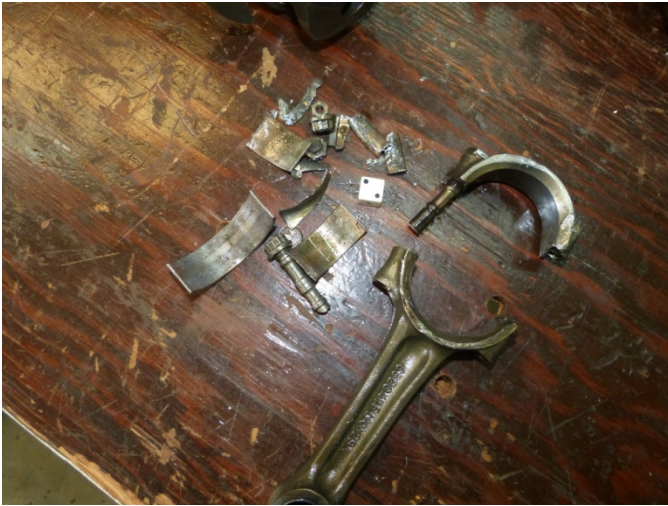
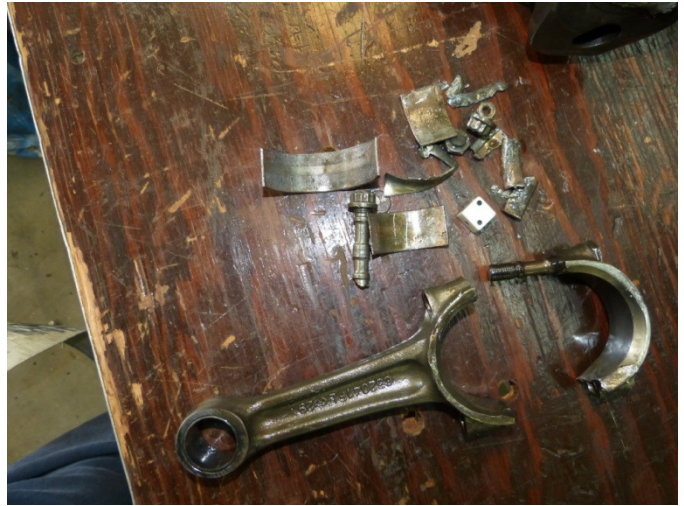
The number two rod cap bearing was impact damaged and broken in to pieces. The remainder of the rod cap bearings were not damaged and were free to rotate on the rod journals.

The camshaft was intact with some impact damage. The camshaft lobes were coated with oil, and had scoring.

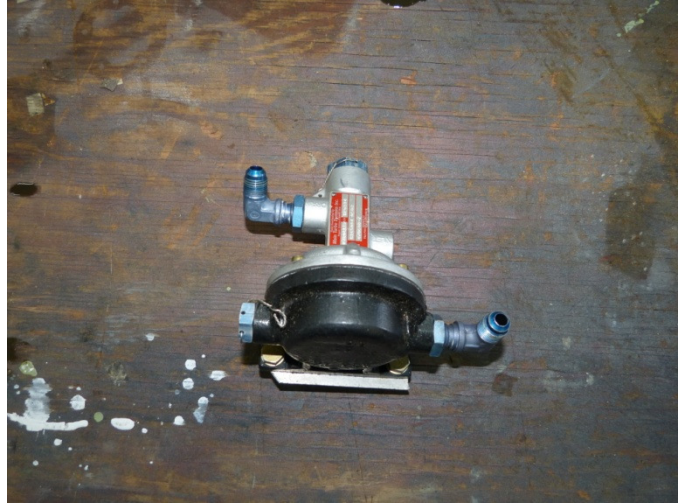
Wastegate: The wastegate was attached and had some impact damage. It was not disassembled.

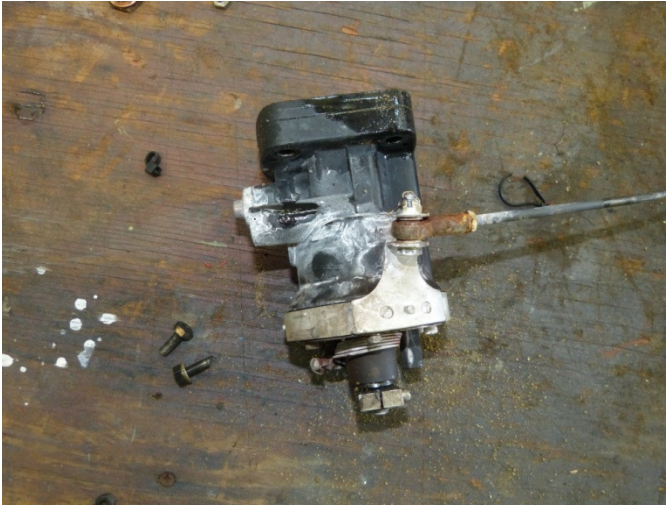
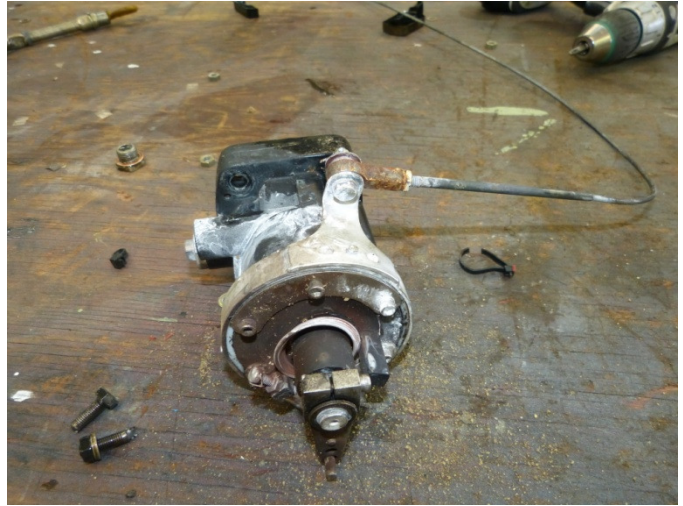
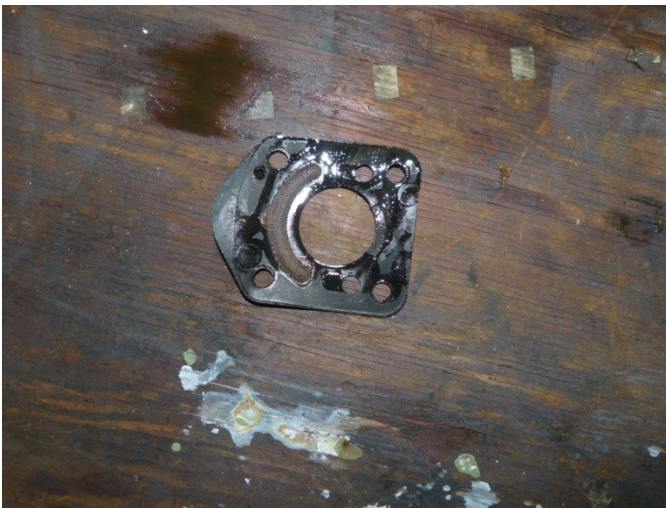
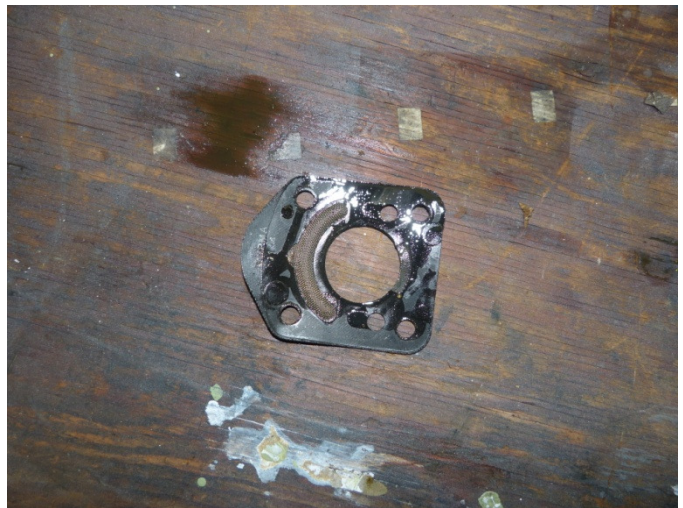
The propeller governor was in place and not damaged. The actuating arm was hooked up and was free to move. The drive shaft was free to rotate, and the oil screen was clean.

The propeller remained attached to the crankshaft, and the spinner was dented. All three blades were curled toward the direction of rotation and had some chordwise scaring.
