# Continental Motors

## ENGINE EXAMINATION REPORT LEFT

ENGINE MODEL	TSIO520EB (8B)
ENGINE SERIAL NUMBER	271215-R
AIRCRAFT MAKE & MODEL	Cessna 335
AIRCRAFT SERIAL NUMBER	335-0023
AIRCRAFT REGISTRATION	N2707J
FILE NUMBER	18-174

## ENGINE EXAMINATION REPORT RIGHT

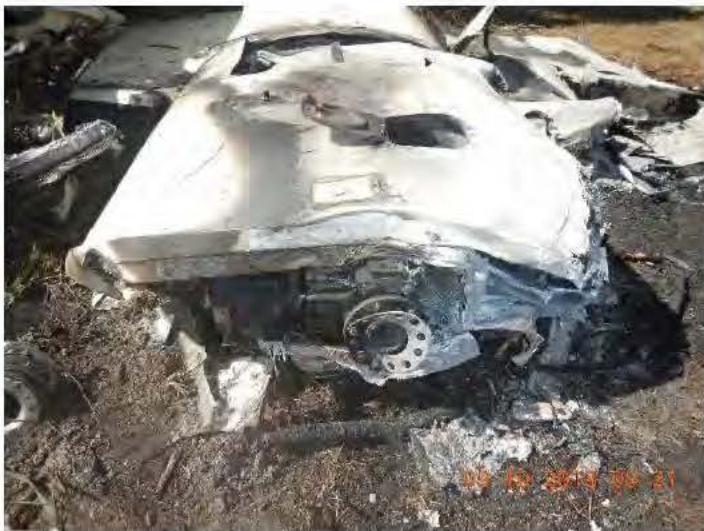
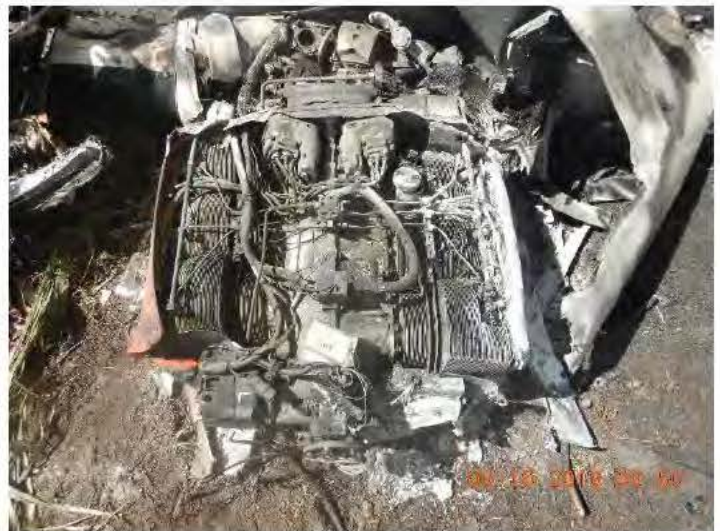
The left engine exhibited impact and thermal damage. The propeller separated on impact by breaking the propeller attachment bolts. The engine crankshaft propeller flange remained intact.

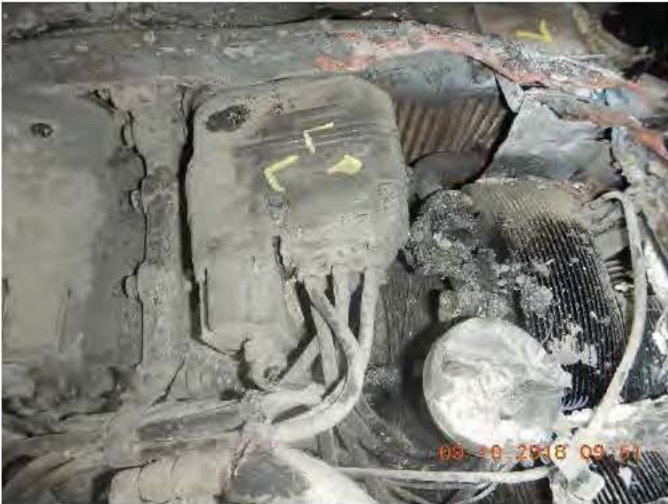
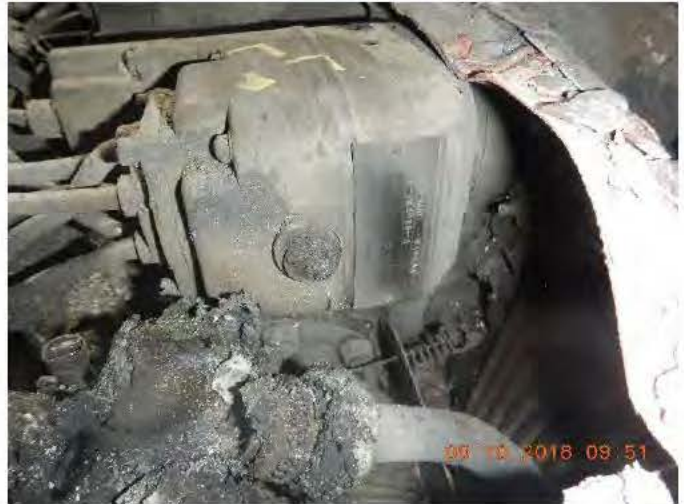
<b>LEFT MAGNETO</b>	Manufacturer: Bendix	P/N: 10-163-020-3	S/N:640654
Condition:	The left magneto produced sparks at all ignition leads when the magneto was manually rotated using a drill motor.

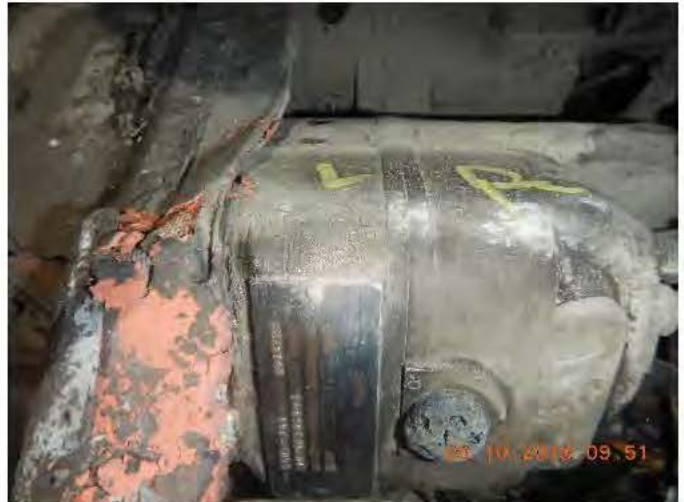
<b>RIGHT MAGNETO</b>	Manufacturer: Bendix	P/N: 10-163060-1	S/N: 801229
Condition:	The right magneto produced sparks at all ignition leads when the magneto was manually rotated using a drill motor.

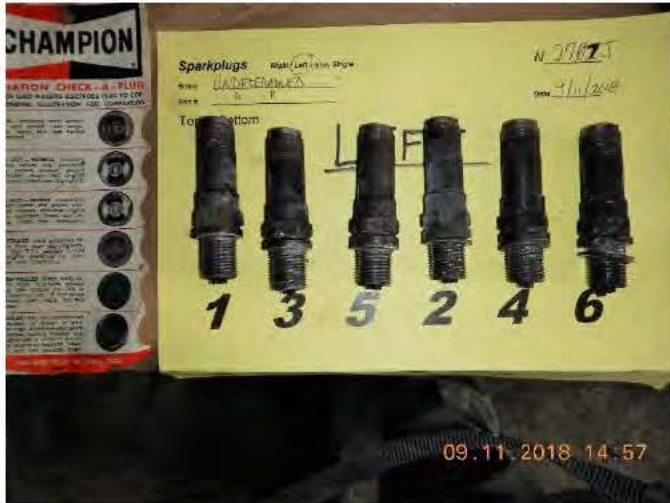
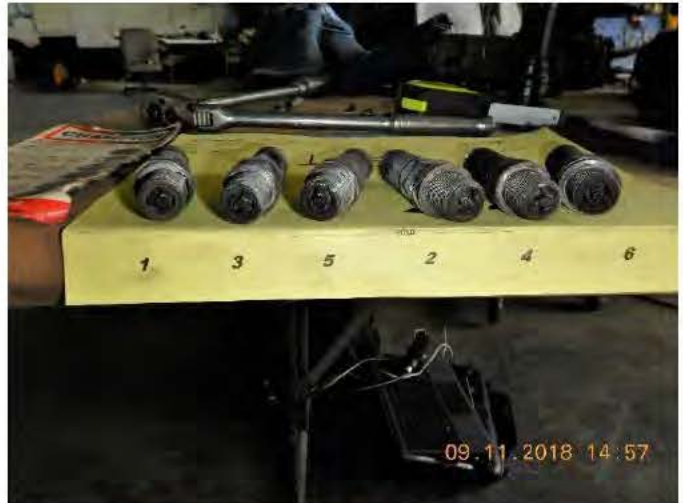
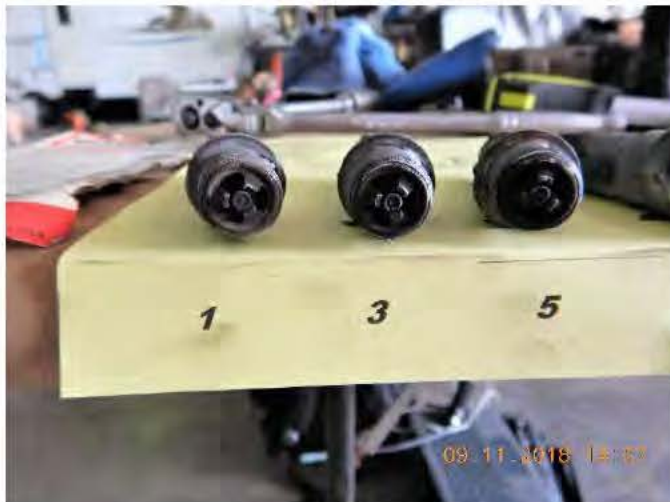
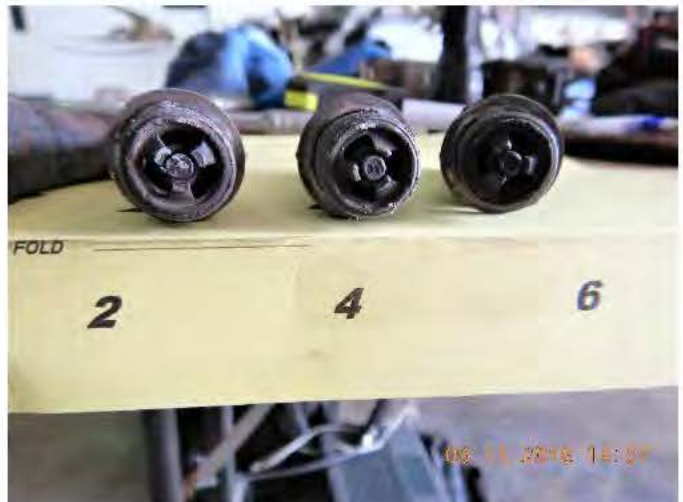
The top sparkplugs were removed and inspected. When compared to a Champion "Check-A-Plug" chart, all six top sparkplugs appeared to be "Normal" in both wear condition and coloration. The sparkplugs had been painted black and the manufacturer's name and part number were unreadable. The sparkplugs featured three massive electrodes instead of the usual two or a single fine-wire type electrode.

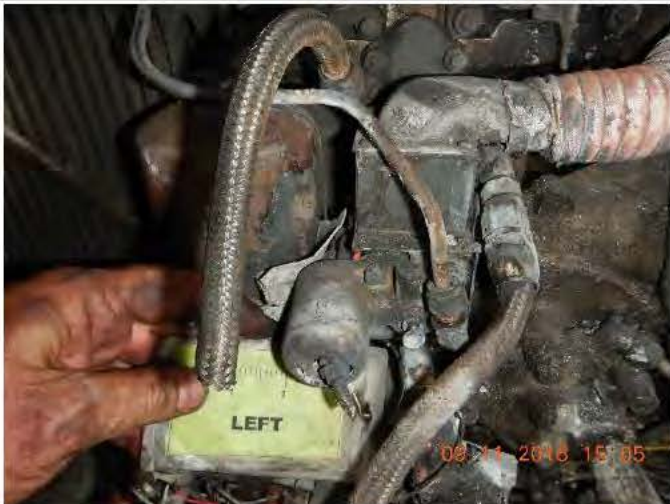
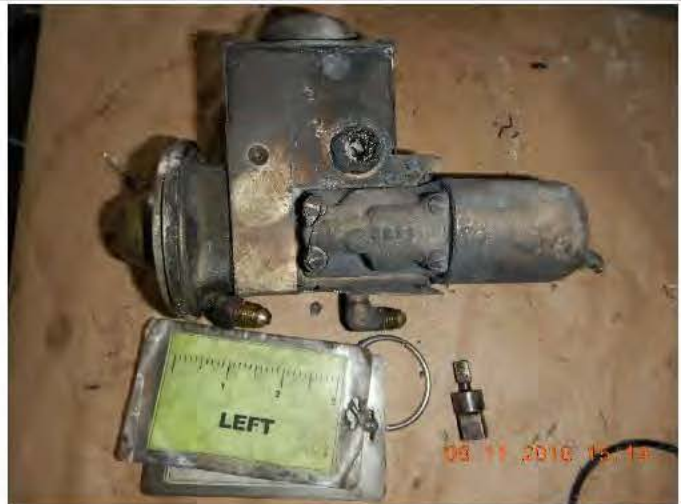
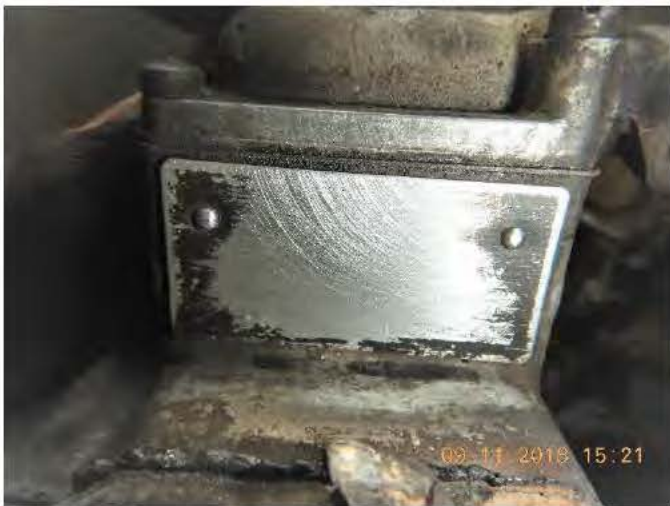
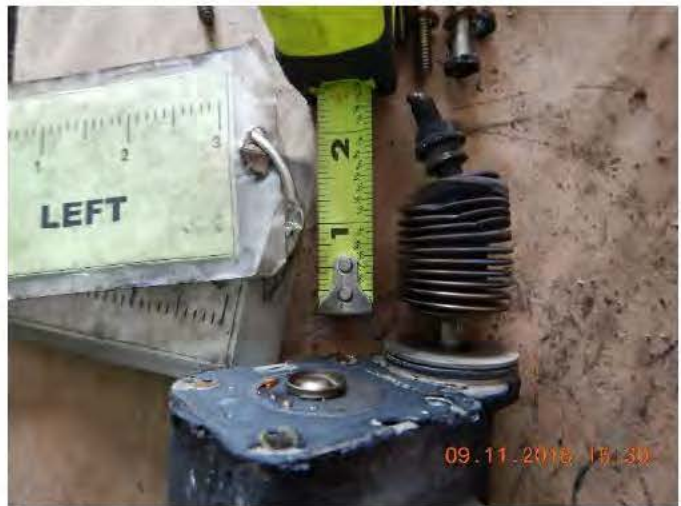
The fuel pump was rotated manually, and no fuel was expelled. The pump input shaft was thermally damaged and the pump impeller blades were intact. The unmetered fuel adjustment screw was impact damaged. The fuel pump case at the bellows assembly was broken.

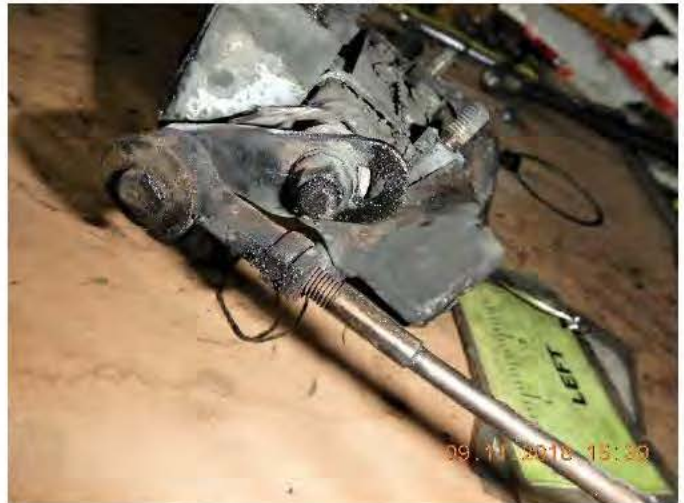
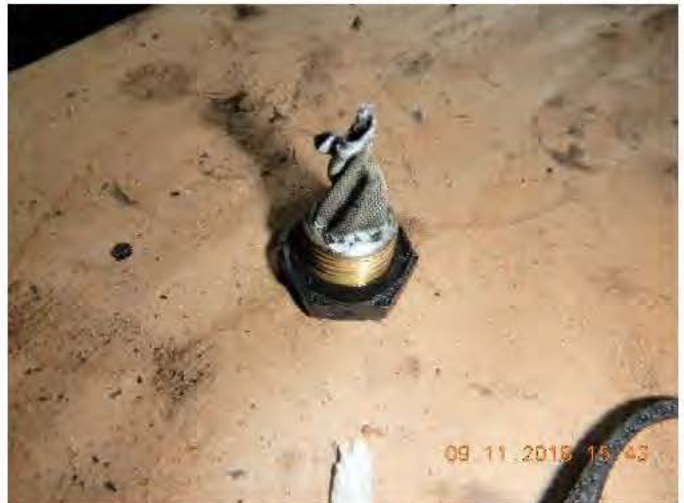
The fuel metering unit was intact but exhibited thermal damage. The control cable was attached properly, and the fastener was tight on the shaft. The fuel screen was not secured with safety wire as required. The fuel screen was removed and was damaged during the removal process. The solder from the assembly of the screen melted attaching the mesh to the throttle body housing. The screen appeared to be uncontaminated.

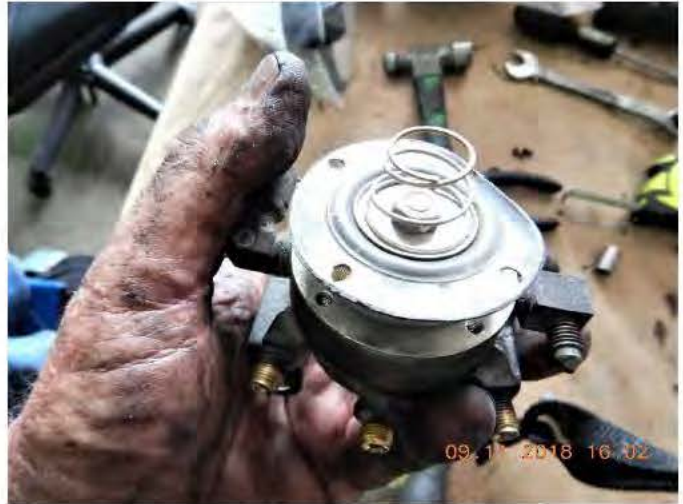
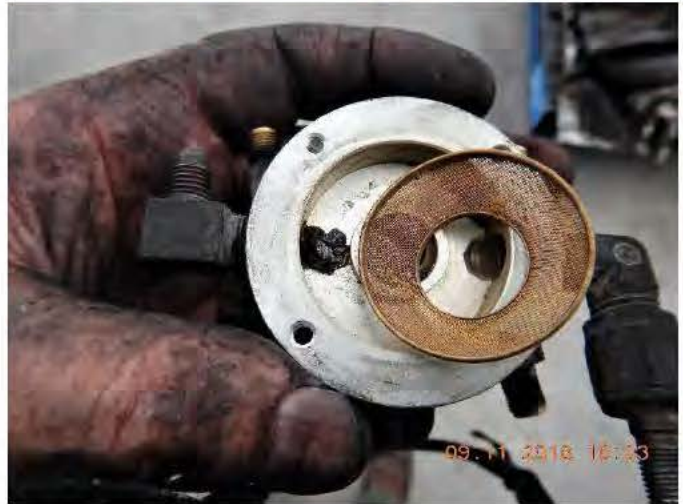
The assembly screws were correctly secured with safety wire and a lead seal was intact. The assembly screws were removed, and the spring and diaphragm were intact. The fuel screen was uncontaminated, but the manifold cavity contained a small amount of unidentified debris. The debris was attracted to a test magnet.

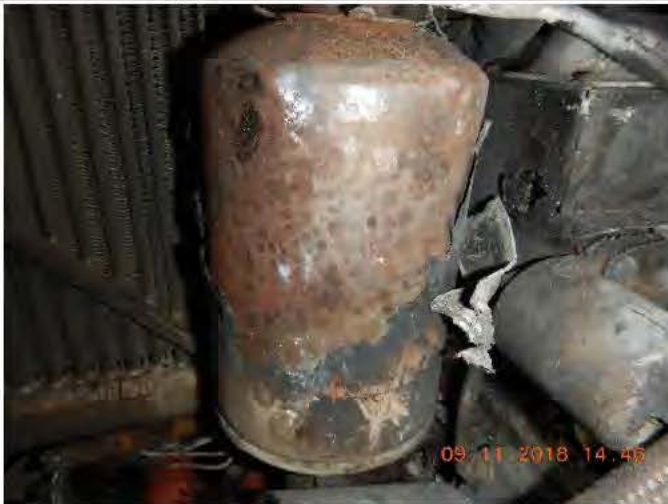
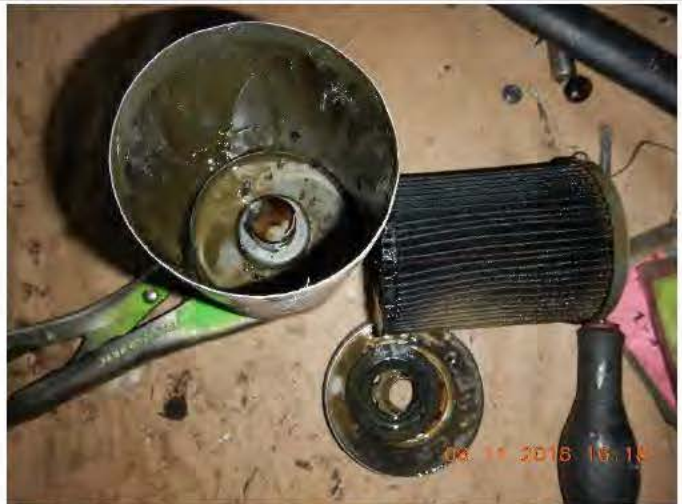
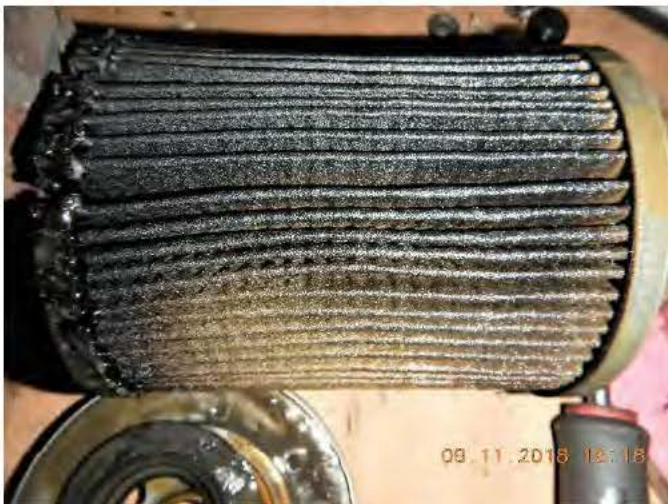
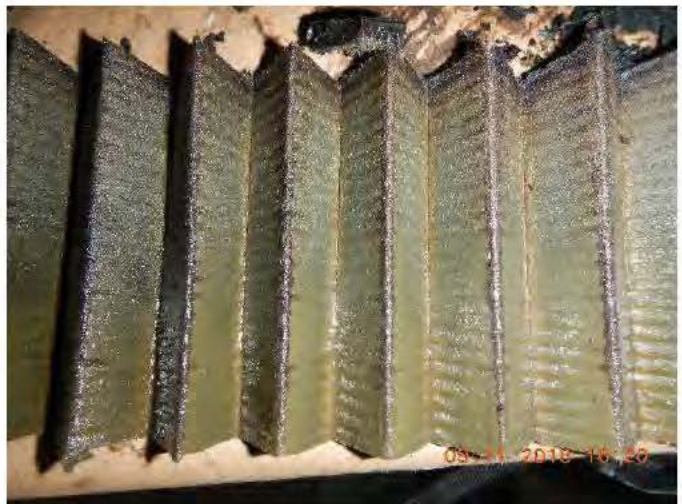
**Condition:** The exterior of the filter exhibited thermal distress and was correctly secured with safety wire. The paper filter media was thermally damaged inside the canister where exposed to the post impact fire. The less damaged filter media was cut from the assembly and examined. No contamination was noted.

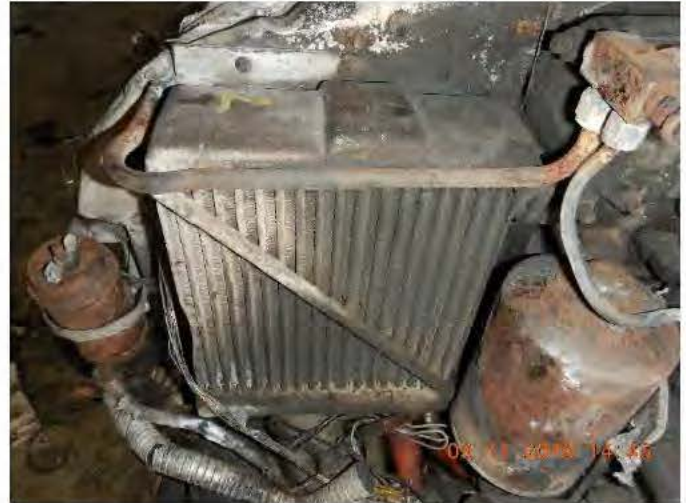
No data plate was attached to the oil cooler. The oil cooler was intact with thermal distress to the lower portion where it had been exposed to the post impact fire.

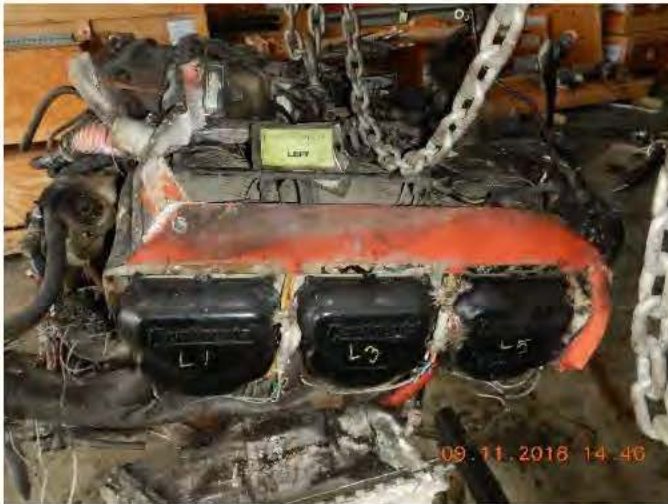
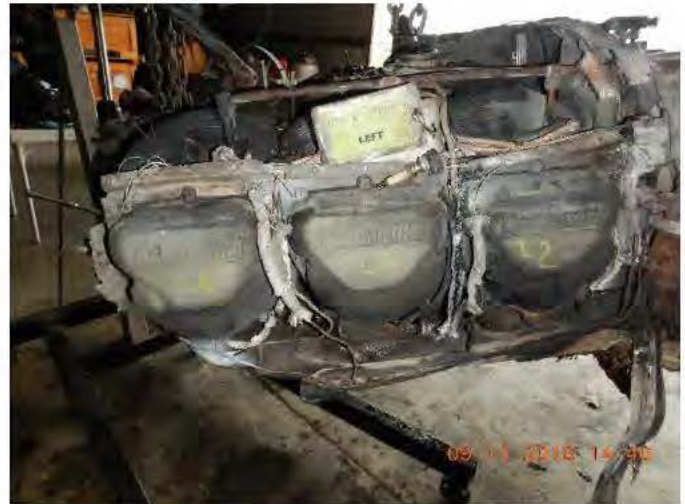
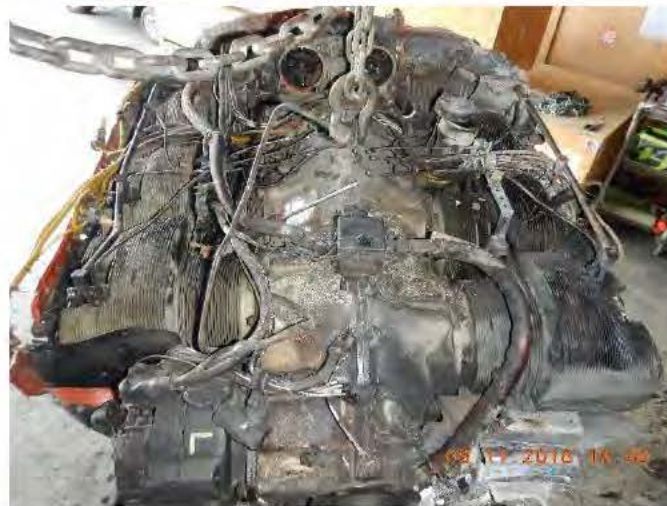
All six cylinders produced thumb compression when the engine was manually rotated. The cylinder rocker covers were removed, and all rocker arms were observed to move normally when the engine was rotated. Camshaft, valve train and crankshaft continuity were confirmed.

A lighted electronic borescope examination was performed on each cylinder. Piston domes exhibited normal combustion signatures. All intake and exhaust valves exhibited normal combustion patterns and were intact.

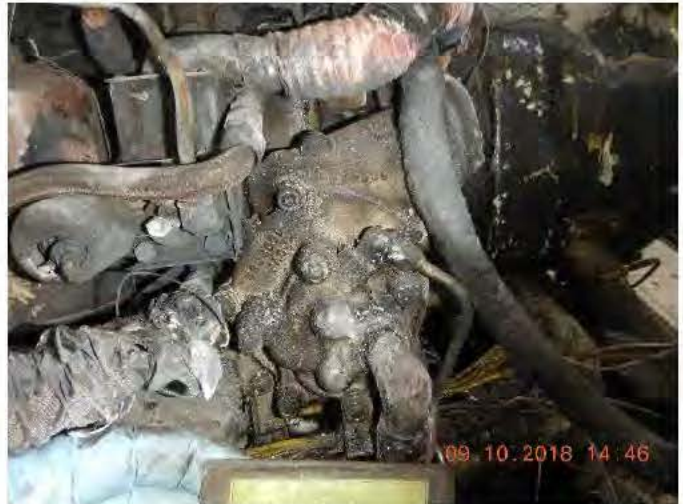
<b>STARTER</b>	Manufacturer: Undetermined	P/N: Undetermined	S/N: Undetermined
Condition:	The starter motor separated from the starter adapter was not presented for inspection.		
<b>STARTER ADAPTER</b>	P/N: Undetermined		
Condition:	The starter adapter was thermally damaged. The starter motor separated and the starter mount was broken. The oil scavenge pump remained intact and attached to the starter adapter.

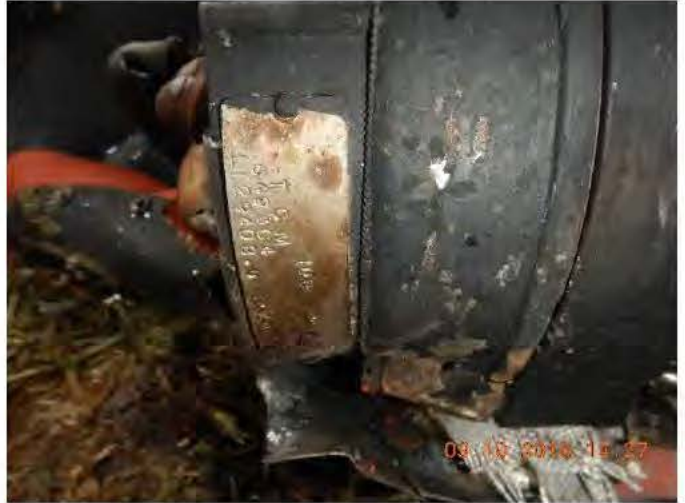
<b>ALT/GEN #1</b>	Manufacturer: TCM	P/N: 649304	S/N: L129403
Condition:	The engine driven alternator received impact damage.

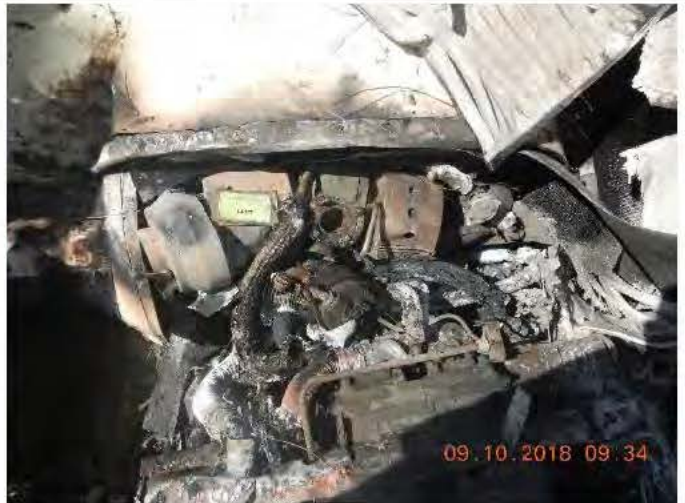
<b>TURBO</b>	Manufacturer: Undetermined	P/N: Undetermined	S/N: Undetermined
Condition:	The turbocharger was exposed to the post impact fire. The compressor and turbine wheels were free to rotate.

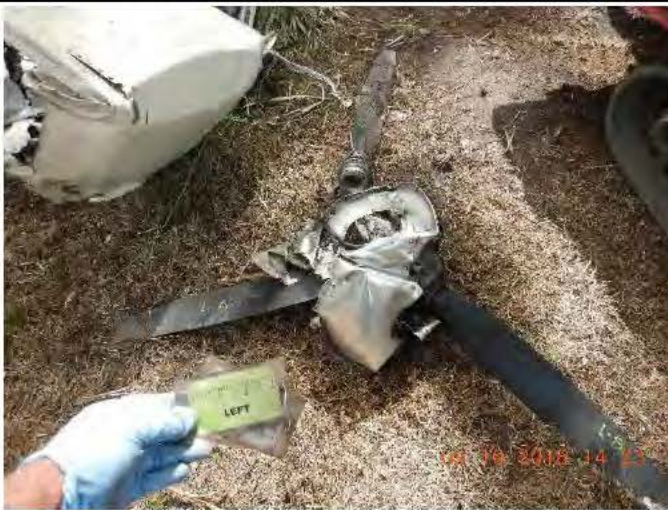
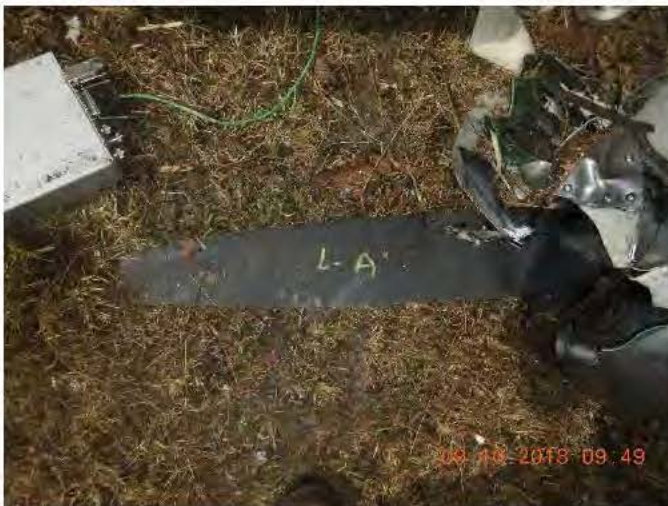
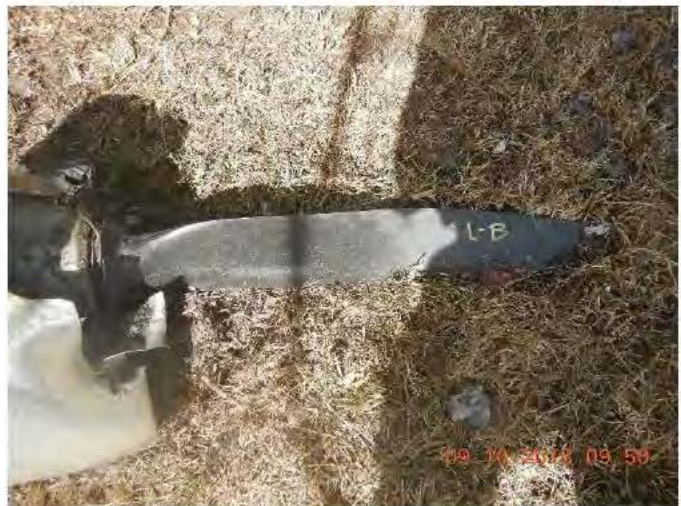
<b>PROPELLER</b>	Manufacturer: McCauley	P/N: Undetermined	S/N: 650681
Blade 1 S/N:	Undetermined		
Blade 2 S/N:	Undetermined		
Blade 3 S/N:	Undetermined		
Condition:	The propeller hub and spinner received impact damage. The propeller blades were relatively straight without cordwise scratching or gouging. Blade C exhibited paint transfer from contact with the ground.

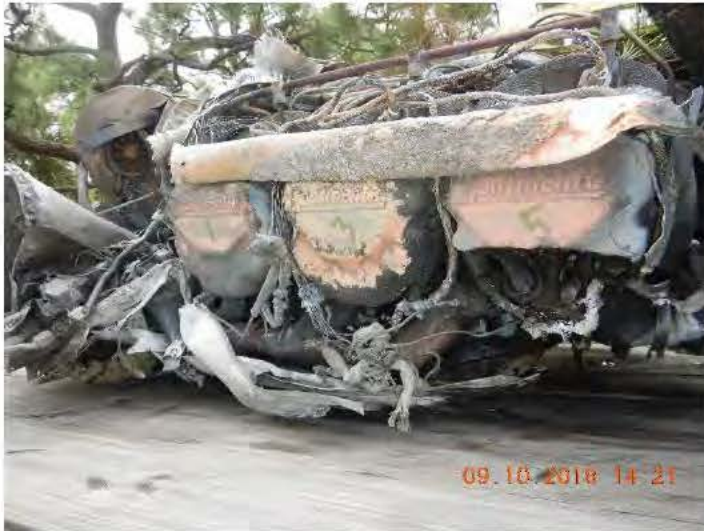
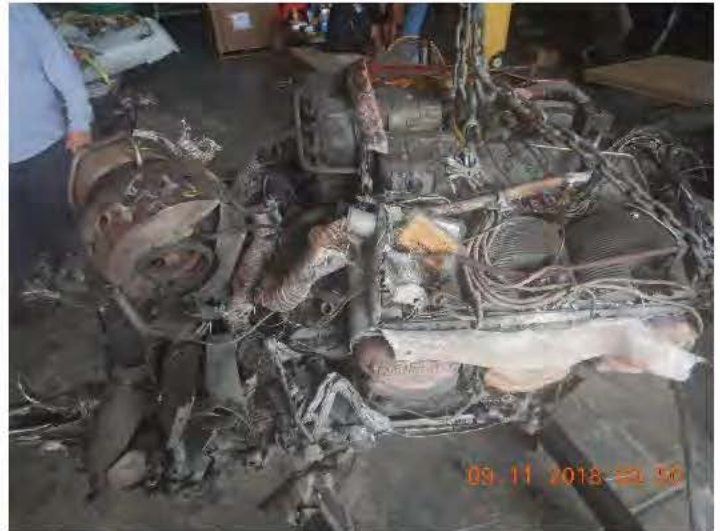
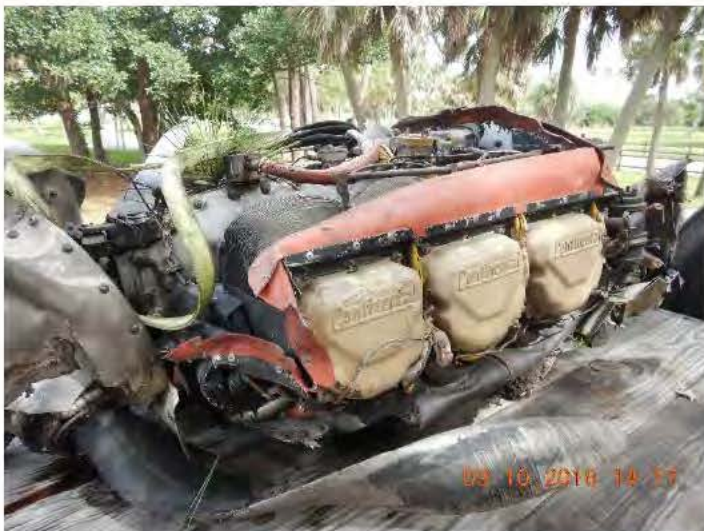
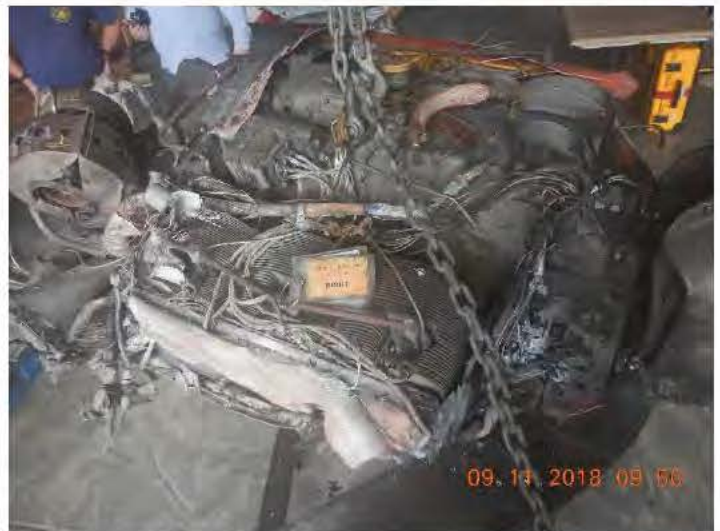
The right engine exhibited impact and thermal damage. The damaged propeller assembly was removed, and the crankshaft propeller flange was impact damaged with a portion of the flange separated. Cylinder # 5 exhibited impact and thermal damage.

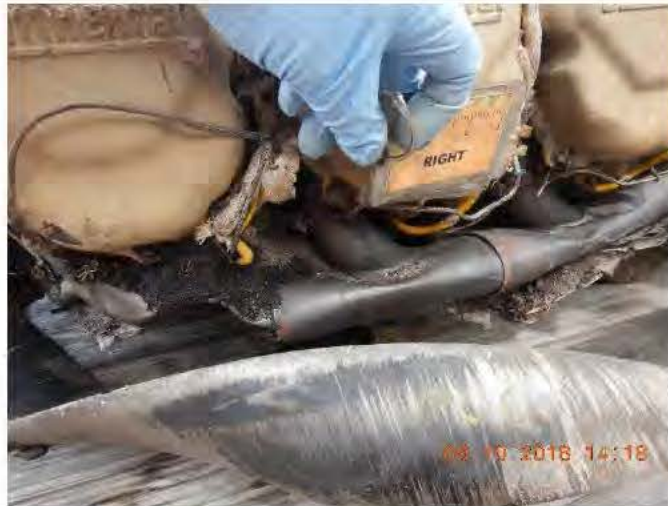
**Condition:** The exhaust components were impact damaged with upward crushing due to impact forces.

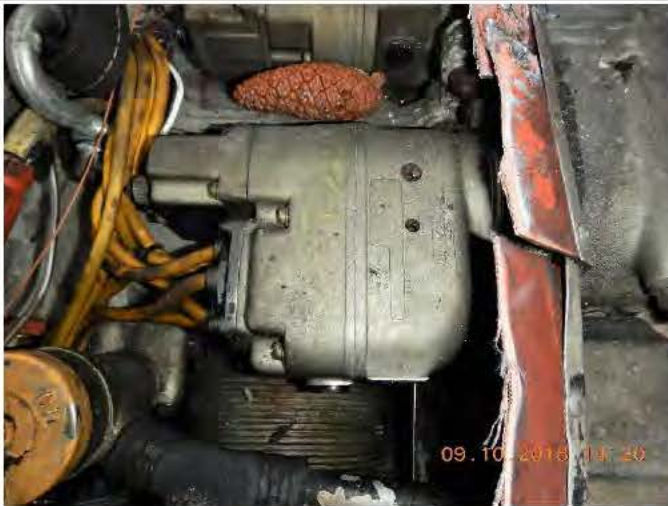
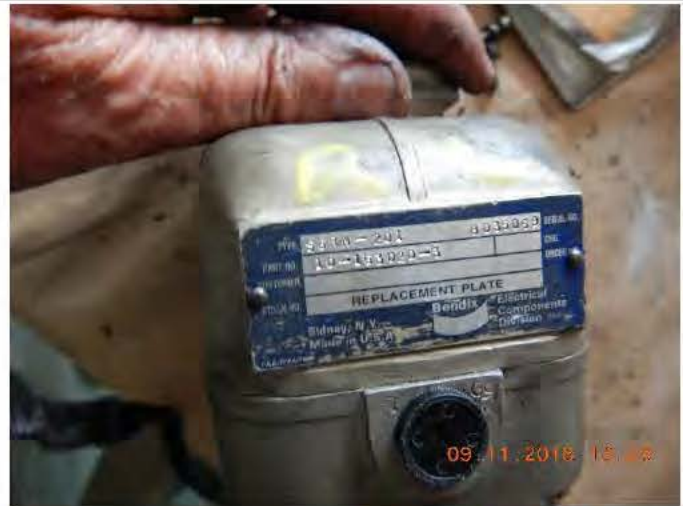
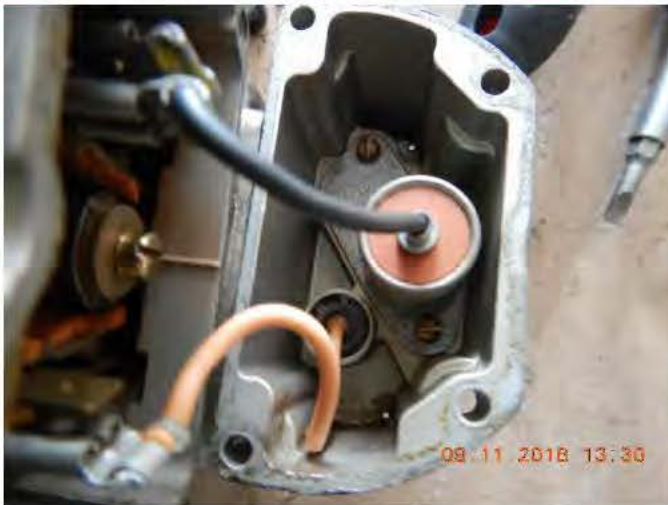
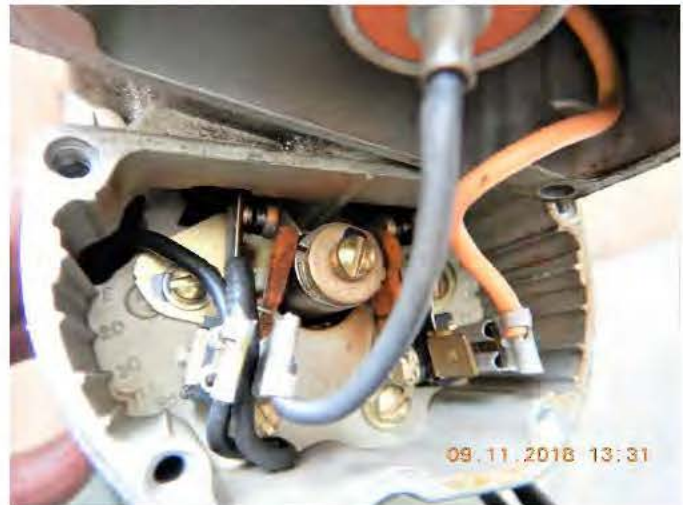
The left magneto did not produce sparks when manually rotated. The left magneto was disassembled and inspected. Both sets of points operated normally, and the capacitor and wiring were intact. The plastic drive gears were intact. No internal thermal damage was noted and the reason for this magneto not producing spark normally was not determined.

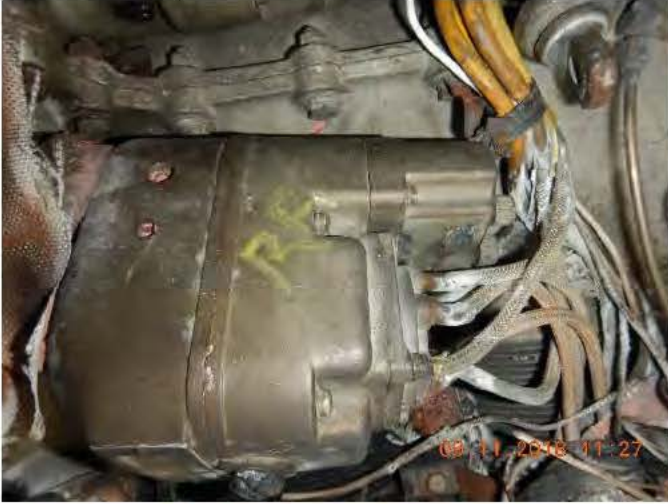
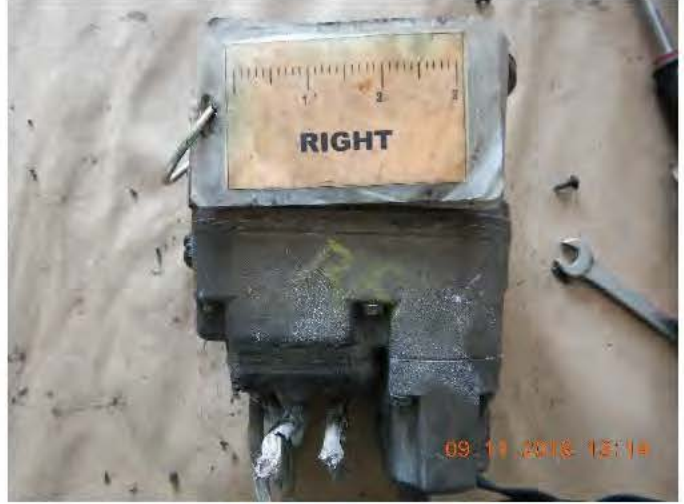
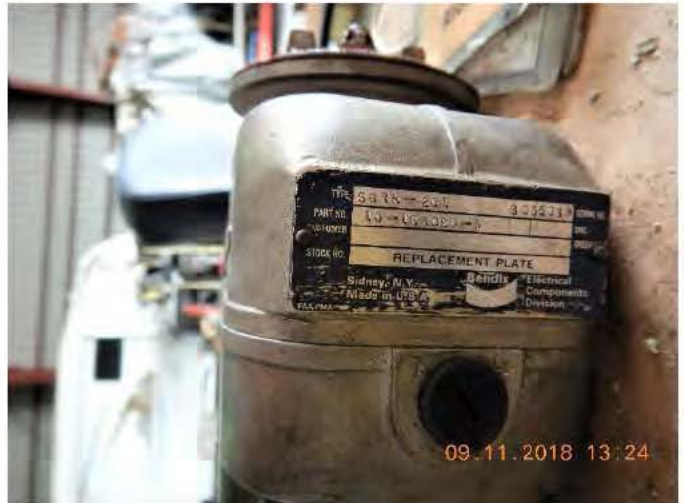
Condition: The right magneto produced sparks at all ignition leads when the magneto was manually rotated using a drill motor.

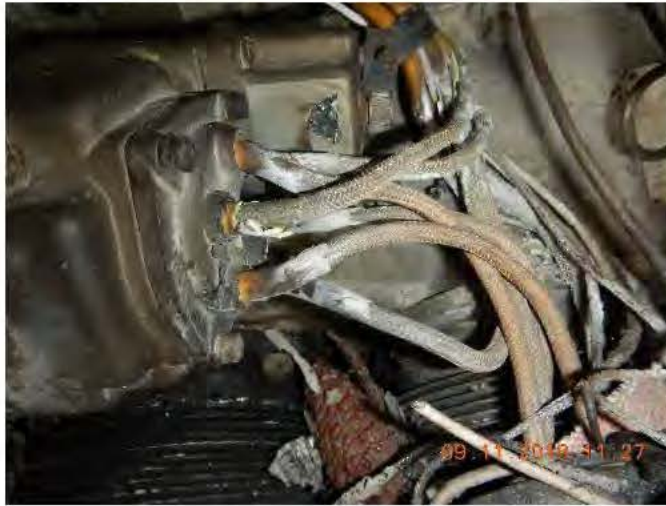
Condition: The ignition harness exhibited thermal distress near both of the magneto terminal attachments. Several individual leads were cut/pinched by impact forces.

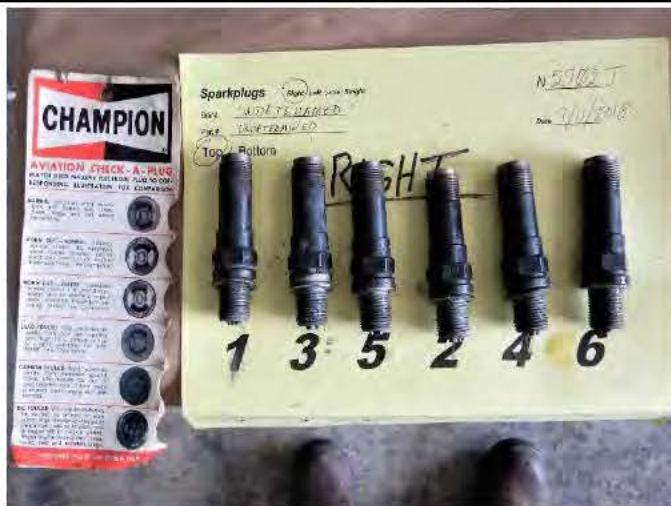
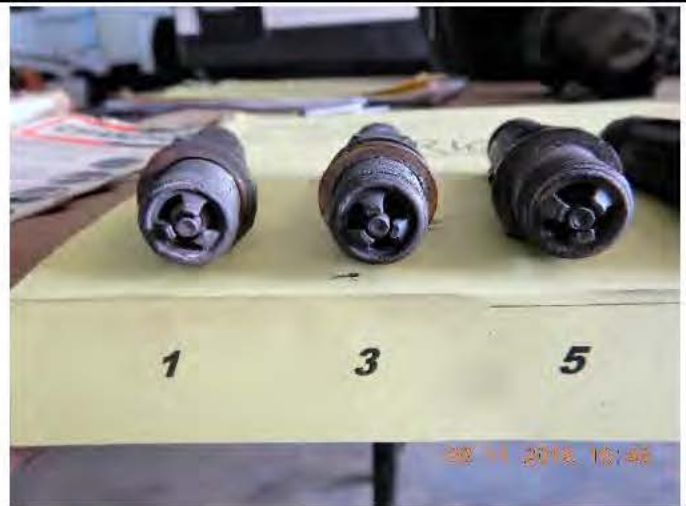
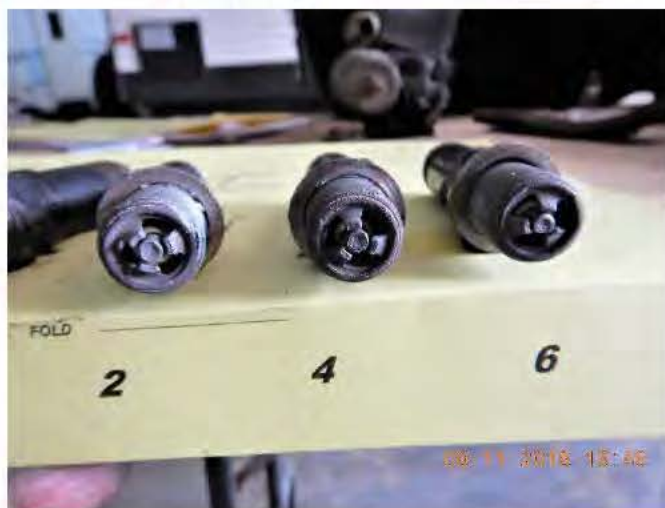
When compared to a Champion "Check-A-Plug" chart, all six top sparkplugs appeared to be "Normal" in both wear condition and coloration. The sparkplugs had been painted black and the manufacturer's name and part number were unreadable. The sparkplugs featured three massive electrodes instead of the usual two or a single fine-wire type electrode.

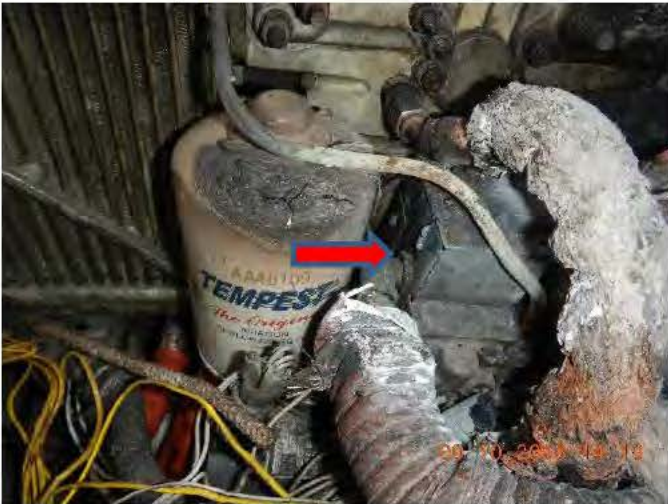
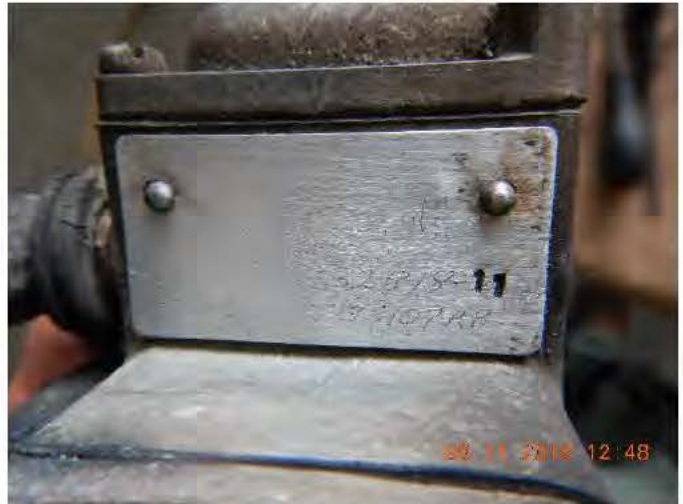
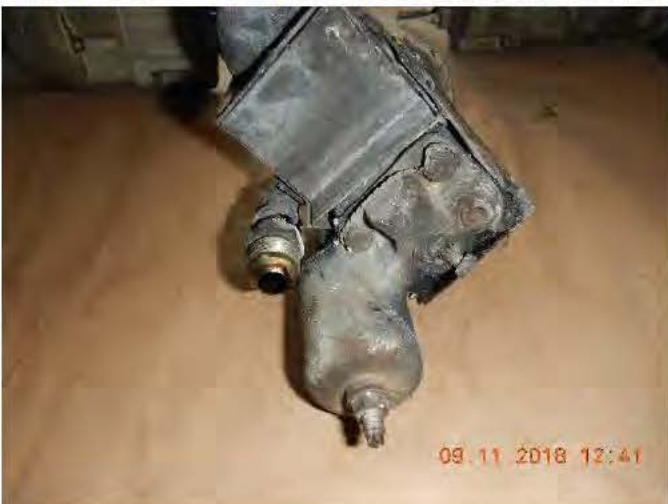
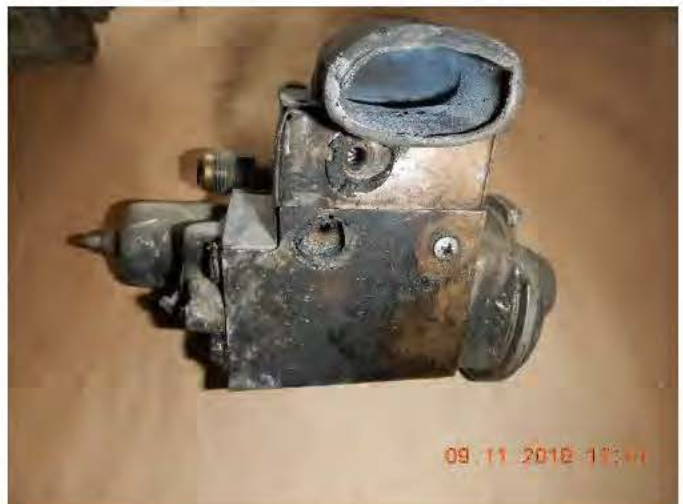
The engine driven fuel pump exhibited thermal and impact damage. The lower portion of the pump was dark and the surfaces sooty from a post-impact fire. The unmetered fuel pressure adjustment bolt and lock nut received impact damage. The drive coupler was broken, and a sharp edge was evident around the circumference of the separated shaft. The broken area was concave/convex in shape. The broken portion of the drive coupler was removed, and the impeller shaft rotated smoothly when manually manipulated. A minute amount of fuel leaked from the pump cavity when the pump was disassembled. The pump shaft and impeller blades were intact. The outer mounting flange was partially broken. Fuel fittings were broken and remained with the thermally damaged flexible fuel hoses. The fuel pump and drive coupling will be examined at CMI at a later date and a metallurgical report prepared.

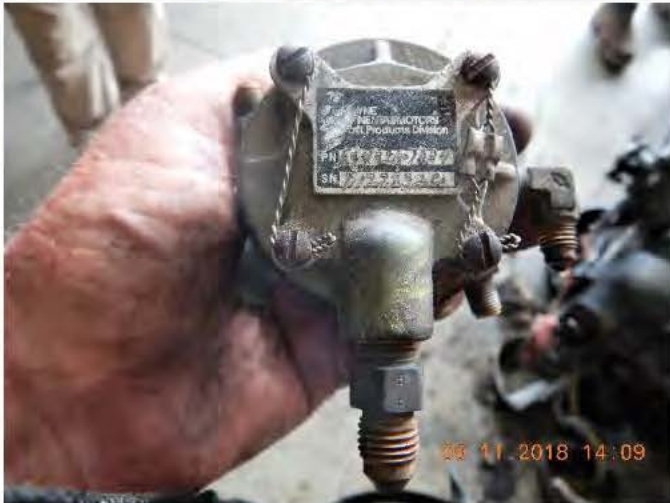
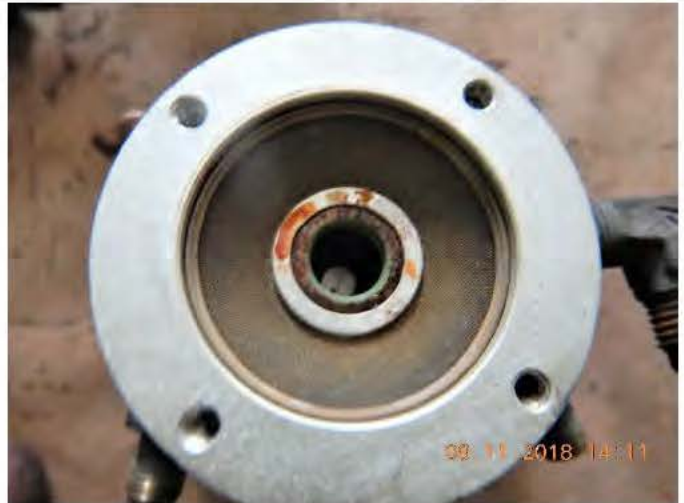
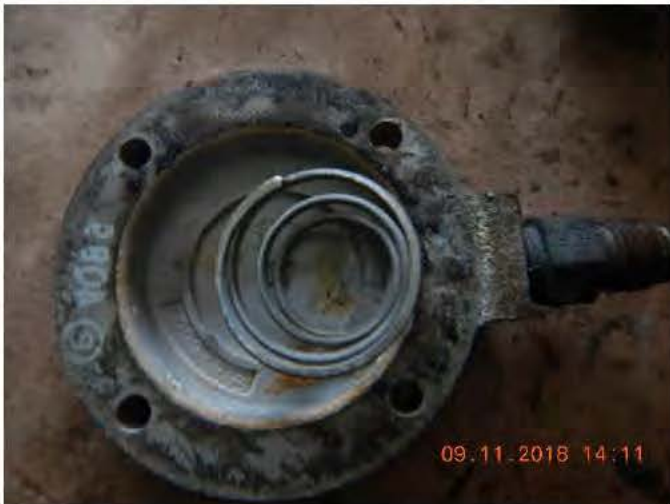
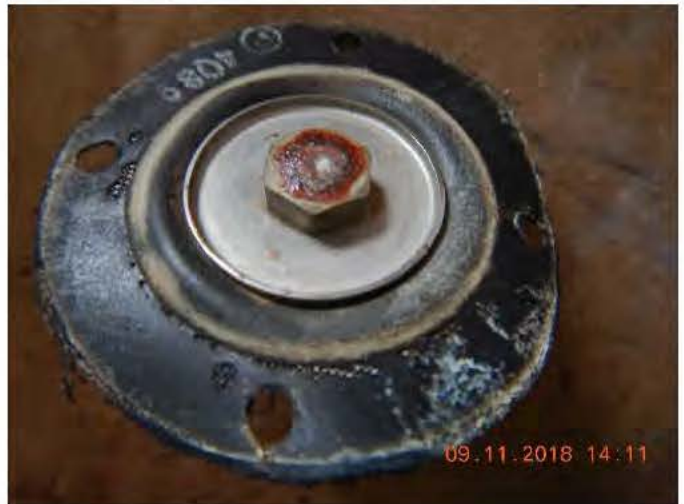
**Condition:** The assembly screws were correctly secured with safety wire and a lead seal was intact. The spring and diaphragm were intact. The fuel screen was uncontaminated, and the pump cavity was clean. No fuel was present in the valve cavity.

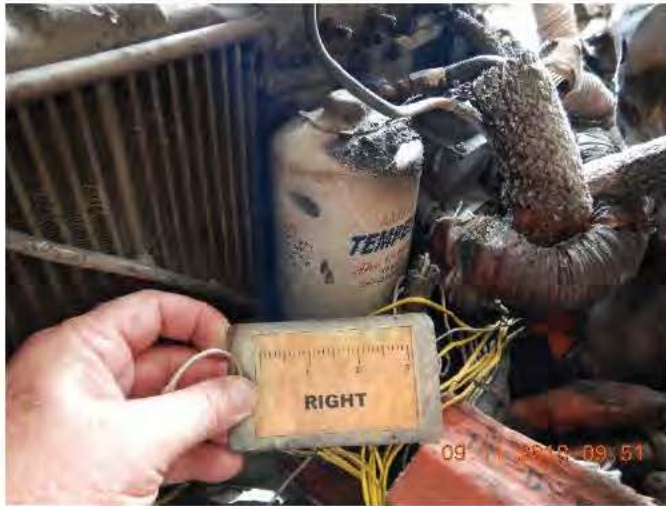
<b>OIL FILTER</b>	Manufacturer: Tempest	P/N: AA48109
Condition:	The canister exterior was thermally damaged.

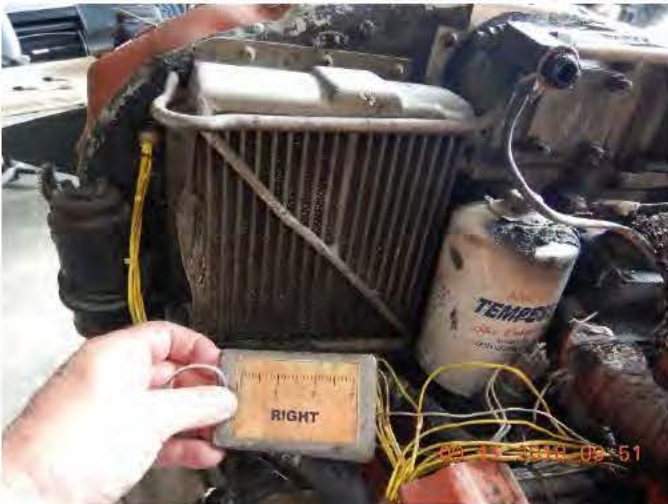
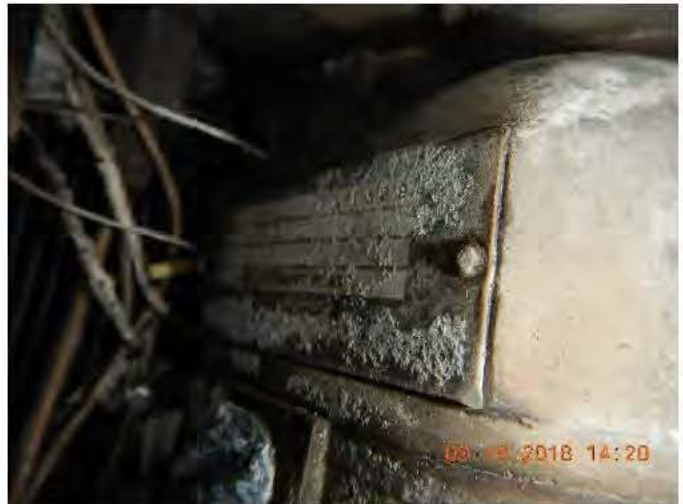
<b>OIL COOLER</b>	Manufacturer: Undetermined	P/N: Undetermined	S/N: Undetermined
Condition:	The data tag was thermally damaged and part number/serial number unreadable. The oil cooler remained intact
