# Continental Motors

## ENGINE EXAMINATION REPORT LEFT

ENGINE MODEL	TSIO520EB (8B)
ENGINE SERIAL NUMBER	271215-R
AIRCRAFT MAKE & MODEL	Cessna 335
AIRCRAFT SERIAL NUMBER	335-0023
AIRCRAFT REGISTRATION	N2707J
FILE NUMBER	18-174

## ENGINE EXAMINATION REPORT RIGHT

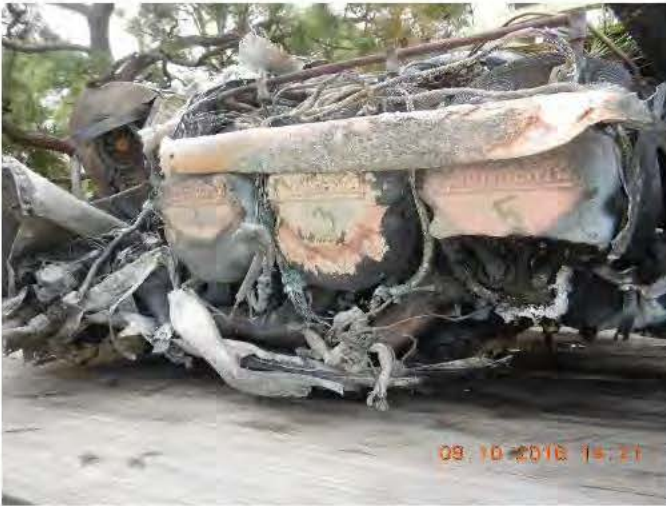
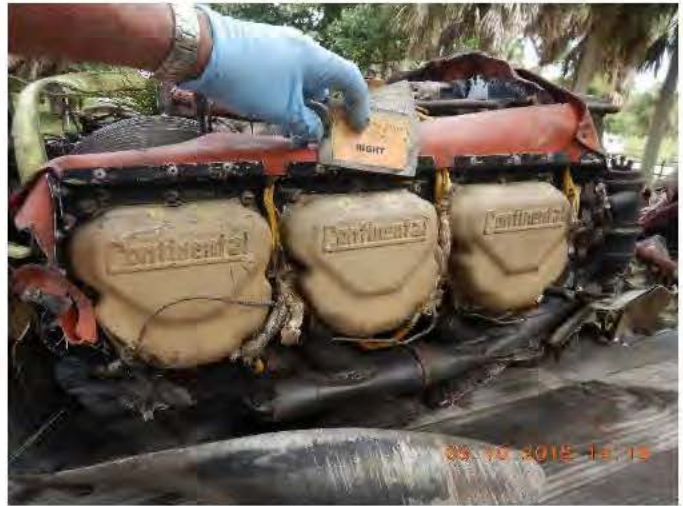
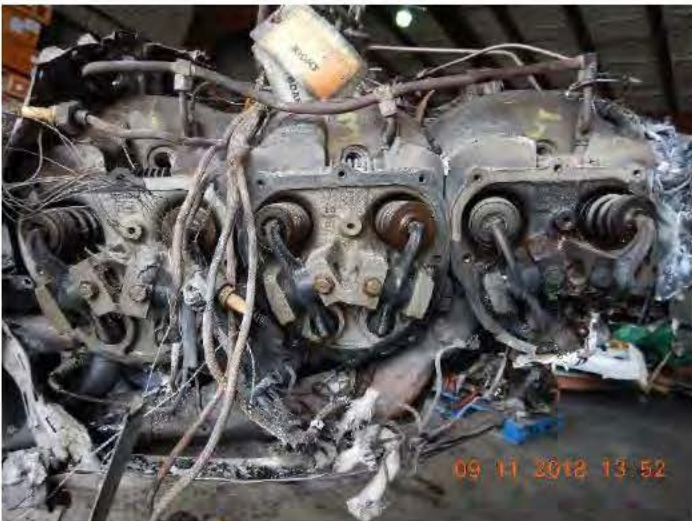
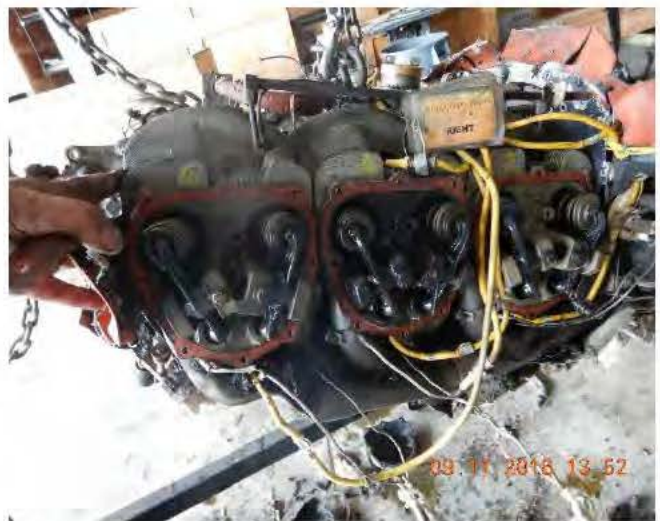
All six cylinders produced thumb compression when the engine was manually rotated. The cylinder rocker covers were removed, and all rocker arms were found to move normally when the engine was rotated except cylinder 5. Cylinder 5 rocker cover was impact damage and the lower portion of the cover separated. The push rod (intake valve) was damaged and curled over. The lower portion of the intake valve rocker arm separated. Camshaft, valve train and crankshaft continuity was confirmed.

A lighted electronic borescope examination was performed on each cylinder. Piston domes exhibited normal combustion signatures. All intake and exhaust valves exhibited normal combustion patterns and were intact.

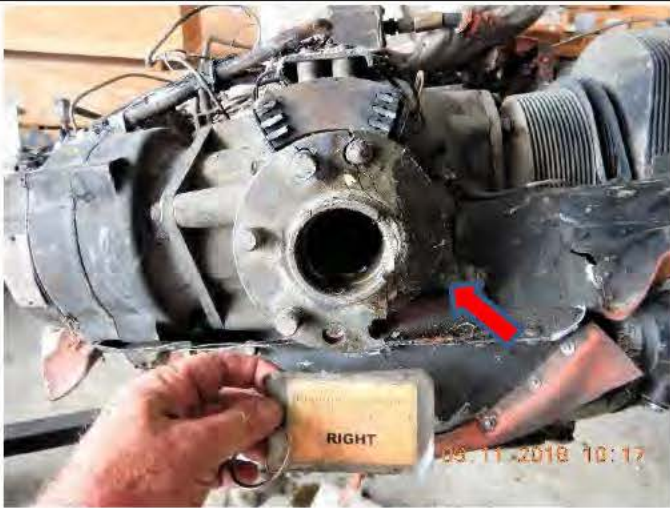
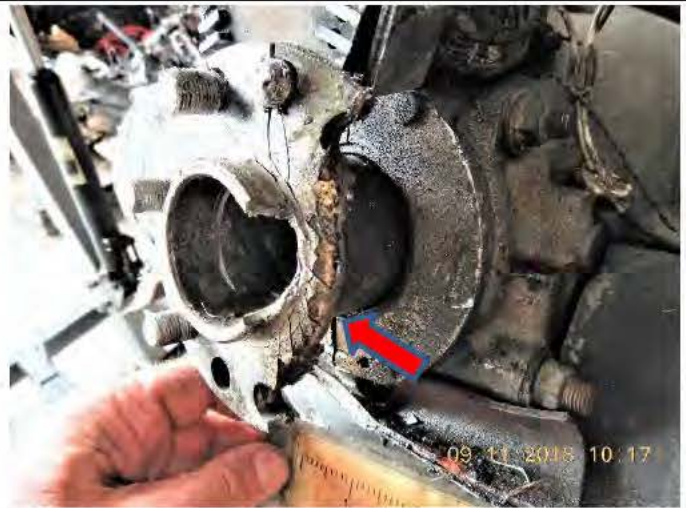
<b>CRANKCASE</b>	Casting Number:	1-3-5: Undetermined	2-4-6: Undetermined	S/N: Undetermined
Condition:	The crankcase halves were impact damaged on the lower front portion. Engine mounts were broken.

<b>CRANKSHAFT</b>	Forging Number: Undetermined	S/N: Undetermined	Heat code: Undetermined
Condition:	The forward portion of the crankshaft including the propeller flange was impact damaged.

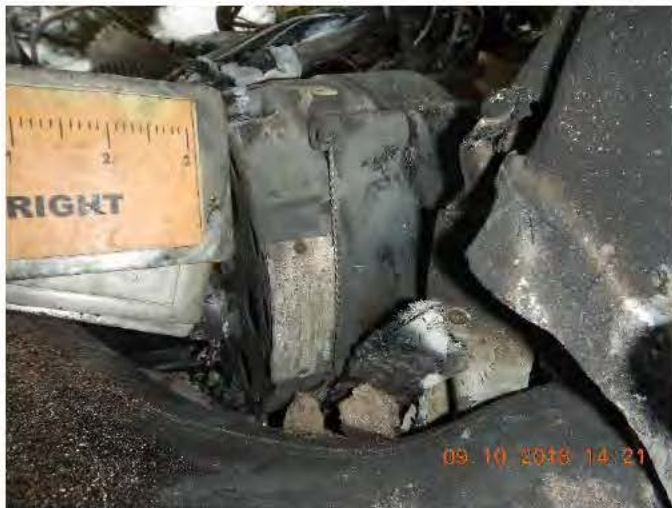
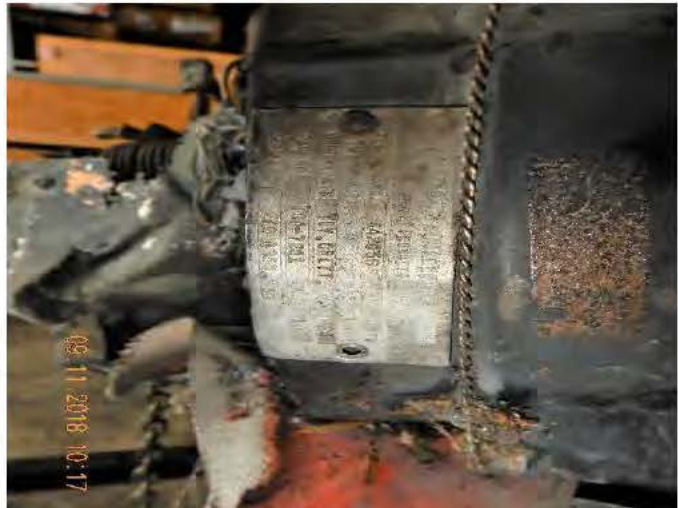
Condition: The alternator remained attached but exhibited thermal damage.

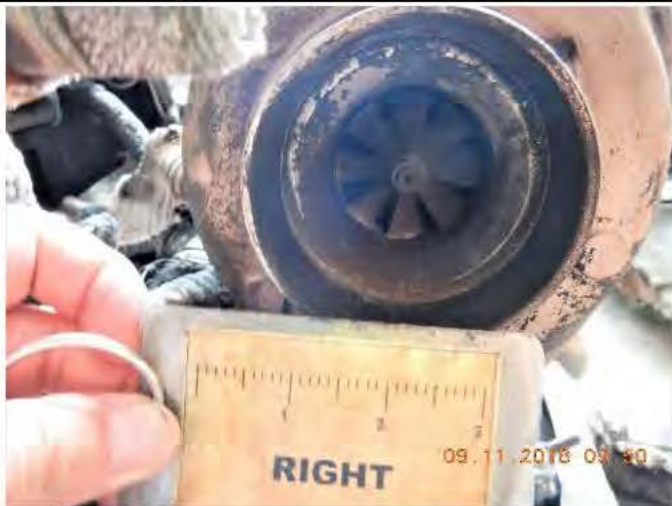
Condition: The turbine wheel was free to rotate in the housing.

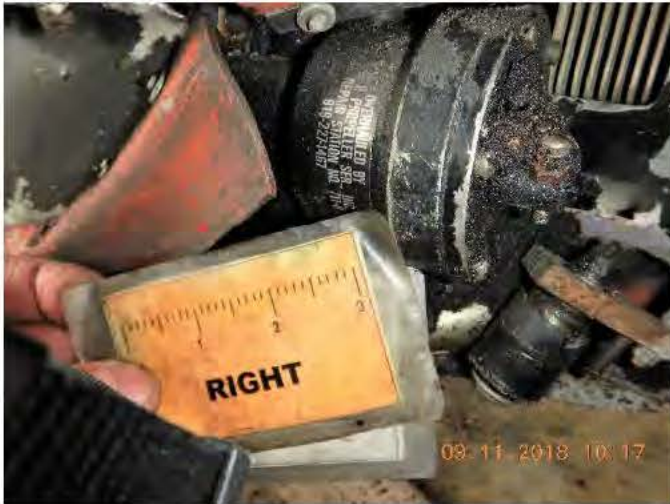
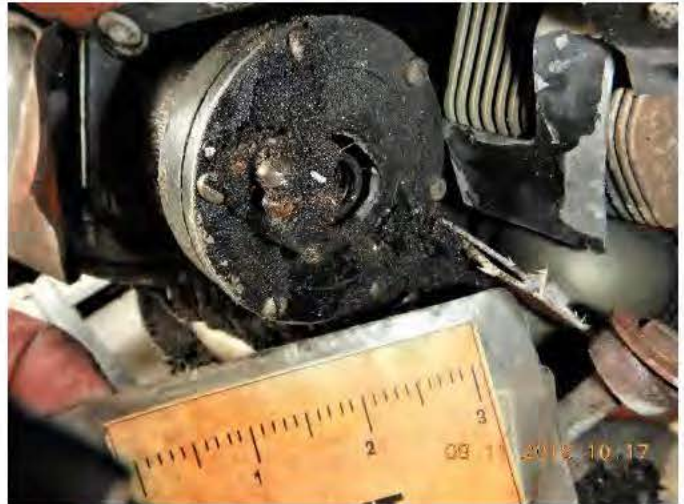
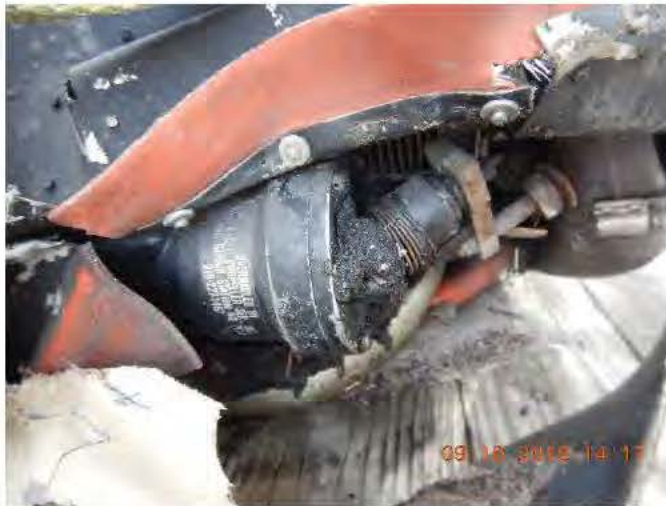
<b>PROPELLER GOVERNOR</b>	Manufacturer: Overhauled by H&H Propeller Services	P/N: Undetermined	S/N: Undetermined
Condition:	The pitch change arm and shaft separated due to impact forces. The control cable was properly attached and secured.

<b>PROPELLER</b>	Manufacturer: McCauley	M/N:3AF32087-N2R	S/N: Undetermined
Blade 1 S/N:	Undetermined		
Blade 2 S/N:	Undetermined		
Blade 3 S/N:	Undetermined		
Condition:	All three propeller blades exhibited s-bending, paint transfer and cordwise scratching/gouging. All three blades were loose inside the hub due to impact forces.
