NATIONAL TRANSPORTATION SAFETY BOARD

ENGINE EXAMINATION

WPR16FA144

Location: Logan, UT
Date: July 18, 2016
Aircraft: Diamond DA40F, Registration Number: N419FP, Serial #: 40.FC019
NTSB IIC: Maja Smith

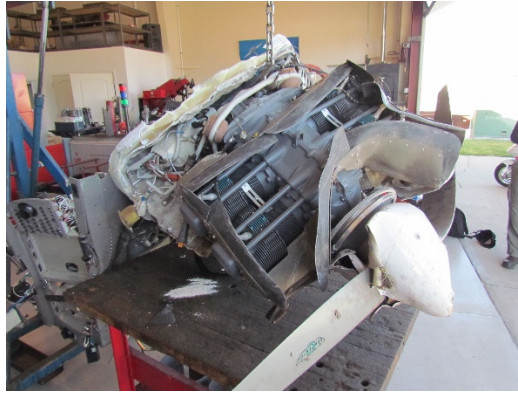
Photo 1. Engine

Examination of the recovered engine revealed that it remained attached to the engine mount structure. Visual examination of the engine revealed no external evidence of pre-impact catastrophic mechanical malfunction. All four cylinders and all engine accessories remained attached to the engine. The propeller remained attached to the propeller crankshaft flange. All engine accessories remained attached to the engine via their respective mounts. The top spark plugs and rocker arm covers were removed from the engine. The intake pipes exhibited signatures consistent with the impact damage. The exhaust pipe was attached but exhibited signatures consistent with the impact damage. Mechanical continuity was established throughout the engine and valve train engine to the rear accessory case. when it was manually rotated using a handtool . Thumb compression was obtained on all four cylinders in proper firing order. Equal movement of the intake and exhaust valve rocker arms was noted on all four cylinders.

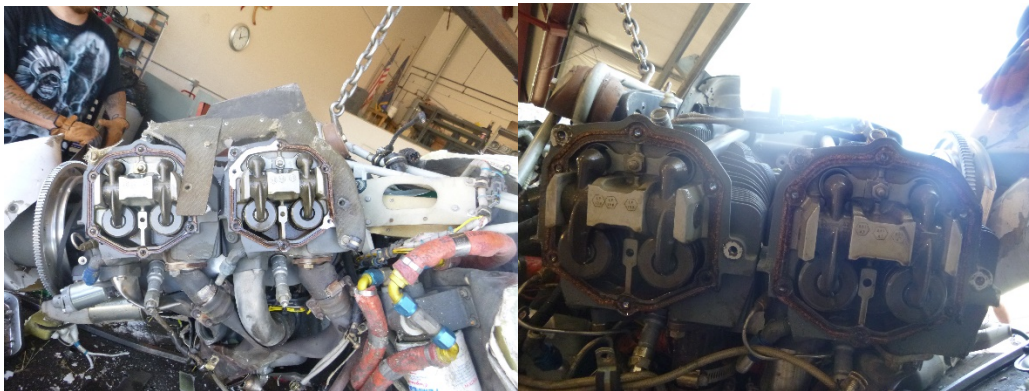
Photo 2 – Cylinders

All four cylinders were examined internally using a lighted borescope. A normal amount of carbon deposits were observed on the tops of all four pistons. All intake and exhaust valves were intact . No evidence of foreign object ingestion was observed.

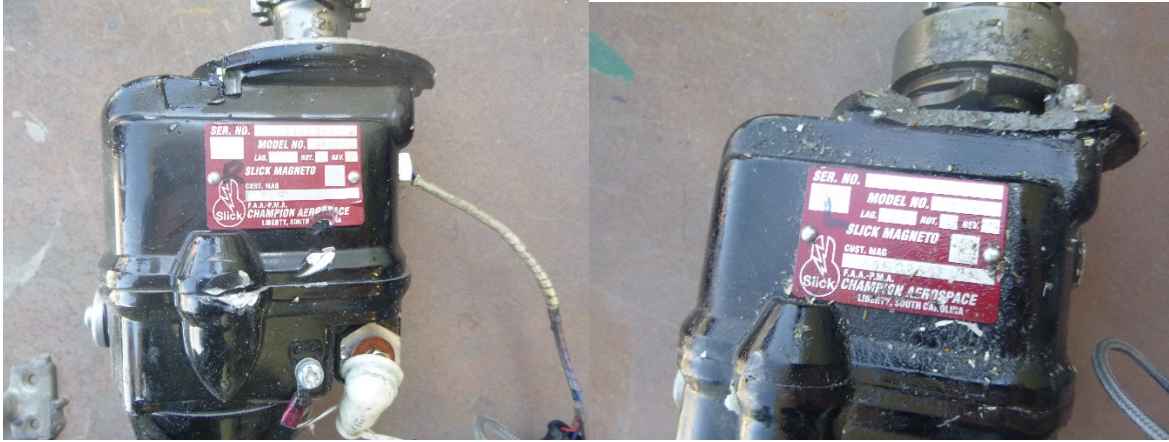
Photo 3 – Right and left magneto

The left and right magnetos were not attached to the engine. Both left and right magneto drive shafts were intact and the impulse coupling functioned normally during hand rotation of the drive shafts. The magneto produced a spark at all posts when the drive shaft was rotated by hand. The ignition harness was intact and undamaged.

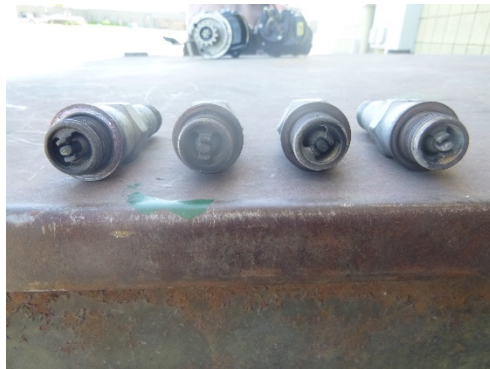
Photo 4 – Top spark plugs

The top and bottom spark plugs remained secure to their respective cylinder location with the ignition harness lead attached. The top sparkplug electrodes were free of mechanical damage and were circular in shape.

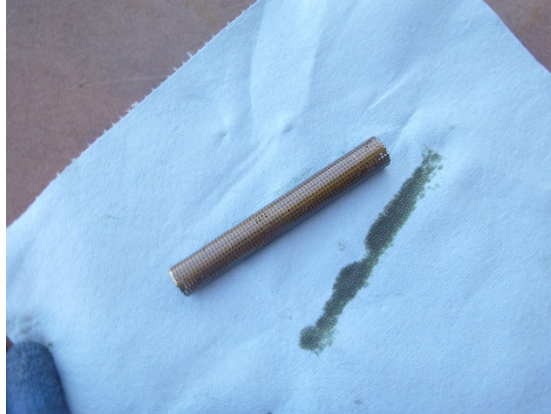
Photo 5 – Oil pickup screen

The oil filter remained secured at the mounting pad. The oil screen was inspected and no particles were noted on the inside of the screen.

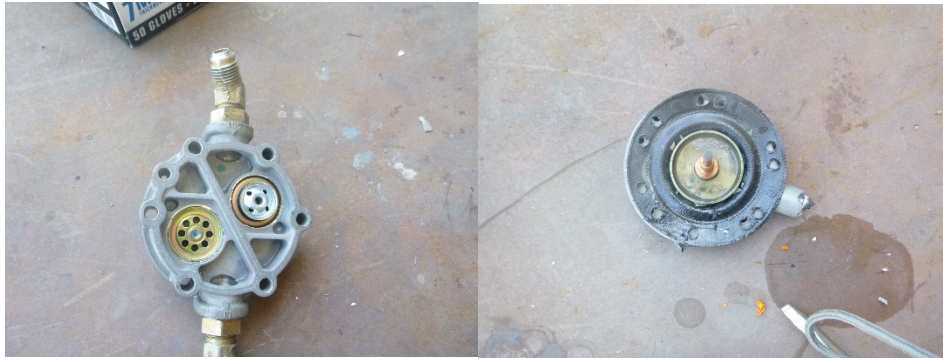
Photo 6 – Fuel pump

The fuel pump remained secured at the mounting pad. The fuel pump was disassembled and the diaphragm was intact.

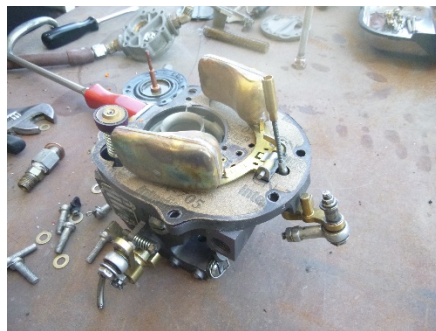
Photo 7 - Carburetor

The carburetor was intact and undamaged. The throttle arm remained attached and moved freely by hand from stop to stop. The throttle plate was intact and undamaged. The mixture control arm lever was intact and remained attached to the carburetor. The mixture control arm moved

freely by hand from stop to stop. The carburetor was disassembled and examined. The single-piece venturi was intact and undamaged. Both metal floats were attached to the carburetor; one metal float exhibited signatures of hydraulic crushing, the other one was intact and undamaged. The carburetor float bowl was found to be free of debris. The carburetor fuel screen was intact and free of debris.

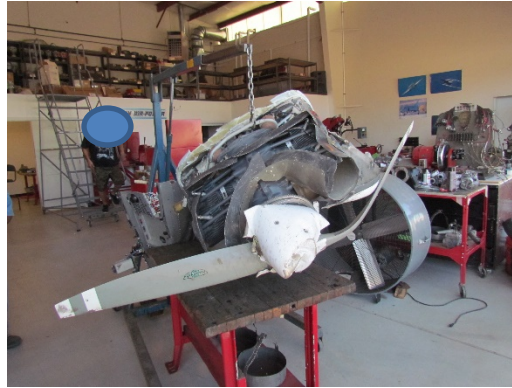
Photo 8 - Propeller

The propeller remained attached to the propeller crankshaft flange. One blade was found relatively straight and the other blade was bent aft. Both blades had leading edge polishing and cord wise scaring.
