NATIONAL TRANSPORTATION SAFETY BOARD

Engine Exam Summary

WPR19FA178

Aircraft: Maule M-7-235B, Registration Number: N118G

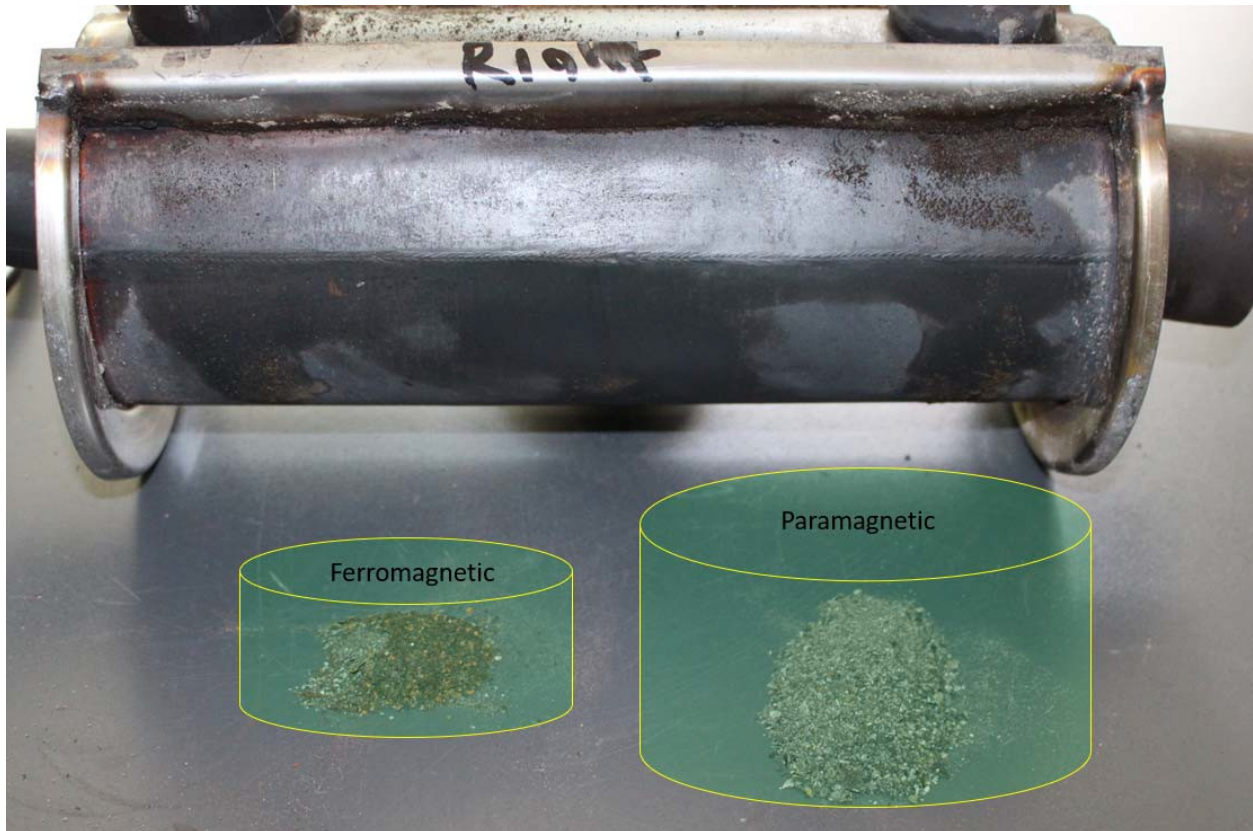
About 1 ½ tablespoons of debris was removed from the muffler. Of which, about ½ tablespoon was comprised of ferromagnetic debris. The muffler was borescoped and machining was noted on most surfaces on the inside of the muffler. About 5 holes (about 2.5 inches) were visible from one side to the other and the baffling was turned 180°.

Figure 2: View of debris from right muffler.

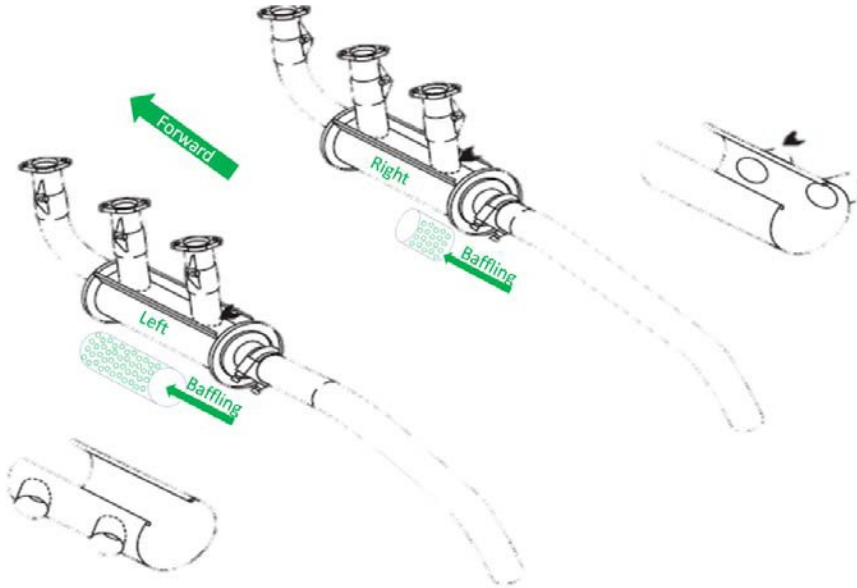
Examination of the muffler revealed that the baffling was separated inside of the muffler. On the right muffler, the baffle was turned 180° and was obstructing the exhaust out hole. The left

muffler baffle was separated and moved freely inside of the muffler. The left and right muffler were removed, and the engine was run.

Figure 3: View of exhaust system.

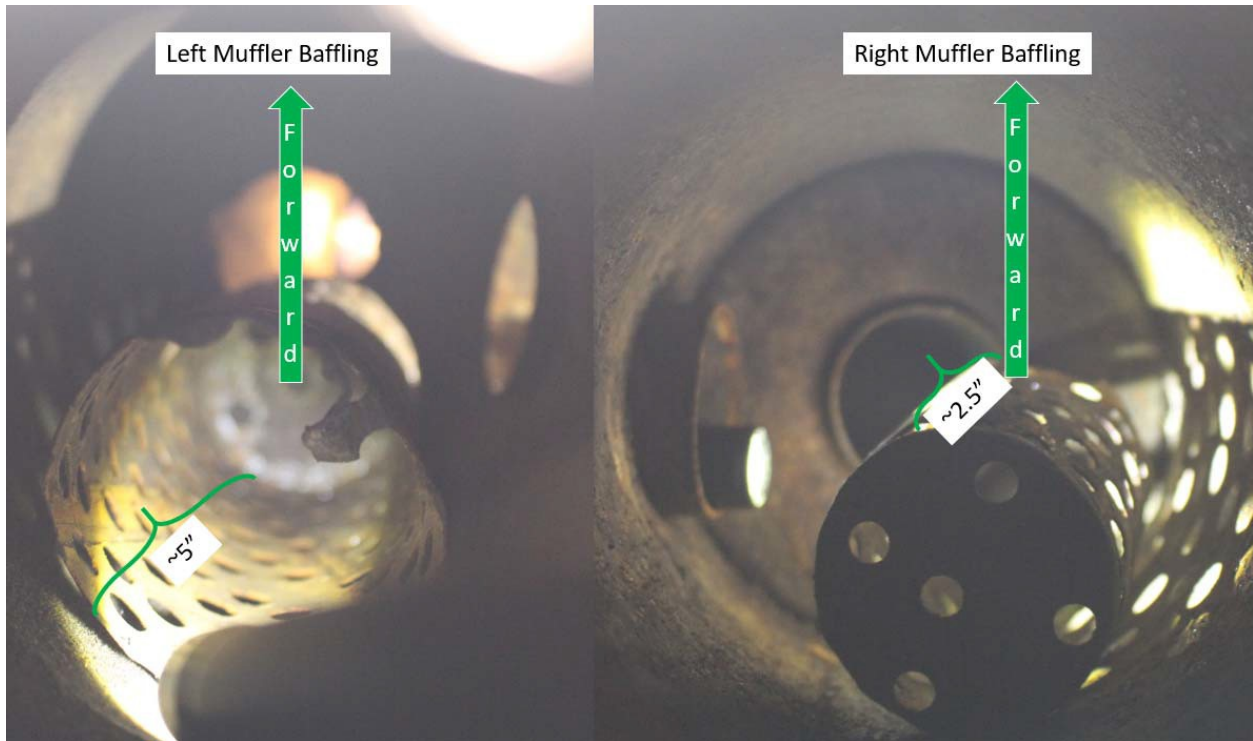
The examination revealed that the muffler baffling was separated inside of both mufflers. On the right muffler, the baffle was obstructing the exhaust out hole.

Examination of the left muffler revealed that the baffling was broken. About 11 holes (about 5 inches) were visible from one side to the other. Some machining was noted to part of the inner surface.

Figure 4: View of right and left muffler baffling.

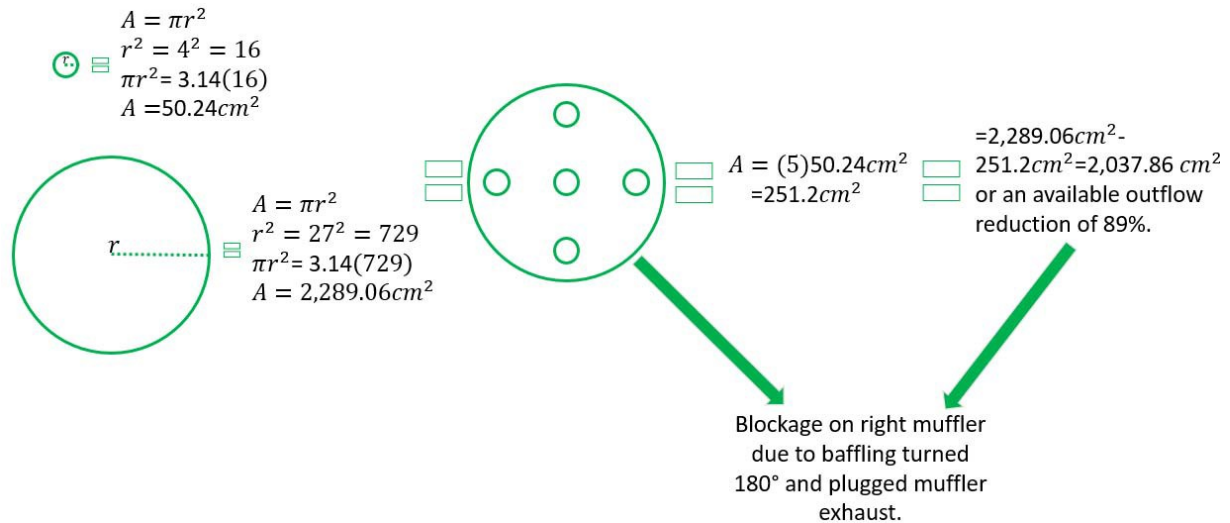
The outflow reduction was calculated based on the area of the small and large holes. Only 5 small holes would have been available for the exhaust gases to escape, which calculates to about an 89% reduction on the right muffler.

Figure 5: Calculation of outflow reduction.
