**Continental Motors, Inc.**

## **ENGINE FIELD INSPECTION REPORT**

ENGINE MODEL: IO-360-ES (6)

REGISTRATION: N764RV

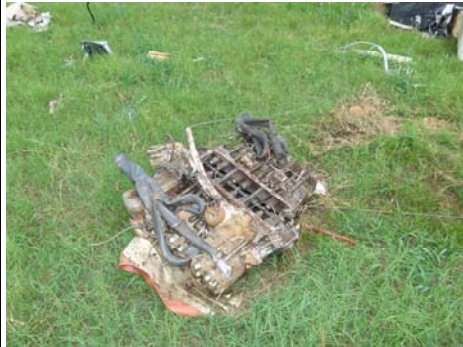
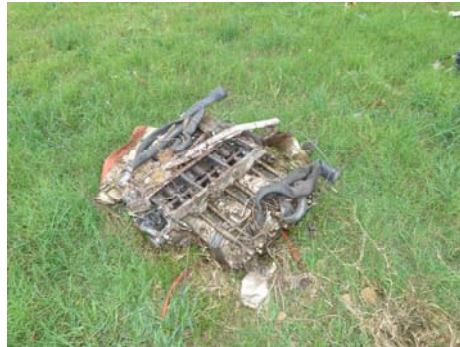
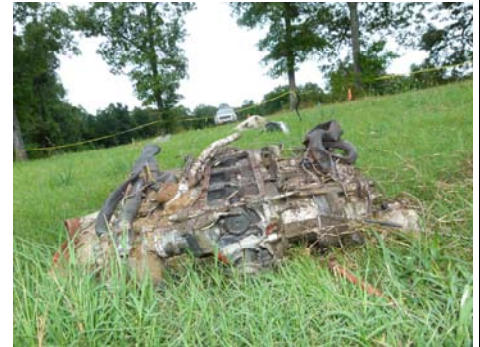
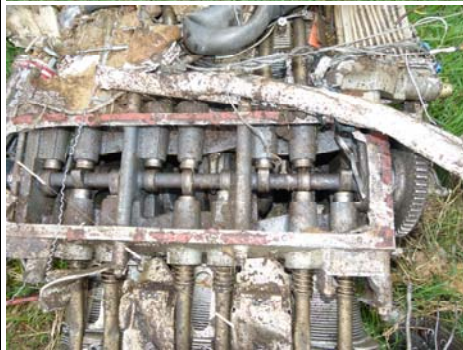
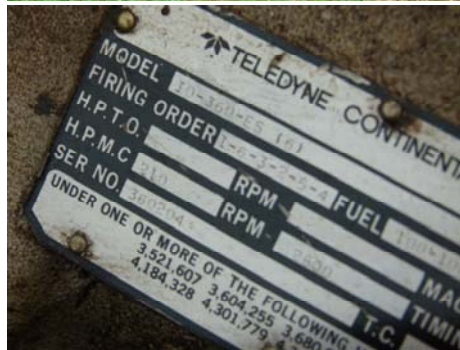
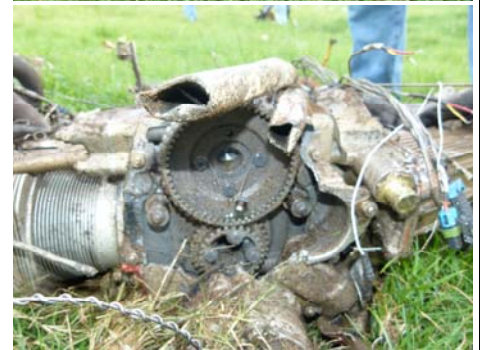
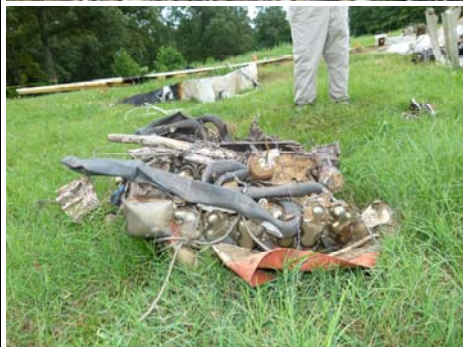
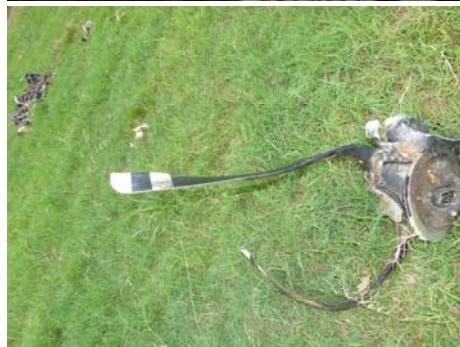
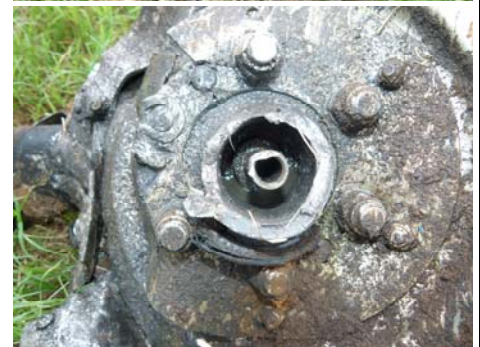
The engine was separated from the airframe and located approximately ten feet from the cockpit. The throttle cable remained attached to the engine and exhibited damage. The engine was found inverted and the oil sump was fractured free of the engine. The propeller and forward section of the engine crankshaft were separated from the engine and located approximately ten feet from the engine. The forward portion of the crankcase and lower, aft portion of the crankcase exhibited damage consistent with impact.

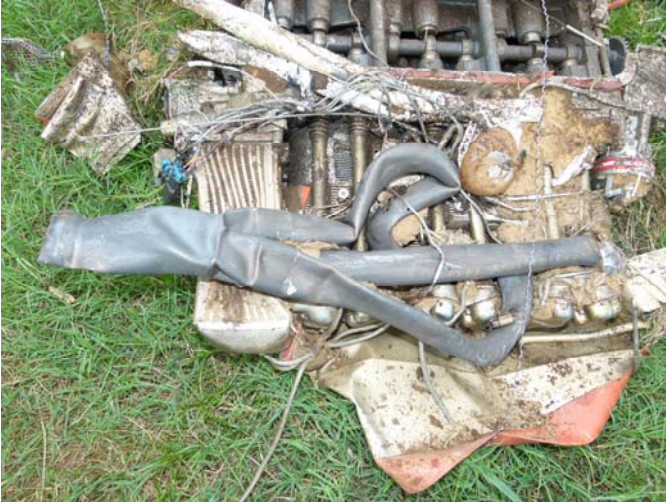
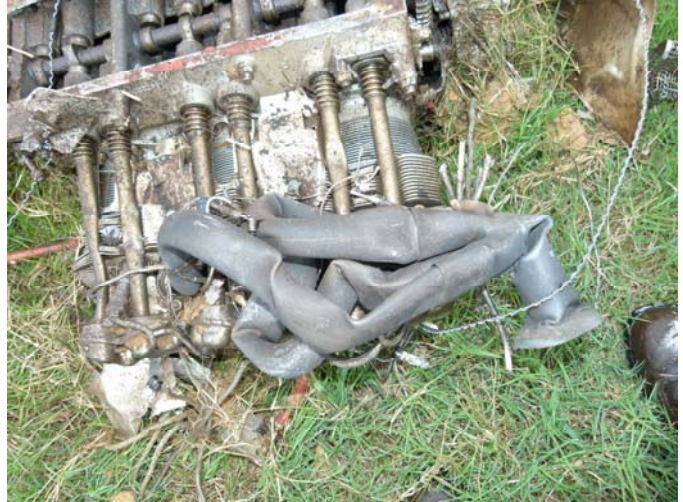
### Exhaust System

Condition: The exhaust system exhibited impact damage.

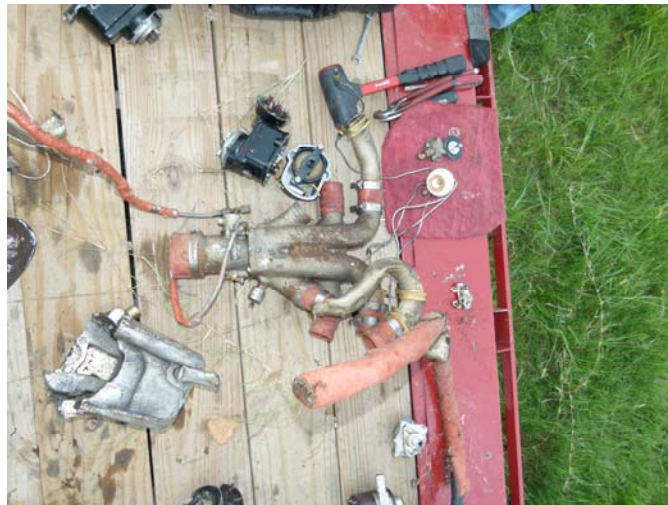
### Induction System

Condition: The induction system exhibited impact damage. All six induction risers exhibited impact damage. The induction manifold was fractured free of the engine and located in the debris field.

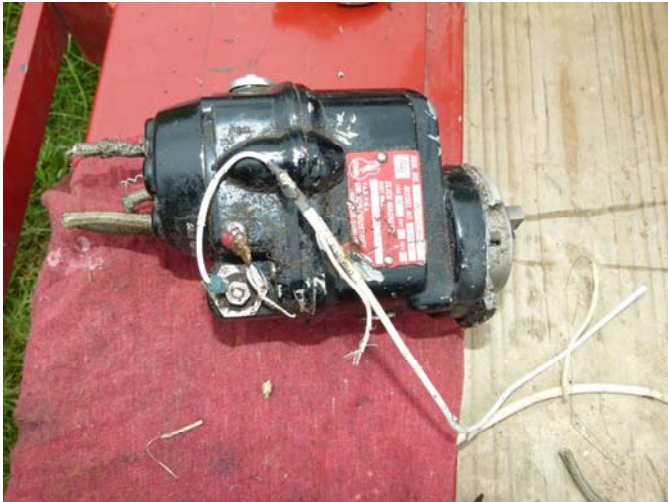
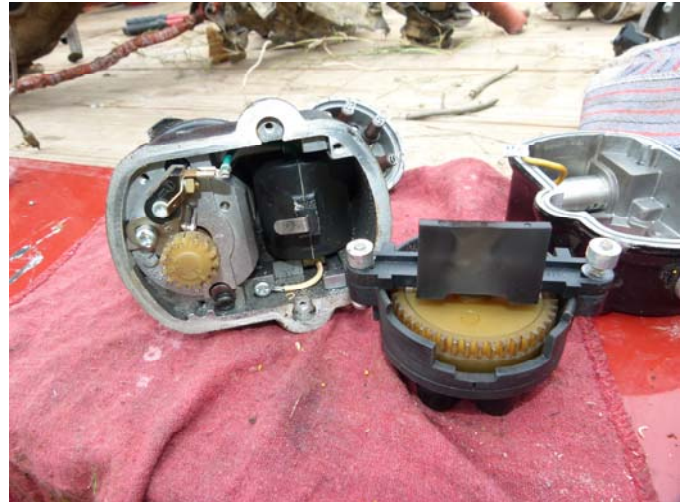
R/H Magneto

The right magneto was fractured free of the engine and located in the debris field. The right magneto exhibited impact damage. The drive shaft turned freely by hand with impulse coupling engagement observed. The right magneto did not produce a spark when rotated by hand and was disassembled with no anomalies noted. The distributor driven and drive shaft drive gears were intact. The magneto drive gear and the drive coupling rubber bushings were not located.

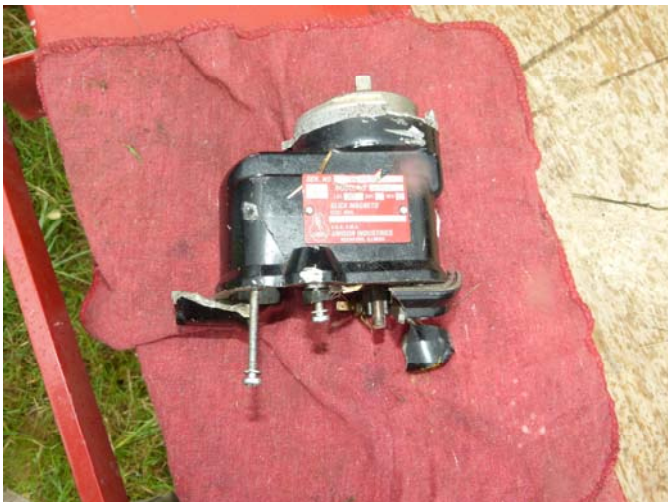
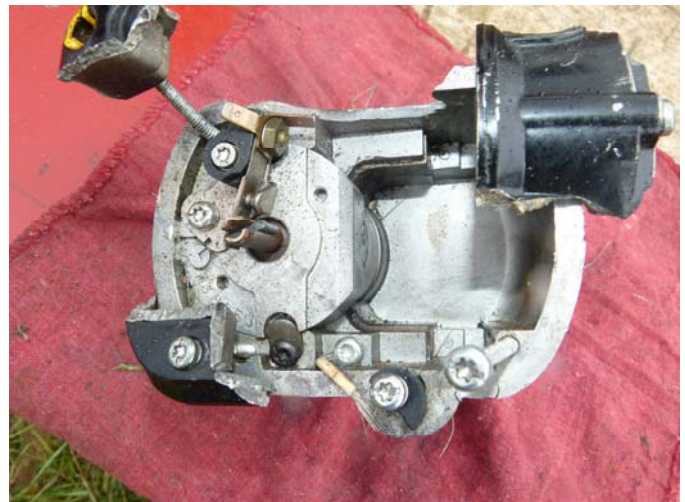
L/H Magneto

The left magneto was fractured free of the engine and located in the debris field.

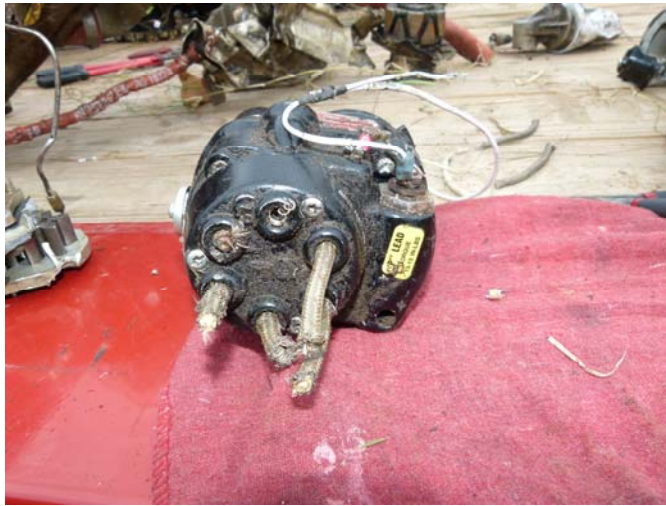
**Ignition Harness** Manufacturer: Model/Part Number: Not Marked Serial #: Not Marked  
 Condition: The ignition harness exhibited impact damage.

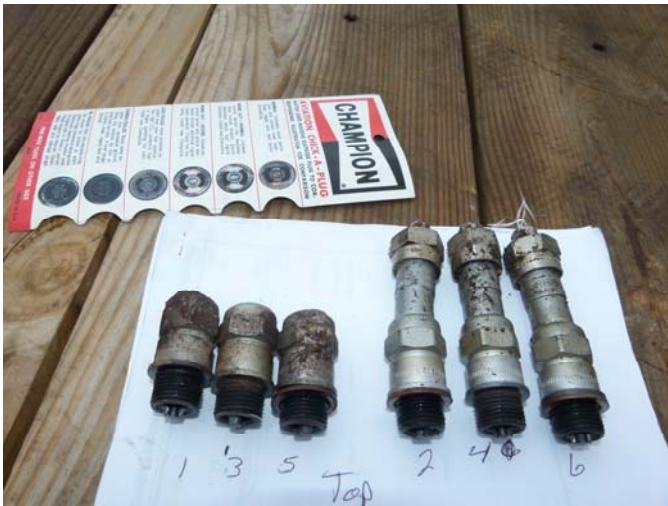
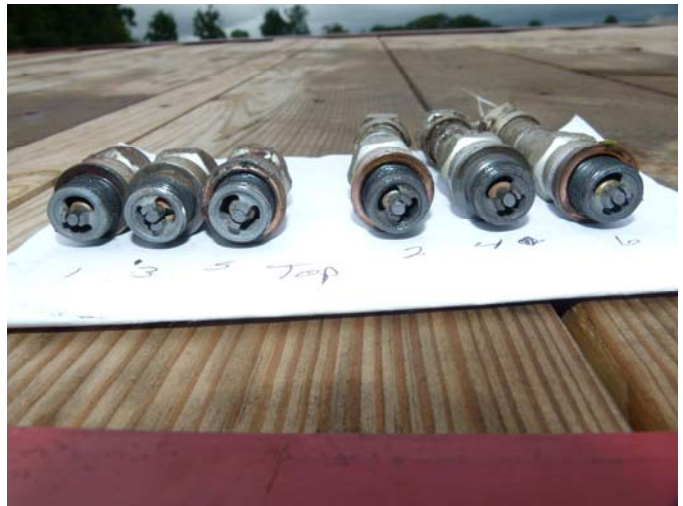
Condition: The spark plugs exhibited impact damage. The spark plug electrodes exhibited normal operating signatures when compared to the Champion Check A Plug chart. The spark plugs exhibited light colored combustions deposits.

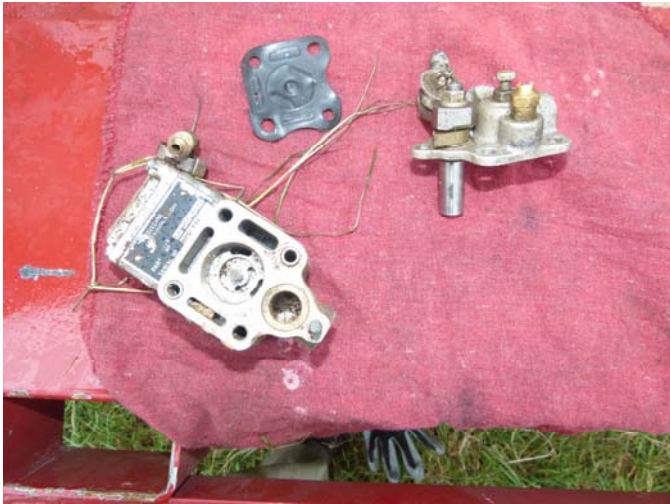
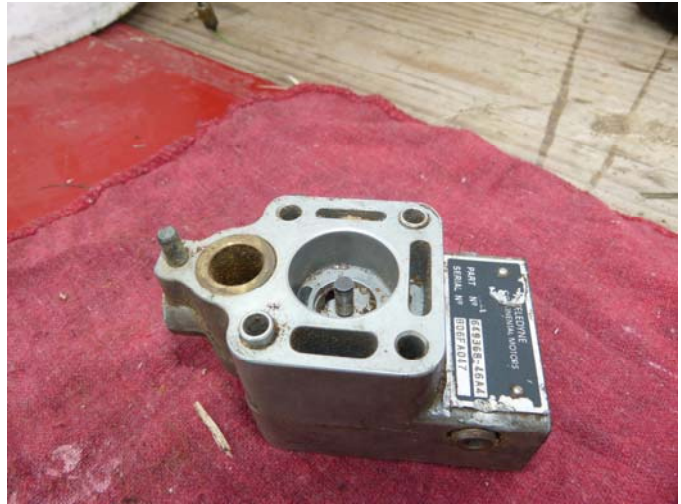
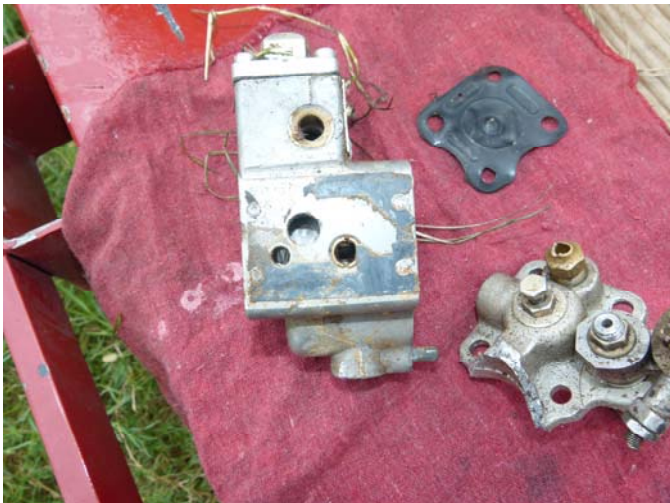
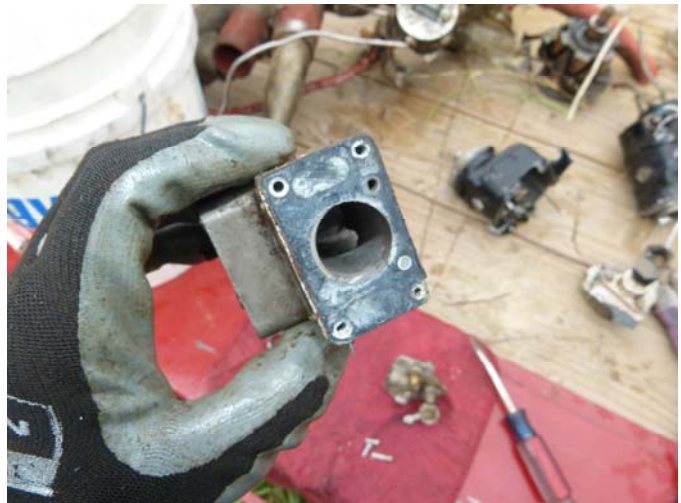
Fuel Pump

The fuel pump exhibited impact damage and only a section of the fuel pump was recovered. No indication of hard particle passage was observed in the fuel pump cavity. The diaphragm was located in the debris field and was intact.

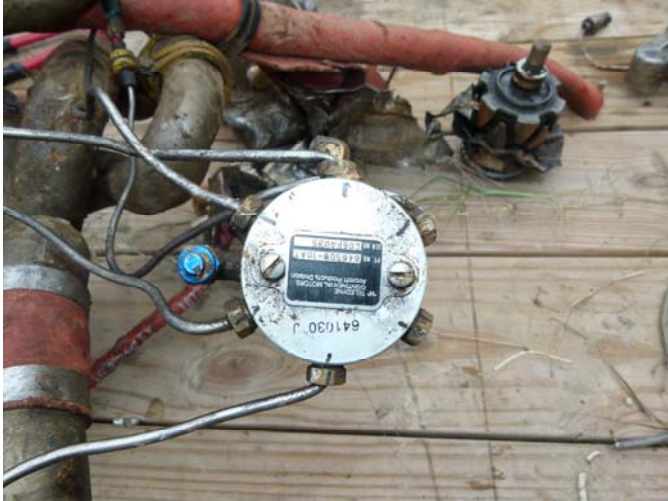
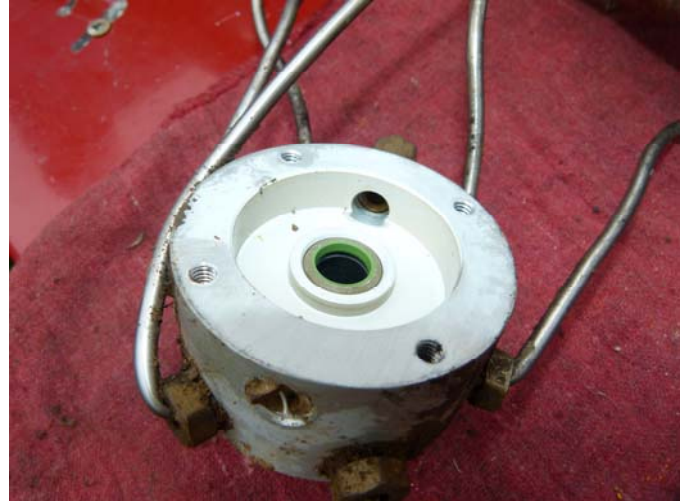
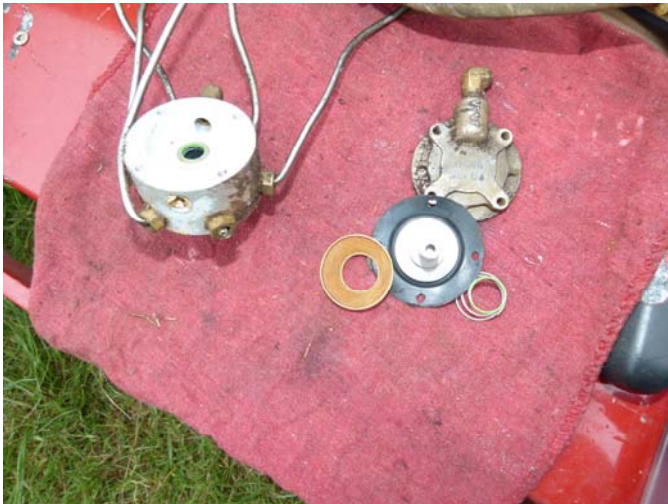
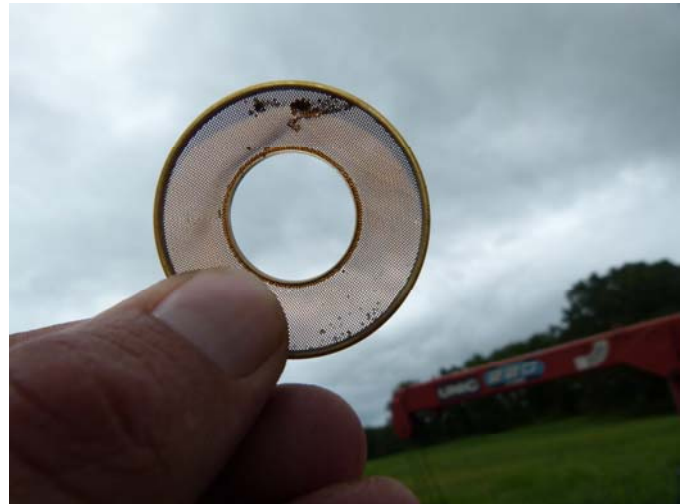
Fuel Manifold Valve    Manufacturer: TCM    Part Number: 646508-10A7    Serial #: C06FA035

Condition:    The fuel manifold valve exhibited intact safety wire and lead seal. The fuel manifold valve was disassembled and the screen exhibited minor obstructions. The diaphragm plunger and diaphragm retaining nut were tight and secure. No scoring was observed on the fuel valve assembly. No indication of fuel leakage was observed in the vent chamber side of the diaphragm. A small amount of fuel was observed in the manifold valve cavity and tested negative for water using Sar-Gel water finding paste.

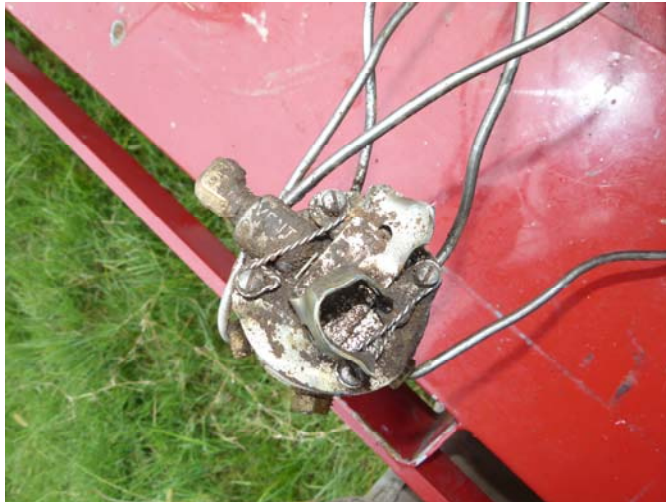
Fuel Nozzles and Lines

Condition: The fuel nozzles and lines exhibited impact damage.

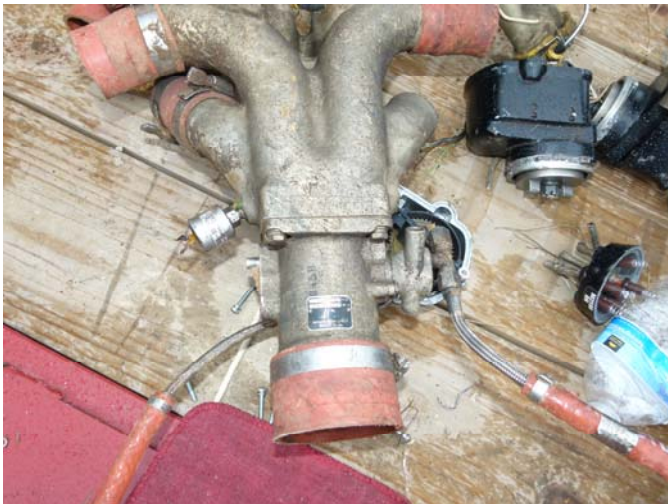
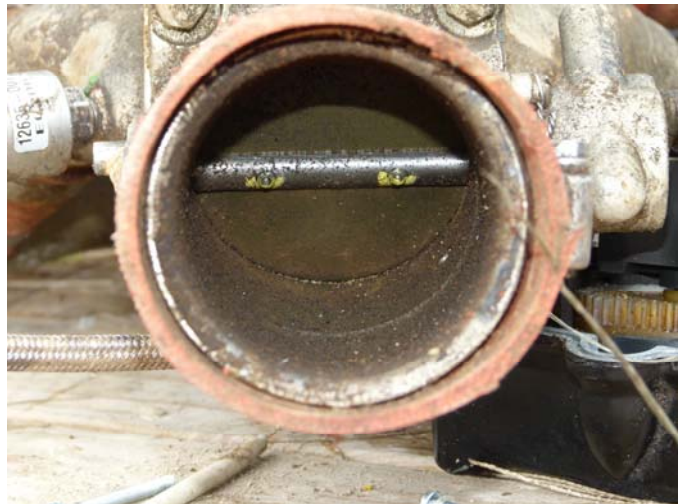
Throttle Body / Metering Unit

Condition: The throttle body remained attached to the intact manifold and was located in the debris field. The throttle body control arm was fractured.

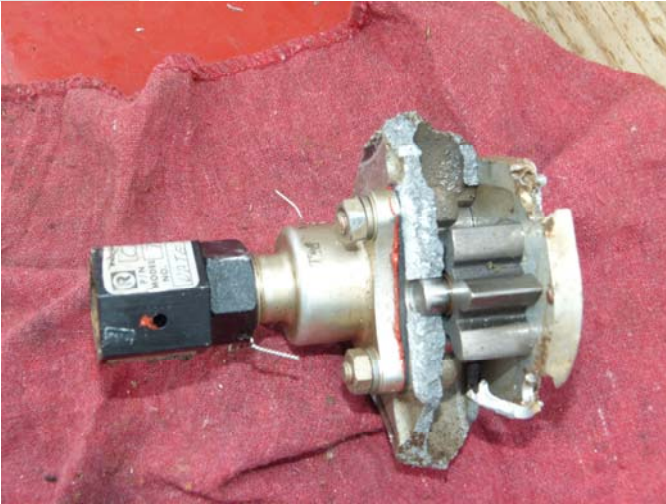
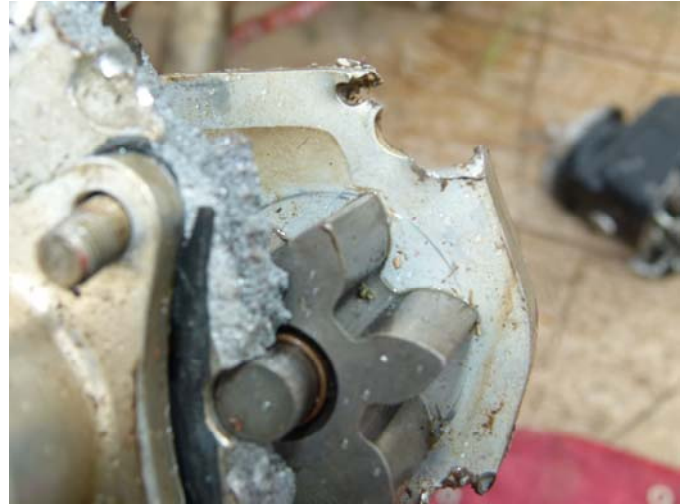
**Oil Pump** Condition: The oil pump was separated from the engine and exhibited impact damage. Marks consistent with rotation were observed on the oil pump housing.

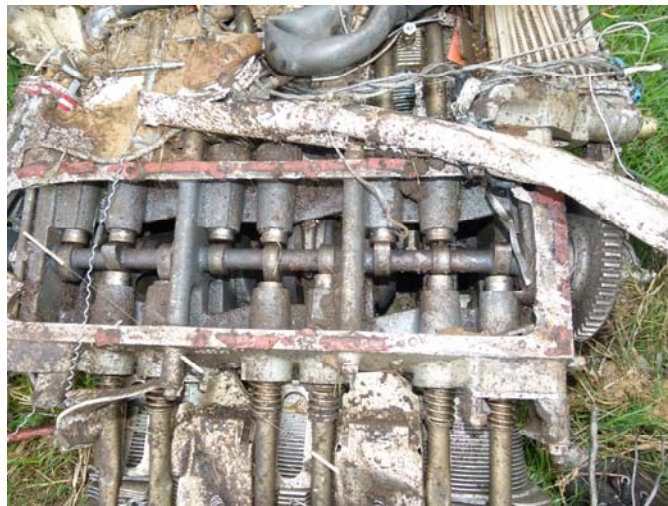
**Oil Sump** Condition: The oil sump was fractured free from the engine. Fragments of the oil sump were located within the debris field.

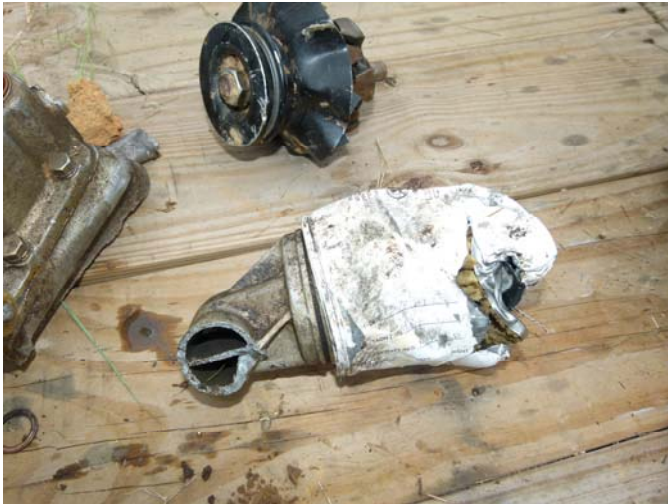
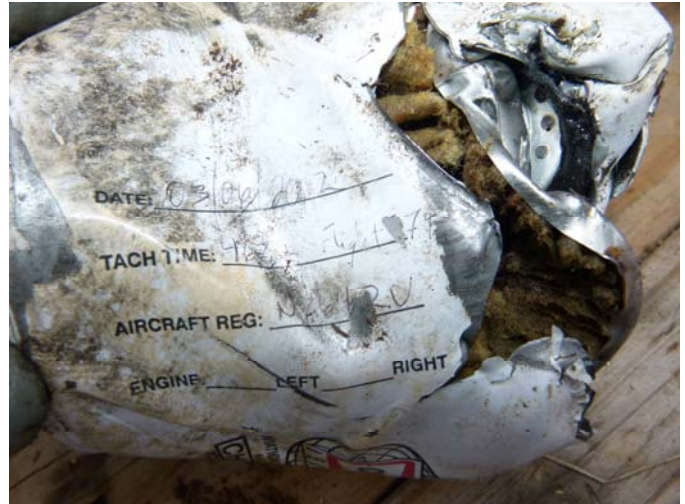
#### Oil Filter

Condition: The oil filter and oil filter adaptor were fractured free of the engine and exhibited impact damage. The oil filter housing was breached. Hand written on the oil filter was a date of "3-6-12" and Tach: "467.1".

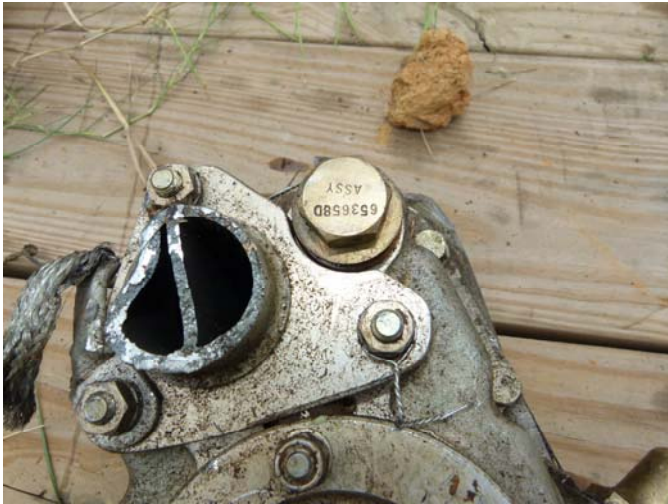
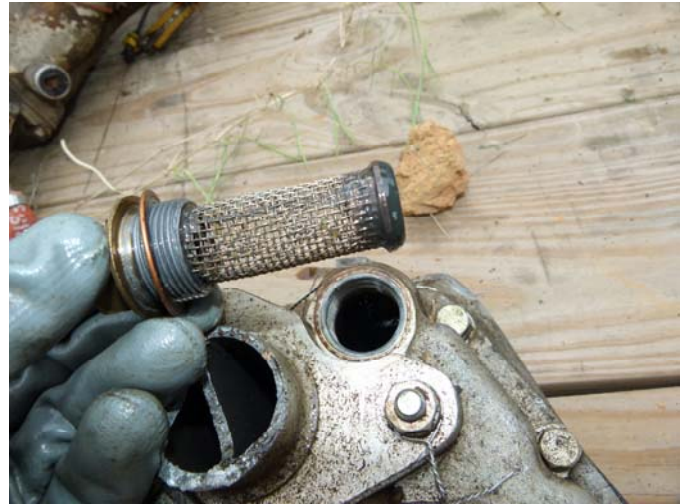
#### Oil Screen

Condition: The oil screen exhibited intact safety wire. The oil screen was clear of obstructions and a residue of oil was present.

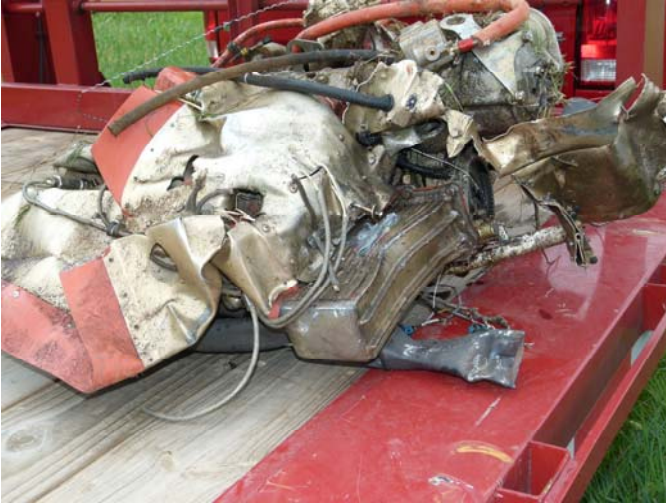
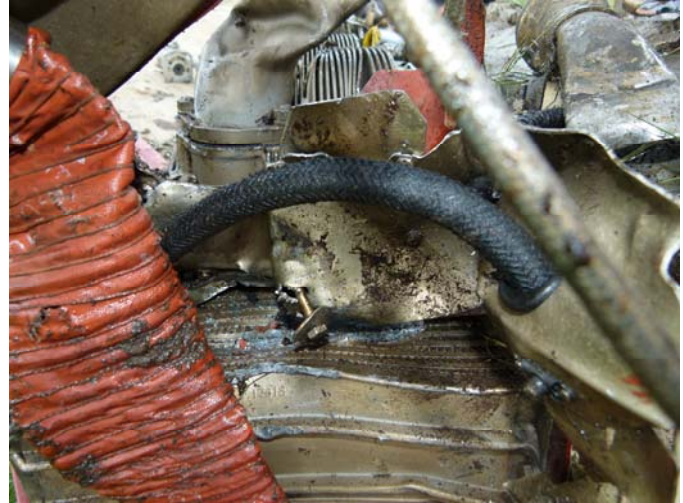
Oil Cooler

Condition: The oil cooler remained attached to the engine and exhibited impact damage.

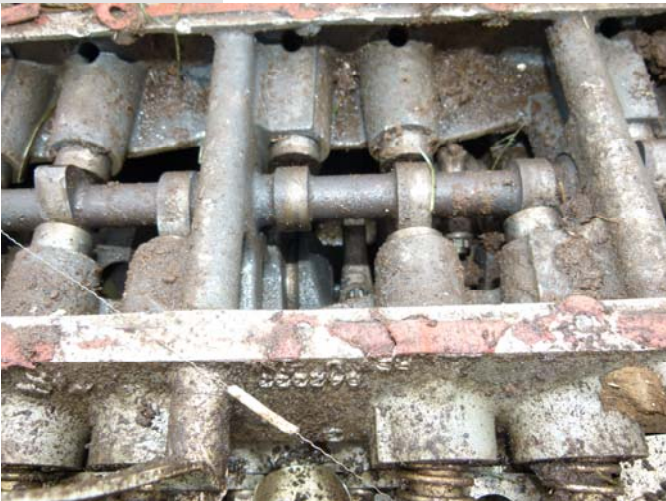
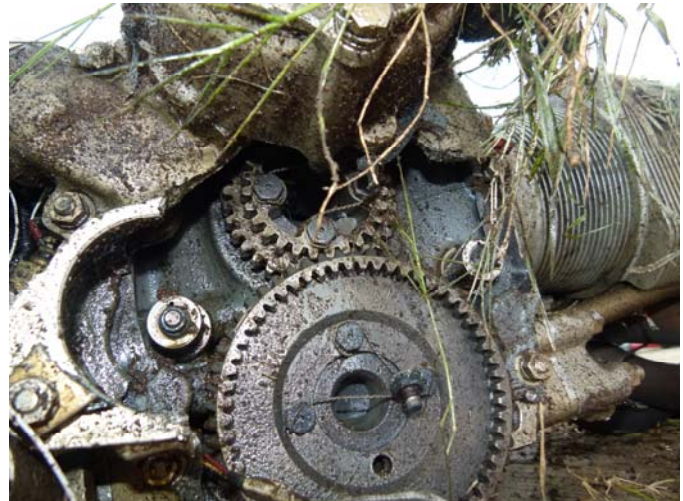
Accessory Gears

Crankshaft continuity to the accessory gears was established visually through the bottom of the engine crankcase.

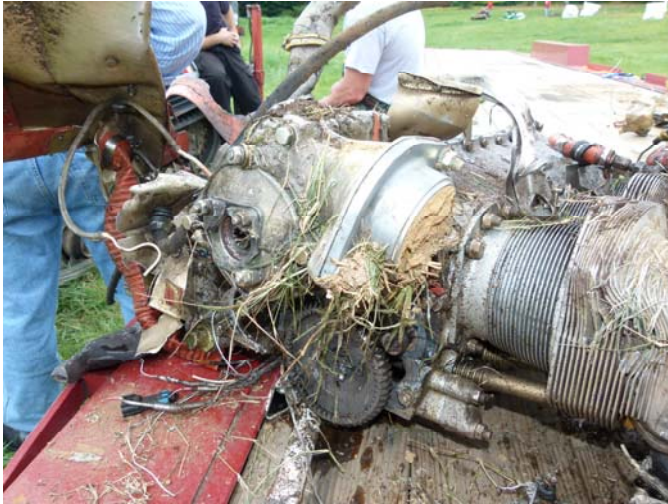
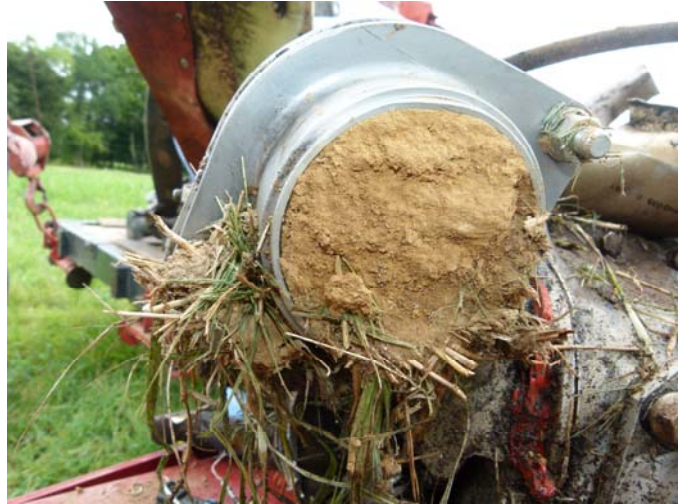
**Starter**

Condition: The starter mounting flange remained attached to the starter adaptor. The starter was not located in the debris field.

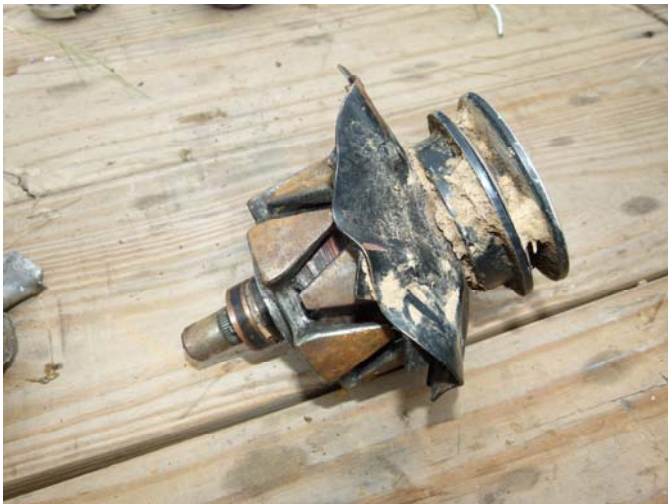
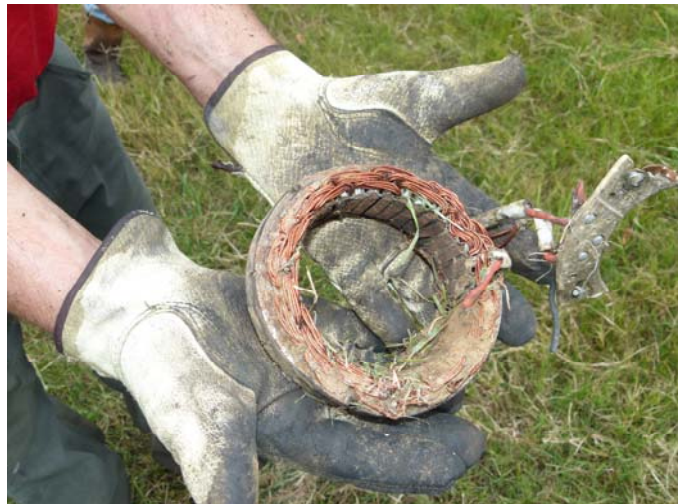
**Alternator**

Condition: The alternator was fractured free from the engine and exhibited impact damage.

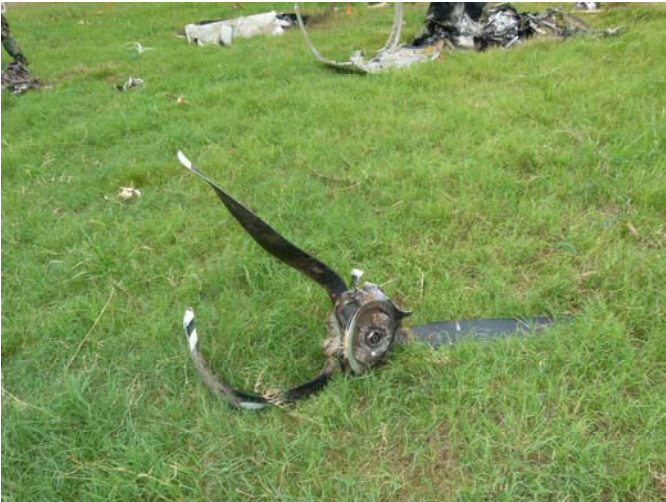
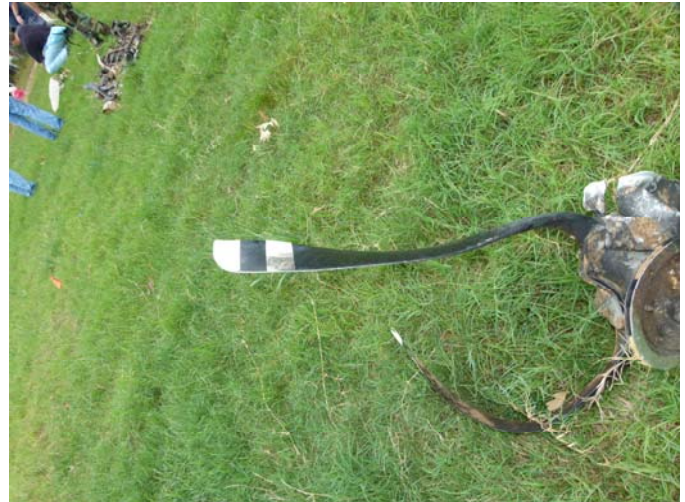
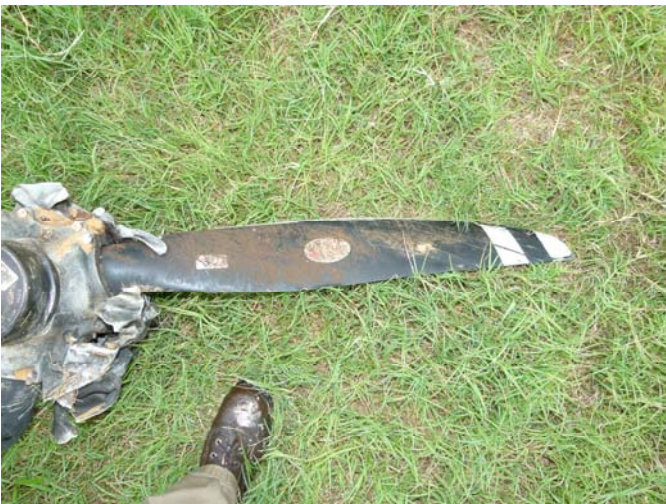
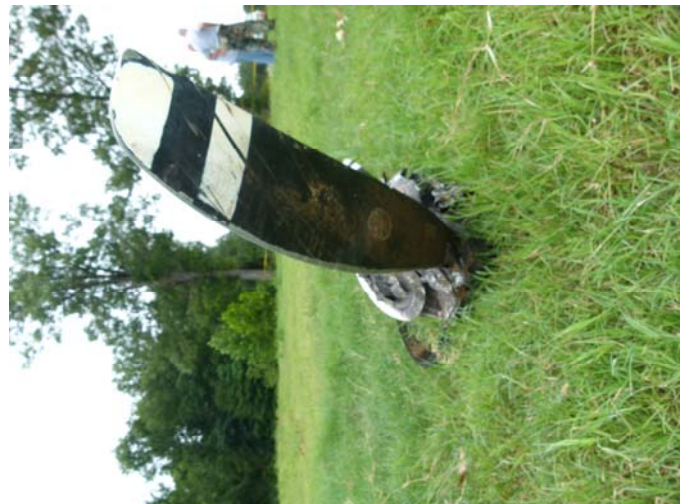
**Condition:** The propeller governor remained partially attached to the engine. The control lever exhibited impact damage and moved freely by hand through its full range of travel. The propeller governor drive shaft was fractured. The propeller governor oil screen was clear of obstructions

**Condition:** Blade one was fractured free in the hub and bowed approximately 90 degrees aft and twisted. Blade one exhibited chord wise scratches on the cambered face. Blade two exhibited leading edge polishing and "S" bending. Blade three was bent aft and exhibited leading edge polishing and chord wise scratches on the cambered face.
