Turbomeca On Site Examination Report

NTSB Reference:
 TM USA Reference:
 TM FR Reference:
 Event Date/Time:
 Event Location:
 Operator:
 Aircraft Type:
 Aircraft S/N:
 Aircraft Registration:
Engine 1
 Variant:
 Engine S/N:
Engine 2
Variant:
 Engine S/N:

<i>ERA13LA242</i>
<i>(A-2013-006)</i>
<i>(RA/13/112)</i>
<i>(08MAY2013) /(0925)</i>
<i>(South Bay, FL, USA)</i>
<i>Mile High Inc.</i>
<i>AS318C</i>
<i>2031</i>
<i>N318DB</i>
<i>0236045100</i>
<i>Astazou IIA2</i>
<i>678</i>

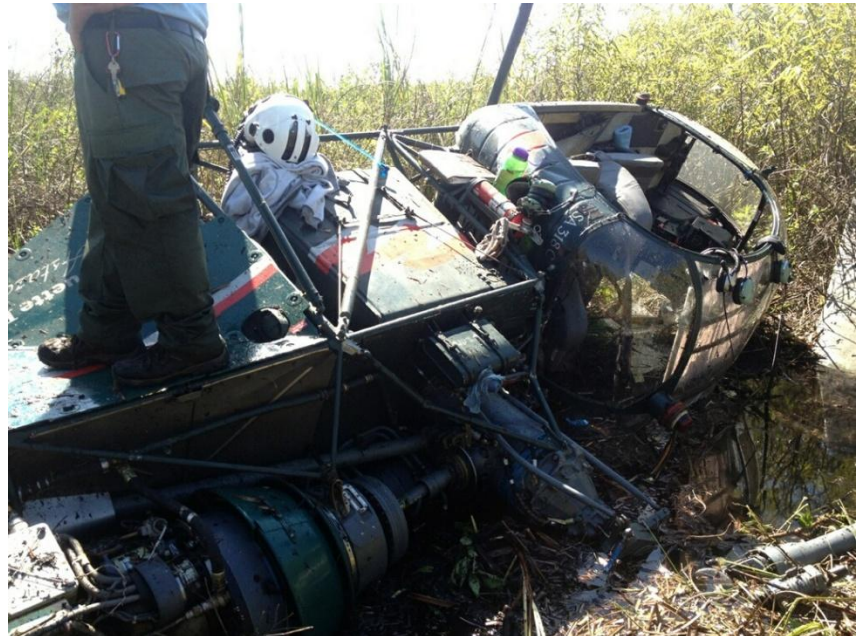
Accident Site Photo

- **Circumstances reported to Turbomeca:**
During a wildlife survey flight, the helicopter was hovering at 20 feet when the pilot reported a decrease in the engine power. The aircraft crashed into a marsh and came to rest on its right-hand side.

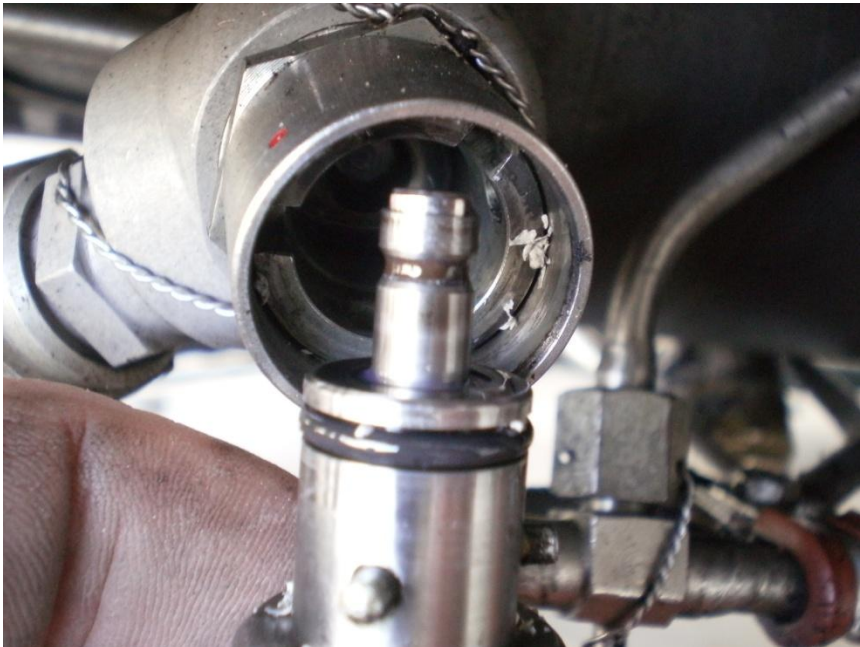
Magnetic Plug Photo

Equipment	Condition
Magnetic Plug	Clean

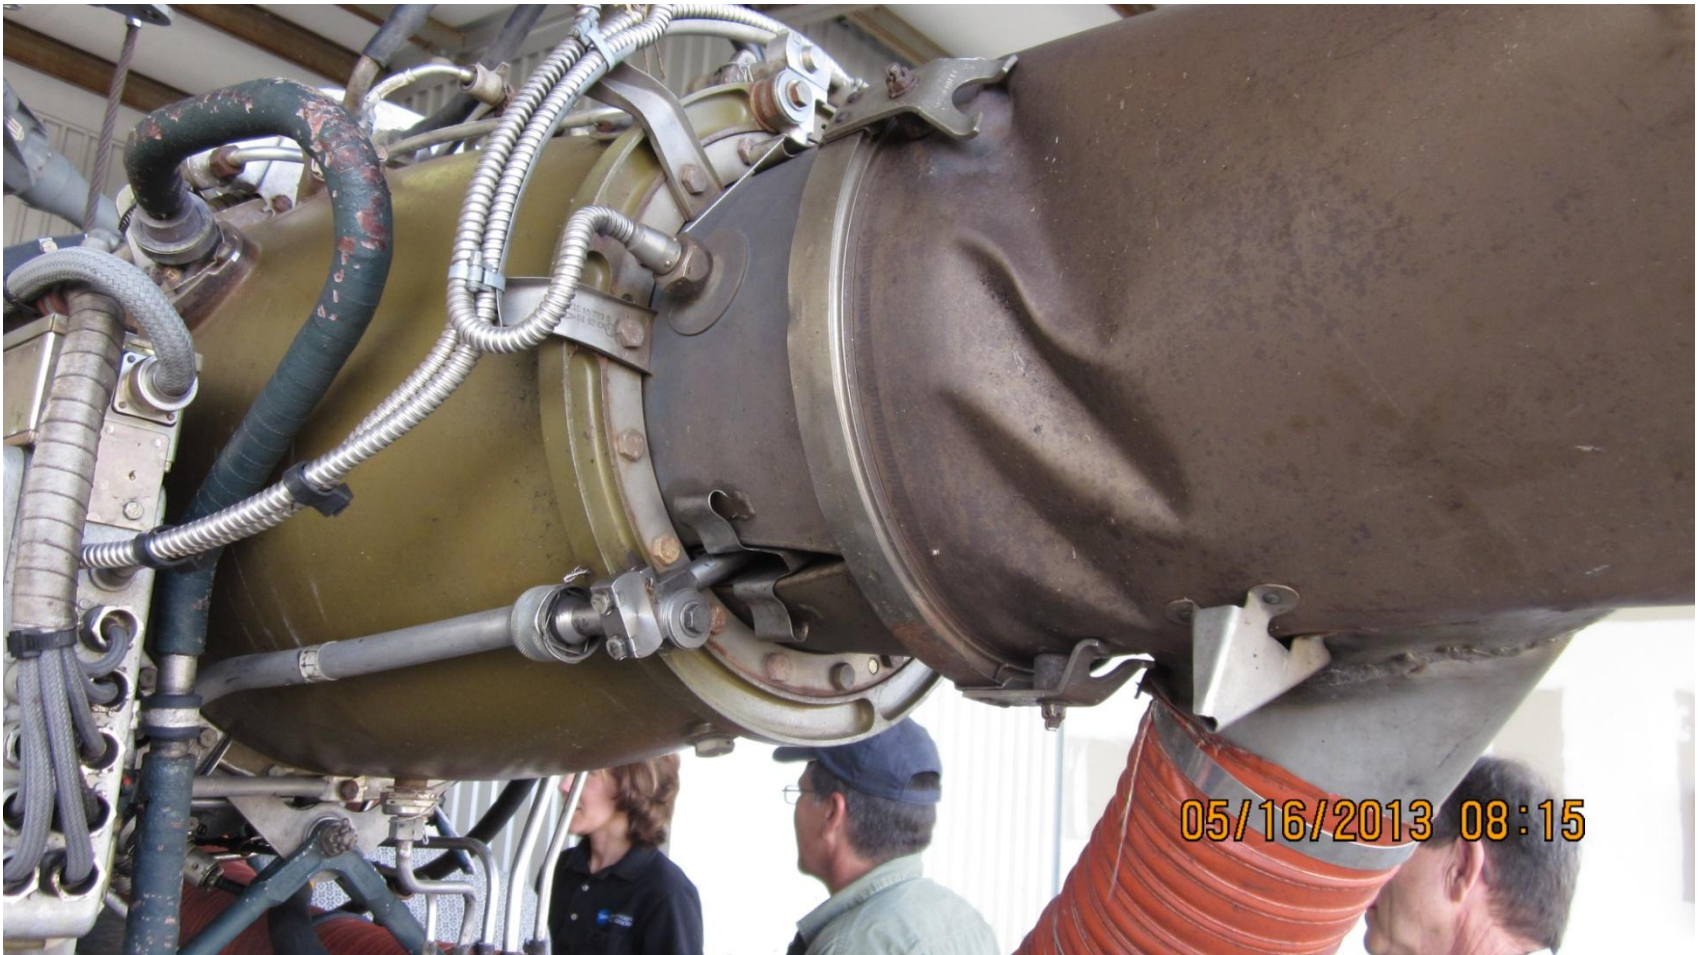
Engine 1 Overall Engine Photo

Other than a distorted exhaust pipe the engine appeared to be undamaged. The air intake cowling was removed and the gas generator could be easily turned by hand. All fuel, oil, and air lines were tight and secured properly. No engine anomalies could be found that would prevent normal operation.
