Continental Motors

ENGINE RUN REPORT

| ENGINE MODEL | TSIO520R |
| FILE NUMBER | 14-491 |

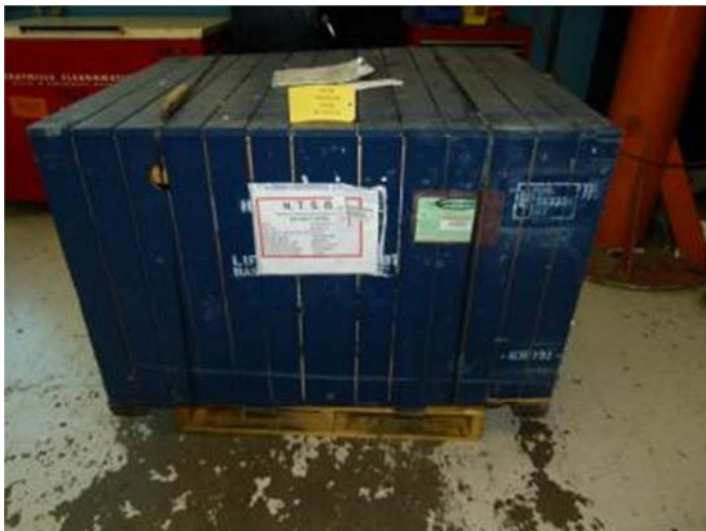
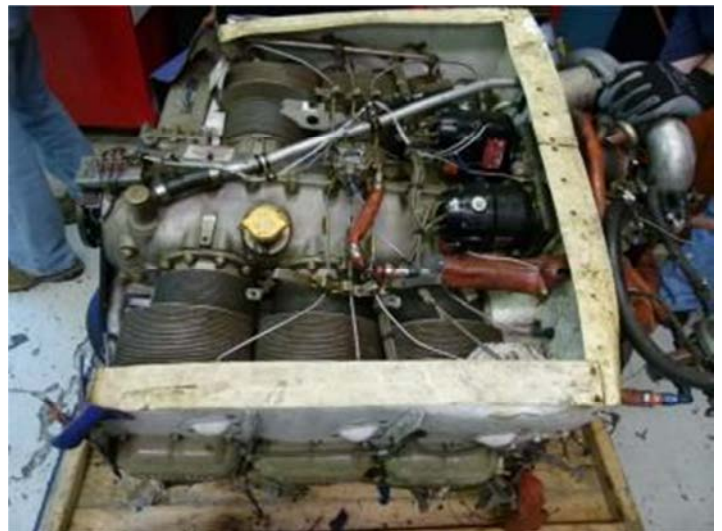
The engine exhibited impact damage to the left front side of the engine. The number six cylinder push rod housing seat was fractured away and the cylinder was replaced for test run. The oil sump was crushed upward to the bottom of the engine and was replaced for the test run. The inlet fuel fitting on the fuel pump was fracture and replaced for the test run. The throttle arm was not returned with the engine and was replaced. The induction runners and exhaust system were impact damaged and replaced with slave units for the test run. The left front and rear engine mounts were fractured and replaced. The number six rocker cover was fractured and replaced for the test run. The right magneto was impact damaged and the flange fractured at the mount hold down clip. The oil cooler lower mounting studs were fractured and replaced for the test run.
