National Transportation Safety Board

Marine Accident Brief

Engine Room Fire Aboard Cruise Ship *Carnival Liberty*

Accident no.	DCA15FM035
Vessel name	<i>Carnival Liberty</i>
Accident type	Engine room fire
Location	West Indian Company Dock, Charlotte Amalie, St. Thomas, US Virgin Islands 18°20'N, 64°55.3'W
Date	September 7, 2015
Time	1133 Atlantic standard time (coordinated universal time – 4 hours)
Injuries	None
Property damage	\$1.725 million est.
Environmental damage	None
Weather	Daylight, clear skies, temperature 86°F (30°C), southeast winds at 10 knots
Waterway information	Port of Charlotte Amalie, St. Thomas

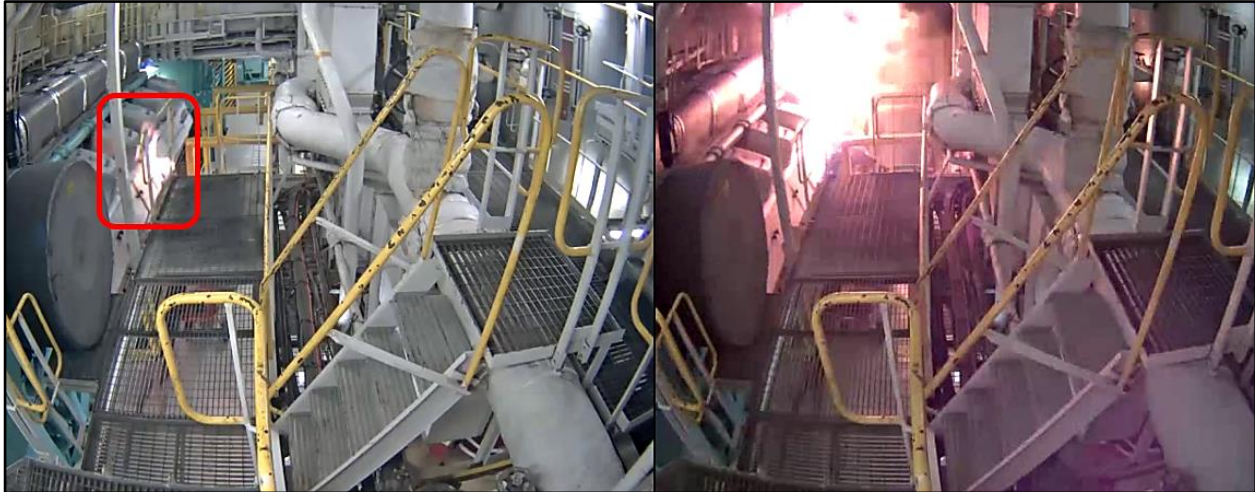
Images from the ship's closed-circuit television of DG 4 from forward looking aft. The red box on the left image highlights the first visual sign of open flame. The right image shows the same area less than 1 second later.

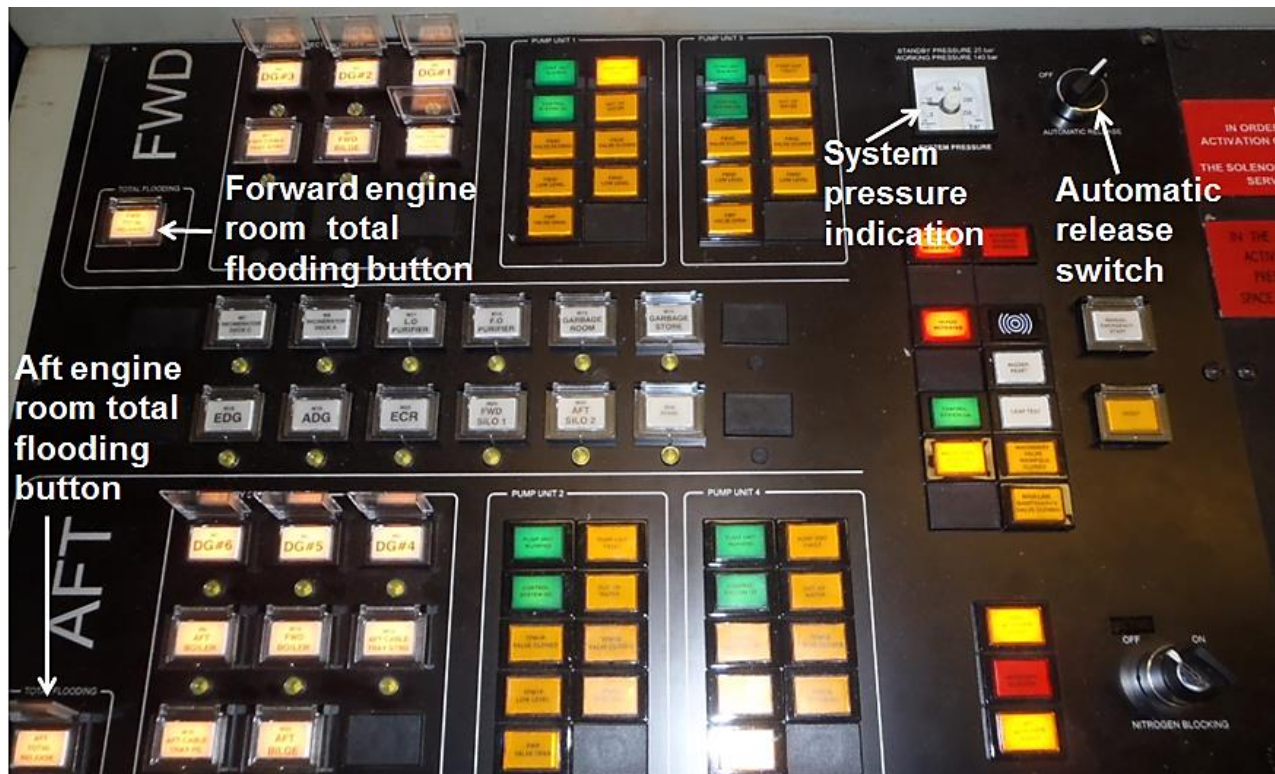
The HI-FOG control panel in the ECR at 1207, about 35 minutes after the fire started. The panel indicates that all section valves in both the forward and aft engine rooms are open. The system pressure in this picture is 26 bar. (Photo by Carnival Cruise Line)

The HI-FOG system continued to operate with low-pressure readings and, at 1203, the master asked the chief engineer why the system did not have adequate pressure. The chief engineer informed the master that all pump skids were running and that the “total flooding” section valves were open in both the forward and aft engine rooms. To address the low pressure, the chief engineer requested that the HI-FOG system be reset, which would stop the water-mist in both engine rooms, and they could then reactivate the system in the aft engine room where the fire originated. About 1211, the ECR crew shut down the HI-FOG system to reset it. Doing so restored all locally activated section valves to the closed position, and the operating pressure began returning to normal. About 2 minutes later, the ECR crew informed the bridge crew that the HI-FOG system was back online with “total flooding” mode in the aft engine room. The bridge crew requested the safety officer to have the fire squads take temperature readings on bulkheads adjacent to the aft engine room to verify that the fire was extinguished.

It is significant that the crewmembers were unaware that the HI-FOG system was incapable of delivering total flooding to both engine rooms simultaneously, and that they then had to use the CO₂ system to try to extinguish the fire. Furthermore, they did not consider, nor did any checklist specify, returning the HI-FOG system to automatic from manual mode immediately after confirmation of a fire. According to the system manufacturer, returning the HI-FOG system to automatic mode would have activated the HI-FOG section valves only in affected areas (based on smoke- and flame-detector activations). The NTSB concludes that comprehensive crew training and familiarity regarding the use and limitations of fixed water-based local application systems in machinery spaces are crucial to safe operations. The NTSB therefore recommends that Carnival Corporation & PLC implement ship-specific familiarization training regarding the use and limitations of fixed water-based local application systems in machinery spaces.

Implement ship-specific familiarization training regarding the use and limitations of fixed water-based local application systems in machinery spaces. (M-17-18)

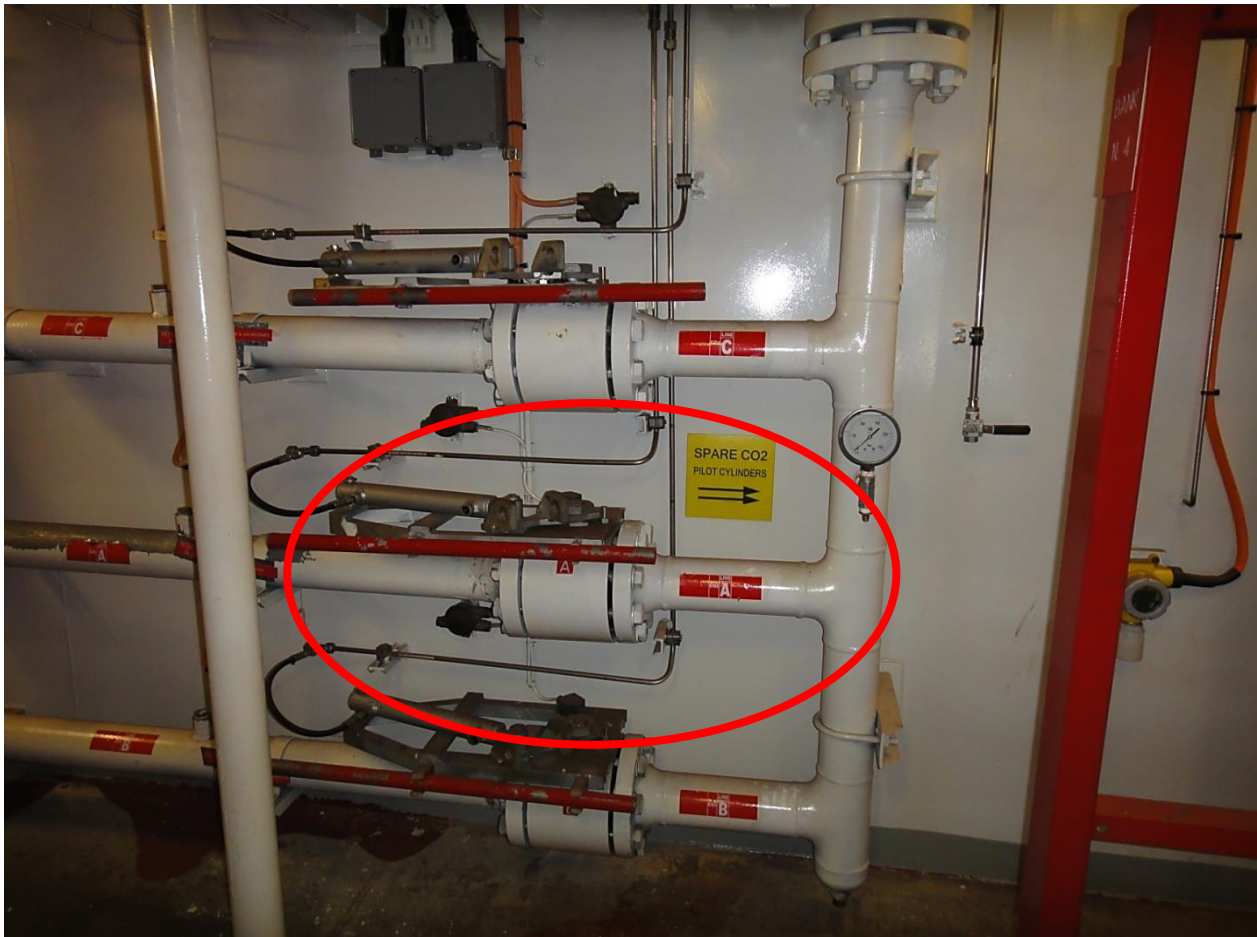
However, a valve that directed the CO₂ toward the aft engine room did not operate properly and triggered a gas leakage alarm in the CO₂ room on deck 11. An engineer whose emergency duty was to stand by at the CO₂ room heard the alarm, donned a self-contained breathing apparatus (SCBA), and entered the space to investigate. Inside, he noticed that directional valve A was partially open, so he kicked the hydraulic arm to ensure that the valve was completely open. Investigators were later provided with a postaccident maintenance test report.¹⁰ It identified a

missing gasket for one of the pilot cylinders as the reason for the partial opening of the directional valve. The report stated that the missing gasket and, in turn, the partially open directional valve “generated a loss of pressure inside the directional valve control line.”

CO₂ directional valve A that had to be kicked to a fully-open position.

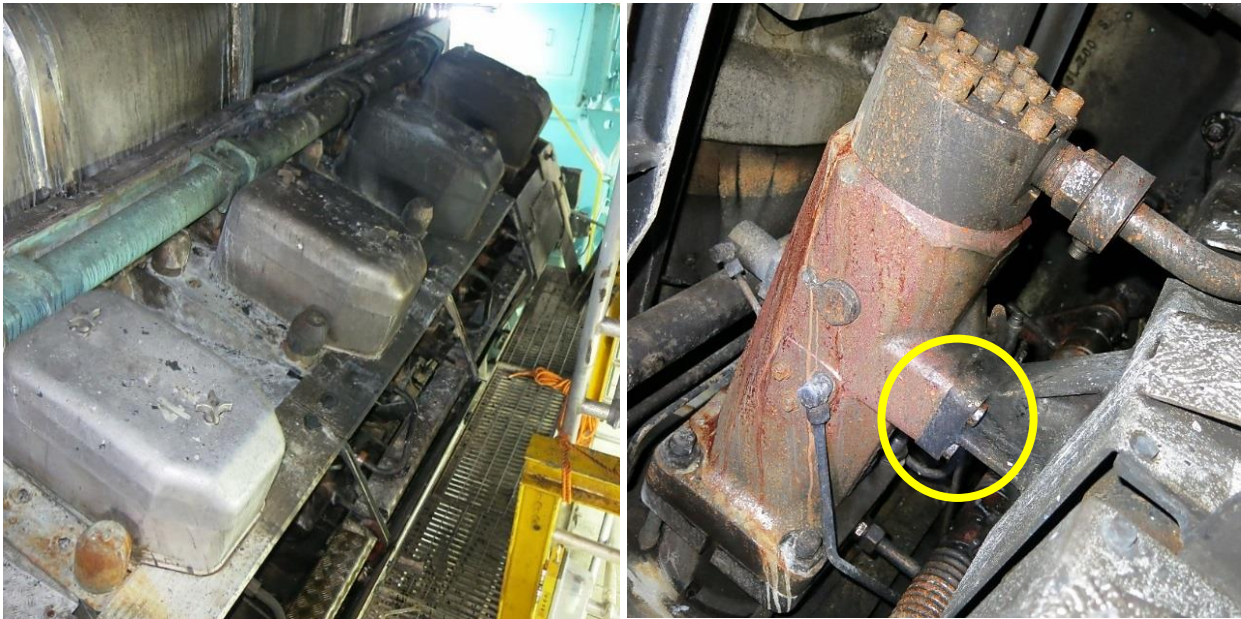
The fire on DG 4 originated from the fuel supply inlet flange for cylinder A2's high-pressure fuel-injection pump. Investigators found that one of the four flange bolts was missing and another was loose but attached.¹² The missing bolt was found in the gallery for the cylinder bank and was collected for laboratory examination along with the loose bolt still attached to the flange.

Left, location of the fire in the A bank of DG 4. Right, fuel-injection pump for cylinder A2 with suspect flange circled in yellow after the fire.

The NTSB concludes that the source of the fuel spray was loosened bolts on the fuel supply inlet flange to DG 4, likely resulting from improper tightening during prior maintenance and vibration of the piping over time.

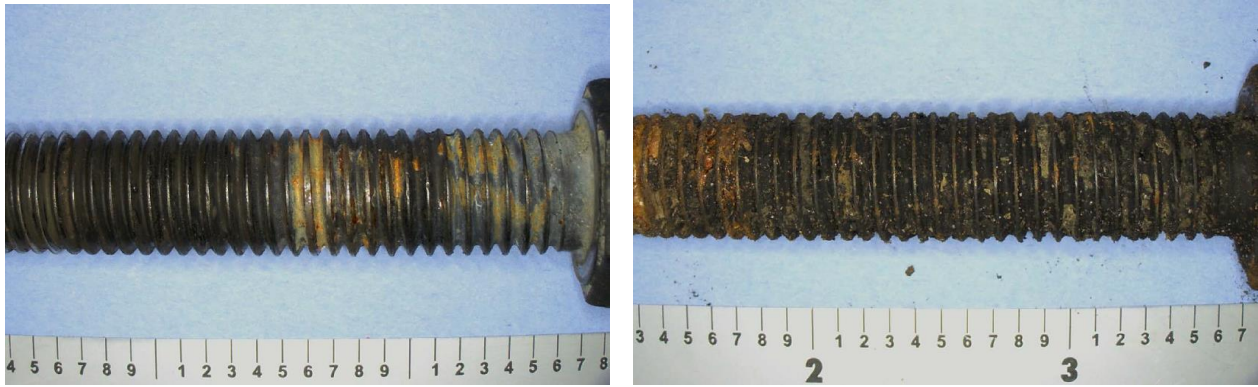
The laboratory examination of the two bolts, conducted at NTSB headquarters in Washington, DC, confirmed that neither bolt was deformed or showed signs of being stretched. Further, the detached bolt had no wear on its threads; the attached but loose bolt had rotational wear in three of its threads (11–13).

Subsequent testing by a commercial laboratory of the two bolts, along with the two remaining bolts from cylinder A2 (not examined by the NTSB), found no signs of excessive or insufficient bolt preload such as thread-root cracking or plastic deformation of the threaded bolt shank.

Left, the bolt found attached to the housing of the fuel-injection pump for cylinder A2. Discoloration and residue can be seen in some of the threads. Right, the bolt that was found detached.

The Wartsila 46 diesel engine instruction manual that was provided to investigators specified tightening torques for multiple bolt connections for the fuel-injection pump.¹³ Specific torque values for the bolts that connected to the fuel supply inlet flange were not included; however, the torque value for their dimensions and strength class was outlined in a general table called “Tightening Torques for Other Screws and Nuts.” It recommended that torque-measuring tools be used when tightening screws and nuts. None of the crewmembers that investigators interviewed were present at the time of the last maintenance and did not know if torque-measuring tools, which were available aboard the ship, were used when reconnecting the fuel-injection pump.
